Status and plans for the LHCb VeLo motion system re-validation

Victor Coco (CERN) for the VELO Group

Analysis of the LHCb VELO RF Foils Incident and First Actions

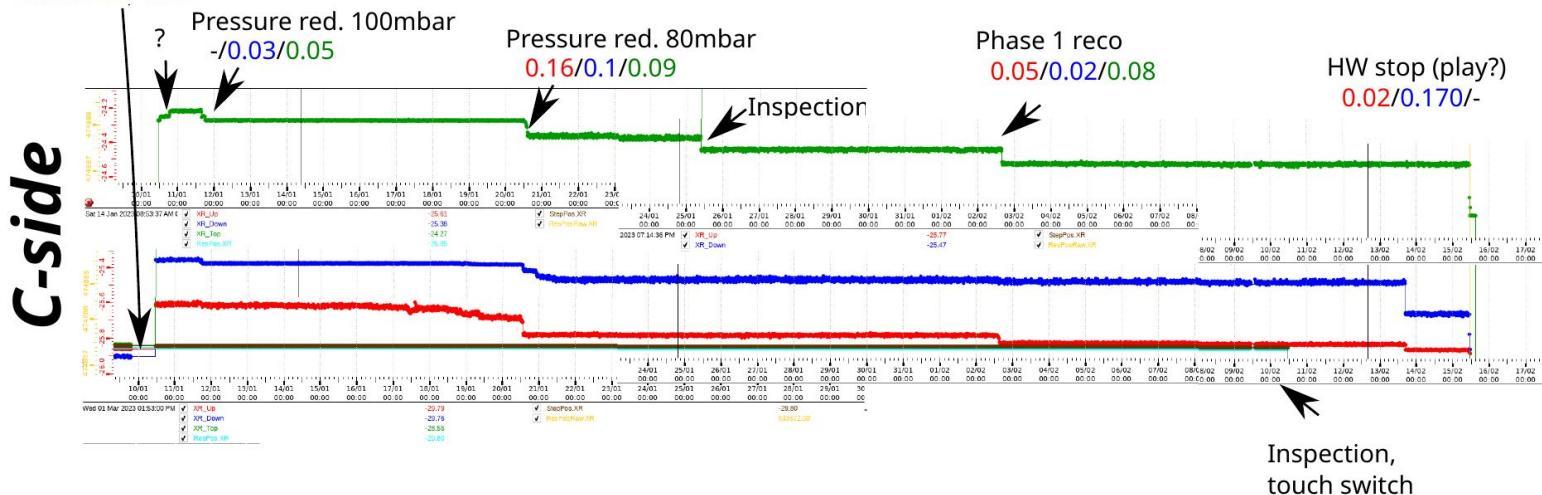
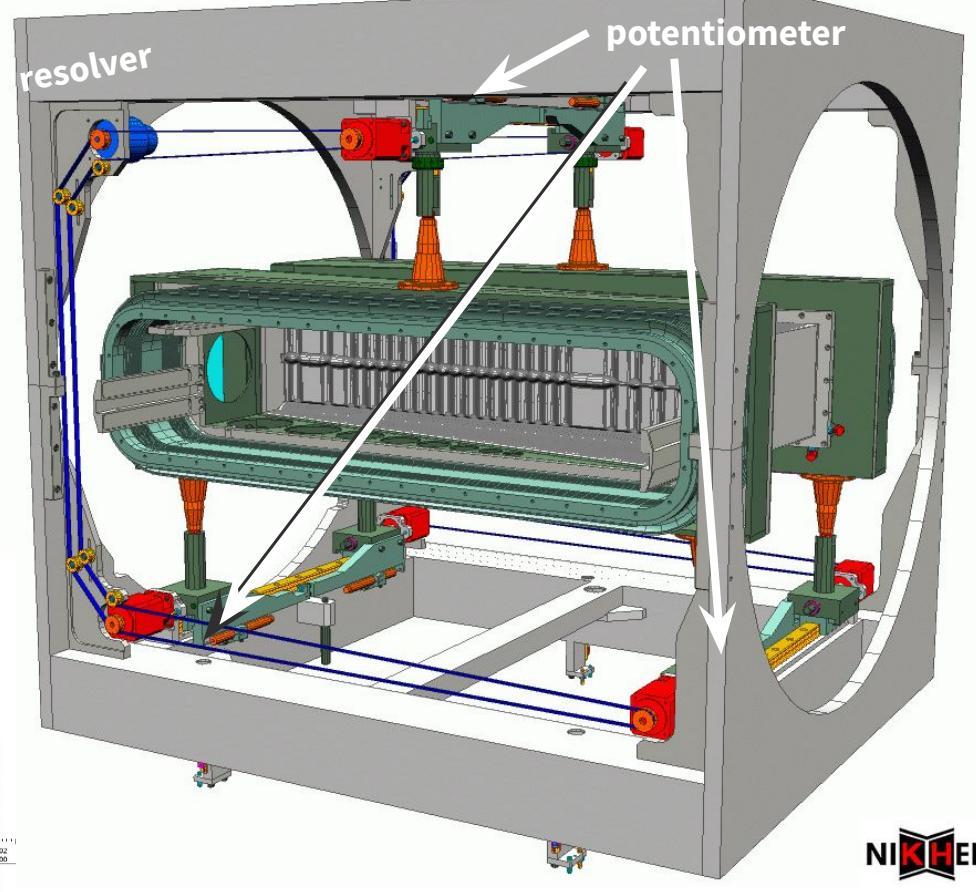
Movement seen on the motion system during the event.

- monitoring was unfortunately OFF during event (all control/monitoring machines were down in preparation for the AUG test)
- Pressure difference pulled on the two halves
- Movement seen on the potentiometer (ie mvt of the detector support cart)
- No significant movement on the resolver (1 step C side, 4 A side, ie few um)
- position relaxed with rebalancing the pressure
- all indicate the movement seen on potentiometer is propagated to the VELO
- beamline reconstruction will give clear answer.

Incident 0.25/0.55/1.56

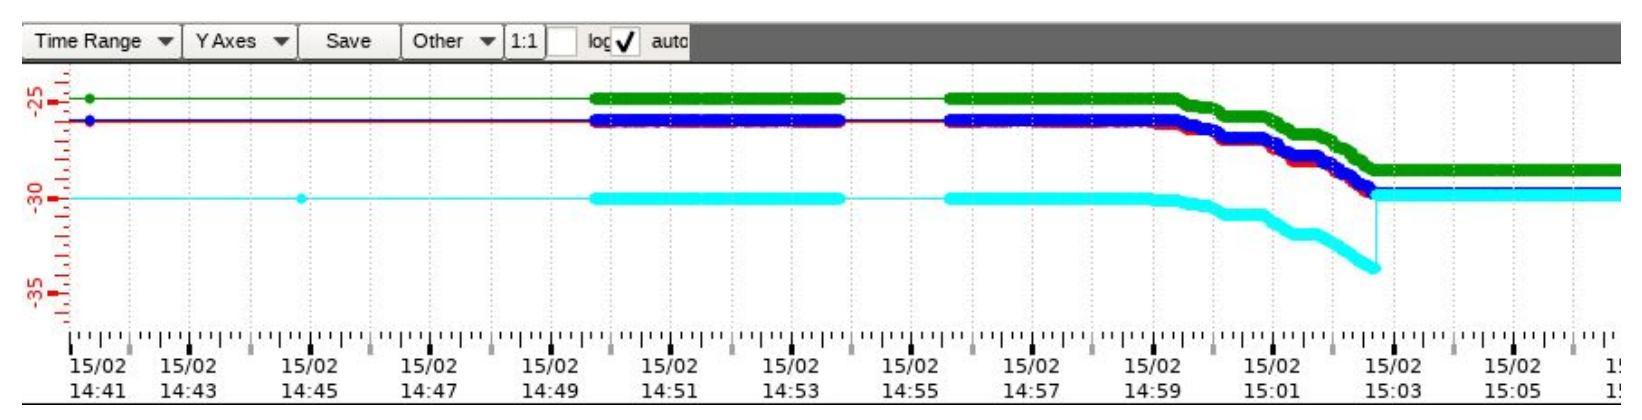
• Good response of the system during test

- small movement between -26/28mm and -29.8/29.8mm
- \circ residual displacement of the top support by 1.25(0.9)mm on C(A)-side

• Hypothesis is deformation of the coupling piece

stress test on-going, significant elastic deformation and deformation by more than 1mm seen, data to be further analysed and quantified

• Re-qualification procedure to be defined

- inspection of coupling pieces need to be done with half closed
- only possible after tomography: with one foil open and one closed closest approach ~1-2mm ie risk of collision

⇒ HW and SW limits on the motion system for now

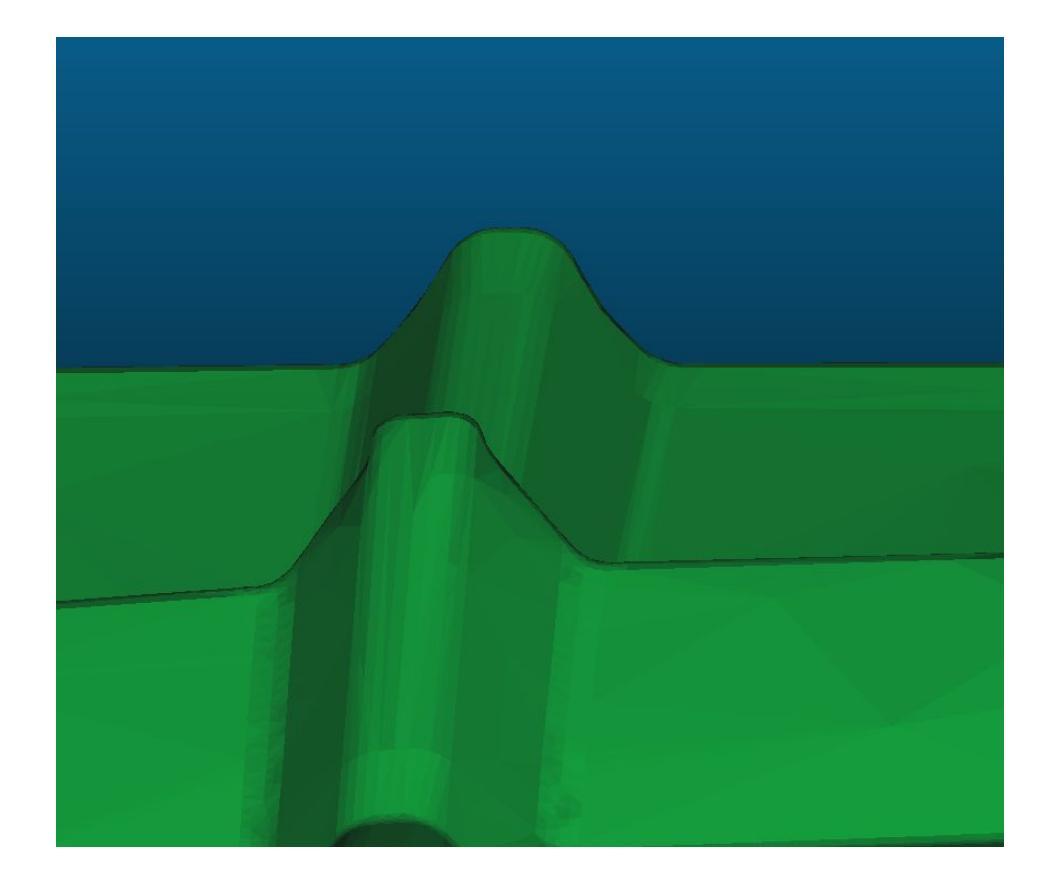
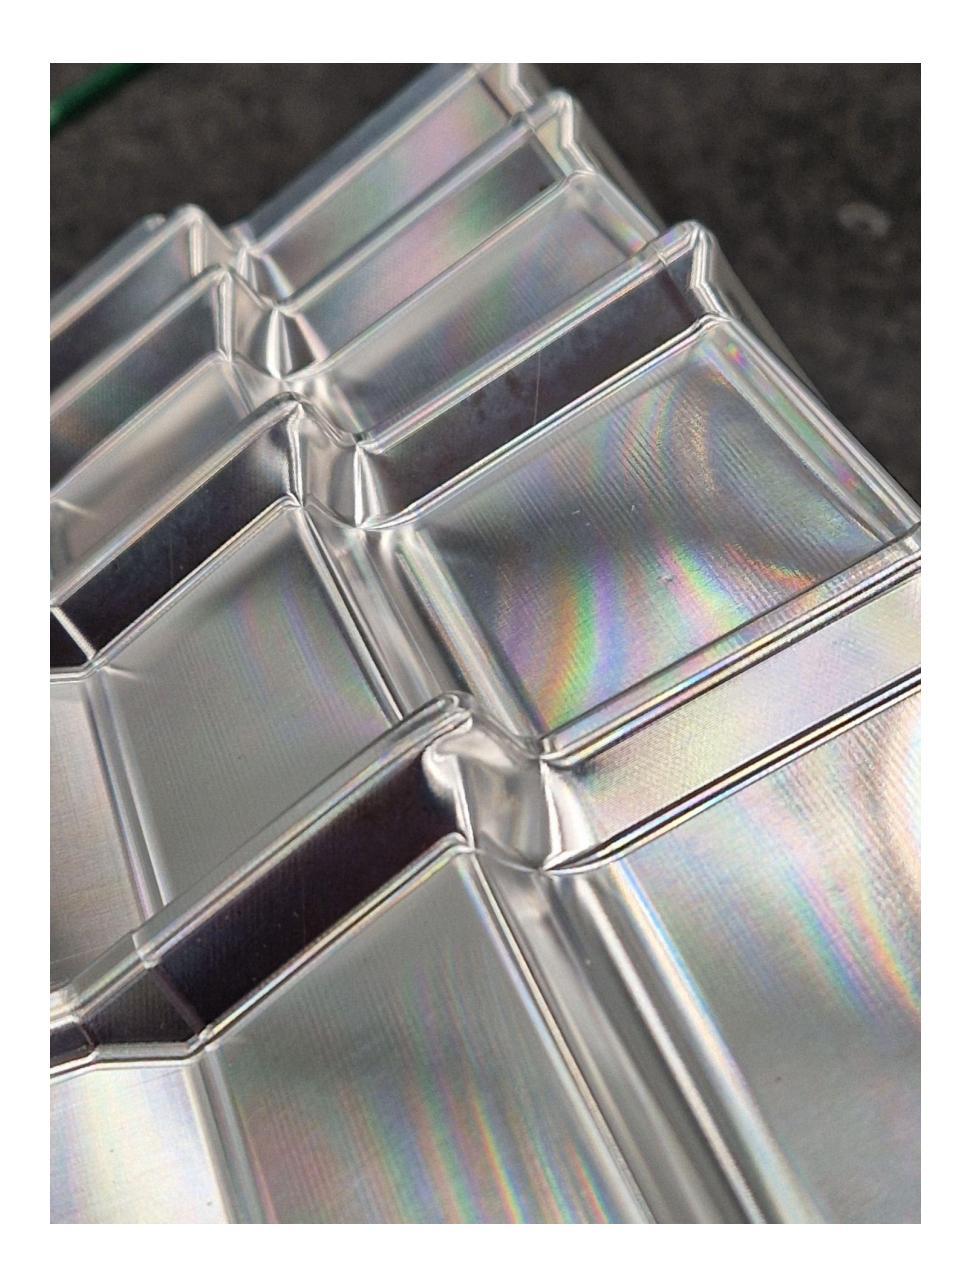
Simulations of the half box

• Local buckling reproduced in simulation

- here with coarse mesh at the same place
- more detailed "pinching" with smaller mesh on the large foil

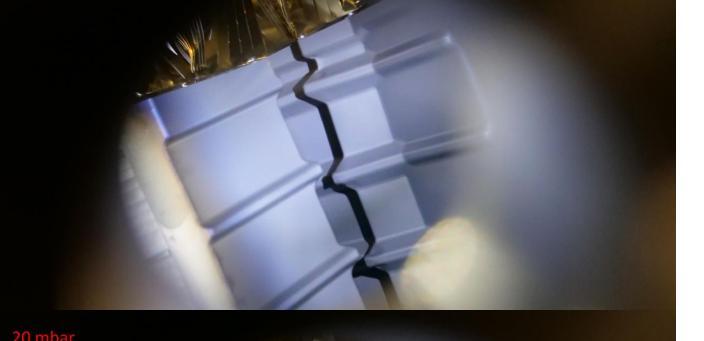
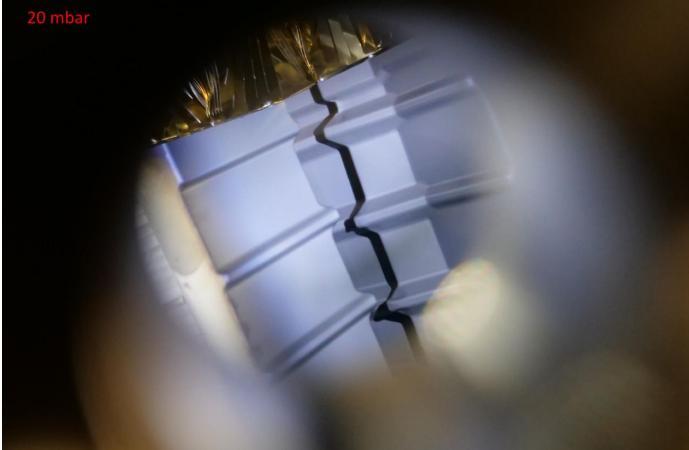
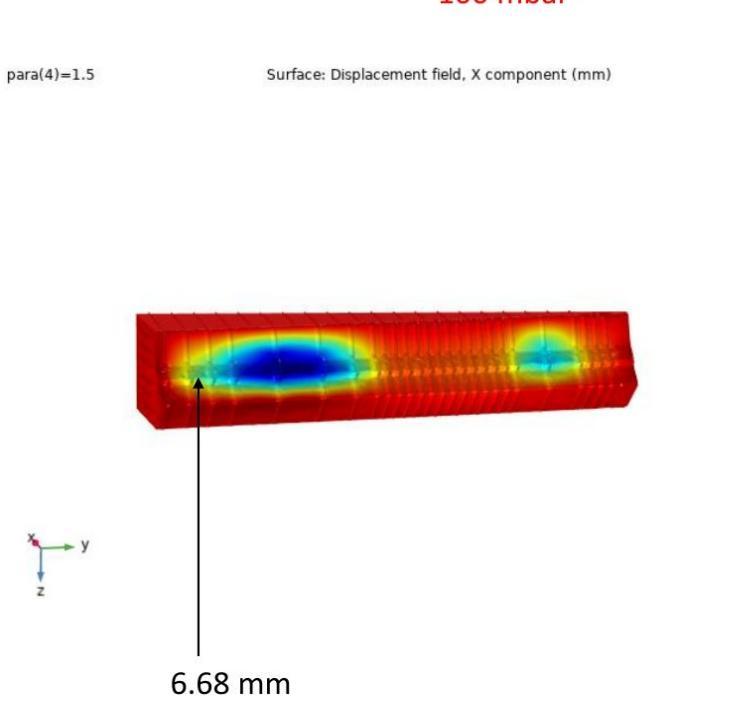
Comparison with view port

Net displacement (derived from mapping): 1.96 mm- 0.85 mm= 1.11 mm

Important: x displacement = perpendicular to view port 100 mbar

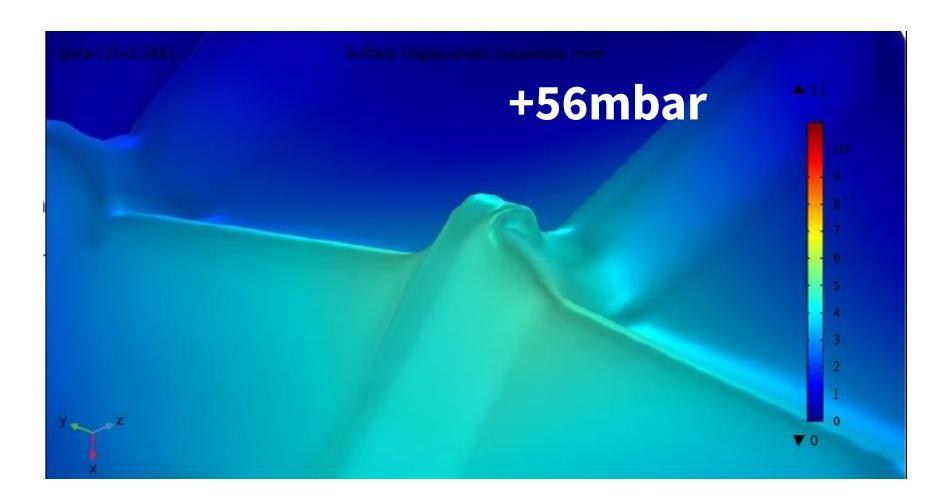
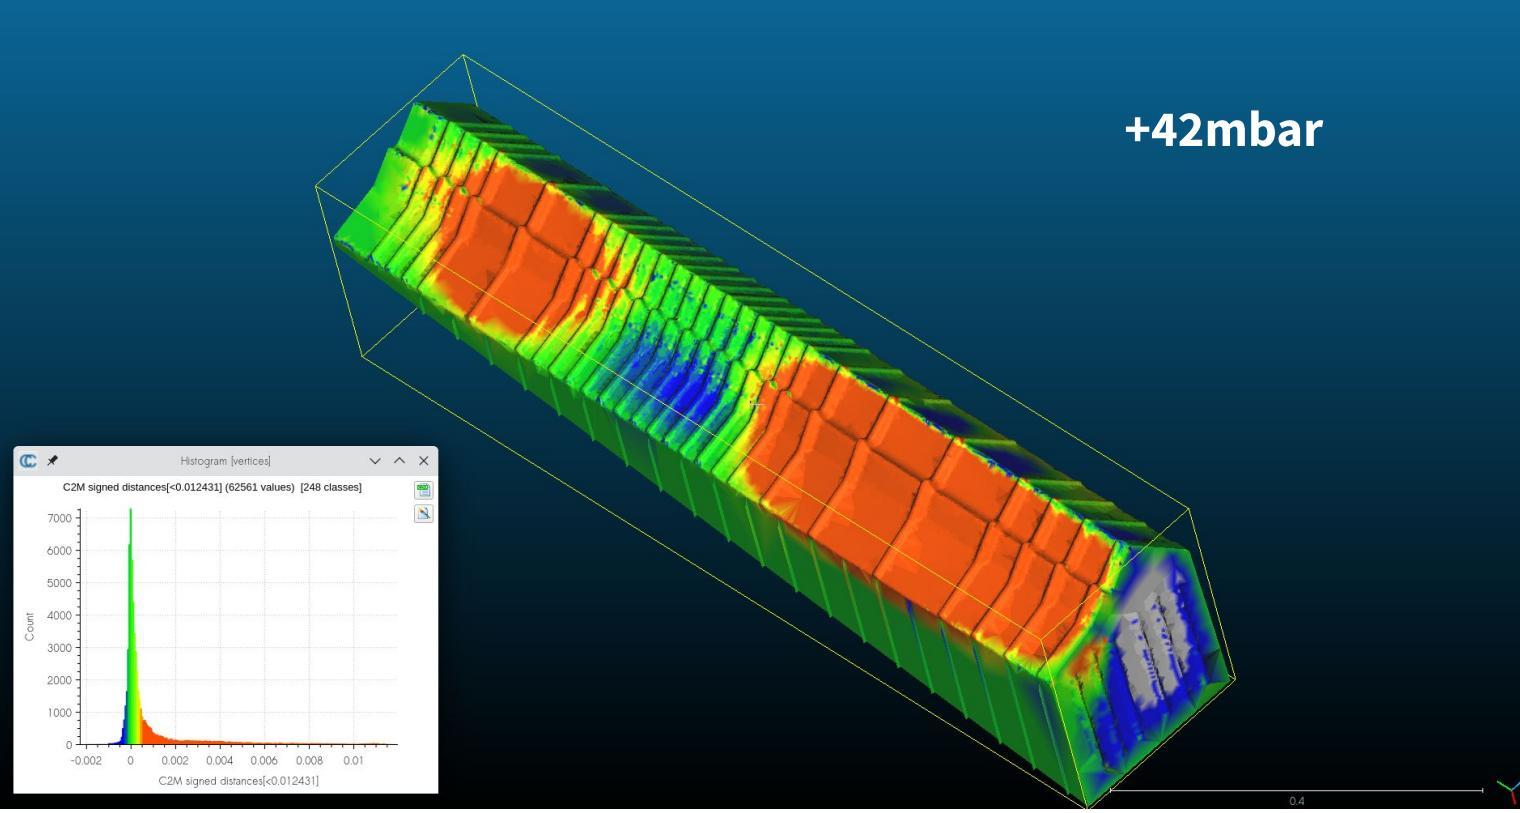
Full box simulation Non-linear buckling analysis

- **REMINDER: Safety limit @+10mbar**
- At +42mbar some part with negative displacement (still within <1mm of the nominal foil close to sensor slots)
- At +56mbar strong local buckling and instabilities

- On the basis of the simulation and measurement @ Nikhef, there is a consensus that:
 - it is safe to go to Ombar with the detector in
 - it is safe to go to +2mbar with the detector in

- Everything indicates it should be safe to go to +10mbar with the detector in BUT if there is a safe way to avoid it, until we either replace the foil or remove the detector it should be considered

- 3 possibilities:
 - go to +2mbar, remove the detector, finalise with +10mbar, put back the detector (not recommended unless we change the foil)
 - go to +2mbar, keep the detector in, operate without risking +10mbar until we change the foil

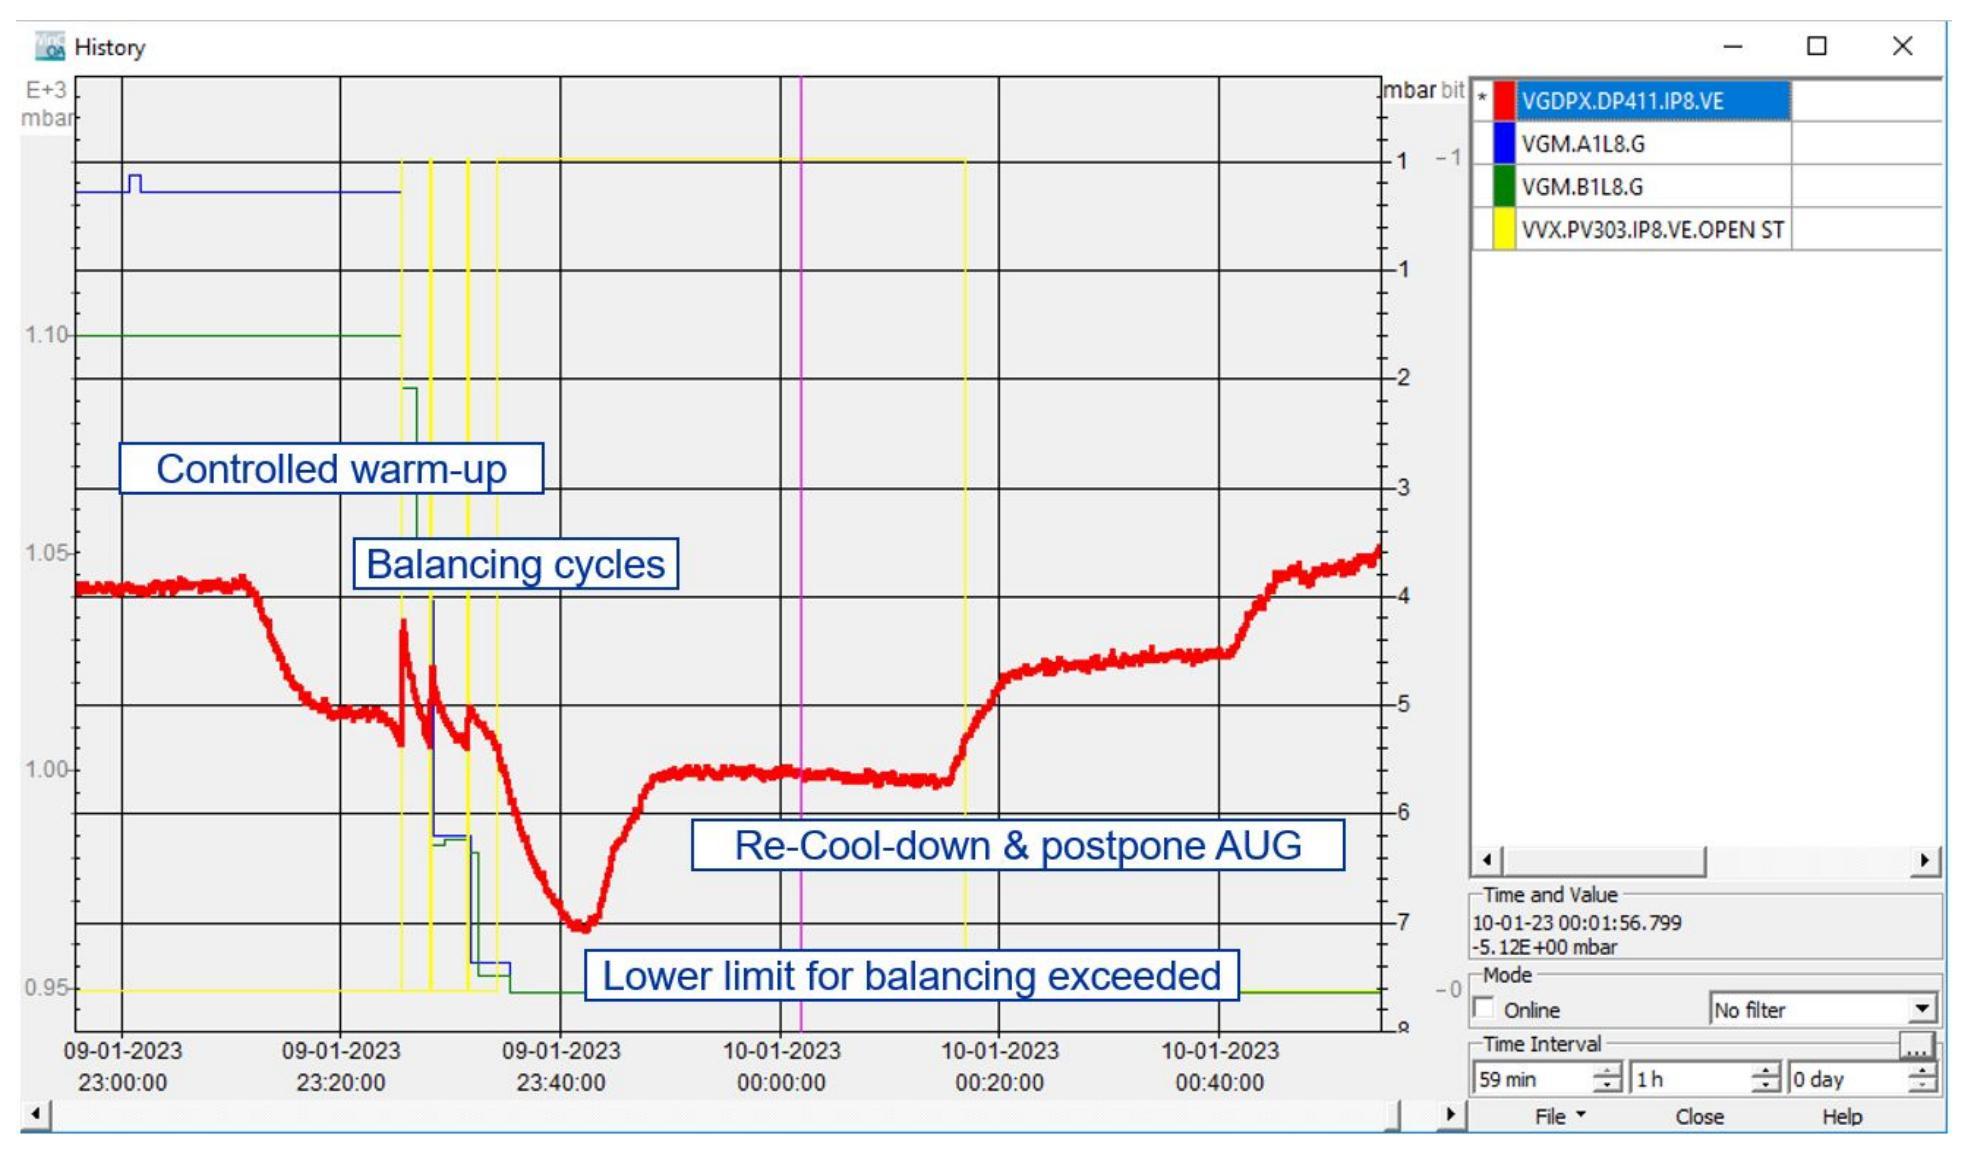
- Dry air supply is stopped remotely by EN-CV as a preparatory action prior to the AUG test
- Loss of dry-air supply results in the shutdown of the cooling plant
- Detector starts warming up to ambient temperature in an uncontrolled way
- A fast differential pressure increase due to gas expansion is experienced in the Detector Volume

- Balancing system correctly starts to compensate the DP by neon injection
- Pressure keeps rising in the Detector volume, but the pressure of the injection system has not yet been increased, so the balancing system is unable to keep up
- The increase in differential pressure continues rapidly, at around 1 mbar/10s (with the Detector volume becoming more over pressurized)

6h24 – DP reaches -8.8 mbar and the Overpressure Safety System is triggered (start of the failure)

- Differential pressure hits the threshold of the pressure switch used in the Safety System (10 mbar by ٠ specification, but around 9 mbar in reality).
- At this point the Safety System should have opened the Overpressure Safety Valve. In reality, the relay used to read the pressure switch is faulty (a hidden failure, only detectable by proof testing) and short-circuits the power supply.
- The combined resistance of the wiring (around 5 Ohm) is high enough that the power supply does not totally shutdown but the voltage drops from **24V** to **9.8V**.
- Due to the failure of this relay the safety system fails to actuate the safety value and equilibrate the pressure differential between the two volumes (the closed pressure switch status is never read).
- Additionally, the low voltage of the power supply causes a second problem in the control system. ۲

Optocouplers and mechanical relays have very different operational thresholds. Optocouplers typically require significantly higher turn-on and hold-on voltages compared to equally rated relays.

- The voltage of 9.8V that is now being output by the pressure switch power supply is not enough to actuate the optocouplers used to read the Balancing Pressure Switches
 - All optocouplers open, meaning that the control system now falsely reads the Beam Volume as over pressurized (OS412A Open).
- The same **9.8V** are, however, **enough to keep the mechanical relays closed**.
 - The relay used to read the status of the pressure switch power supply remains closed, so the system **falsely** reads the **power supply status as being OK**.
- The software is designed to deal with a fault such as this. By design, the PLC interlocks all balancing valves in case of a Power Supply failure (i.e. nothing is actuated if the values of the pressure switches cannot be trusted). But because the supply status was still reported as OK, the Balancing system actuated as normal.

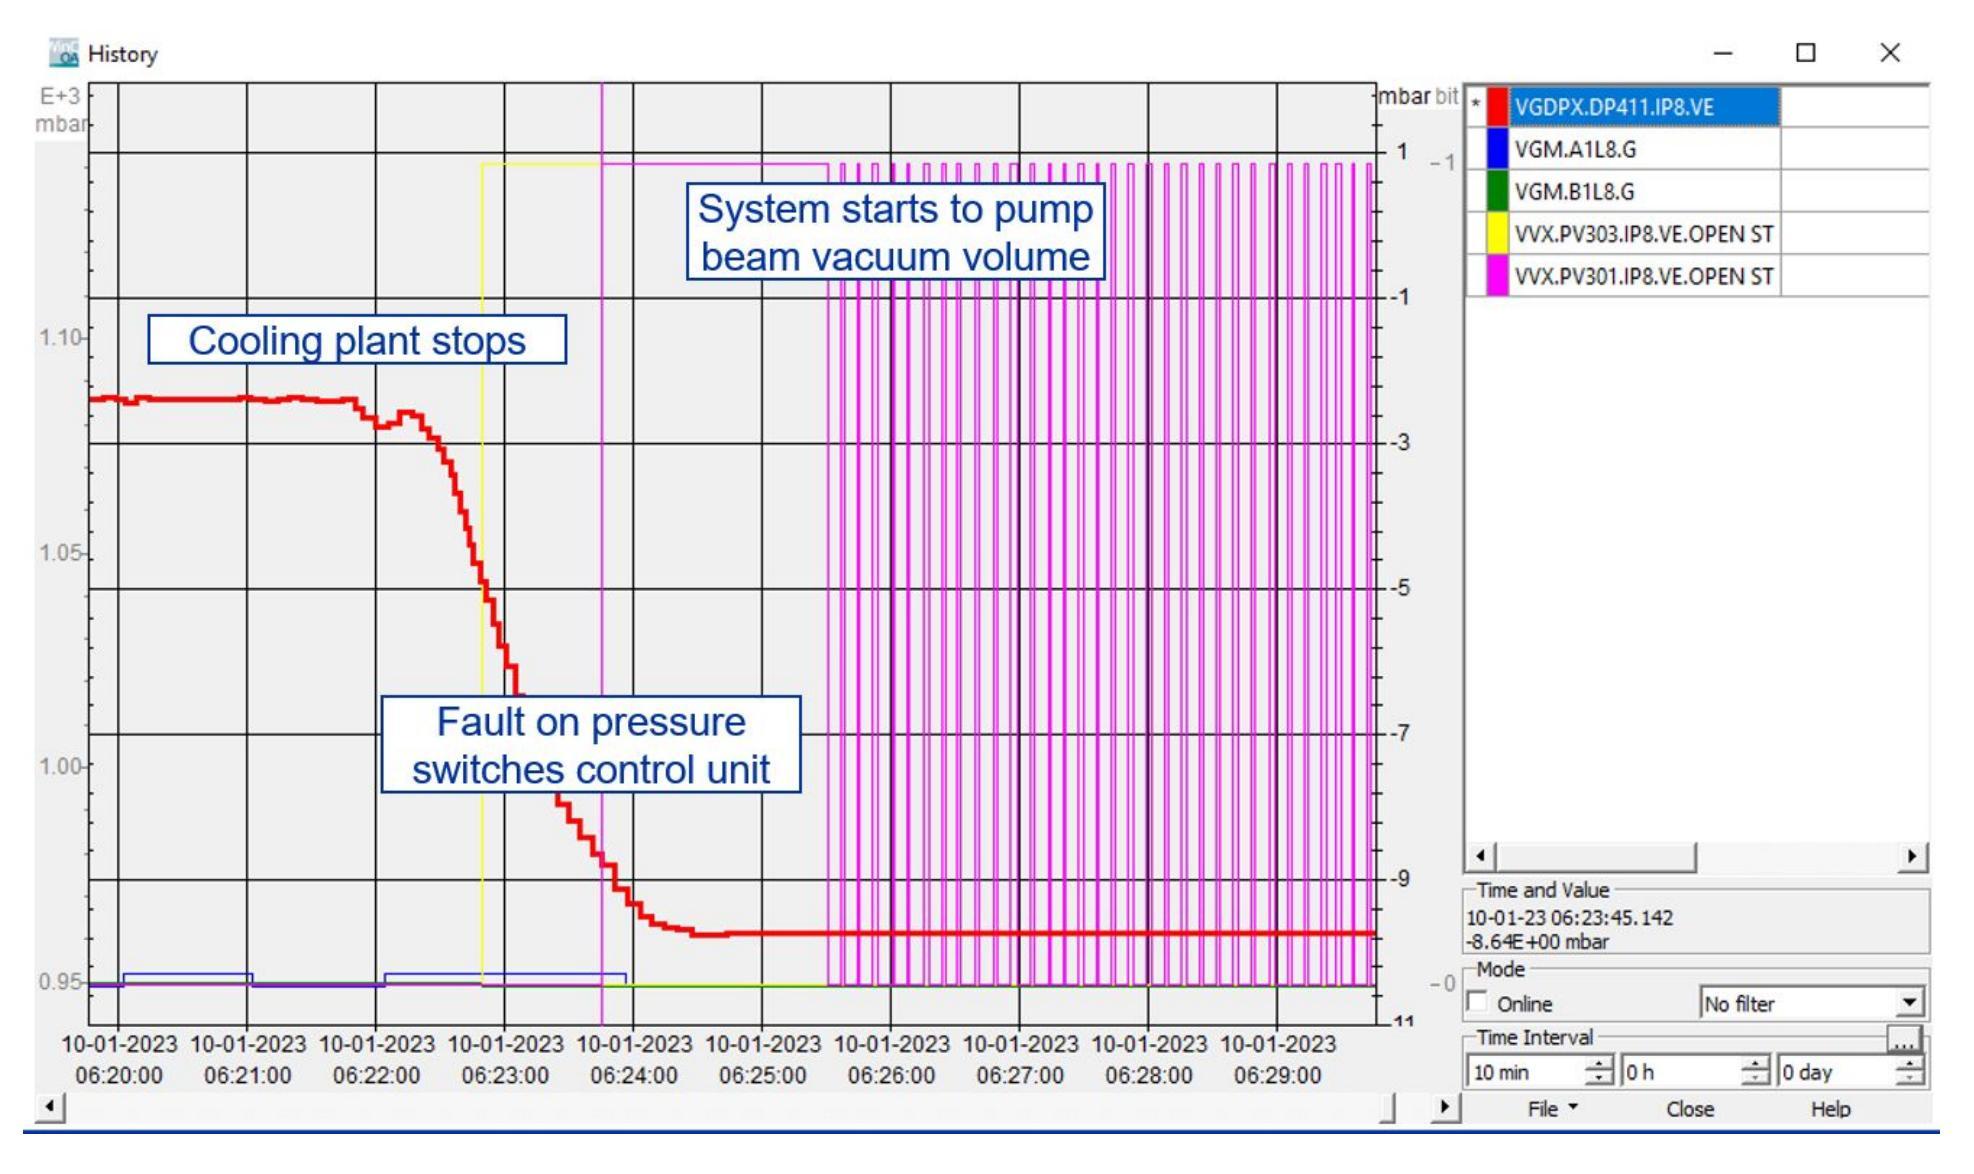
- The instrumentation shows entirely inconsistent information (and thus cannot be trusted):
 - OS414 and OS411 indicate that **both volumes are over pressurized** in relation to atmosphere
 - Absolute pressure measurement gauges indicate we are **around 650 mbar** in the Beam ۲
 - Pressure switch OS412A indicates a Beam **overpressure > +2 mbar** ۲
 - Differential pressure measurement reads -9.8 mbar of Beam under pressure ۲
 - Safety pressure switches indicate that we are within the -10/+10 mbar range
- **SV421 is closed** and the safety system did not trigger ۲
- Beam Vacuum is being pumped via PV301 by the Balancing System
- The **power supply** for the **pressure switches** is **working properly** ۲

- VELO elliptical head zone is inspected (rupture discs control, safety valve physical status)
- VELO control racks are inspected and the issue with the power supply is identified

- Neither the Absolute nor the Differential Baratron gauges can be trusted at this point
- Pressure gauge on the GIS line is used to measure Beam volume pressure, confirming the drop to be around 180 mbar.
- Gauges on the VELO Detector vacuum volume indicate a pressure increase of approximately 40 mbar compared to before the event
- This means the differential pressure between Beam Vacuum volume and Detector Vacuum volume would be in the range ≈ 200 – 220mbar.
