MQXFA Mechanical Assembly and Preload

Daniel Cheng, For the MQXFA team 28-Sep-23

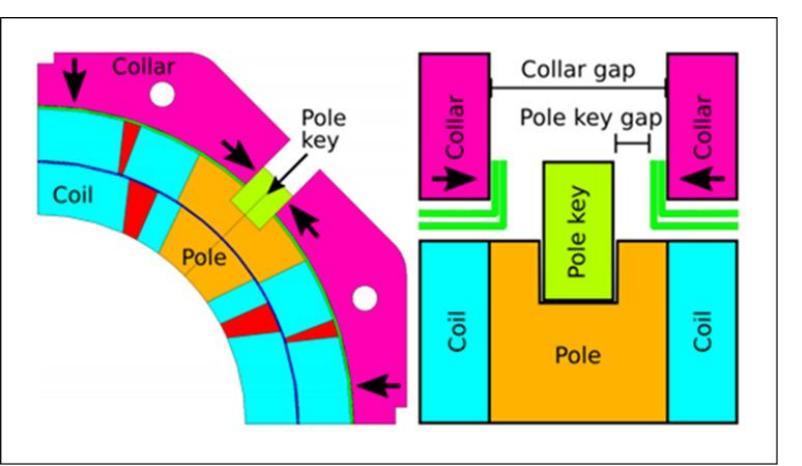
Closed pole key gap in a coil may lead to poor longitudinal preload in the ends of that coil at edge to end-spacer transition

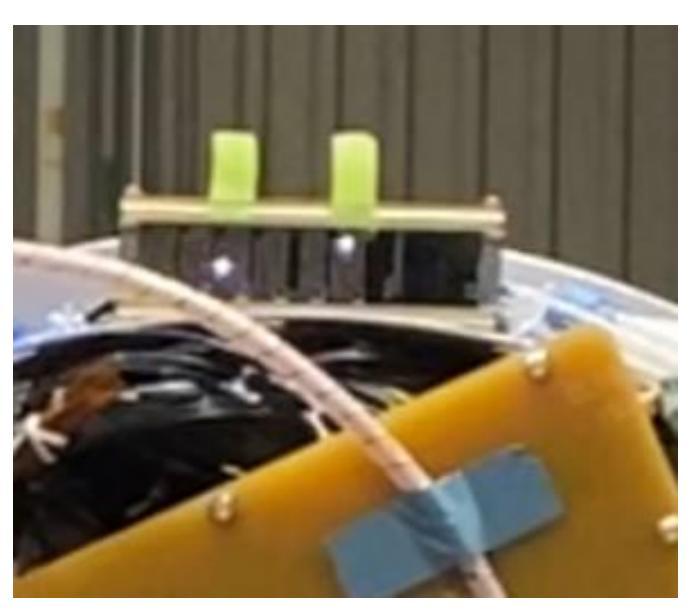
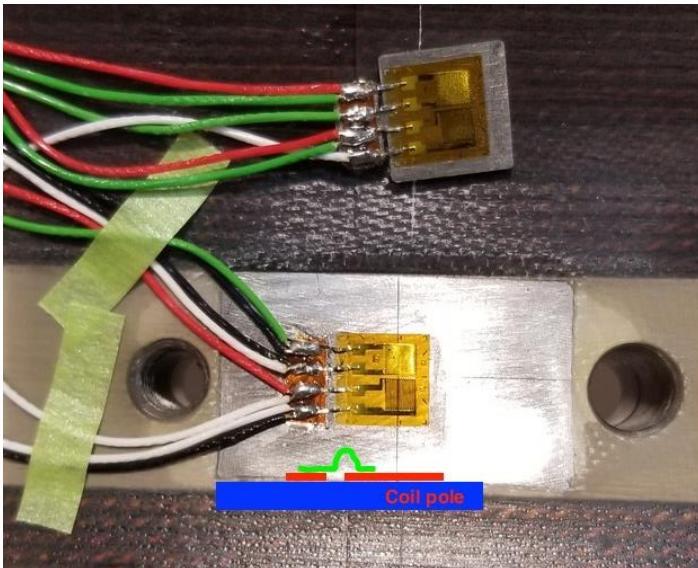
MQXFA12 Lesson: Strain Gauges and Hipot

- Issue discovered during final EQC Hipot of MQXFA12 revealed potential weakness of SG to coil pole
 - Cause: SG pins of coils and shells were mixed on one connector

All tests after MQXFA08b have had coil SGs disconnected during final hipot test and magnet test campaign

Shells and Rods can still be present

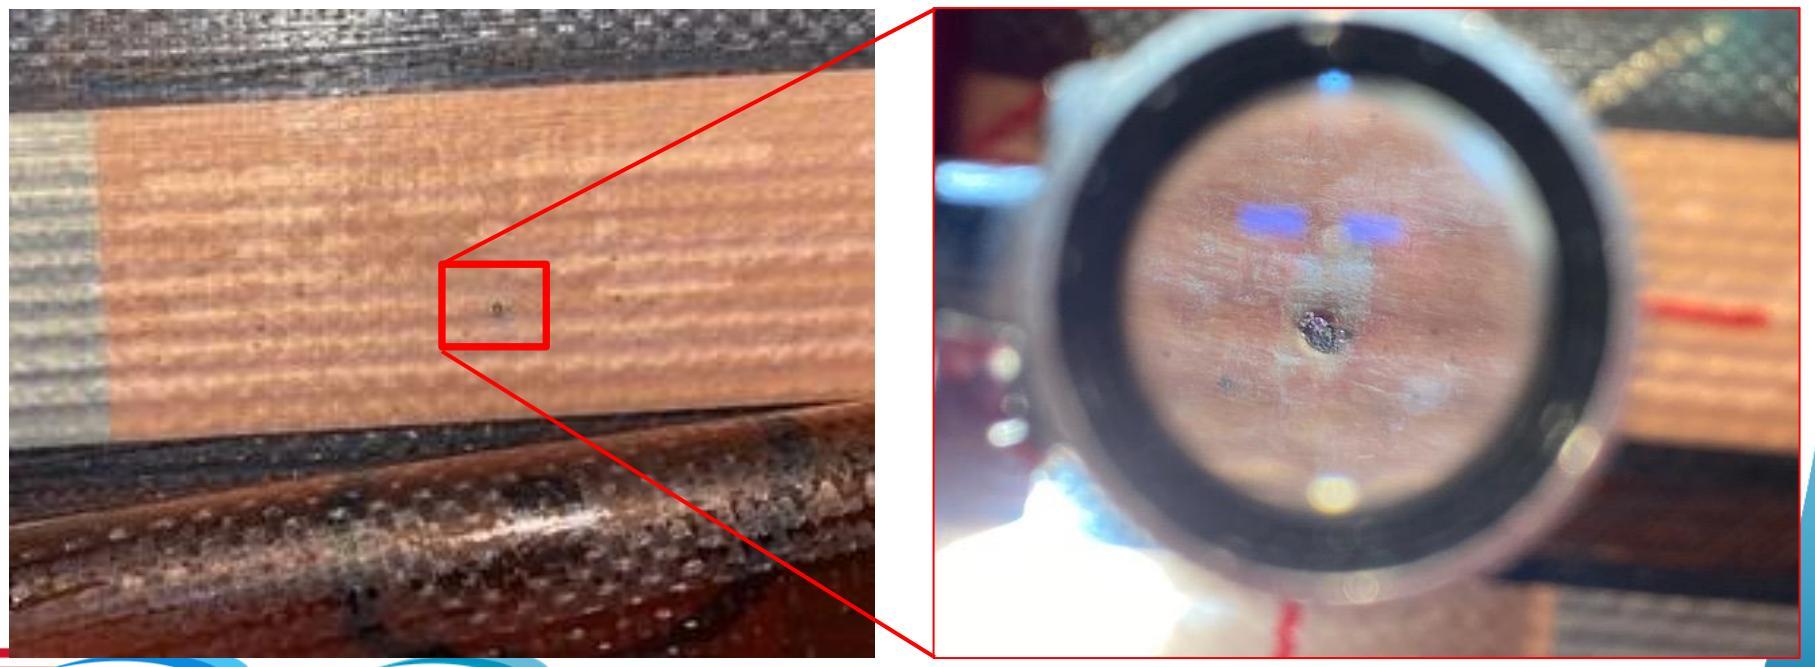
MQXFA14 QH Hipot failure

- Coil 142 developed a hipot failure from QH3 to coil during the EQC after preload
 - Glass bead puncture/burn was found upon disassembly
 - Replaced with Coil 217 from MQXFA09
- Similar anomaly was found in a MQXFA15 coil, and it was replaced with the other MQXFA09 coil
 - Coil fabrication processes no longer use laser-cut fiberglass sheets

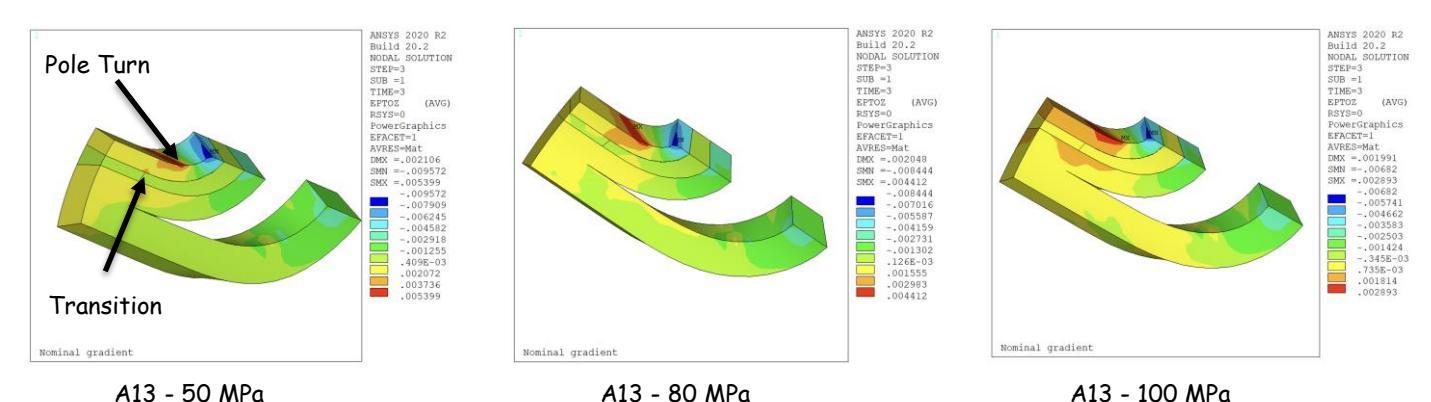
Peak Strain as a function of the pre-stress

Strain increases reducing the azimuthal prestress at R.T.

Two critical locations:

Pole turn:

Real peak might be lower because of some remaining pole turn bonding

- Wedge/endspacer transition
 - Peak might be significantly higher due to the discontinuity (after a gap opens), not fully captured by the FE model

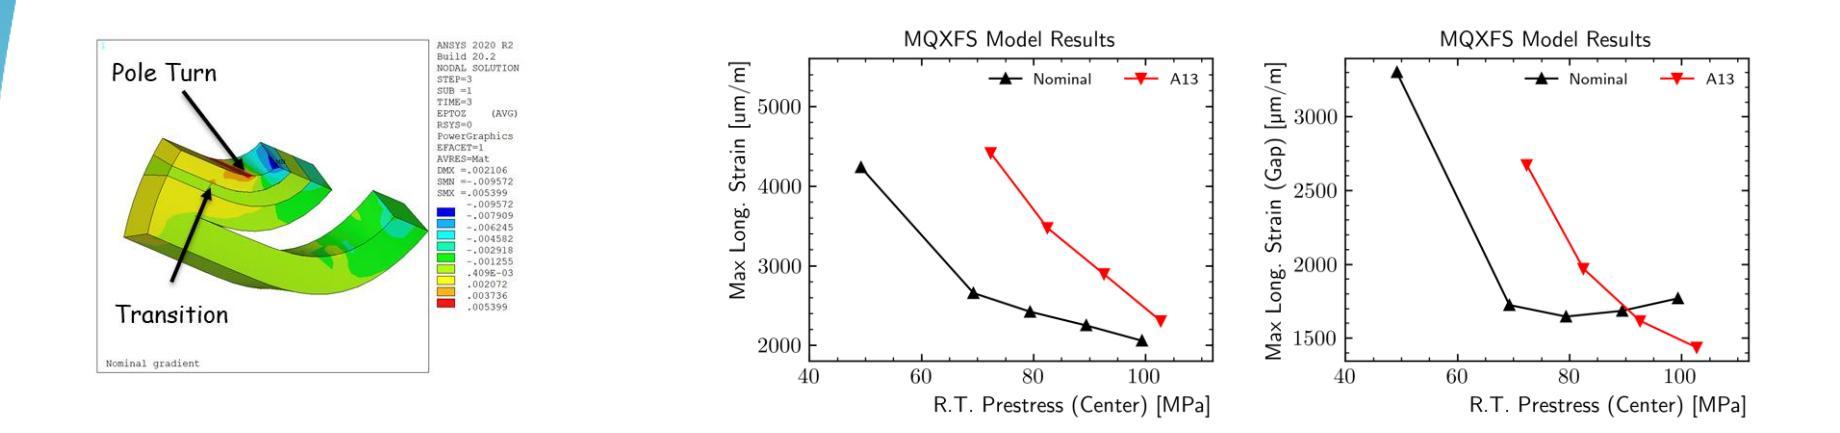
Peak Strain as a function of the straight section pre-stress

- The peak strain is a function of the applied prestress
- Effect on max strain on the transition seems similar:
 - A13 requires higher room temperature prestress to keep the strain below the 'knee'

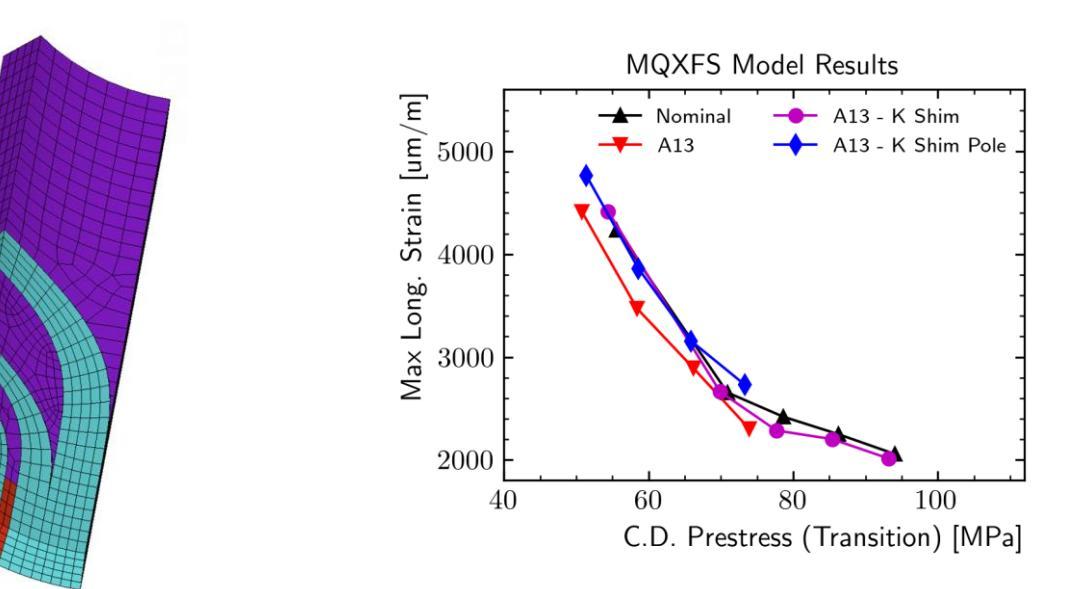
Peak Strain as a function of the local prestress

- Pole stress at cold computed on the same z location of the wedge/endspacer transition
 - Blue/magenta lines represent end-region modifications
 - All the points are on the same lines!
- The effect seems to be controlled by a local prestress loss

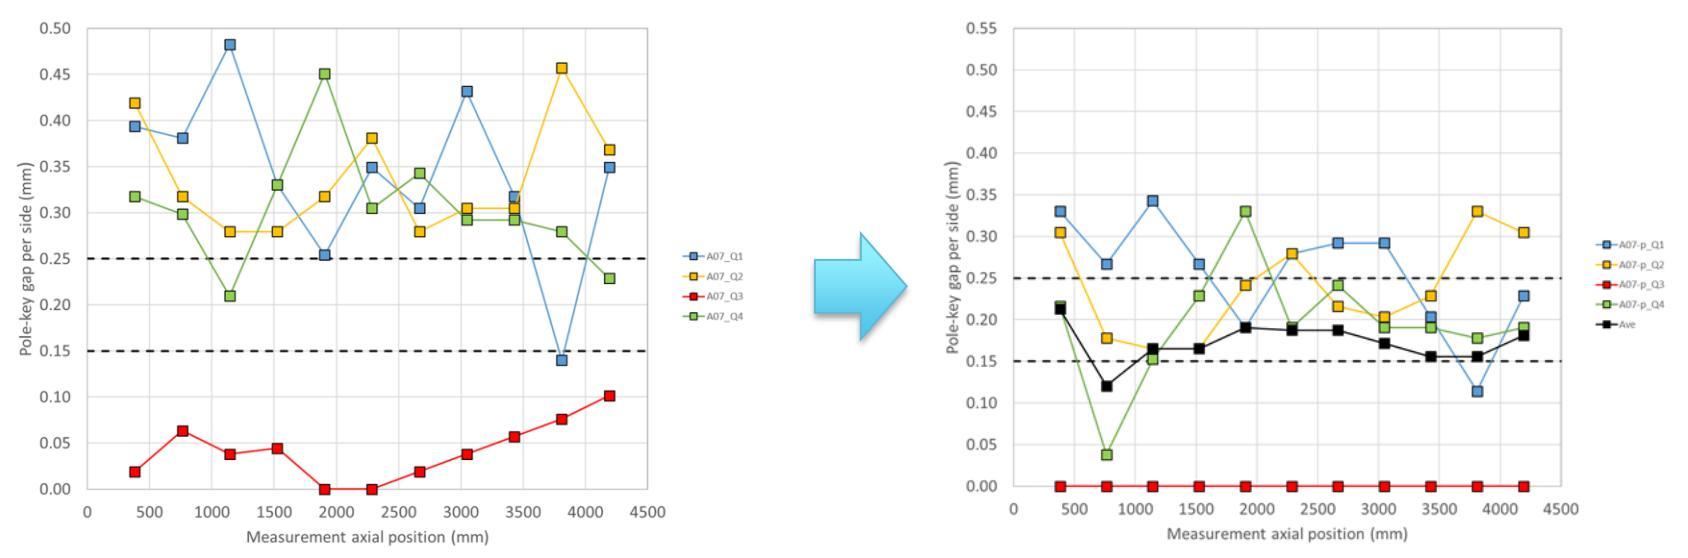
Pole-key gaps in MQXFA07

- The measured pole-key gaps were not as uniform in MQXFA07 and MQXFA08 as in past magnets; this is particularly apparent on the limiting coils (Q3 for both magnets)
- Only the total average (on the 4 keys) was targeted in the specification. The underlying assumption was that the gaps would be redistributed across coils during loading.
- Investigation of the effect of this non-uniformity on the mechanical performances with 2D and 3D FE models
 - 2D effect: preload variation within acceptable range

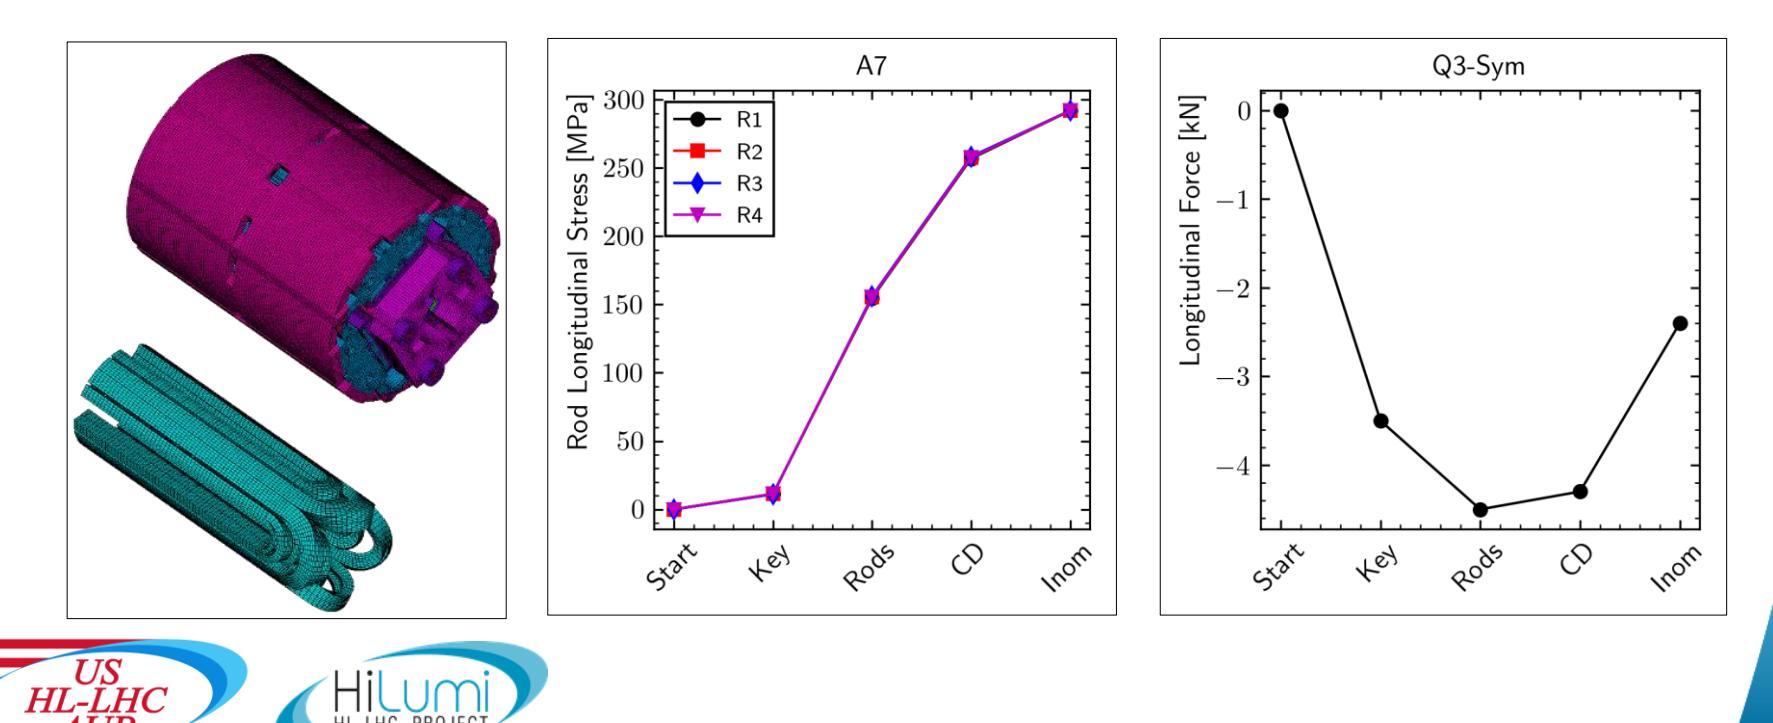
Axial behavior

- No difference in the rods stress, but less force axial pre-load on the Q3 coil
 - Lower azimuthal pre-stress results in less friction coilstructure → "axially softer coil"

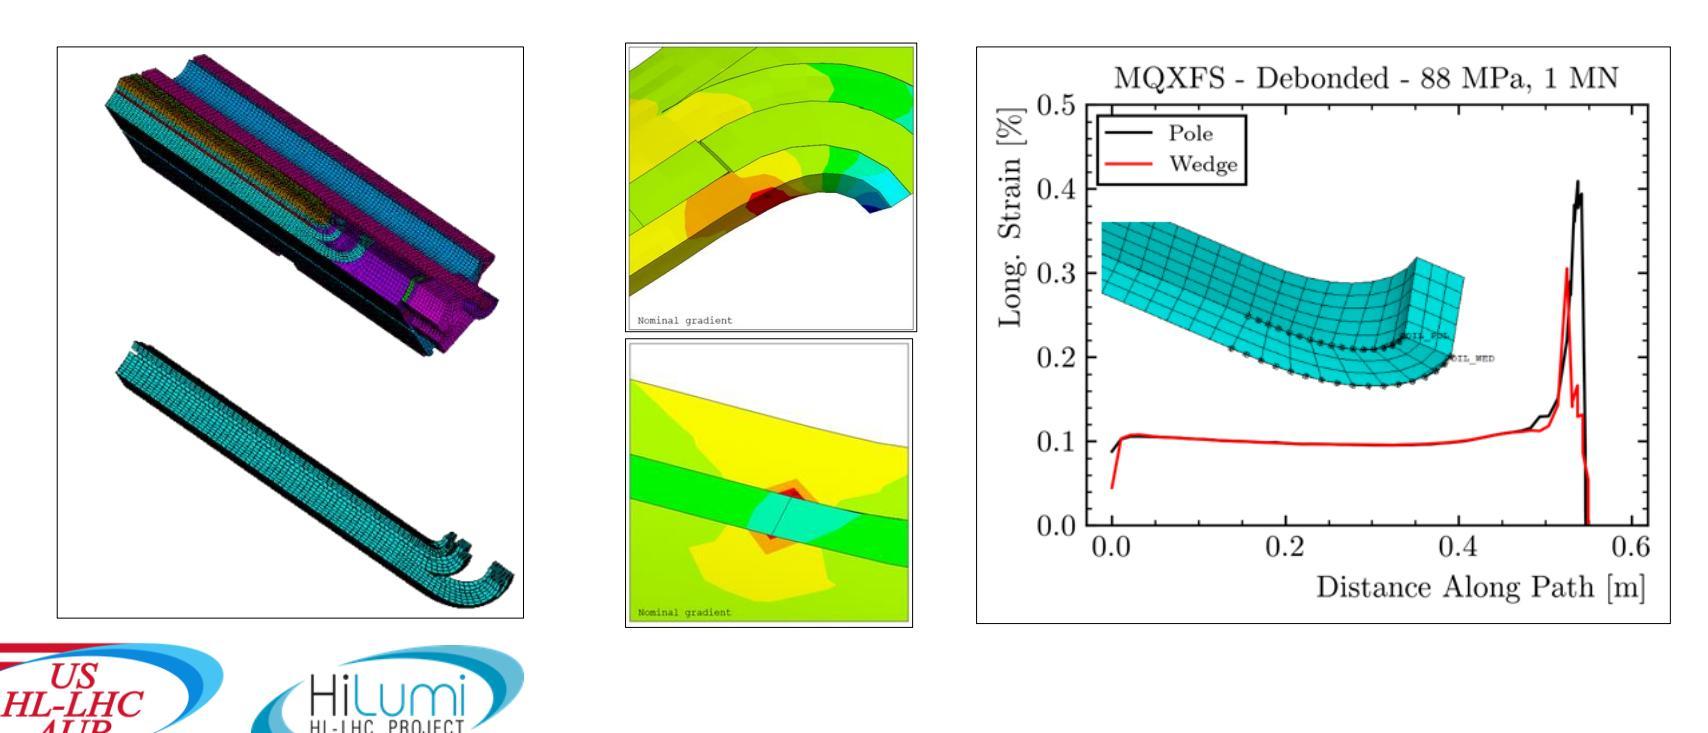
- More detailed analysis with refined meshed
 - Not bonded, so as if epoxy cracking has occurred
 - The gap between wedge and end-spacer, induces a spike in axial strain in the coil, which can reach the 0.4% level

Iarger increase in the turn towards the pole.

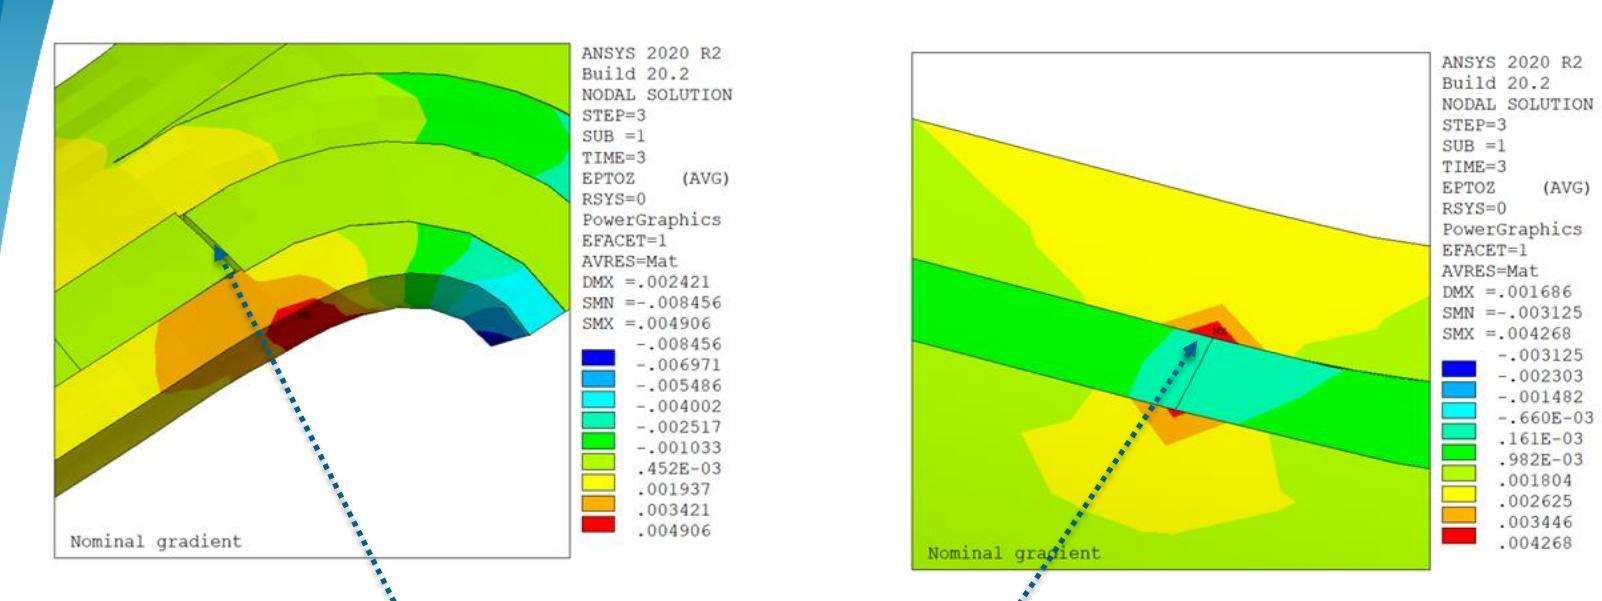
Possible Damage at Wedge-Spacer Interface

- At cold the coil with less azimuthal preload ends up with less longitudinal preload
- At nominal current tension develops between the inner wedge and the end spacer, and a (small) gap may open
- This may result in high longitudinal strain (up to 0.4%) in that location
 - This location is consistent with quench data
 - Effect is larger on the pole block, but also visible on the mid plane block
