IT.L8 Leak and Repair

LHCC Meeting, 13/09/2023 S. Le Naour

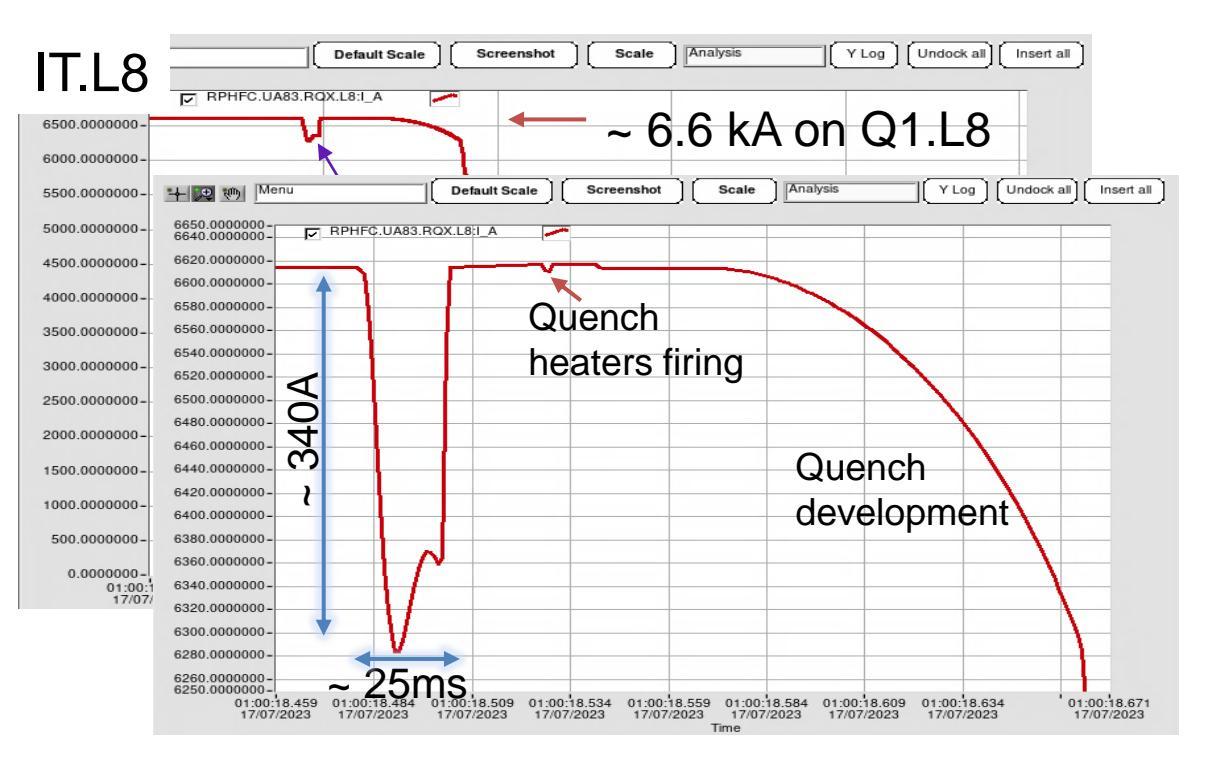
Monday, 17 July, 1 a.m.: ROOT CAUSE

The reason for the electrical glitch that caused the safety systems in the LHC to dump the beam and several magnets to quench was found: a tree on the Swiss side (about 55 km from CERN in the Canton of Vaud) fell on the power lines and disrupted the power system.

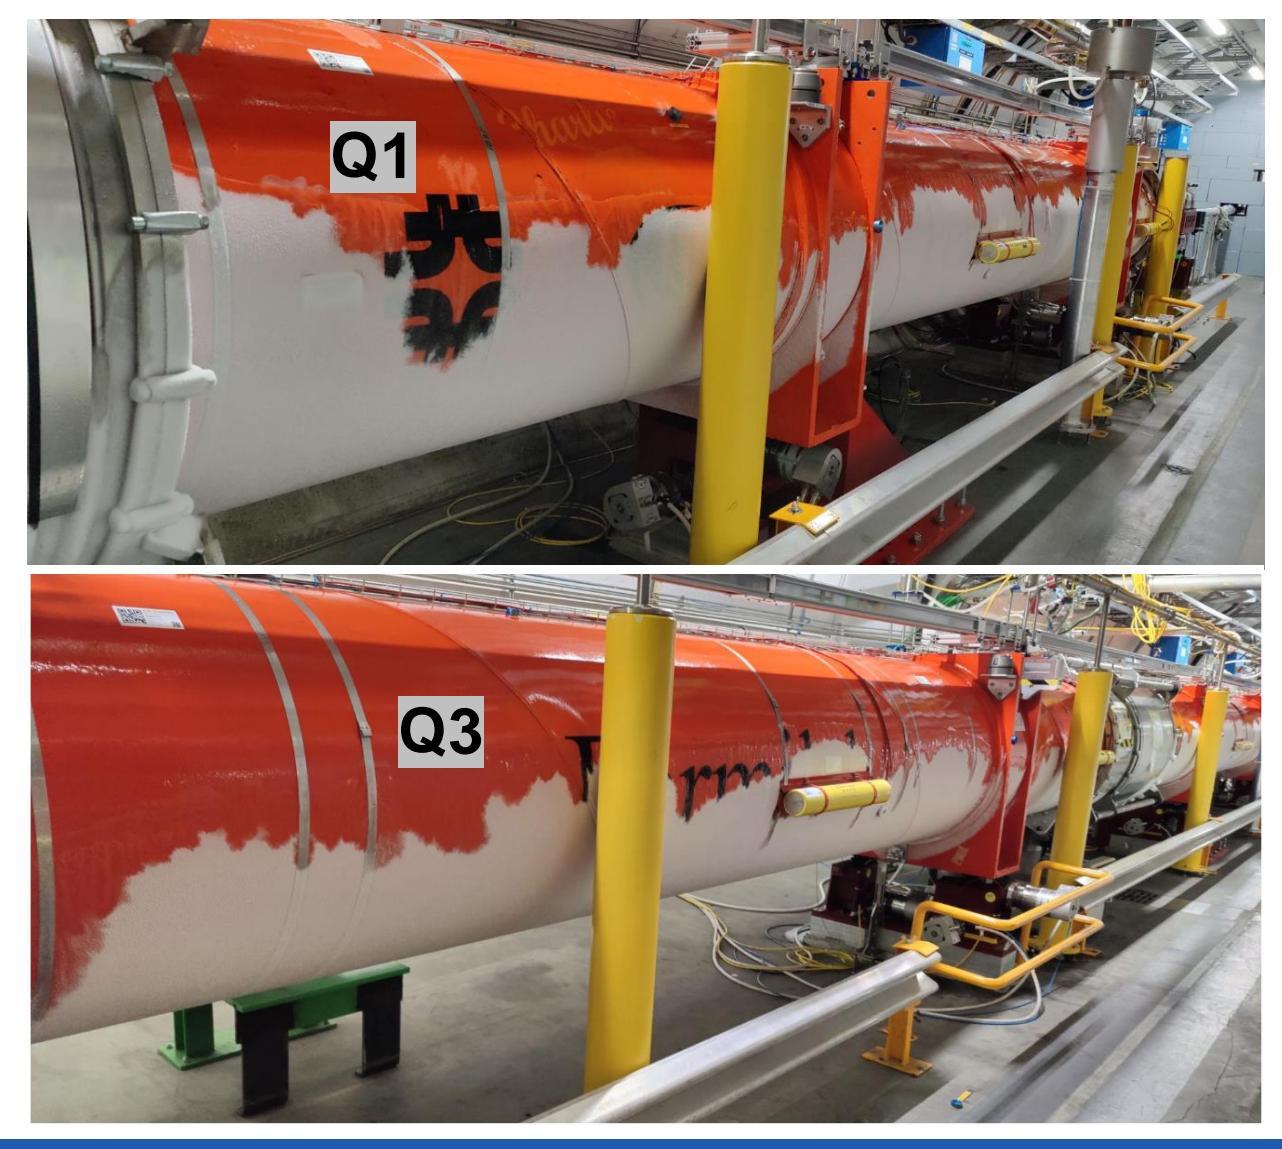
17th July event : Electrical glitch and consequence

30s after the quench, a significant leak appears in the vacuum vessels of IT.L8 assembly.

8 hours after the quench, the pressure in the vacuum vessels is at 1bar and the average temperature of the cold masses is 150K

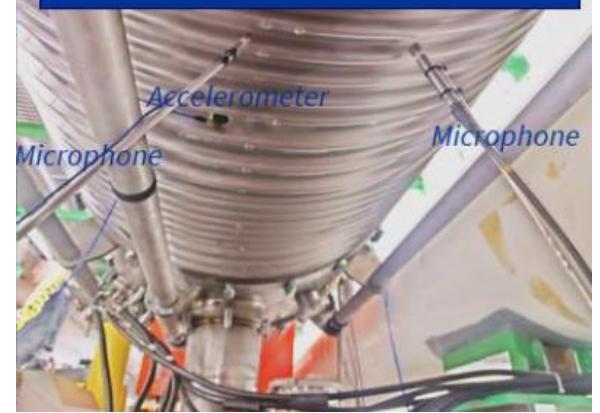
<u>Q1 Label</u> (Interconnect Q1/Q2) Microphones Tri-axial Accelerometers

Confirmed in the cold masses volume, the helium leak must be localised over the 40m of the triplet assembly. Microphones and accelerometers were installed below the interconnection bellows.

With the pressurisation of the cold masses, accelerometers in Q1-Q2 interconnection measured significant vibration, indicating a possible position of the leak

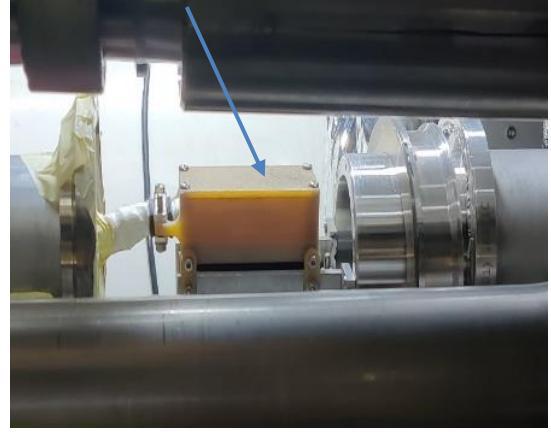
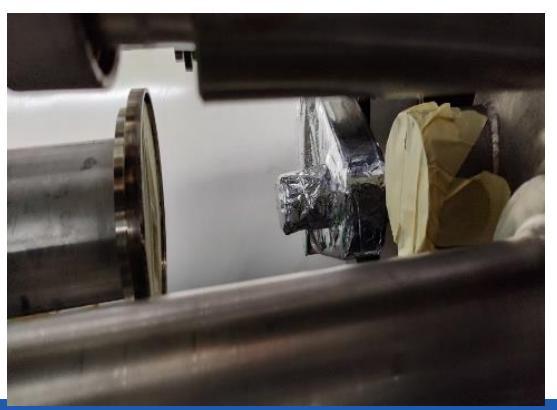
Bellow removal

In IT.L8, the M2 bellow is removed.

Connection box of instrumentation

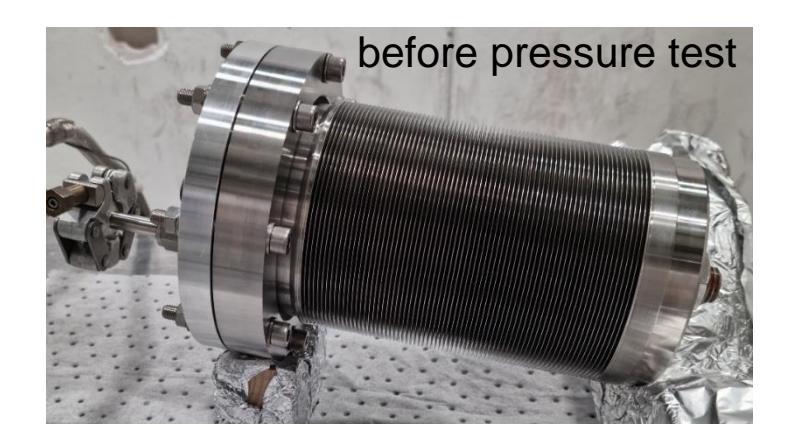
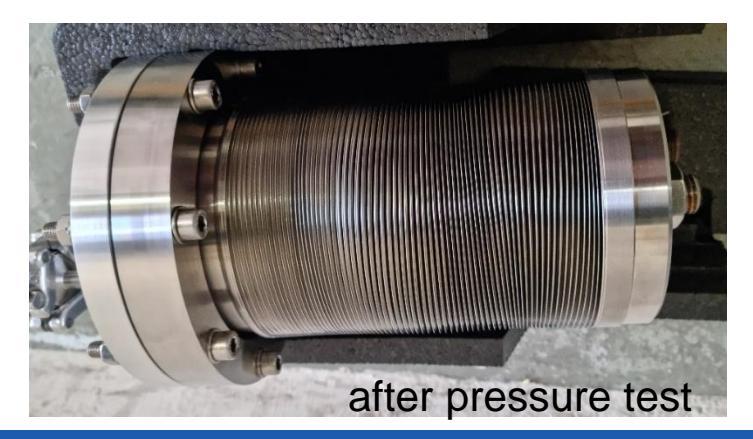
In the lab, 2 spare bellows are pressure tested. Leak test ⇒ pressure cycle to 20 barg ⇒ leak test

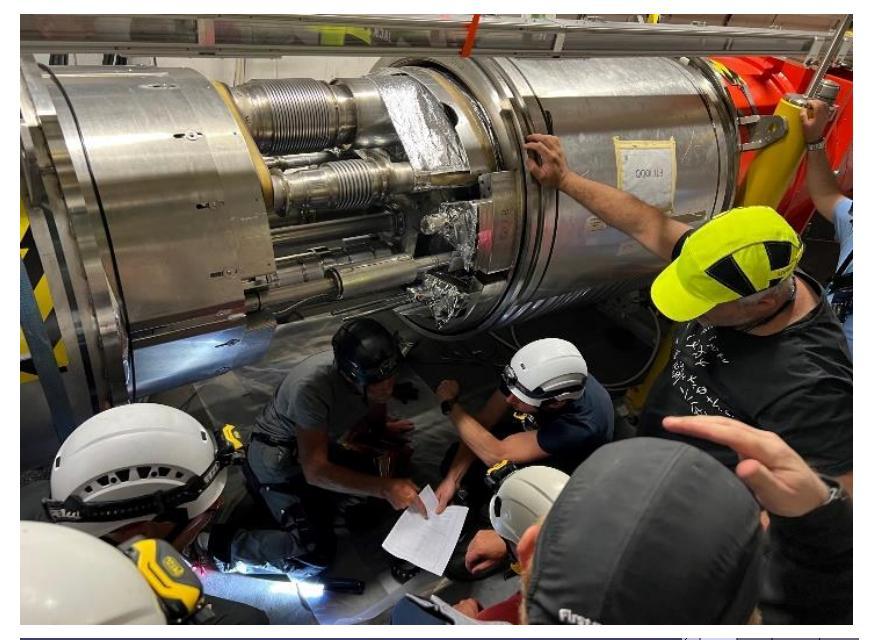
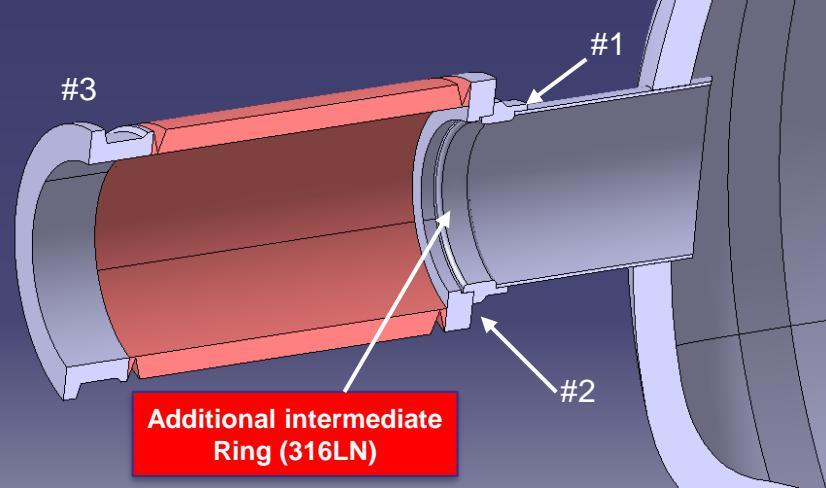
Spare bellows welding

The M2 bellows is an integral component of the asdelivered Q1 cold mass. In-situ replacement of the bellows requires a new strategy of welding at the interconnection.

First approach for weld execution was to insert a closefitting ring into M2 tube inner diameter to avoid the installation of a gas inerting system (impossible to remove afterwards). However, irregularities in the M2 pipe geometry wrt the ring resulted in a root porosity appearing in the new weld – hence invalid for a pressure vessel. The new bellows and its weld to the M2 line had to be removed.

A new weld strategy was proposed with an intermediate ring first welded on the M2 tube allowing easy installation and removal of an inerting gas system.

#1 weld at intermediate ring was validated (endoscopy & leak test) before 2nd spare bellows installation.

#2 weld joins the new bellows to the intermediate ring

#3 weld joins the new bellows to the Q2 flange

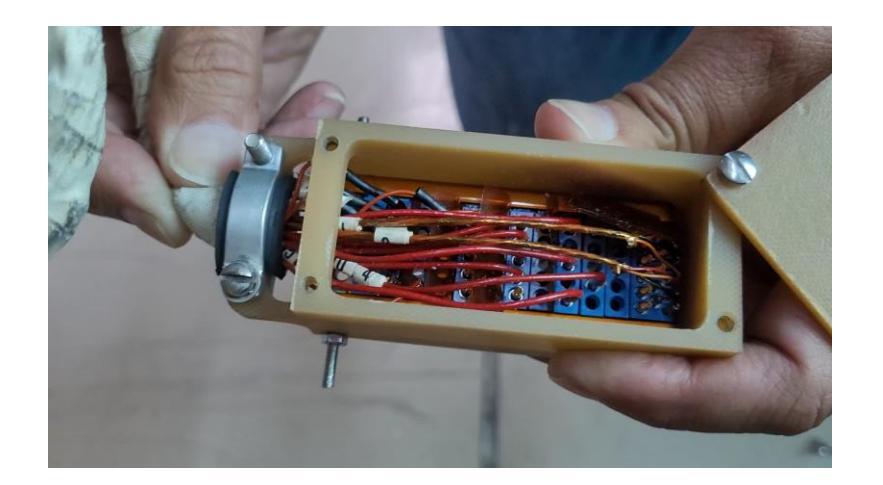
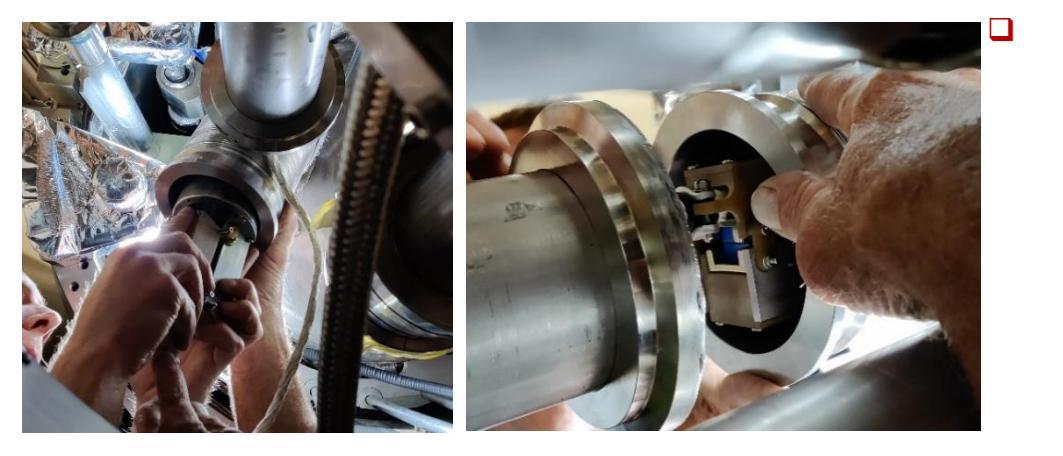
Instrumentation connection box issue

Installed in the core of the M2 bellows, combined with the limited in-situ access, the instrumentation box was found to be sensitive to cable movement:

During the installation of the 1st spare bellows, two Vtaps connections were lost (one mid-point of the coil). Due to the invalid weld of the bellows, and its subsequent removal, Vtap repairs were made.

With Vtap connectivity restablished at installation of the 2nd spare bellows, one wire of a temperature sensors was lost during the reassembly. Due to the high probability to break other wires and the time requested to access the instrumentation box within bellows, the non-conformity is left as is. The temperature sensor signal is recovered with a 3-wire configuration.

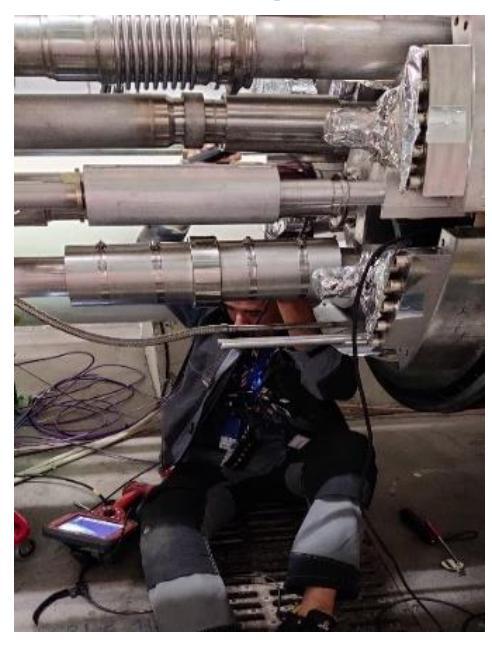
Bellow welding validation

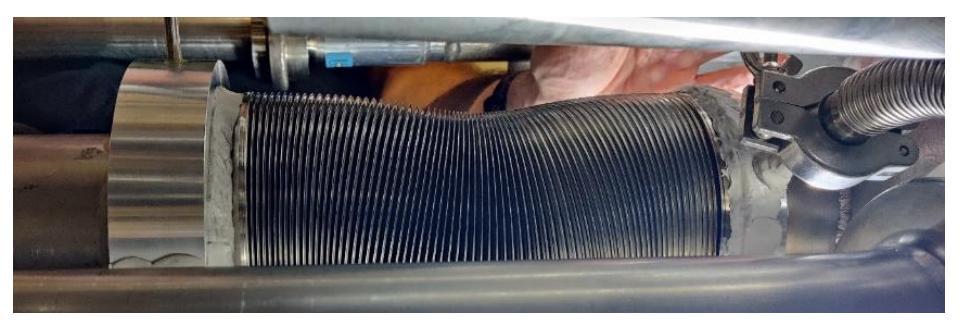
M2 bellows with 0.5 barg in the cold mass

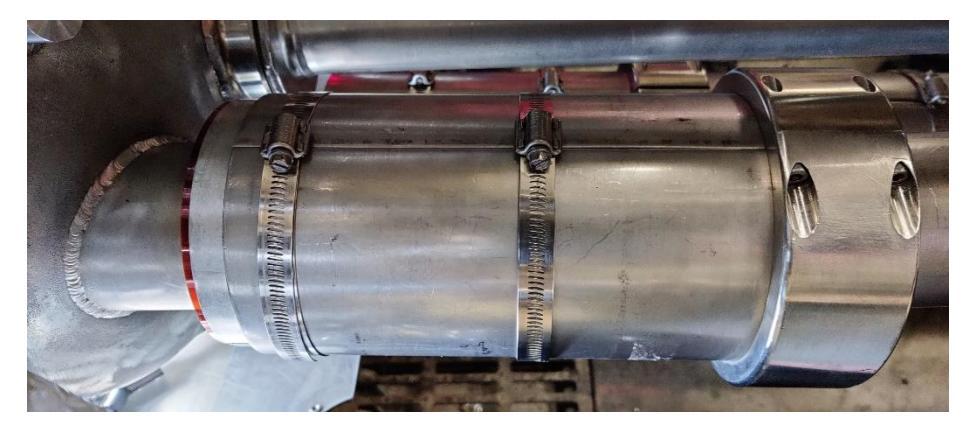
Bellows is surrounded by 3 layers kapton, then aluminium + stainless steel guide shells

and installation of bellow protection
