New BCT5 Connection to the SPS-SMP and Implications for the YETS 2023-24

240th Machine Protection Panel Meeting

17th November 2023

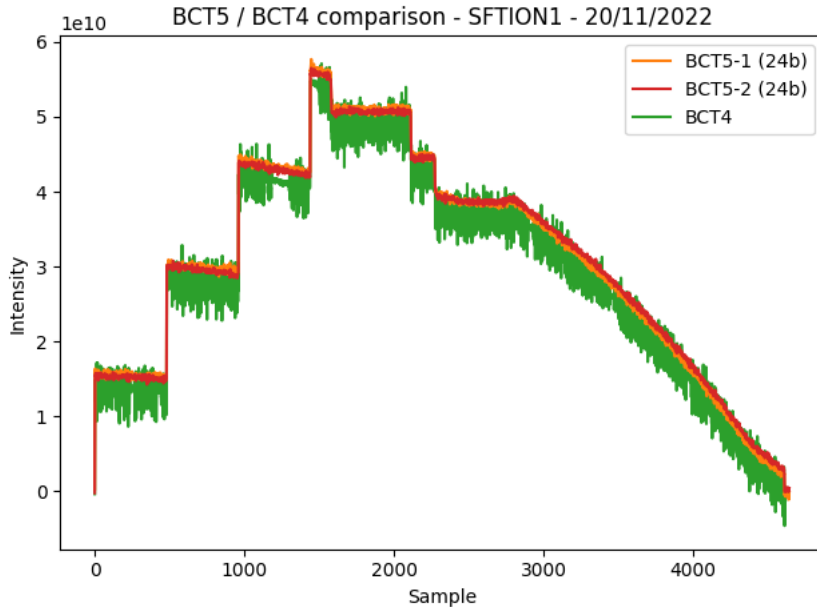
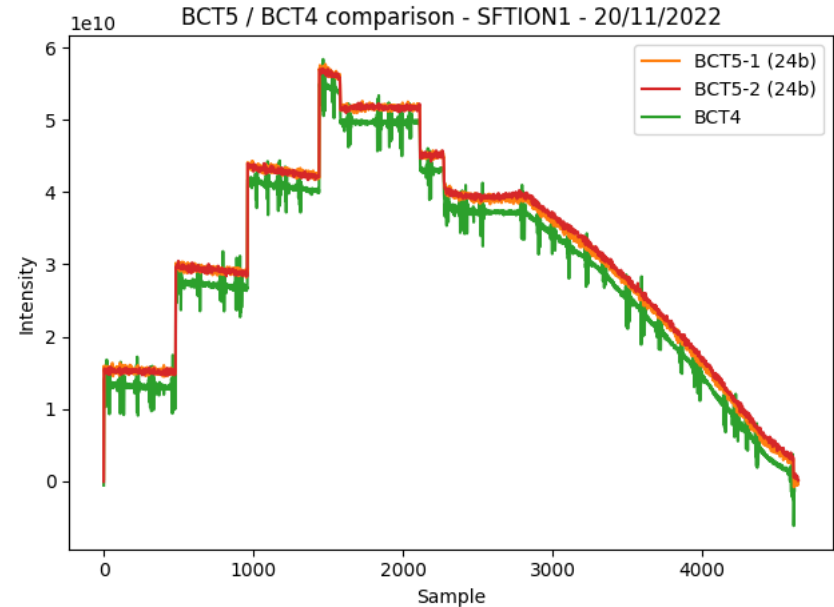
“Recent” issues with BCT4 – I

- Noise reported by OP on BCT4 (both OASIS & FESA) on (Sunday) 20/11/2022 ([BIIQ-458](#))
- Disappeared by itself before we could investigate...

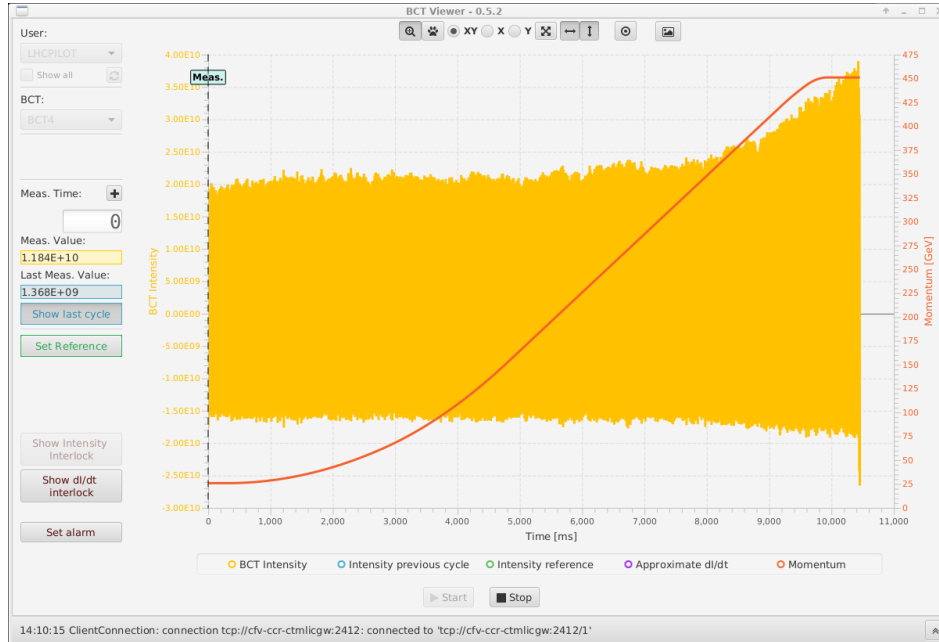
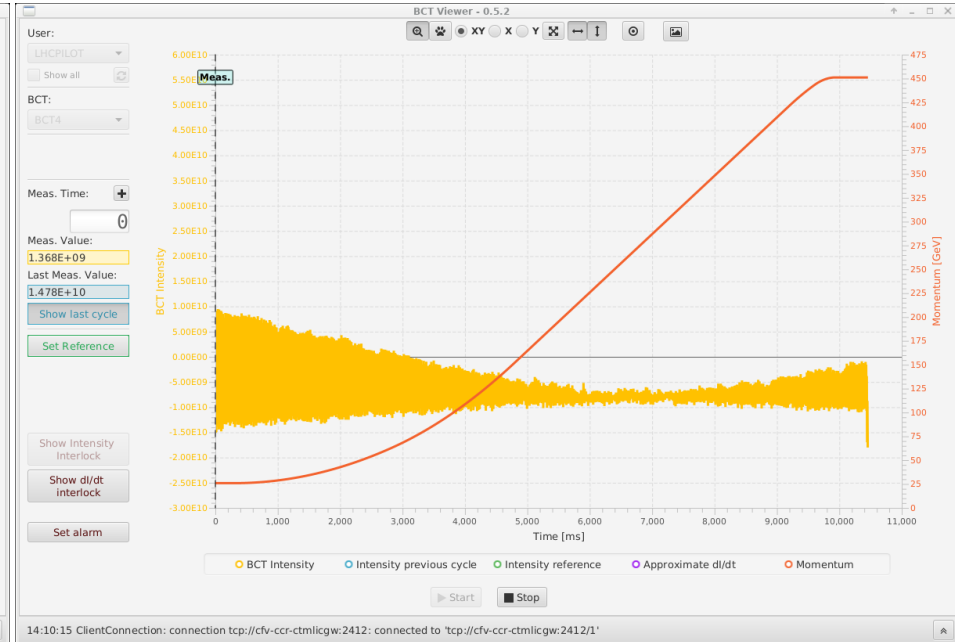
Recent issues with BCT4 – II

- Again, noise reported by OP on BCT4 on **02/09/2023** ([BIIQ-663](#))
- Level above PBF and blocking extraction to LHC via SMP – **OP disable BCT4 and operate only with BCT5**
- Back-end electronics exchanged by the spare. OK after **but we have no more spares!**

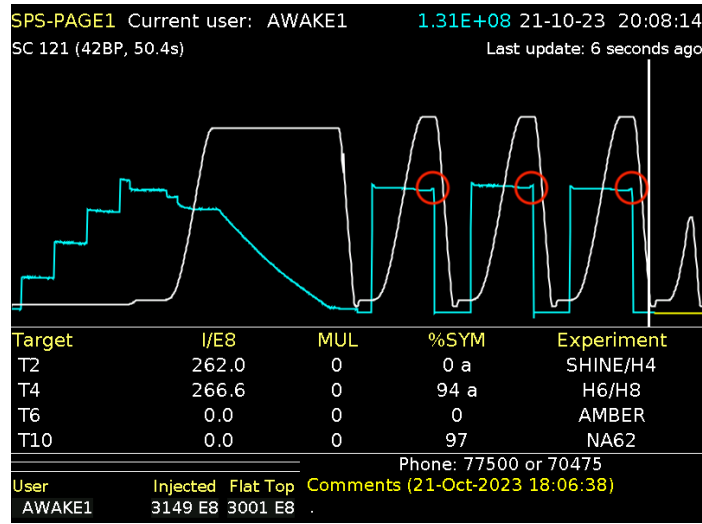
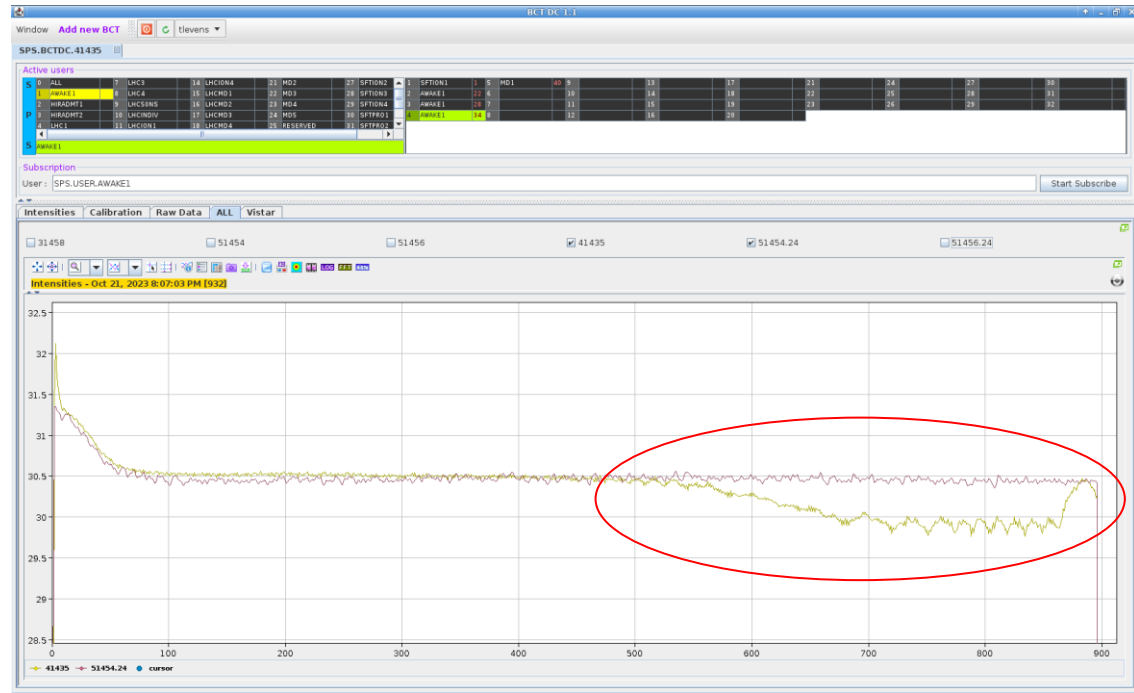
Recent issues with BCT4 – III

- Strange behaviour at flat top with AWAKE cycle reported on 21/10/2023 with 3e11 ppb ([BIIQ-679](#))
- So far not explained...
