I.FAST task 7.5: CompactLight Prototype Accelerating Structure

3rd I.FAST Annual Meeting - 18/04/24

CompactLight Prototype Accelerating Structures

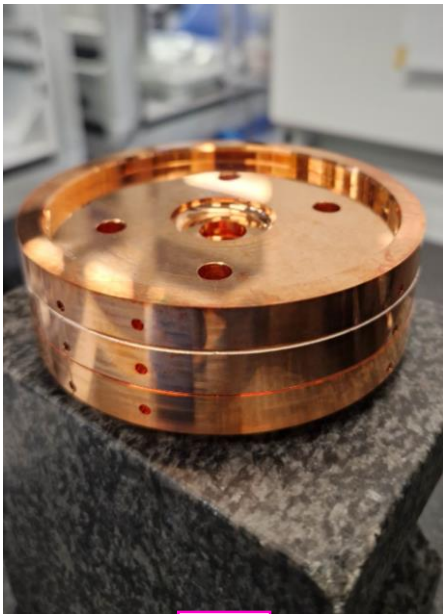
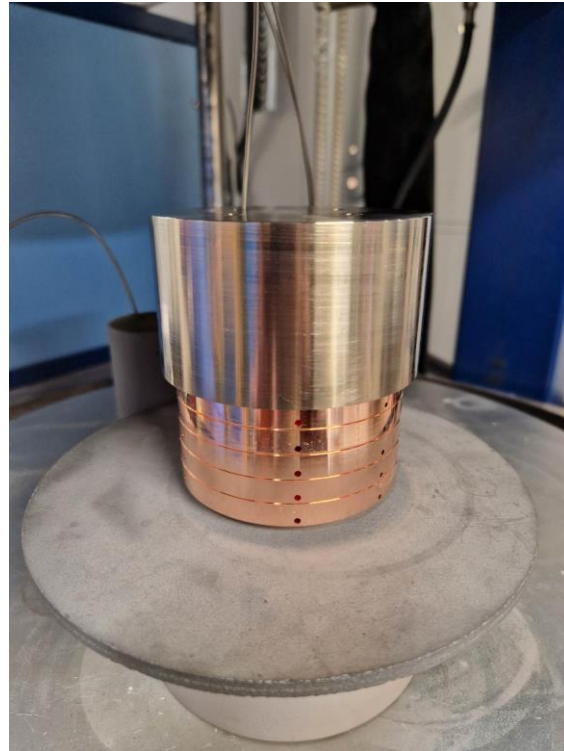
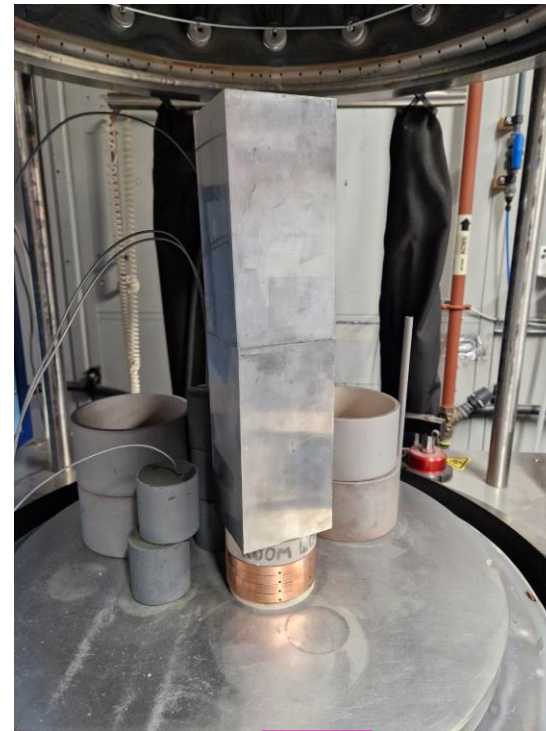
- Machinability
 - Interlocking alignment
 - Brazing material
 - Leak tightness
 - Weight
- The alignment and flatness of the structure were kept as expected after the cycle with the 40kg on top.

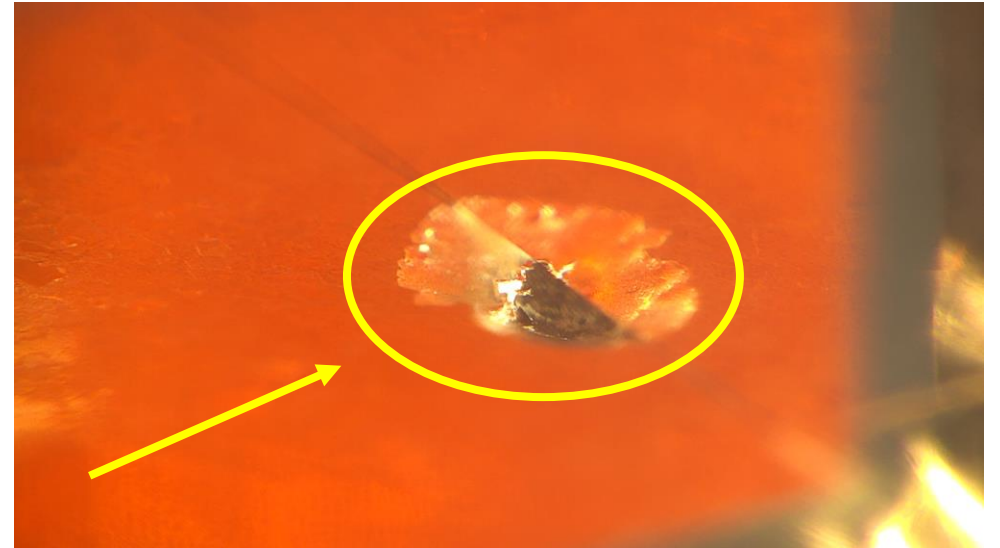
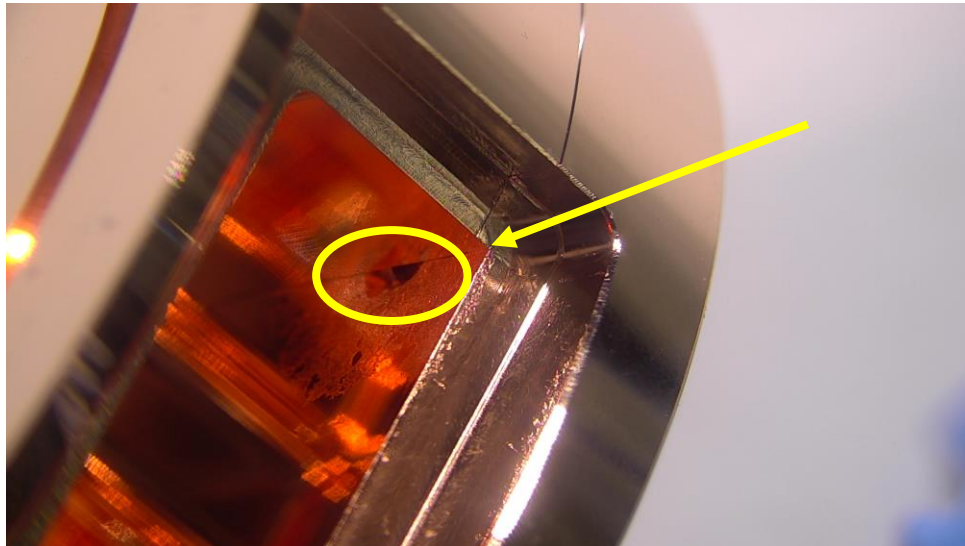
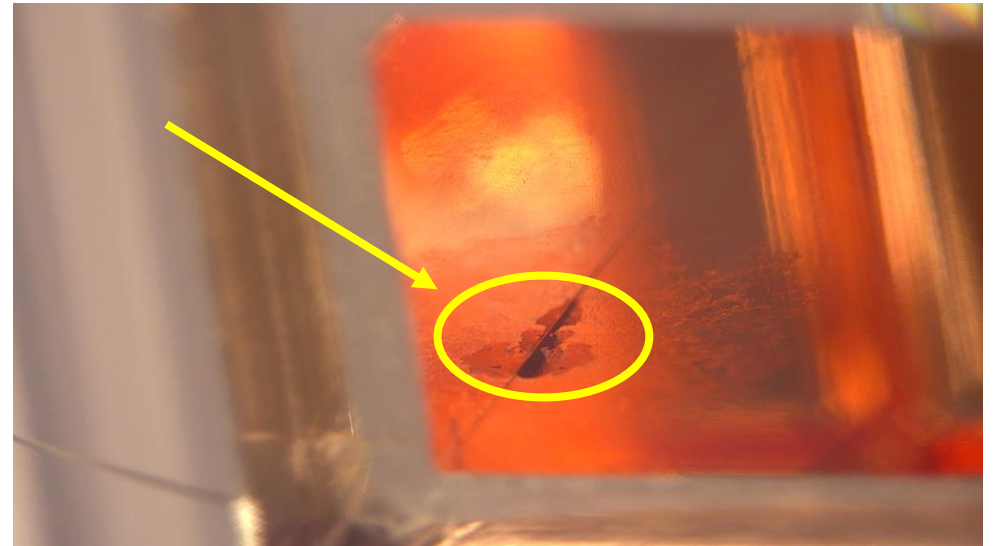
End stack brazes II

- One end stack brazed well, and both stacks had visible evidence of the braze flowing.
- Clear evidence however of the braze eating into the copper in second end stack.
- Visible hole in cavity wall in 2 places, not present in other side of disk.

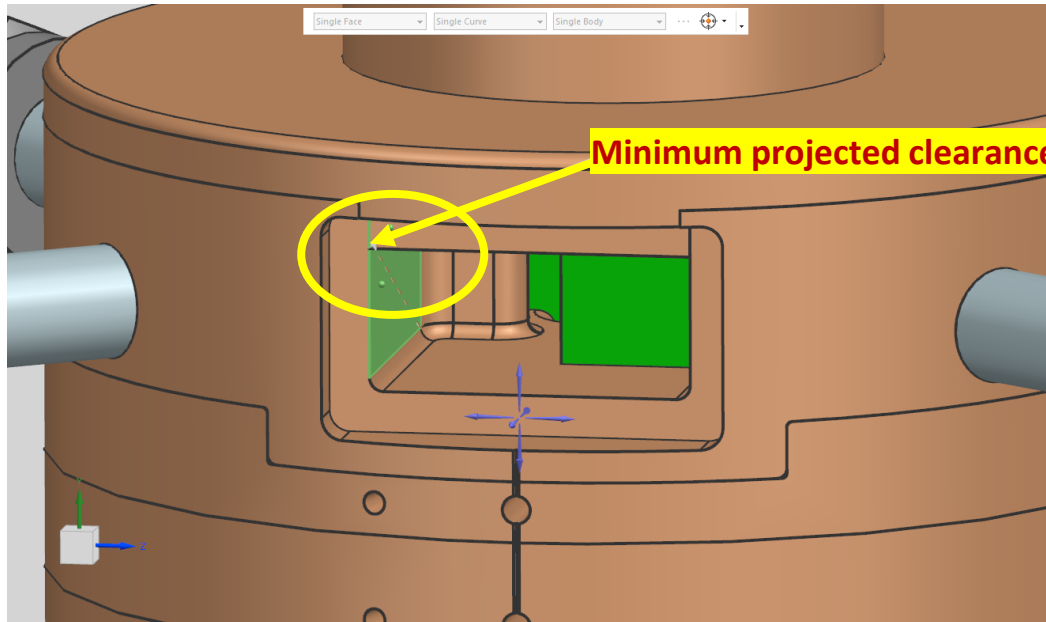
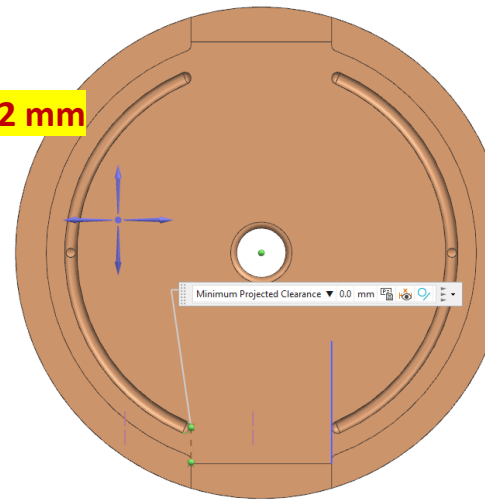
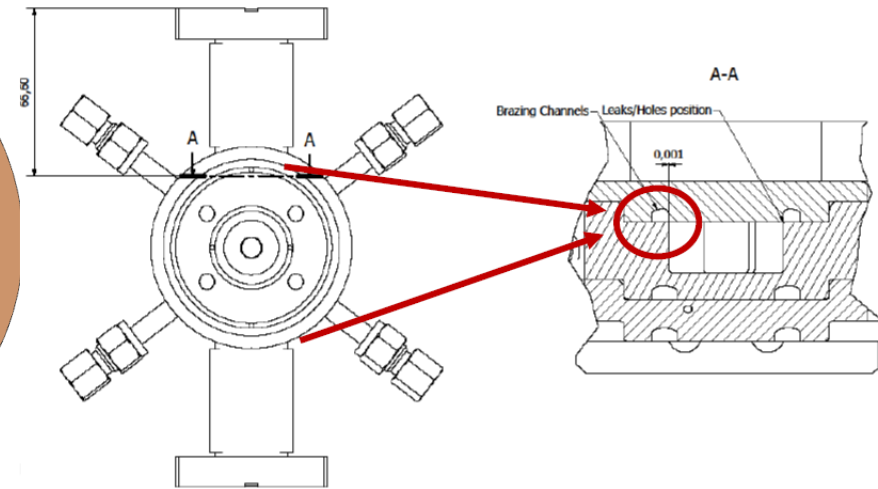
End stack brazes IV

- Unsure exactly why the braze ate into the copper
- Concern however that braze channel appears to touch inner cavity wall

- Waveguides run individually, OK (4 runs)
- Stack ends constructed using the same braze material and run simultaneously with the same braze program, however 1 stack end brazed very well, 1 stack end had less visible braze run but some braze has eaten the copper and exposed the braze channel through the cavity wall
- Visible hole in cavity wall in 2 places.
- Unsure exactly why the braze ate into the copper (temperature too high?), but the fact the braze channel appears to touch inner cavity wall appears to be an issue.
- Three problems were found on the furnace used for brazing:
 - vacuum leaks;
 - hydrogen contamination with oxygen;
 - large differences and low accuracy in the measurement of the temperature profile (made at different heights in the furnace).

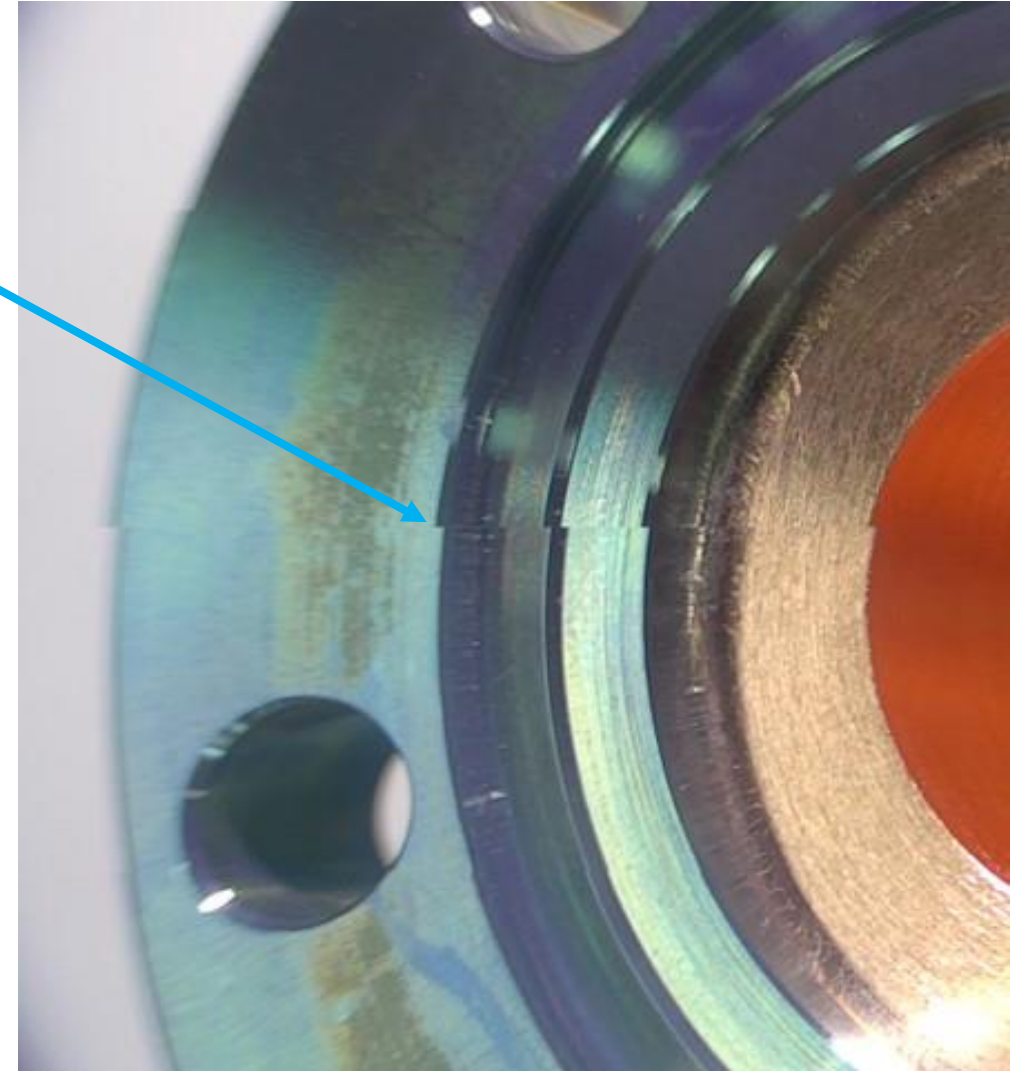
Furnace leaks

The hydrogen inlet of the furnace might also have introduced bubbles of Air, which caused the oxidation of the flange (**Blueing ~300°C**).

- A leak in the hydrogen piping would cause the formation of **air bubbles which would be pumped in together with the Hydrogen during the brazing process.**
- This might have weakened/influenced the bonding strength of the braze
- Further tests are required before proceeding:
Introduce a stainless steel part into the furnace and carry out a similar brazing cycle.
The furnace shouldn't be vented until circa 100°C (as a precaution)
- If no blueing occurs then this phenomenon has been caused by early venting which should be avoided for the next brazing cycles

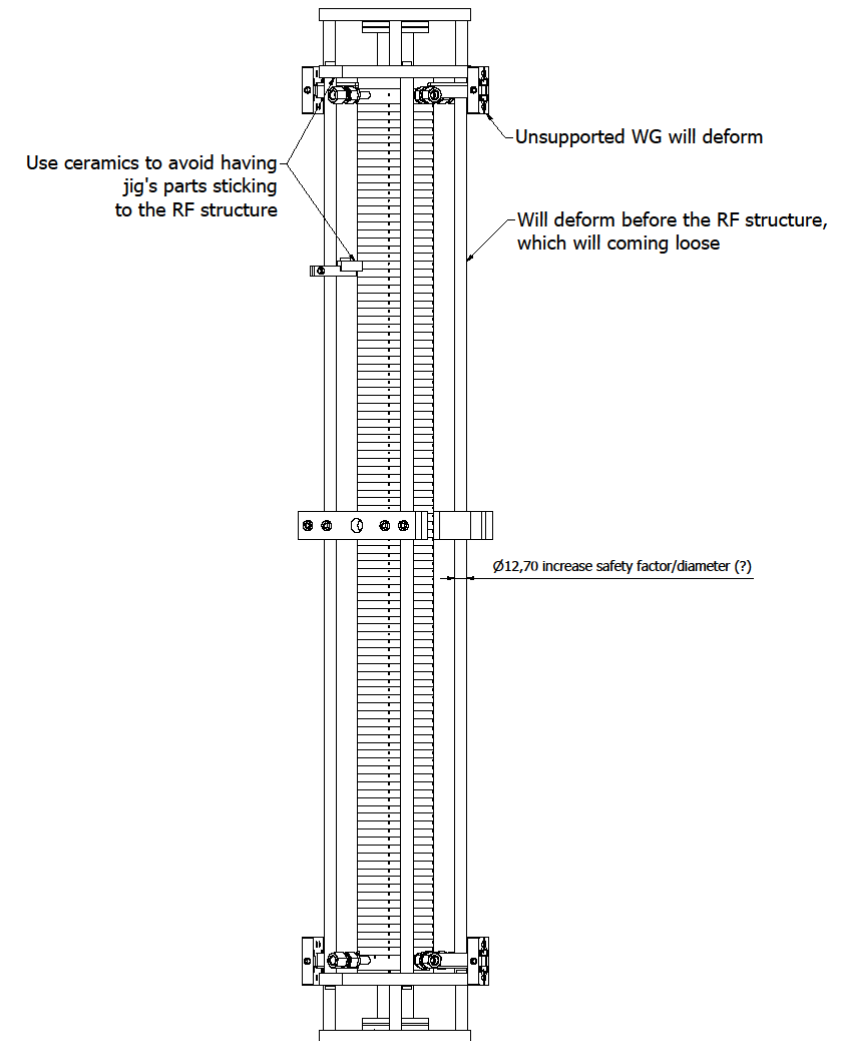
TMD jig modifications

The use of screws in a jig furnace is unrecommended.

The difference in mass between the RF structure and the steel jig leads to a sensible difference in thermal inertia that could cause the structure to get free of the jig during both the heating and cooling phases.

- **Heating Phase:**
The jig heats up and deforms faster than the RF structure, the rods lengthen faster, and the top of the **RF structure is no longer in contact with the jig**
- **Cooling Phase:**
Jig cools down faster than the RF structure compressing it more than anticipated, potentially resulting in the **deformation of the RF structure due to buckling strength**

Waveguides should be adequately supported during brazing to avoid unnecessary deformations
