# FPGA IRRADIATION @ NPTC-MGH (Round 2: SU vs Boston)

Syracuse University

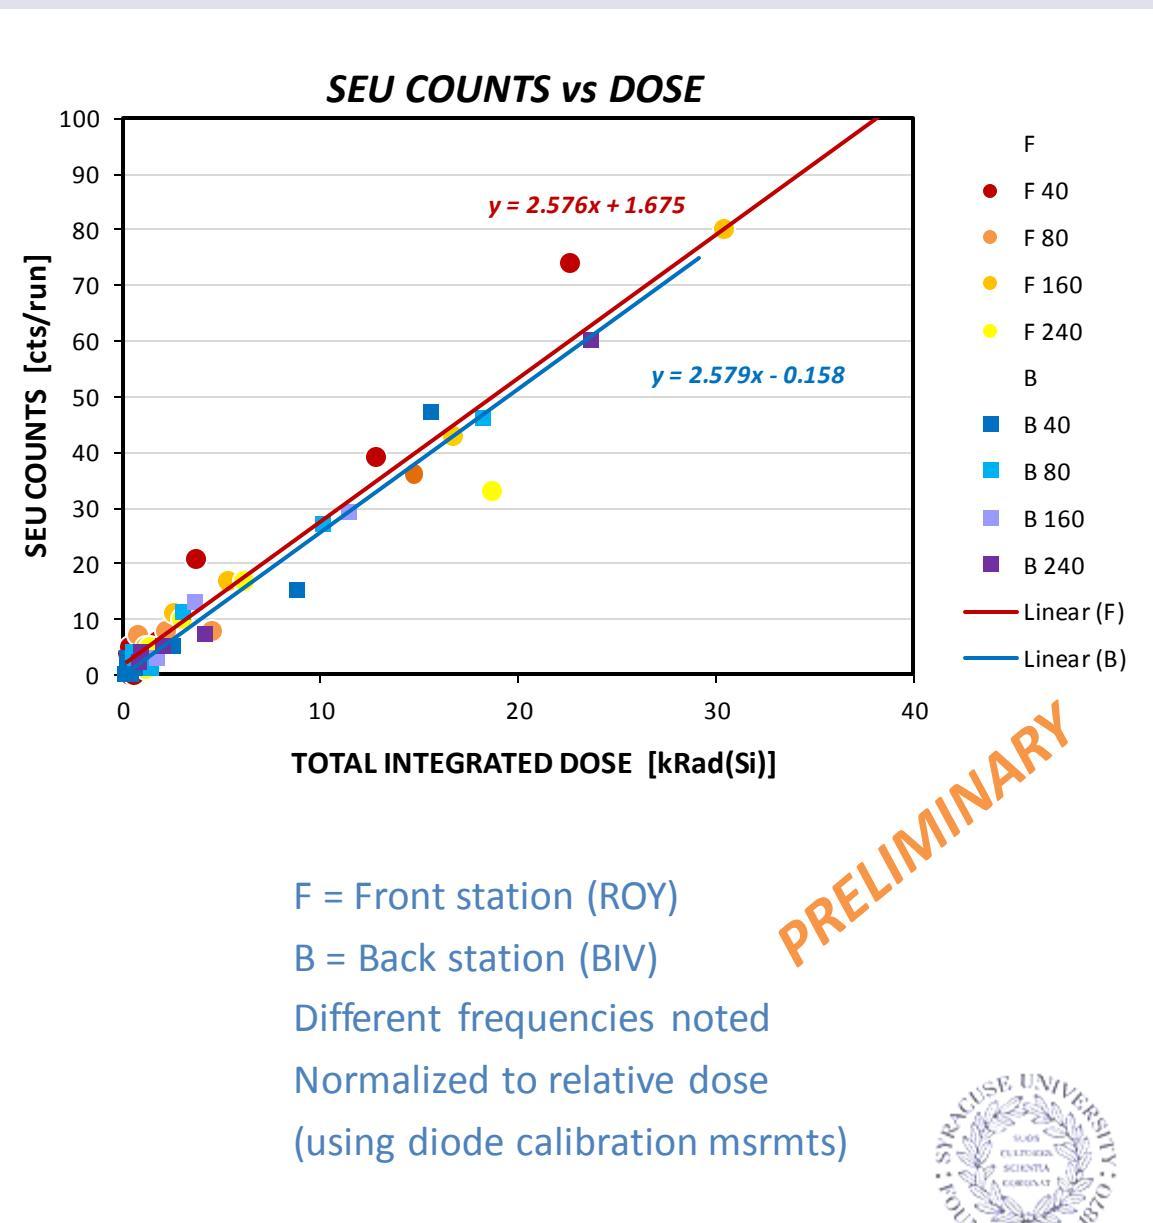
# SEU Test (2)

- See onset of SEU right away, even at very low doses
- Linear increase with dose
- Need to convert counts to a more physical quantity, etc.
- Seems understandable but expect threshold behavior?
- Still working on this

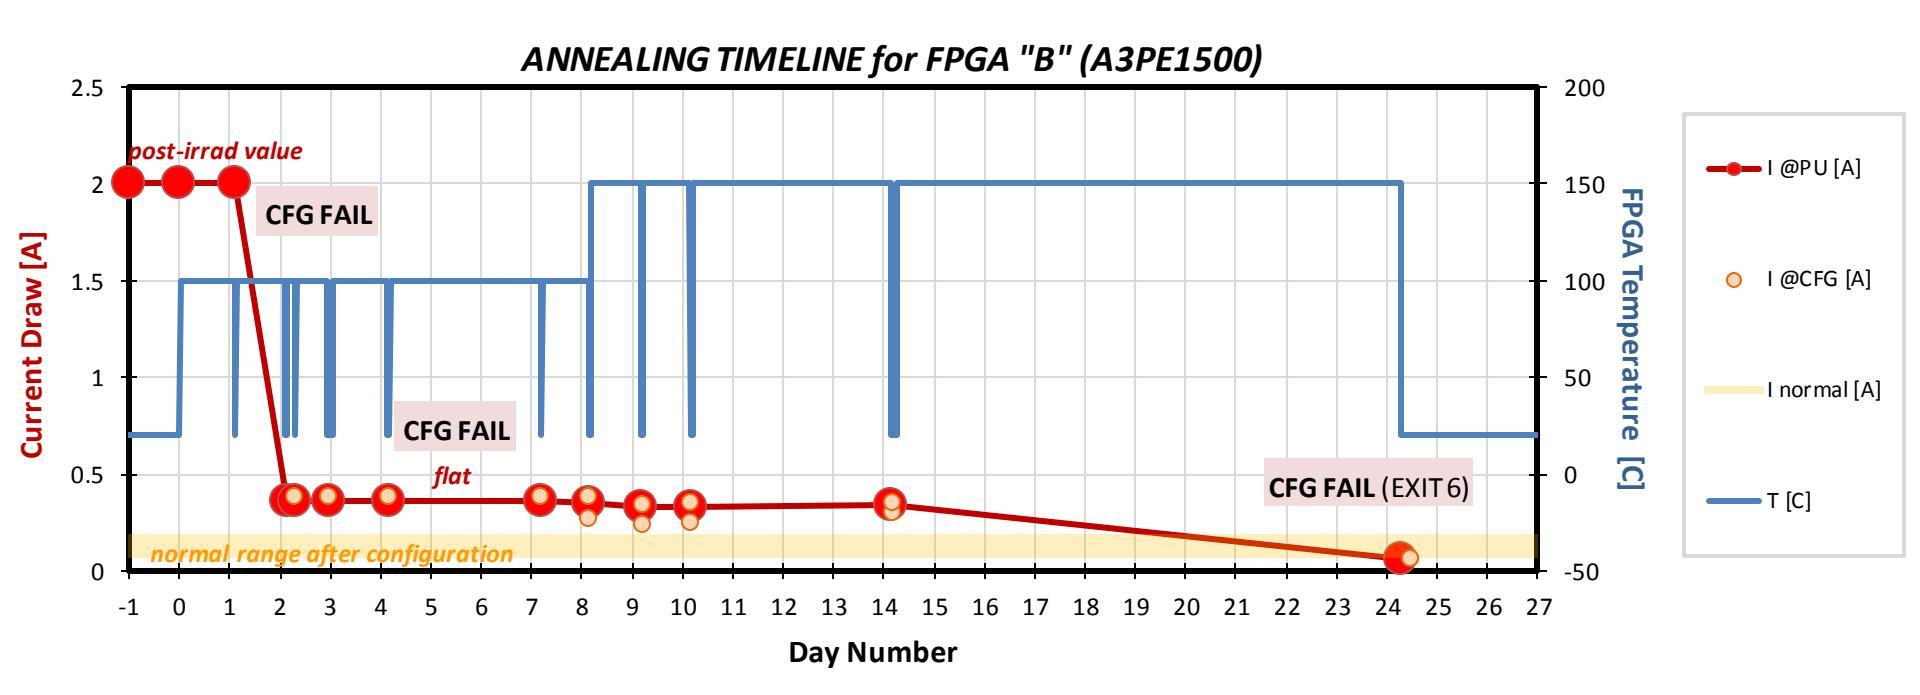
• FPGA B (rad damaged last year)

- Never recovered from radiation damage
- Cannot run program
- Cannot configure (even a small program, confined to periphery of FPGA tiles)
- Not just a low Vcc preventing it from functioning (provisional explanation)
- Seems to be really most sincerely dead
