UiO ITK Status: Assembly of R0 Triplets

ATLAS Upgrade meeting in Oslo

25th June, 2024

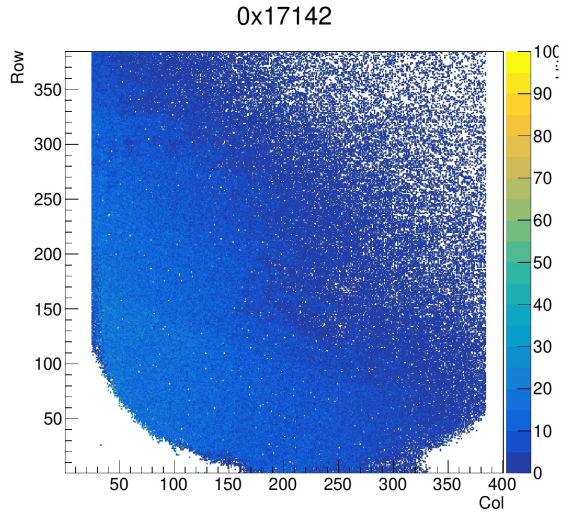
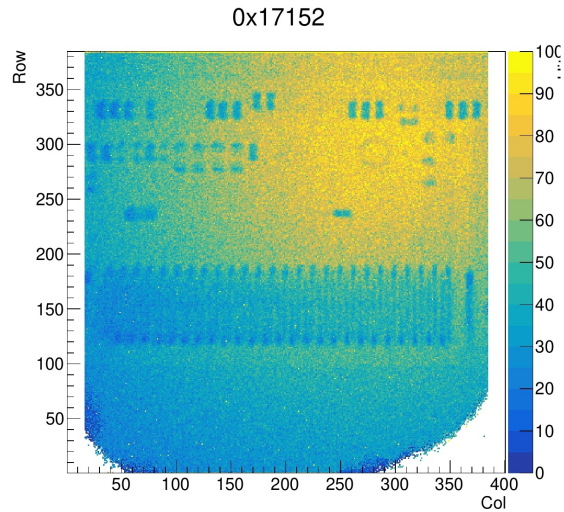
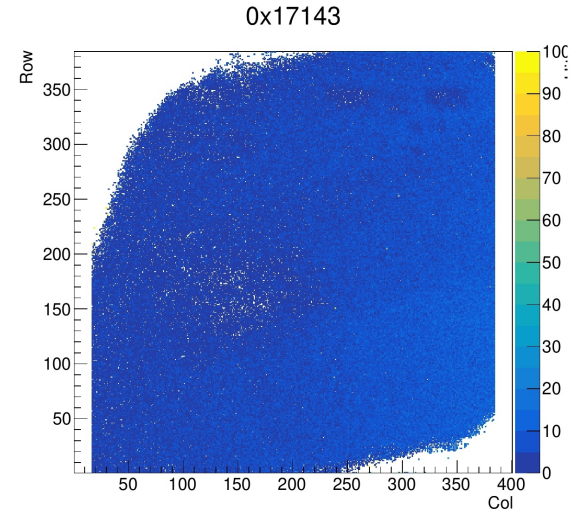
Had to run YARR scans and tunes for chips 1 and 3 separately from 2.
Still have errors if run all three chips enabled even after tuning (scans work, if disable chip 2 or enable only chip 2).

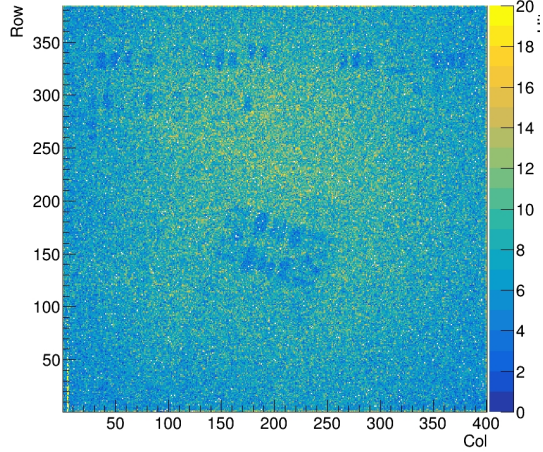
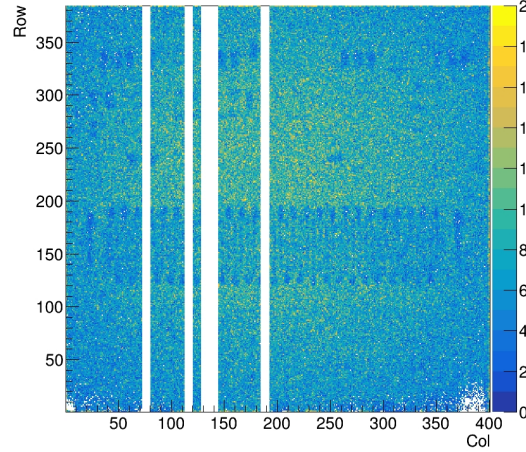
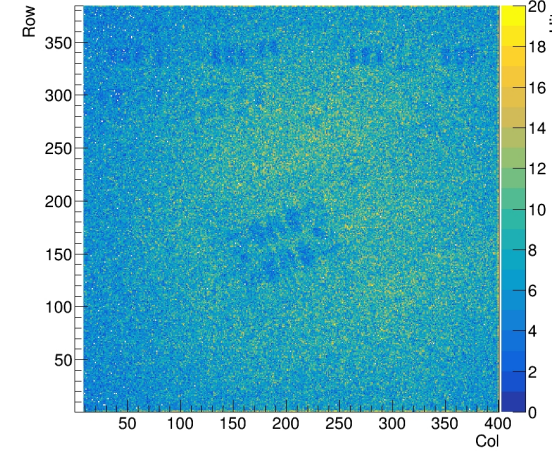
SINTEF/IZM 20UPIM02202131 (double-glass)

Had to disable several core columns for the middle chip, otherwise the module is good.

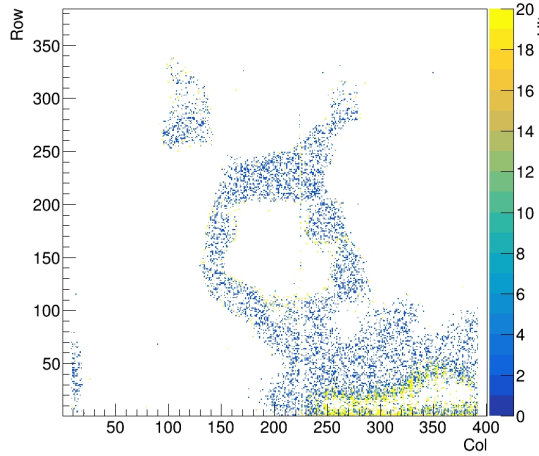
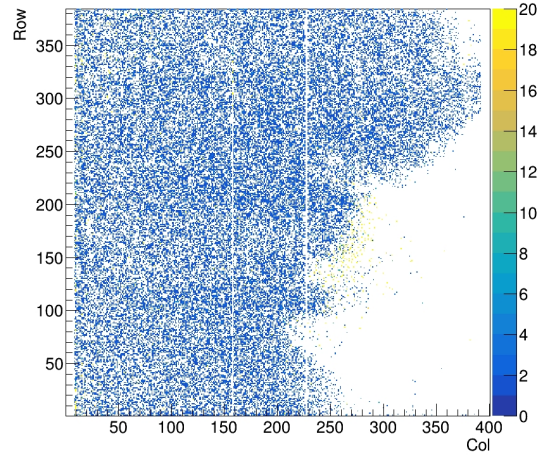
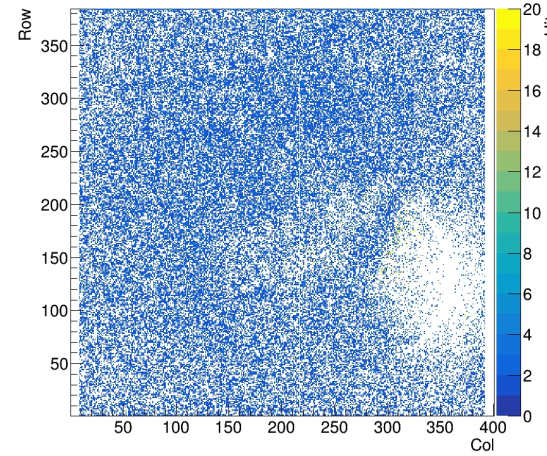
Chips 1 started coming apart during wire bonding, had to use some glue.

Could not run source scan for long due to errors.
