Richard Soluk – MoEDAL Collaboration (Technical Coordinator)
University of Alberta

MAPP TS2 2024 STATUS

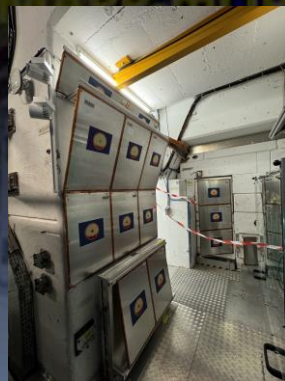
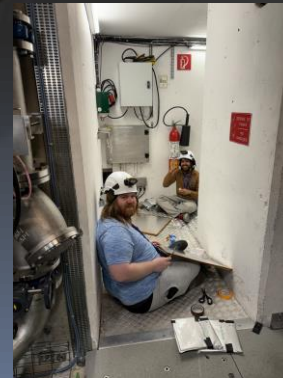
- NTD replacement over 3 days
 - Oct 21 Jack Lindon, Abhinab Mukhopadhyay, Richard Soluk
 - Oct 22 Jack Lindon, Richard Soluk
 - Oct 23 Jack Lindon, Richard Soluk
- TPX power supply repair
 - Oct 22 Martin Farkas
- All NTDs replaced and new temporary TPX power supply installed for use until YETS

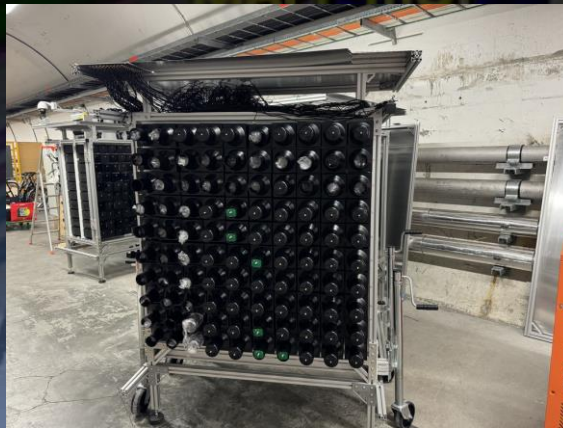
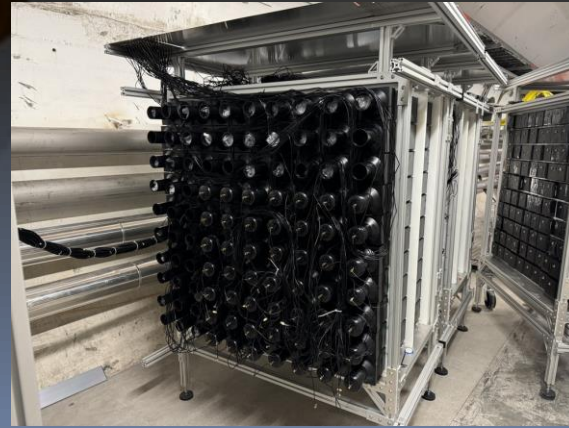
- Flame shield removal
 - Oct 21 brief access Mukhopadhyay, Soluk
- Detector frames moved (>1 ton)
- Scintillator bars reconfigured to 7x7 array with PMTs and colinear between frames
- Cabling done on both sides of detector patch panel
- Flame shield reinstalled and all seams sealed
 - Oct 22 Subash Behera, Mukhopadhyay, Soluk
 - Oct 23 Behera, Soluk

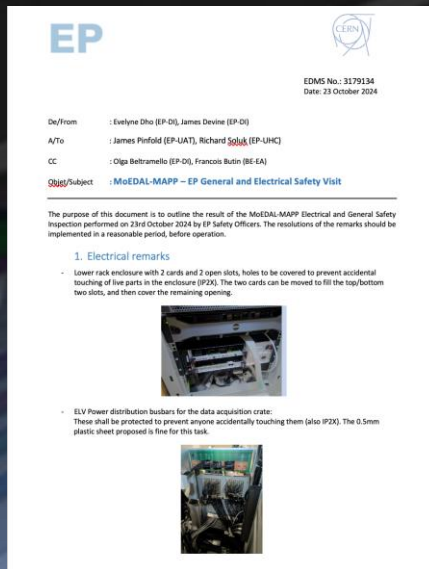
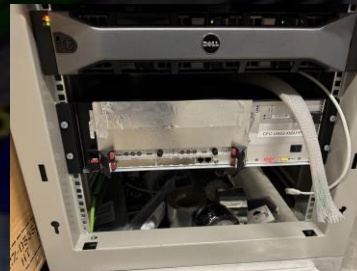
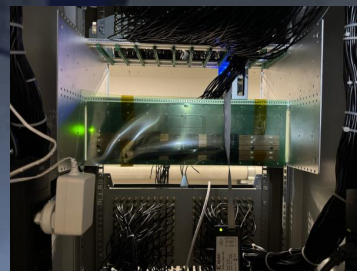
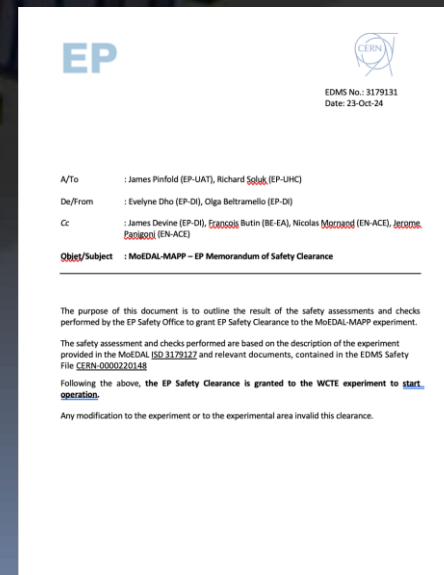
- Minor modifications needed to satisfy safety requirements
 - Mainly IP2X requirement that electronic components could not accidentally be touched
- Run certificate granted

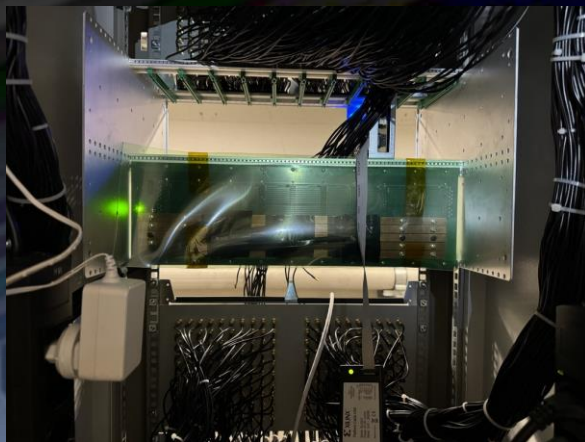
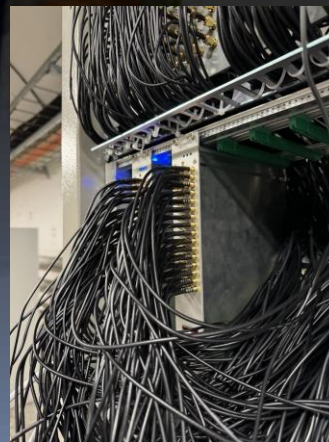
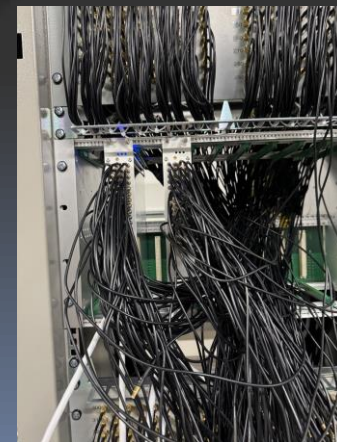
- Oct 23 access ran out before electronics-side cabling could be done or second ADC board installed
- Oct 24 short access granted, warned it could be as short as 20 minutes
- Installed 64 channels on first ADC board
- Installed second ADC board and connected additional 64 channels
