HL intervention in TI2/UJ22 during EYETS 24-25 follow-up

Francesca Paola Nicoletti
ATS-DO, HL-LHC WP15 Integration

10/01/2025

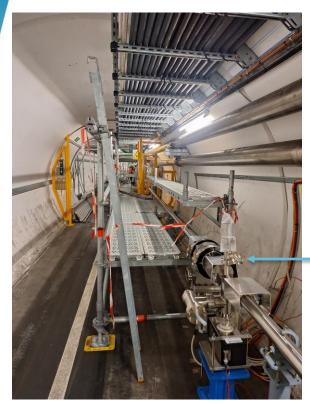
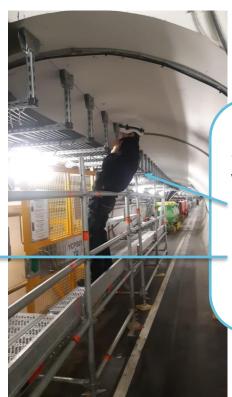
Scaffolding installation in TI2

Scaffolding modifications in Tl2 were requested to:

- enable EN-EL contractors to work properly
- better protect TE-VSC equipment

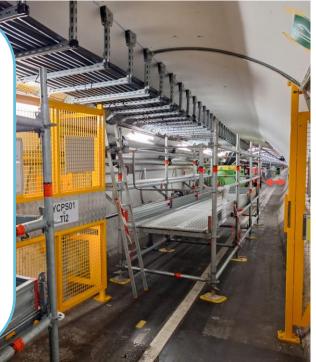
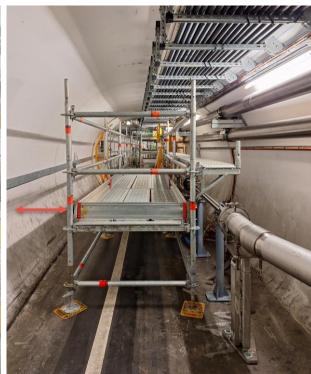
Scaffolding installation in TI2

This caused reduced passage in TI2, limiting fire brigade effective intervention

- → Exceptional authorization was accepted, subject to there being no major risk intervention in TI2
- → Scaffolding was finally validated by EN-EL, TE-VSC, EROS and the Fire Brigade on Tuesday 17/12

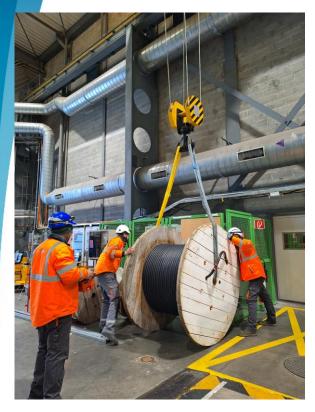
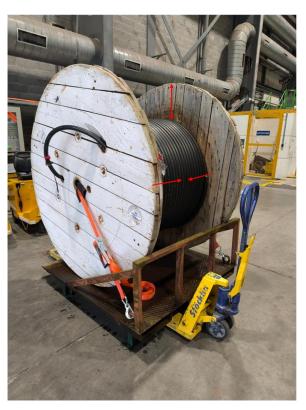
New cable coil transport

Transport slightly delayed (one day) because of:

- TE-VSC equipment in the transport area
- coil was bigger than standard for LHC
- → Transport done this morning
- → No impact on overall planning

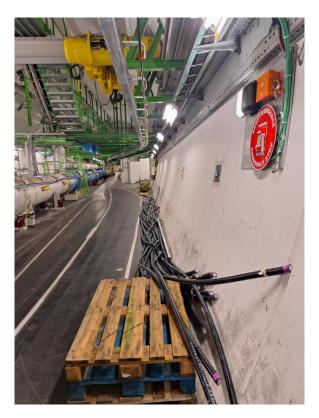
Cables waste ©

- RP checked cable sample
- → Cables are not considered radioactive
- → They will go in standard waste

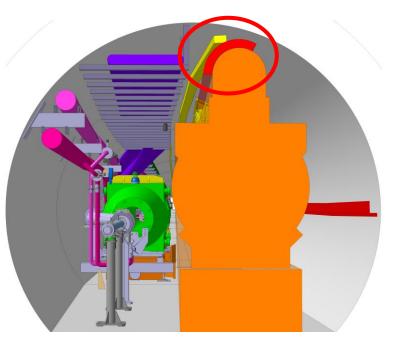
17th cable tray support

Power rail interferences in TI2

Action New path for power rail in the vault

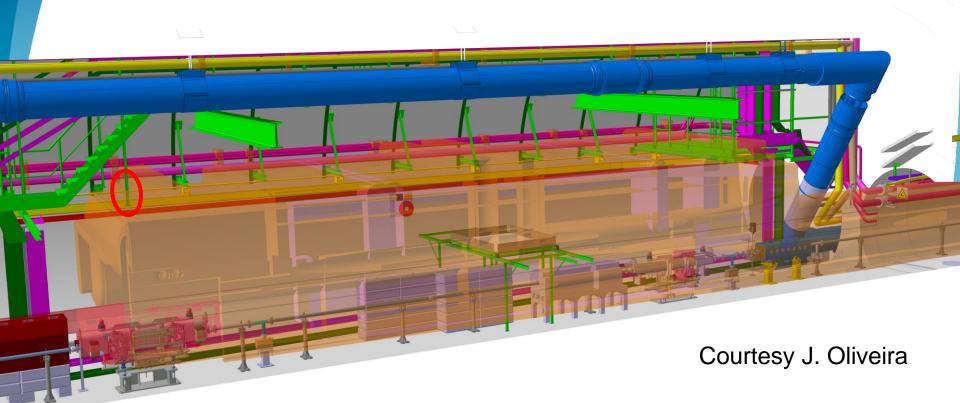
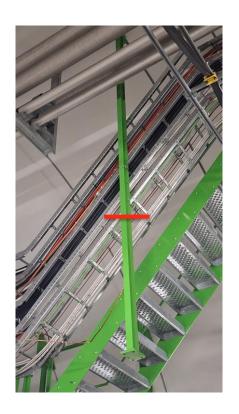
Metallic structure interferences in TI2

Action
Metallic bar to be cut just
below the lowest cable tray
