New Mice Target Stator

Progress of New Mice Target Stator.

Geoff Barber Imperial College
Eamonn Capocci Rutherford Lab

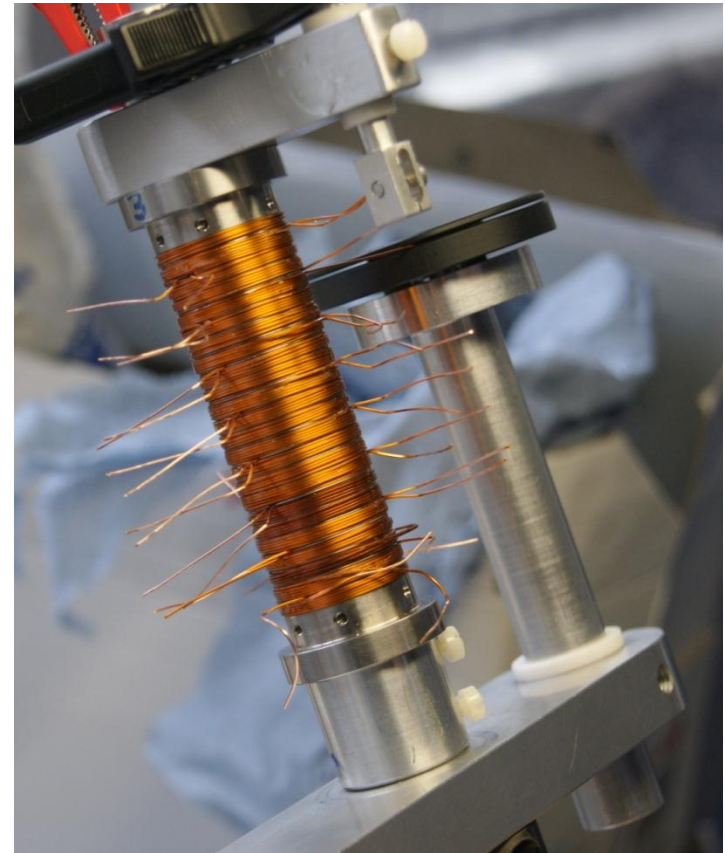
Once the coils were wound and tested the segments of the cooling jackets were fitted... This caused 3 coils to short 'NOT GOOD'. However the cooling segments were given a larger radius and this seemed to solve the problem.

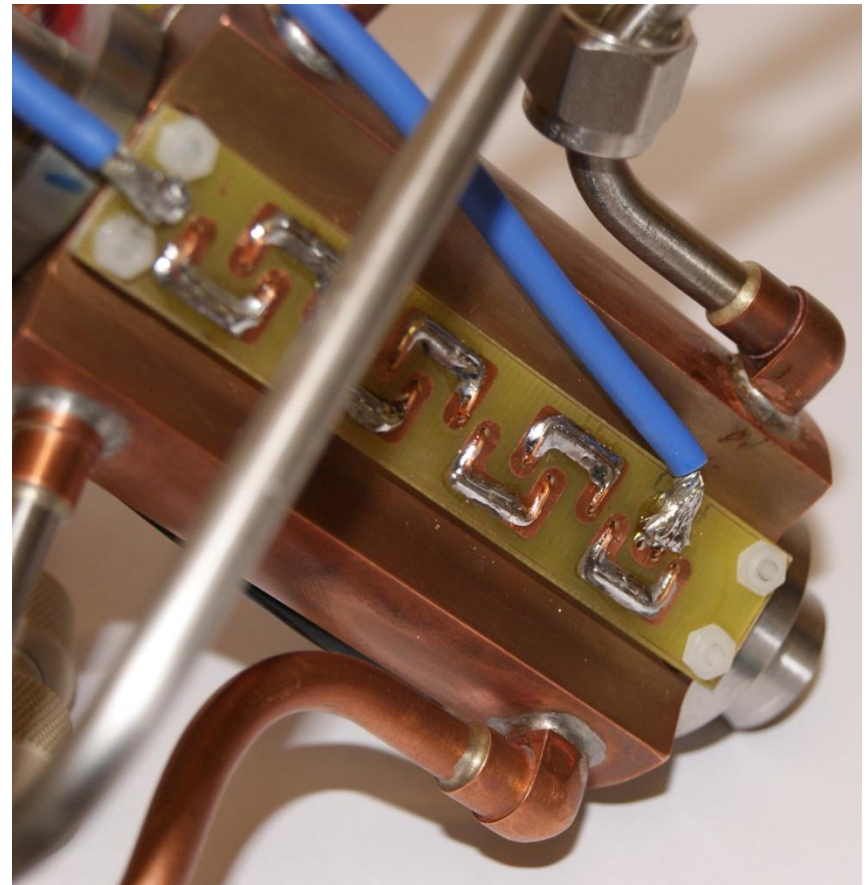
The Next step was to fit the printed circuit power rails. This highlighted the problem that with the current layout too much stress can be put into the coil wire and although this still held the voltage it will be redesigned to be kinder to the leads. The next step was to solder the tails onto the board and make one final check.

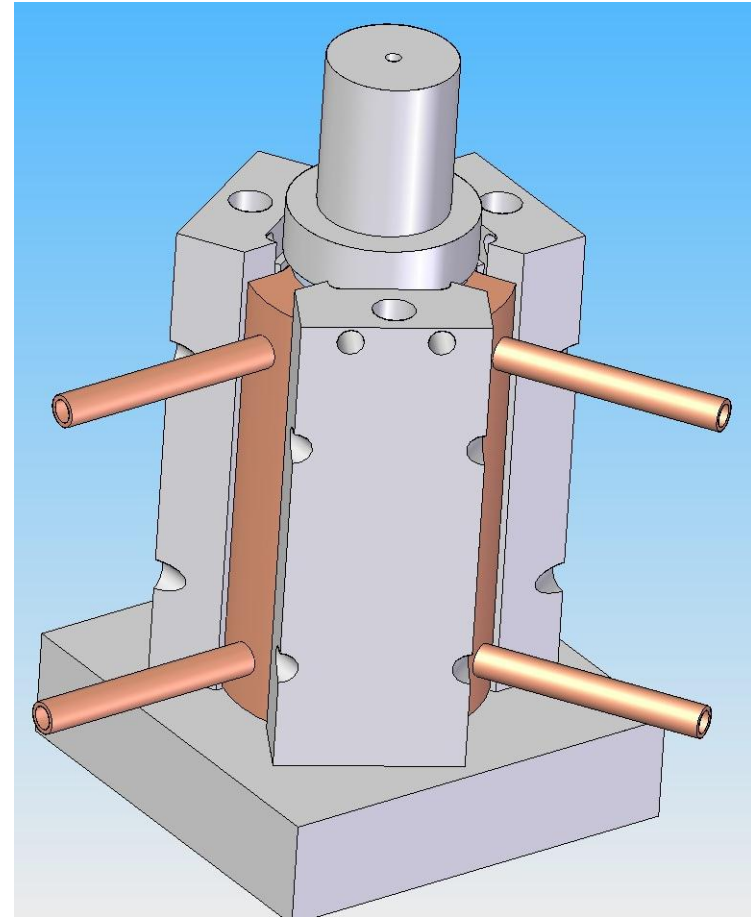
When the assembly was fitted into the potting jig we found the final problem.

When the potting jig is secured around the body cable ties were used. these secure the sections of the jig around the stator assembly and in order to make a seal these need to be quite tight. It was found that applying this pressure caused shorts between the coils and the bobbin body

This is now been re-designed
