Status of J-PARC Recovered from the Earthquake

Michikazu KINSHO

J-PARC/ KEK&JAEA

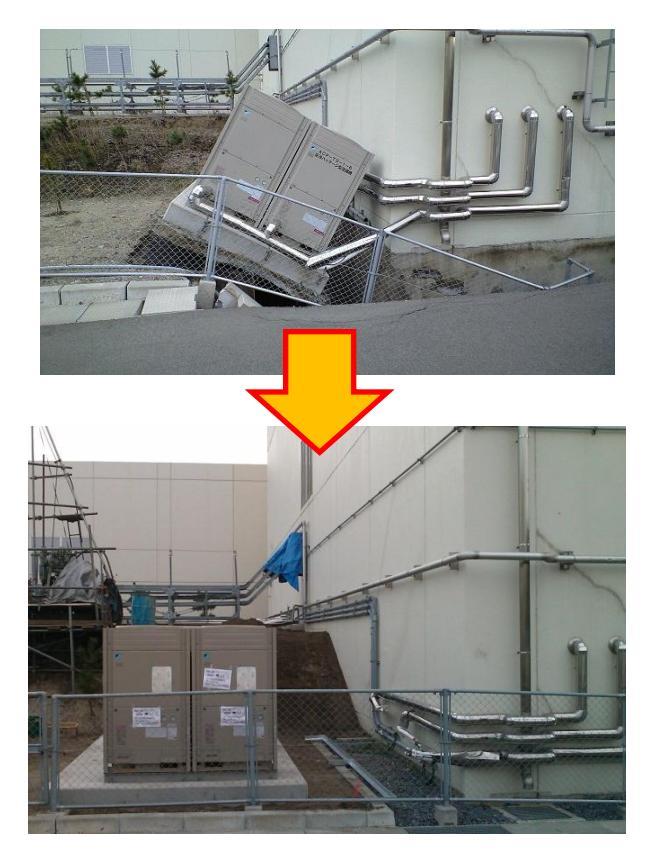
AC device tilted toward a depression of a road. Many pipes were damaged

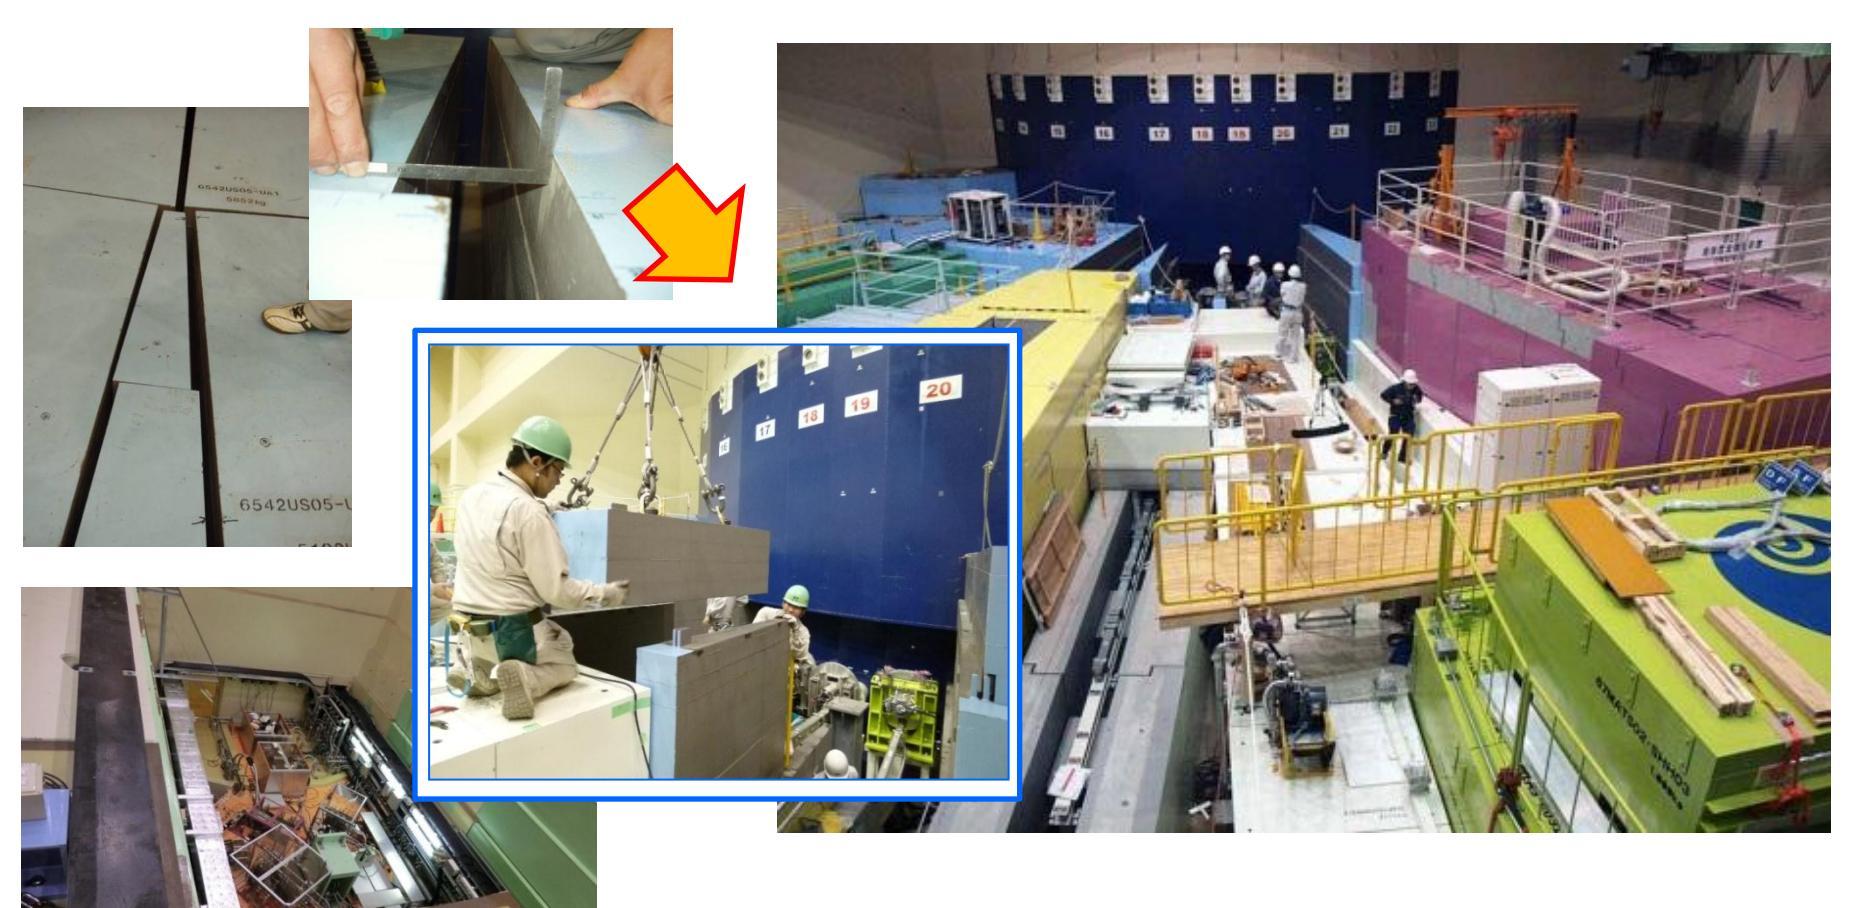
Reassembling work of shielding blocks for neutron beams in the 2nd experimental hall (above). Inspection of the inside of the muon beam facility after removing shielding blocks (right). This area does not have any serious damage.

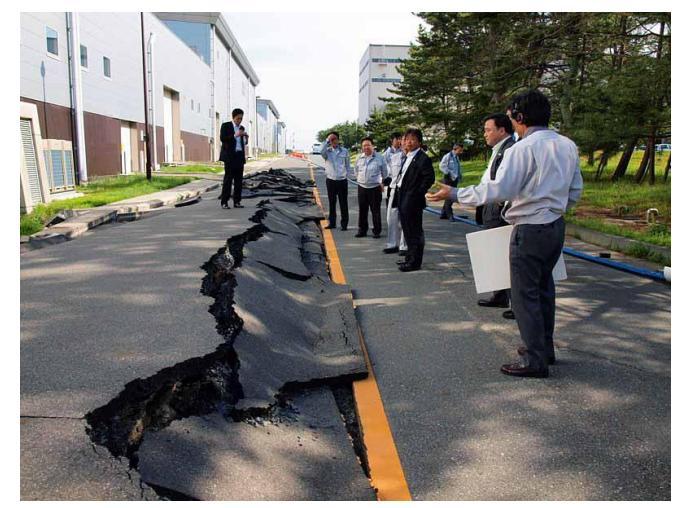
Immediately after the Earthquake

Outside of LINAC building was also heavily damaged.

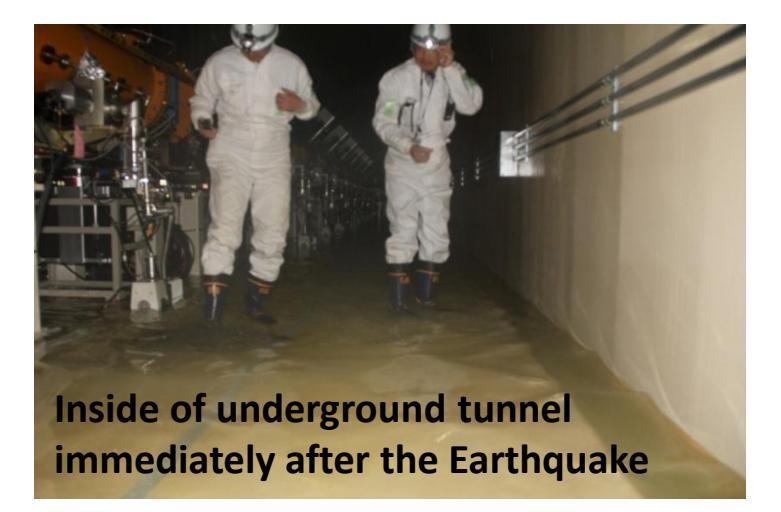
• Many spiles reached to a basement rock minimized a direct damage to the tunnel. However, groundwater leaked into the tunnel and the water depth increased to 10 cm (100 tons) within two weeks after the earthquake.

Repairing water leaks in the tunnel is completed.

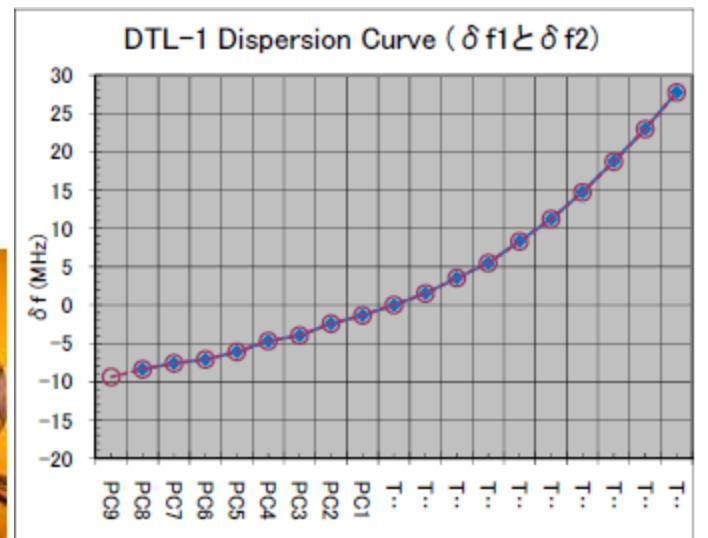
Red Before the earthquake. Blue: After the earthquake.

No significant change observed Before and After.

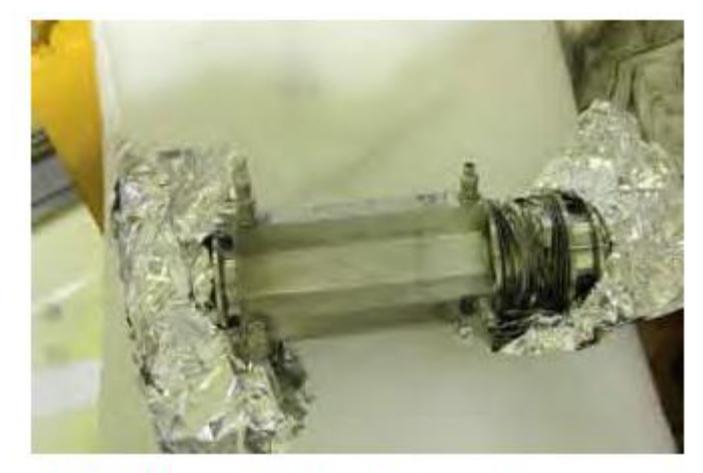
- Many CT's (Current Transformer) and BPM's (Beam Profile Monitor) were damaged.
- Vacuum leak test for individual BPM was done.
 > Replaced.

BPM (Beam Profile Monitor) extracted from Q-Magnet. Bellow was desctroyed.

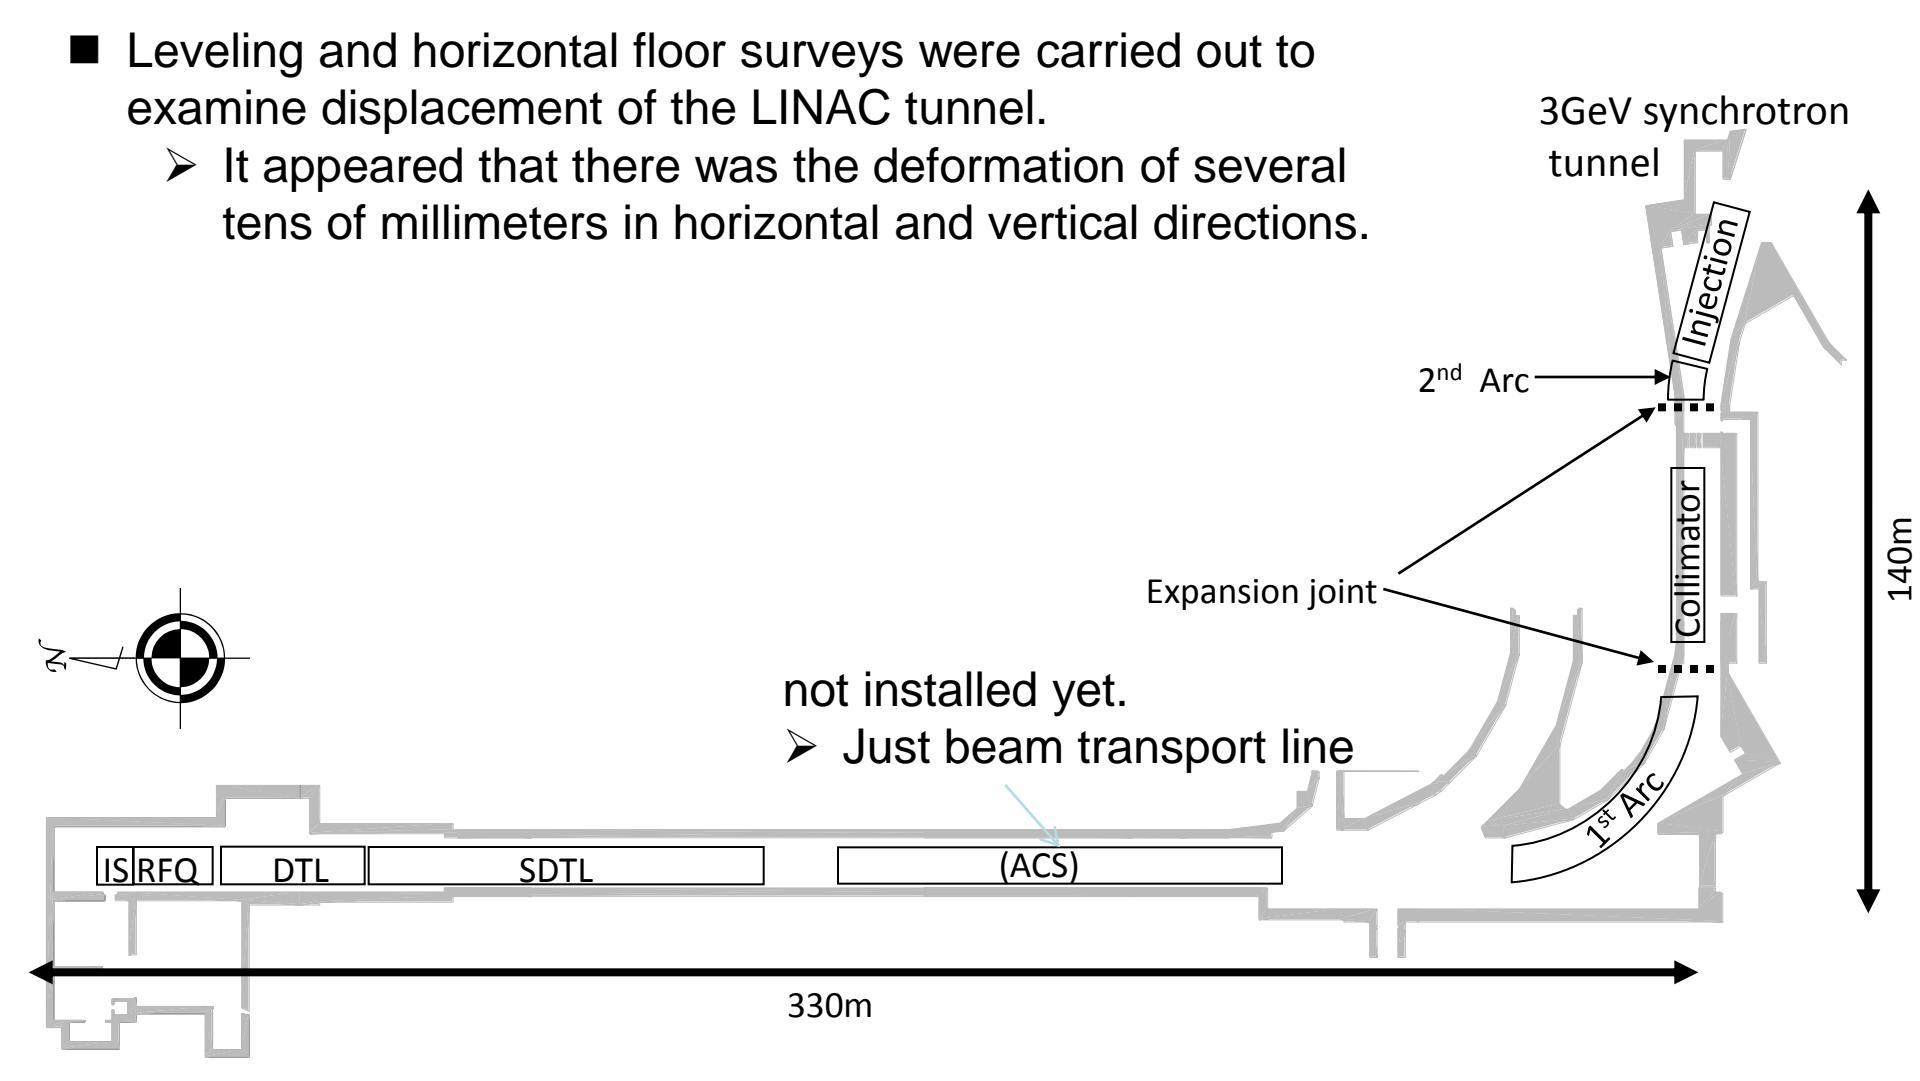
Measurement of LINAC tunnel

The floor level sagged 4 cm downward in the tunnel. Since accelerator cavities should be aligned within $\pm 1 \text{ mm}$ to each other along the beam line for the operation, they have been leveled and realigned where necessary.

We considered a better scenario for the realignment of the DTLs and also SDTLs to meet the entire restoration schedule with minimizing an effort on the beam degradation.

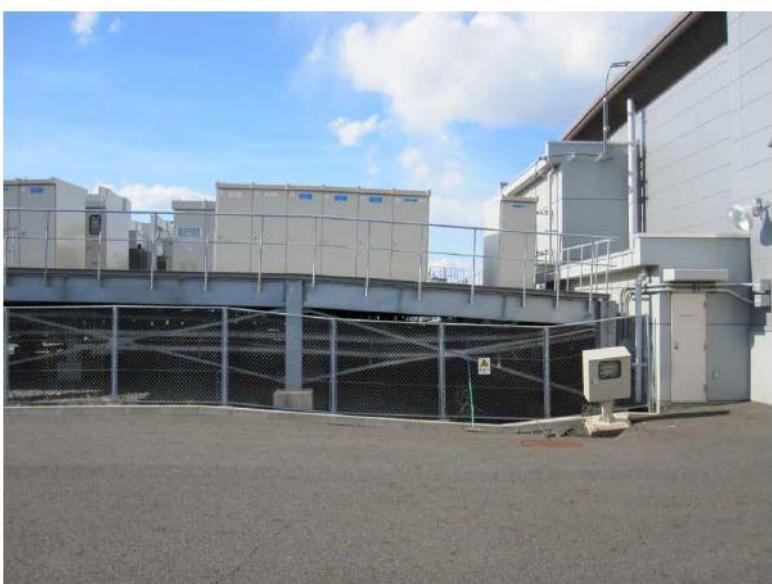
3 GeV Electric Device

Stage for electric power devices leaned

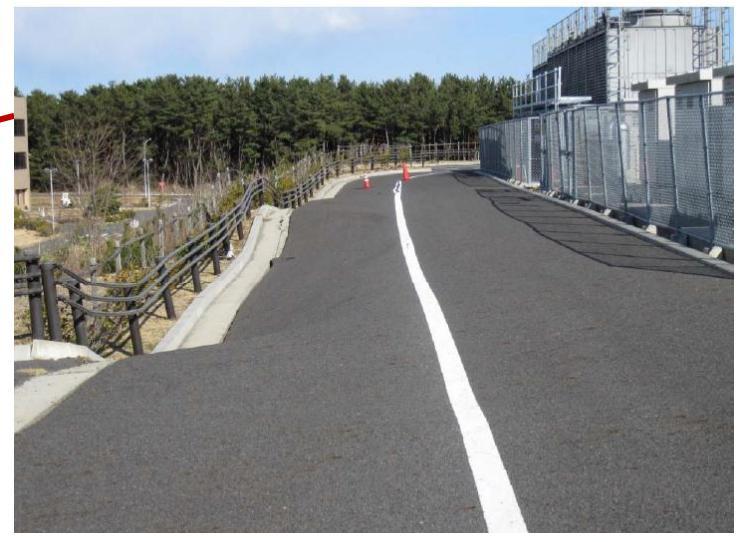
Road around 3 GeV

Wave road. Bump in the middle. Both sides of the bump were sinking. Capacitor bank and transformers

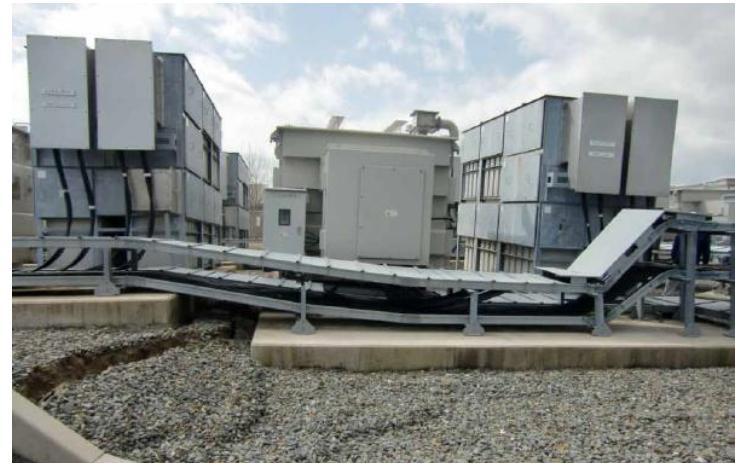
Capacitor bank and transformers were tilted. Cables were distorted with heavy weight on them.

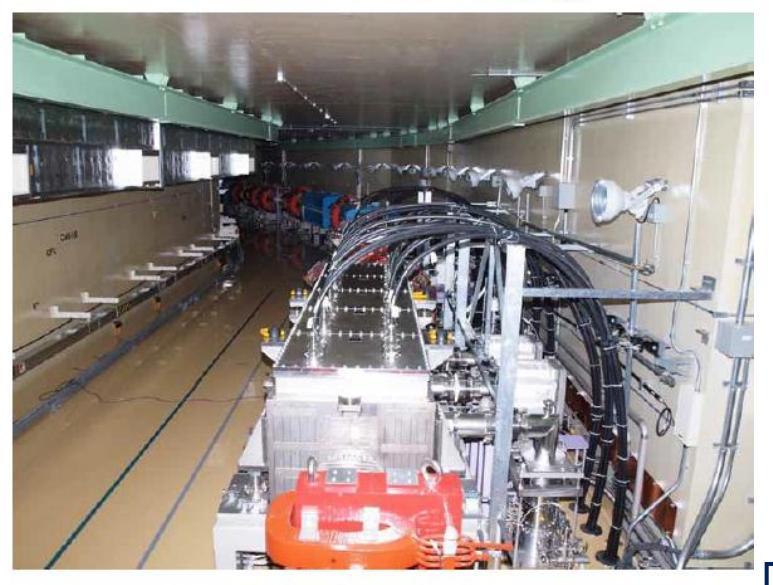
March 29, 2011

No obvious damages were observed.

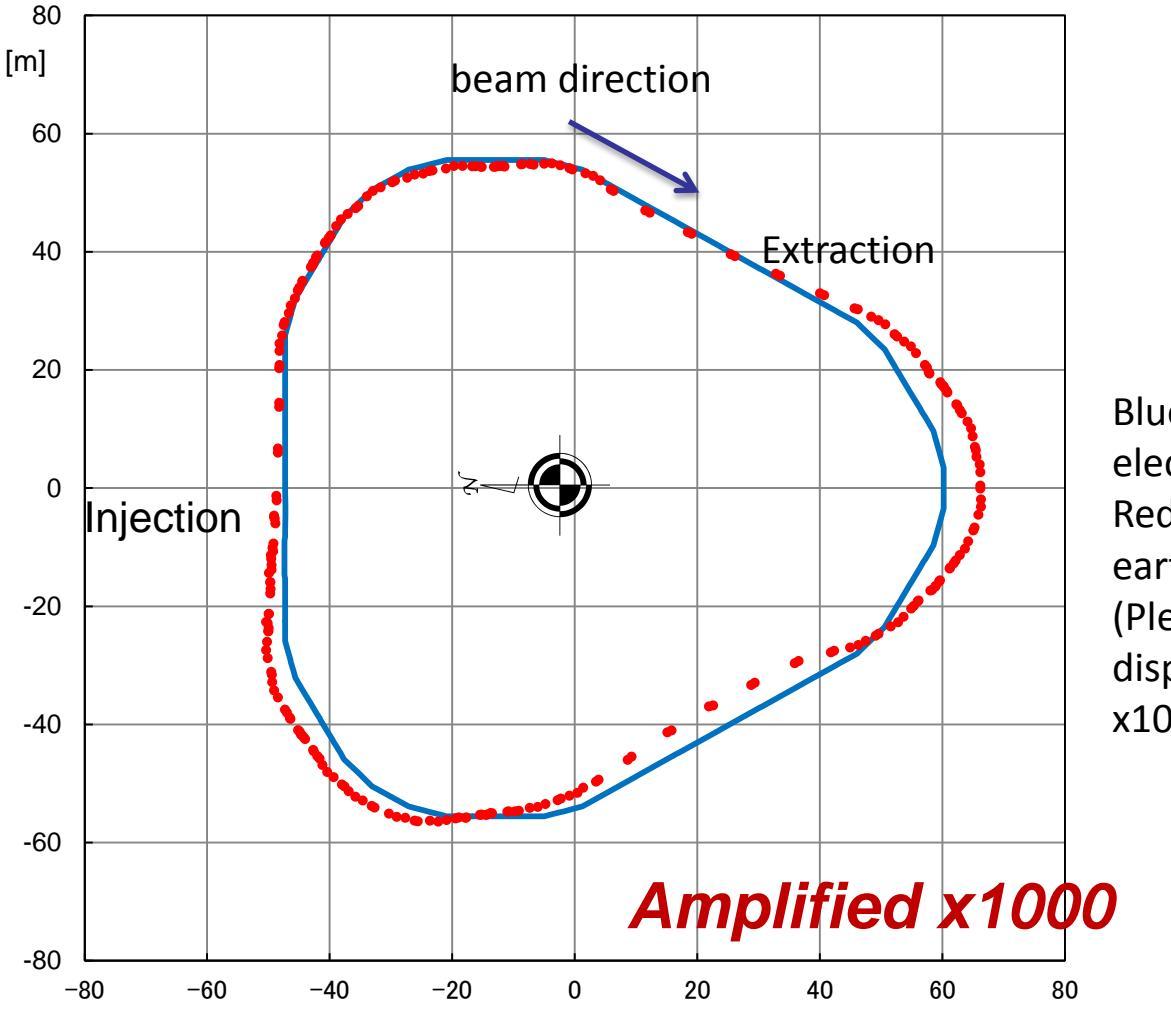
- No serious damages on the equipment/instruments in RCS tunnel.
- Position of all equipment/instruments, such as electromagnet, were precisely measured. The misalignment was up to ~3.7 mm vertically and up to ~10 mm horizontally.

Blue: Reference positions of electromagnets Red: Actual positions after the earthquake (Please note the magnitude of displacement is amplified x1000.)

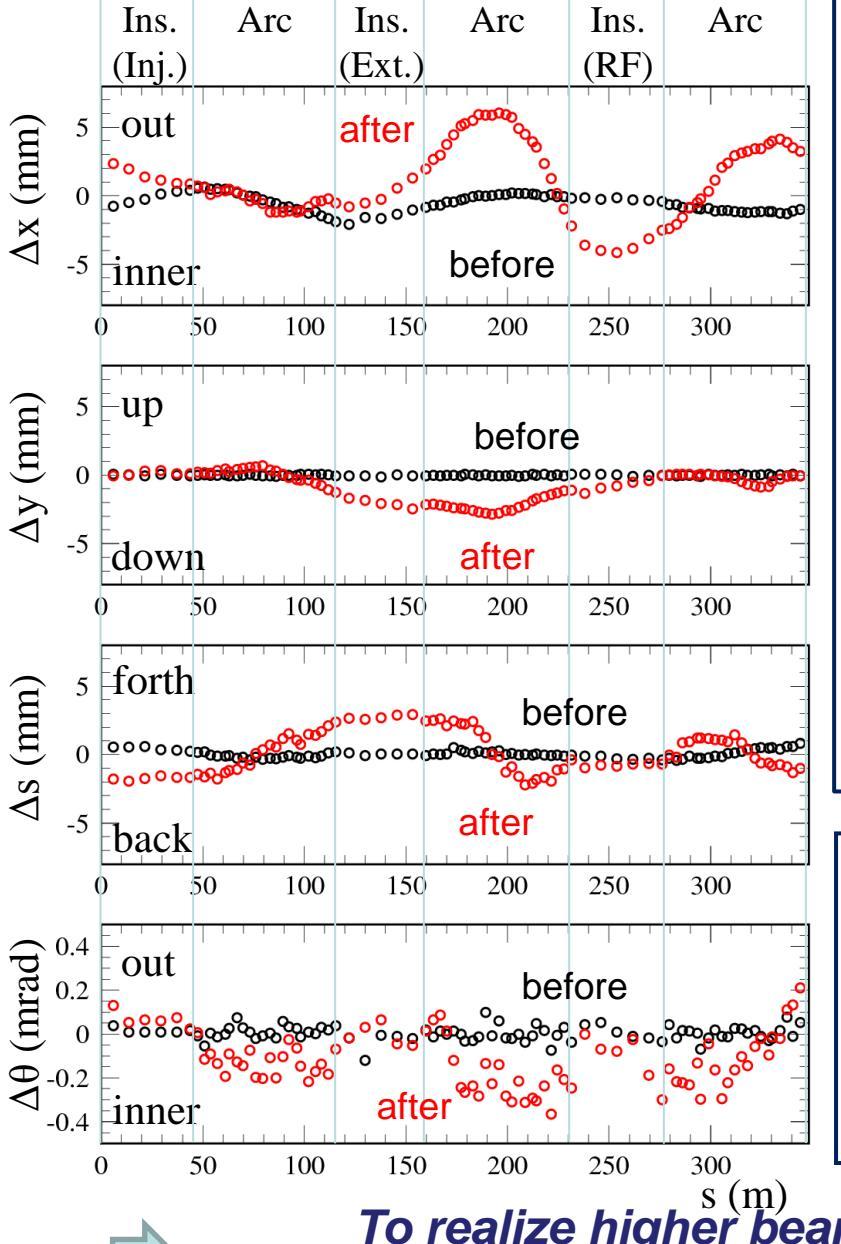
RCS alignment errors (position & rotation)

Position errors for horizontal & vertical plane Δx : - 4mm ~ +6mm , Δy : - 3mm ~ +1mm ➤ cause the closed-orbit distortion \blacktriangleright reduce the physical aperture for the beam Correct the COD by the steering magnets \geq Position errors for longitudinal plane Δs : - 3mm ~ +3mm cause the phase advance distortion The effect is very small Rotation errors for transverse plane $\Delta \theta$: - 0.4mrad ~ +0.2mrad \succ enhance the liner coupling resonance > The effect is small It appeared there was a large misalignment in both horizontal and vertical directions. However, since it is possible to correct the beam orbit with correction magnets, we decided that we did not perform realignment at this moment (during this shutdown period).

To realize higher beam power (e.g. 1MW with 400MeV inj.) realignment is planned in the 2013 summer shutdown period.

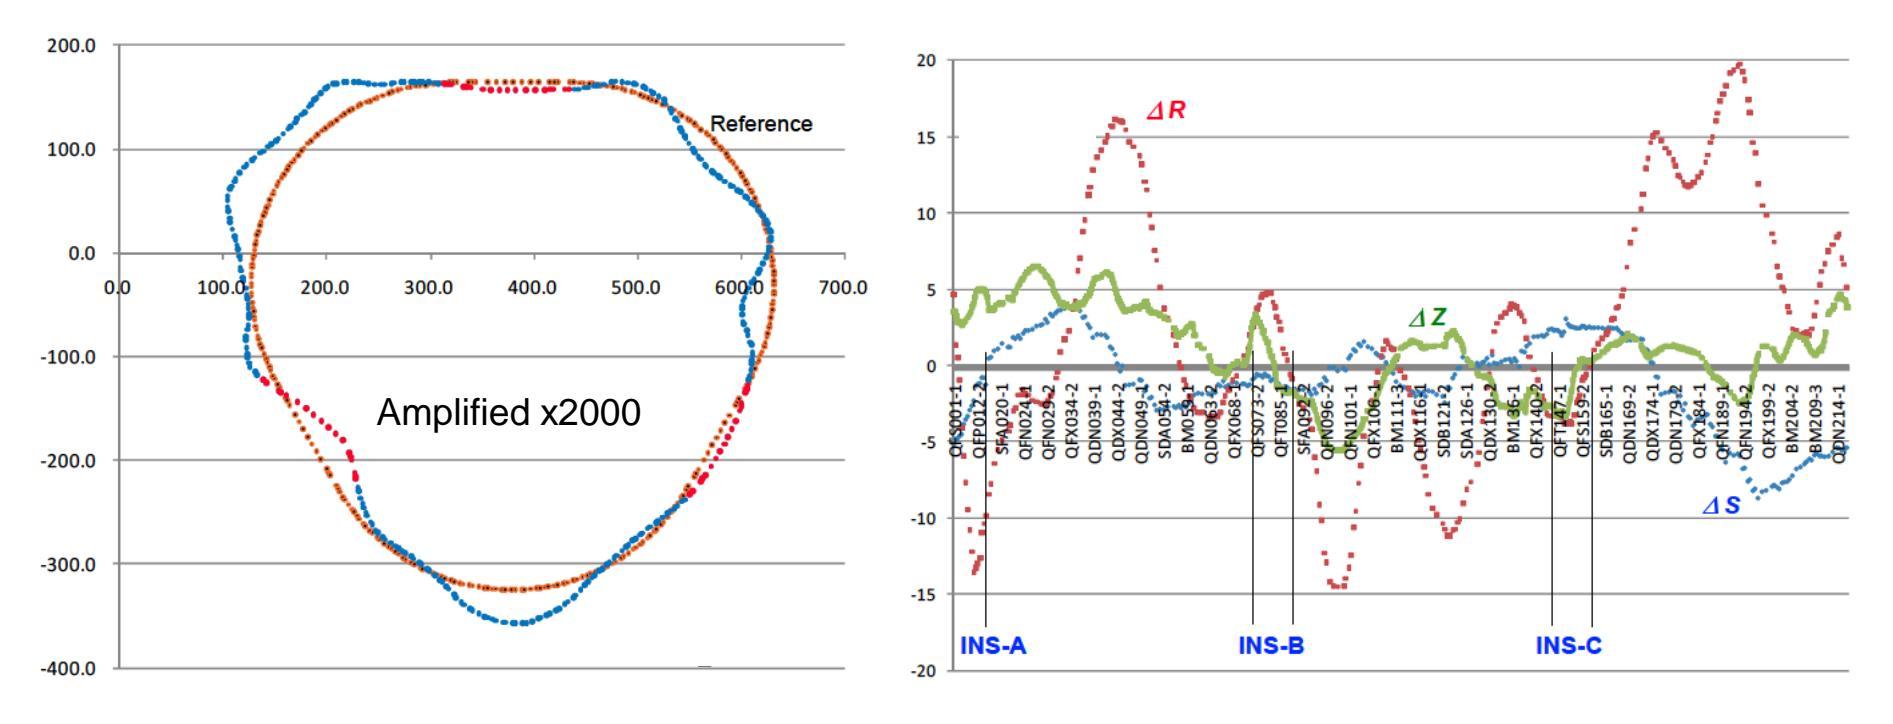
• There were no serious damages on all MR equipment/instruments, such as electromagnets. However, it appeared they misaligned in both vertical and horizontal directions.

Red: Reference positions of electromagnets Blue: Actual positions after the earthquake (Please note the magnitude of misalignment is amplified x2000.) Electromagnet misalighnment in a vertical direction

• Some electromagnets that misaligned greatly are realigned with replacing a stage and/or an anchor part.

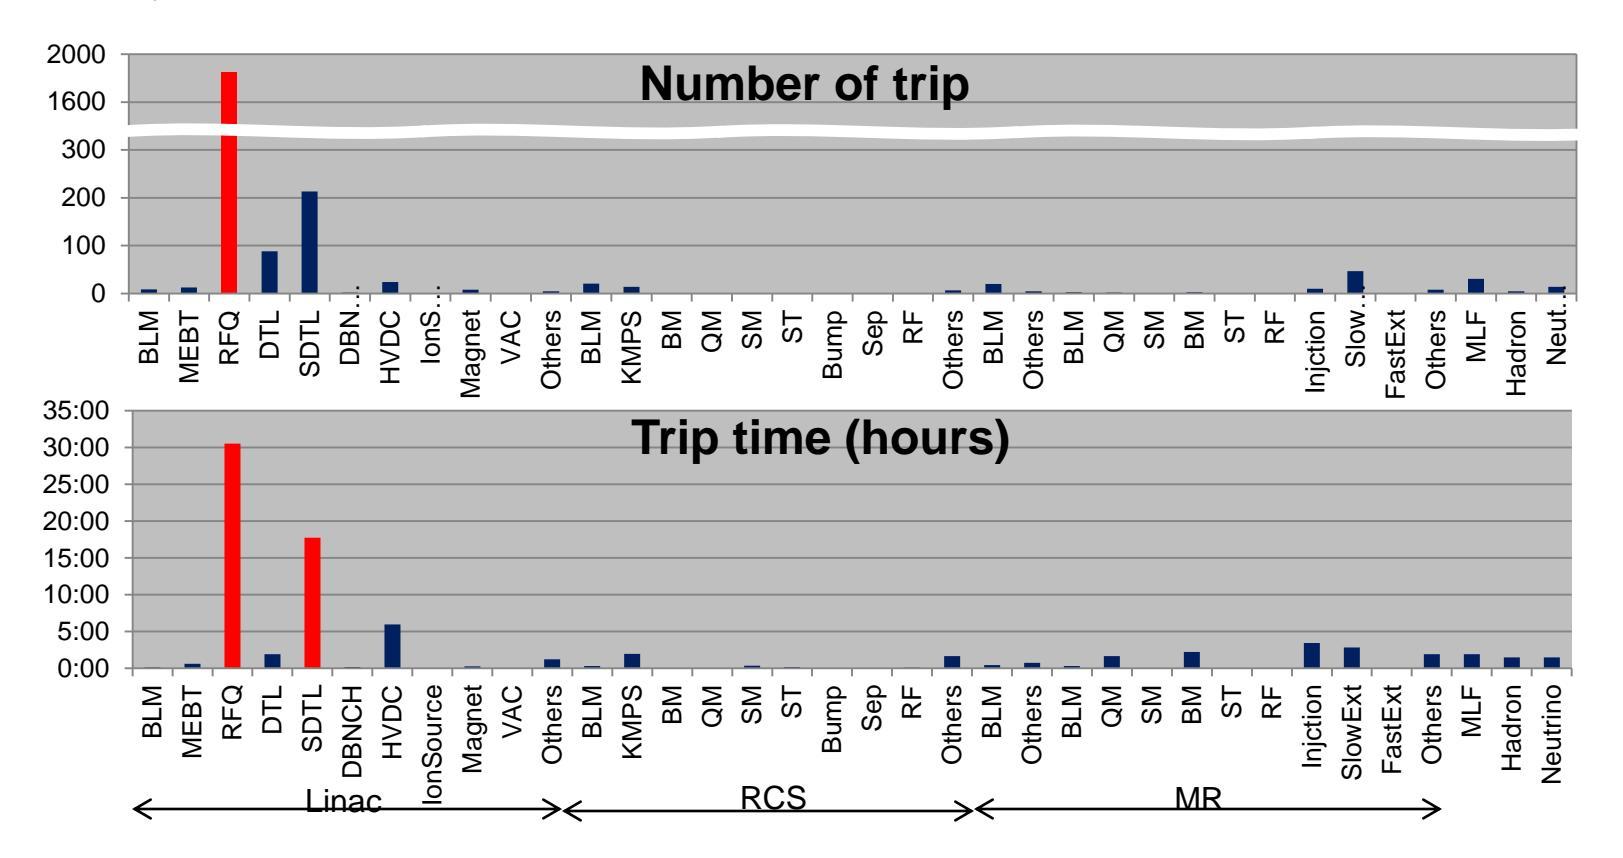
Number and time of beam trips in Run#40 (Jan.7 – Feb. 22, 2012)

Number (50-60trips/day) and time of beam trips due to the RFQ discharge is dominant.

The situation was similar to the restoration of the RFQ discharge problem in 2009. Based on the experience, the condition will be getting better, but the trend should be carefully watched.
