Operating Experience and Reliability Update on the 5 kW CW Klystrons at Jefferson Lab

Richard Walker & Richard Nelson Jefferson Lab, Newport News VA

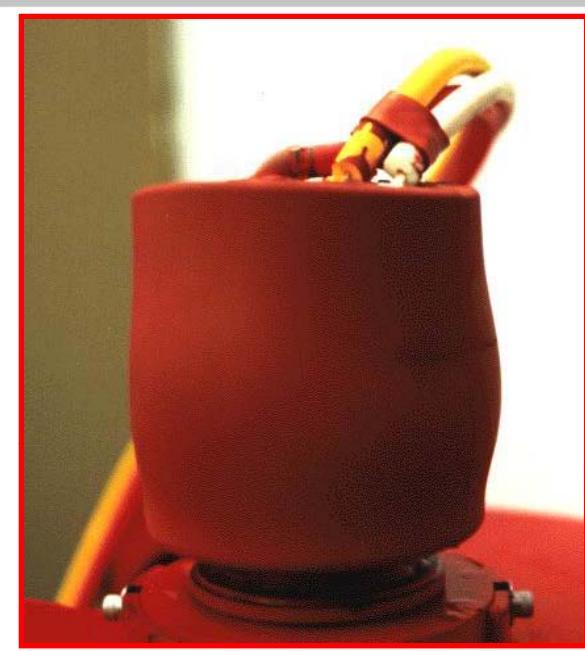
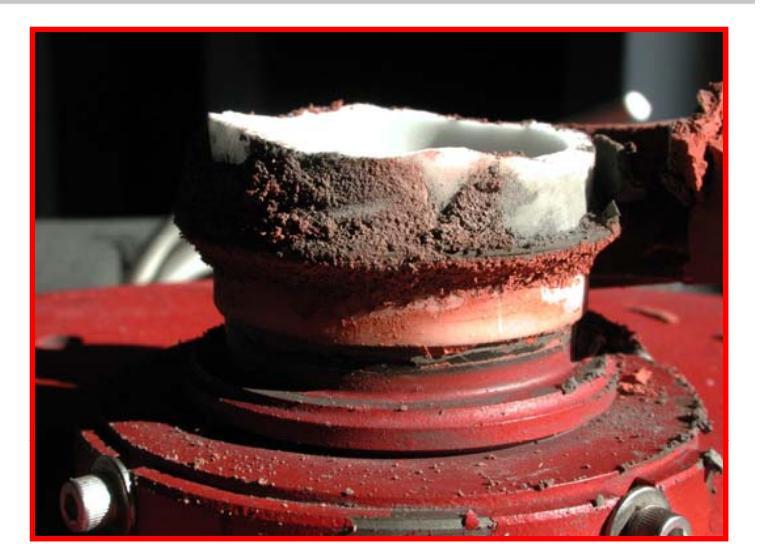
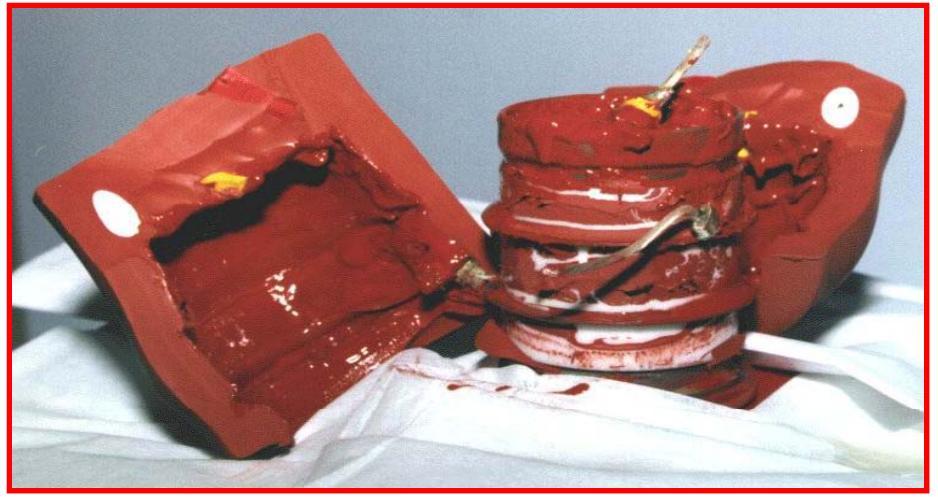
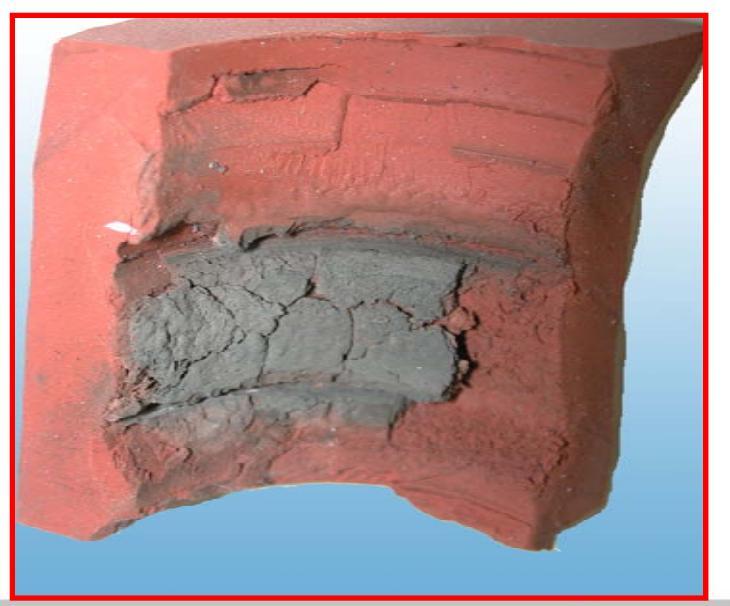
Potting Problems

Liquefied, dried, and decomposed

- Try to find potential bad potting
 - Visual inspection
 - Tactile (Charmin[®] test)
 - Ultrasound examination
- All methods found some pending failures; no test proved 100% reliable
- Result All surviving tubes were repotted (4/95 – 6/96)

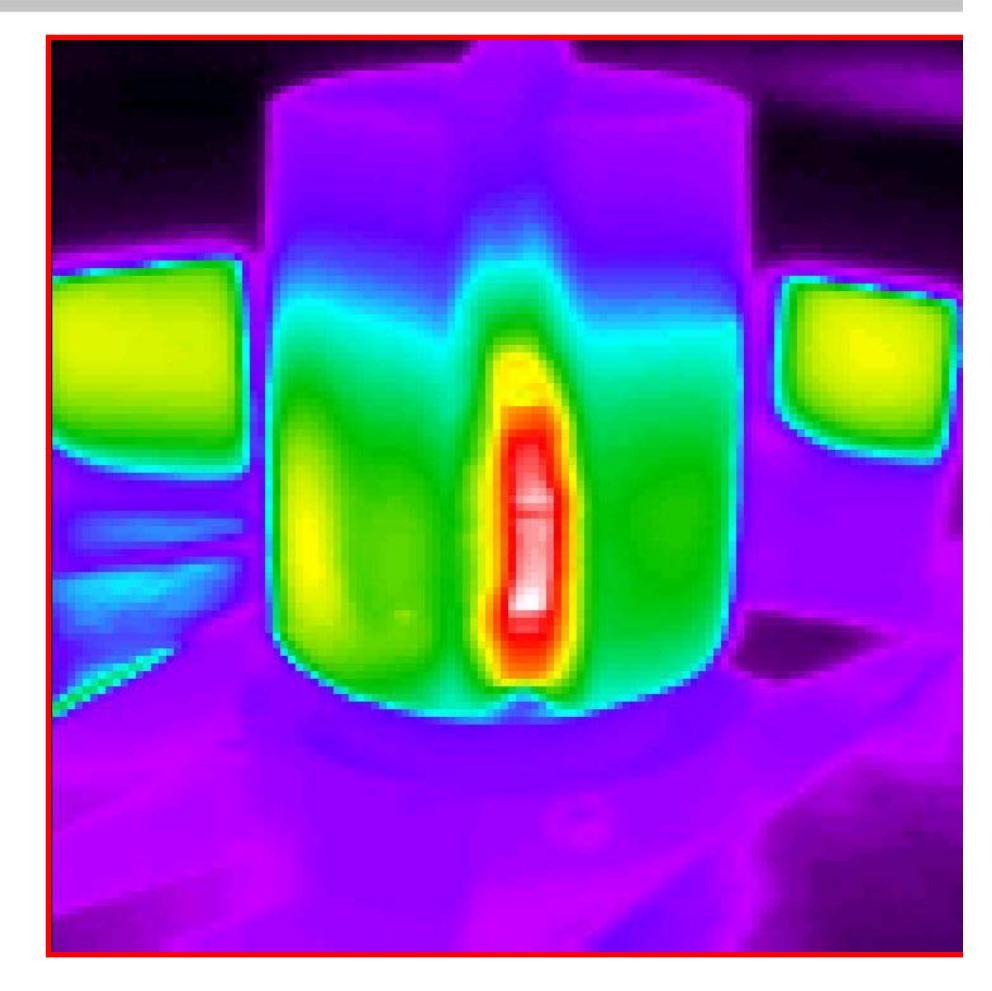
Potting and Ceramic Failure

- Due to excessive heating from
 - Heater power
 - ~30 watts
 - Found 60 watts met rated RTV temperature
 - Intercept currents on modulating anode
 - Leakage across gun ceramic insulators

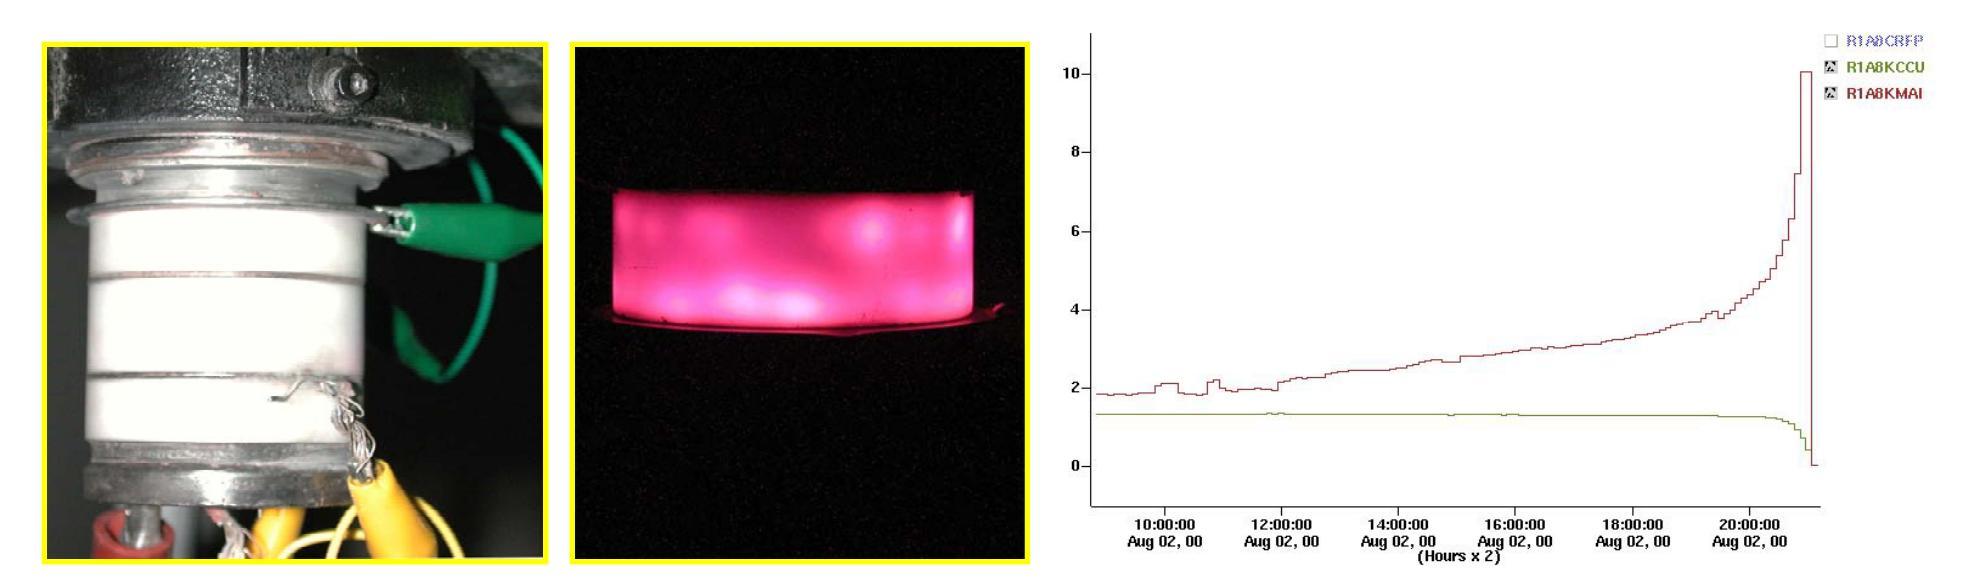
Internal Barium Deposition

- Tubes exhibit linear and non-linear leakage
- Non-linear due to field emission
 - Conditioned out by hipotting or controlled operation
- Linear due to internal leakage across ceramic
 - Thermal runaway can occur resulting in ceramic breakage
 - Catastrophic runaway can occur in hours, if left unchecked

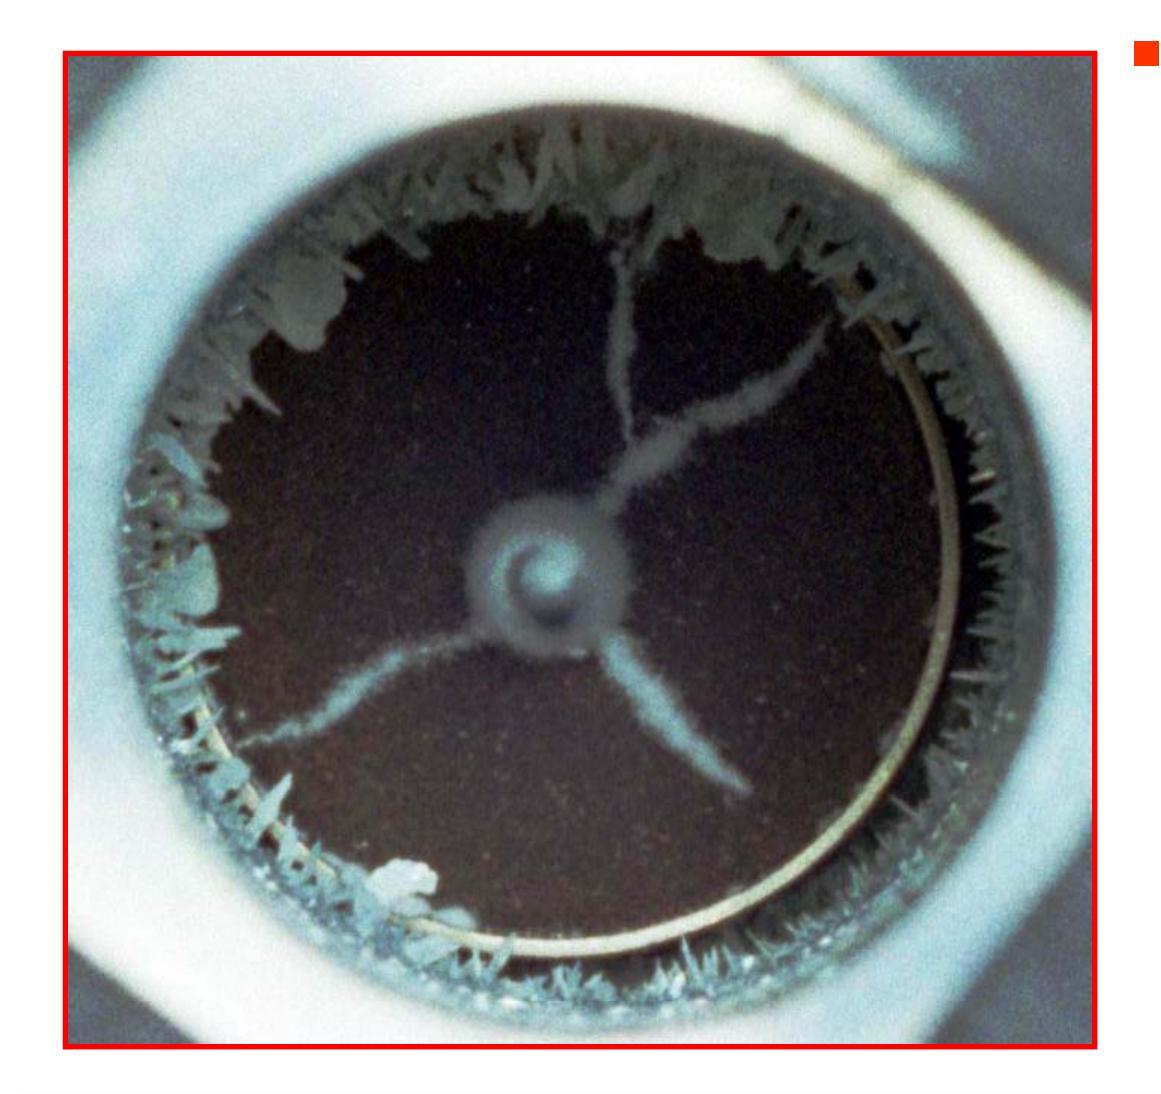
Crystal growth behind cathode heater

View inside gun stalk showing heater potting with cracks

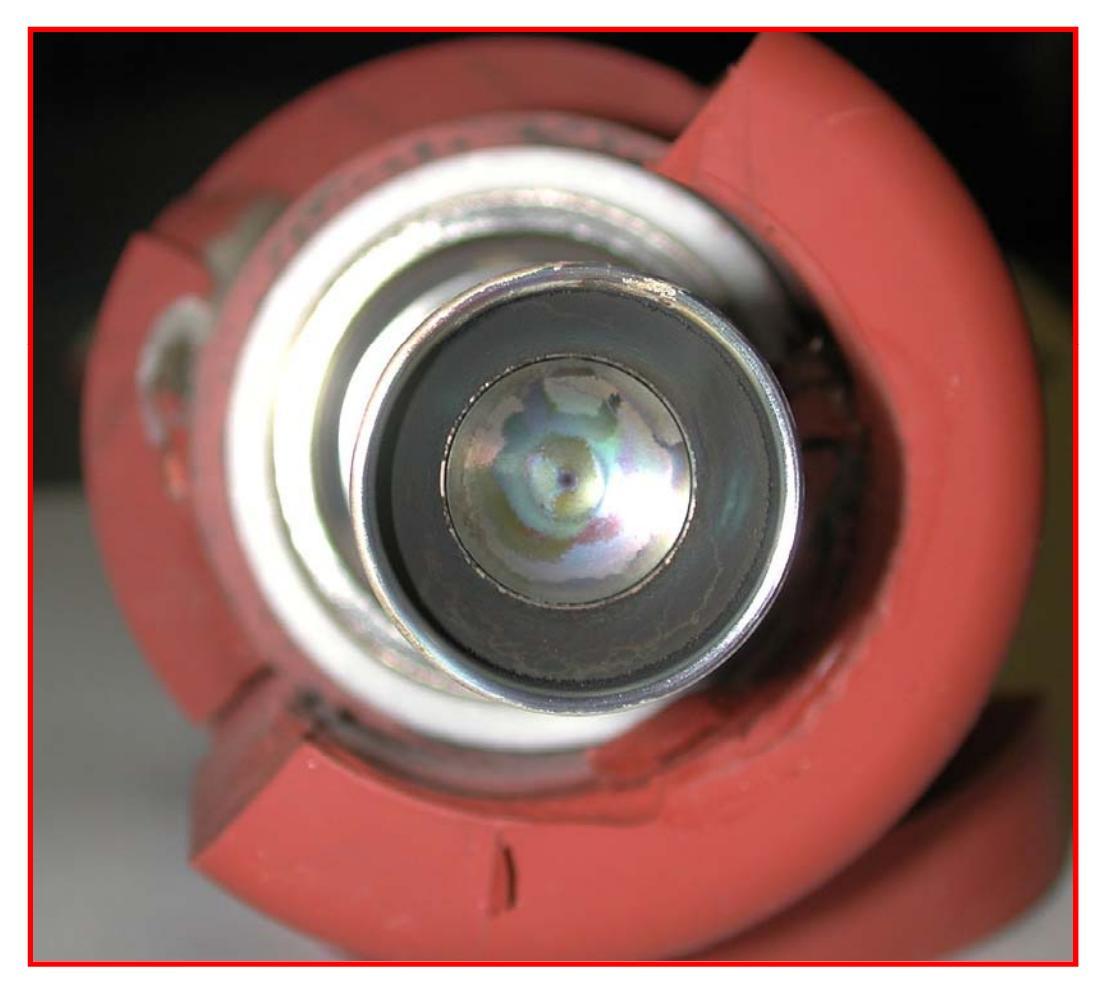
Ion Burn

- Cathode shows ion burn
- Tube has no separate ion pump

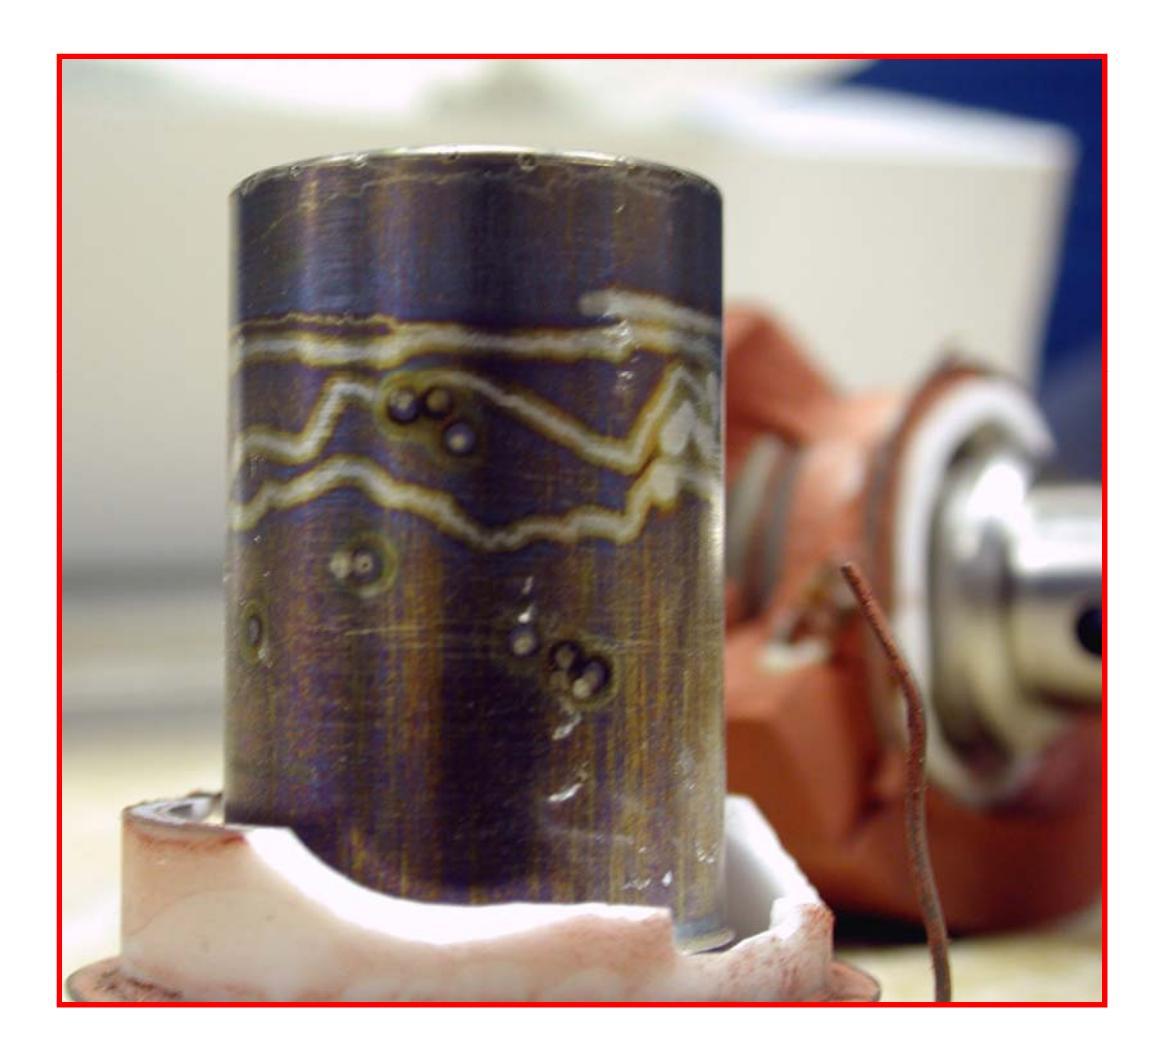
Mod anode arc tracks

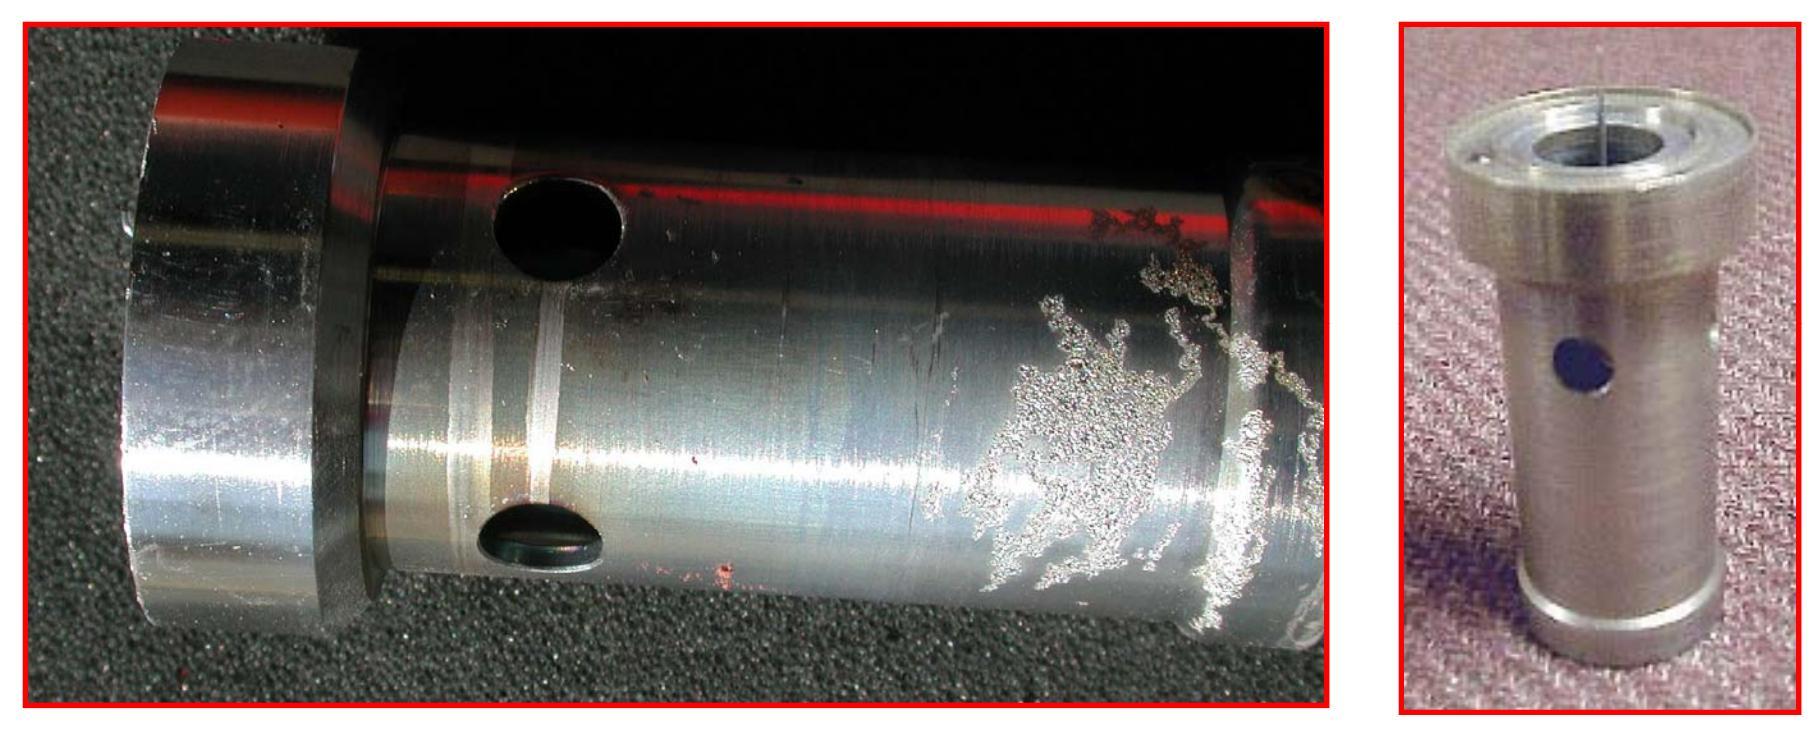
Gun stem arc tracks
