Machine Protection Panel Workshop, March 2013

LHC BLM SYSTEM: HARDWARE CHANGES DURING LS1

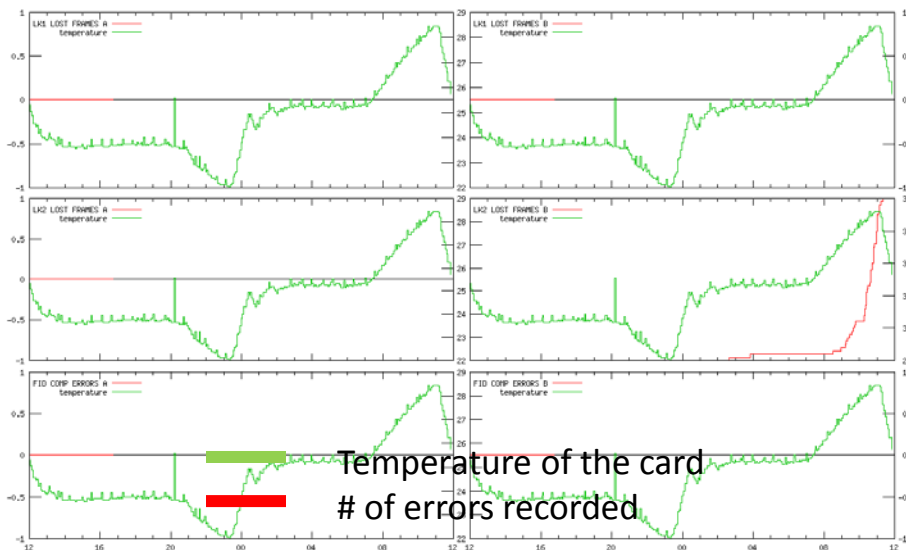
- Daily **automatic** analysis of the systems performance
 - Unavailability due to errors from optical link failures **increased**.
 - **Prototype** detector types were installed
 - Many **cards, detectors** and **cabling** have been exchanged in the shadow before affecting LHC availability.

Example of the daily optical link report

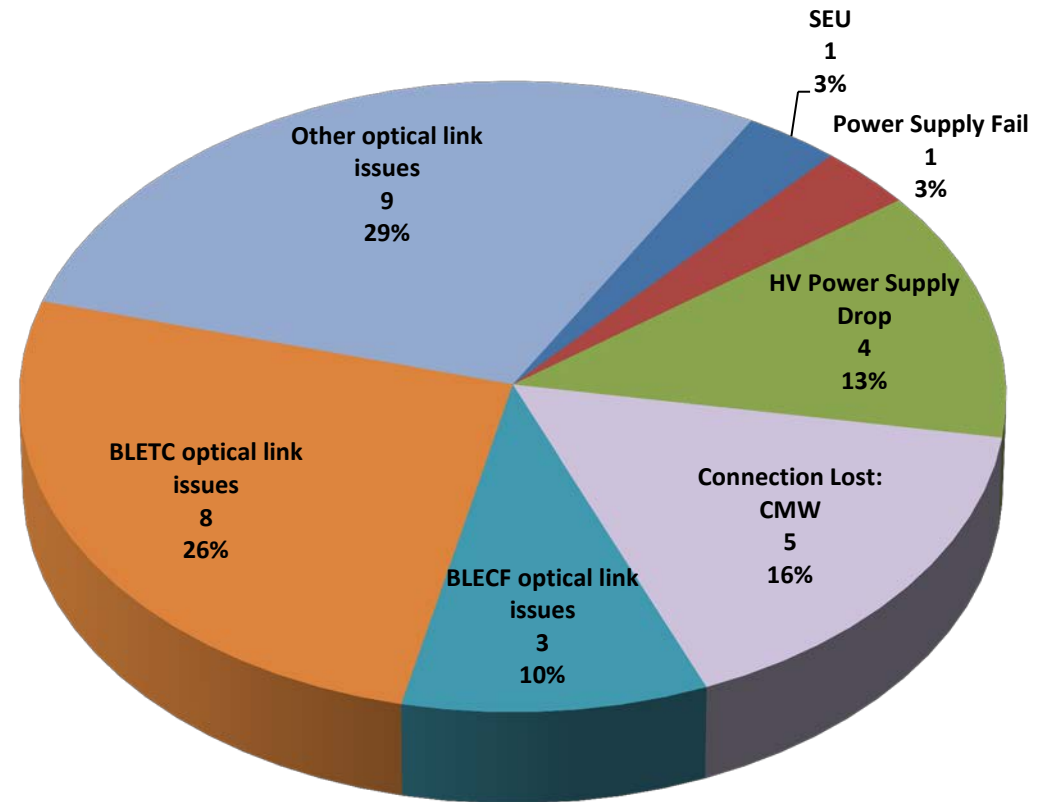
Summary of interlocked system faults (Mar'12 - Mar'13)		
Type	#	%
SEU (surface)	1	3.23%
Power Supply Fail	1	3.23%
HV Power Supply Drop	4	12.90%
Connection Lost: CMW	5	16.13%
BLECF optical link issues	3	9.68%
BLETC optical link issues	8	25.81%
Other optical link issues	9	29.03%
Total	31

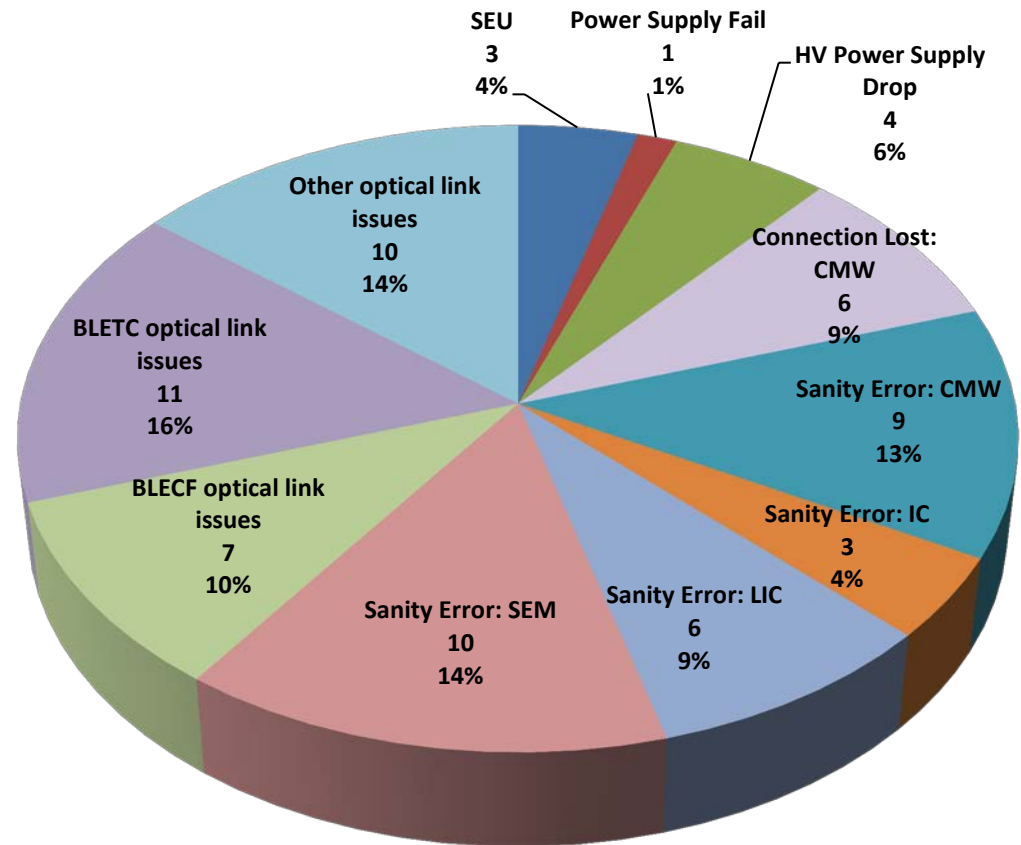
Summary of all system faults (Mar'12 - Mar'13)		
Type	#	%
SEU (surface)	3	4.29%
Power Supply Fail	1	1.43%
HV Power Supply Drop	4	5.71%
Connection Lost: CMW	6	8.57%
Sanity Error: CMW	9	12.86%
Sanity Error: IC	3	4.29%
Sanity Error: LIC	6	8.57%
Sanity Error: SEM	10	14.29%
BLECF optical link issues	7	10.00%
BLETC optical link issues	11	15.71%
Other optical link issues	10	14.29%
Total	70

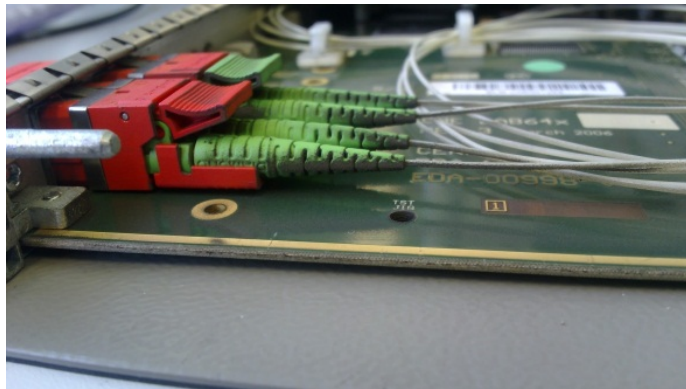
- Maintenance of all processing modules (~400)
 - Fix or Replace ~ 20% of mezzanines
 - Clean-up of the optical adaptors and connectors
- Shuffle optical links
 - Expect to improve availability by removing common mode failure
 - 80% of optical link errors and failures were in LK: 1-2

Accumulation of dust on the connectors
