TRT DAQ

Status and plans

Sarah Heim (University of Pennsylvania)
for the DAQ team

10.29.2013

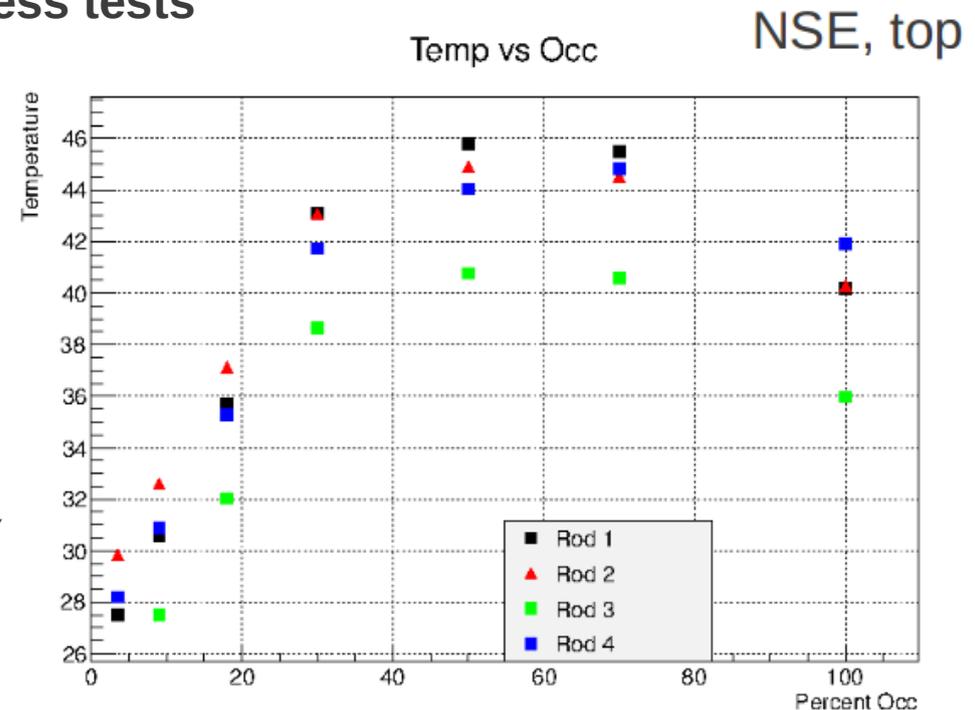
- crate power supplies *done*
 - fan upgrade
 - current limit was increased for 5V line for end cap power supplies (possible cause for increase of resyncs in 2012 could be power fluctuations, as the current approached the recommended limit)
- temperature checks on ROD chips
 - showed no critical values in stress tests
- rack turbine update
 - will be done next year*

Temperature vs detector occupancy measured on the compression chip

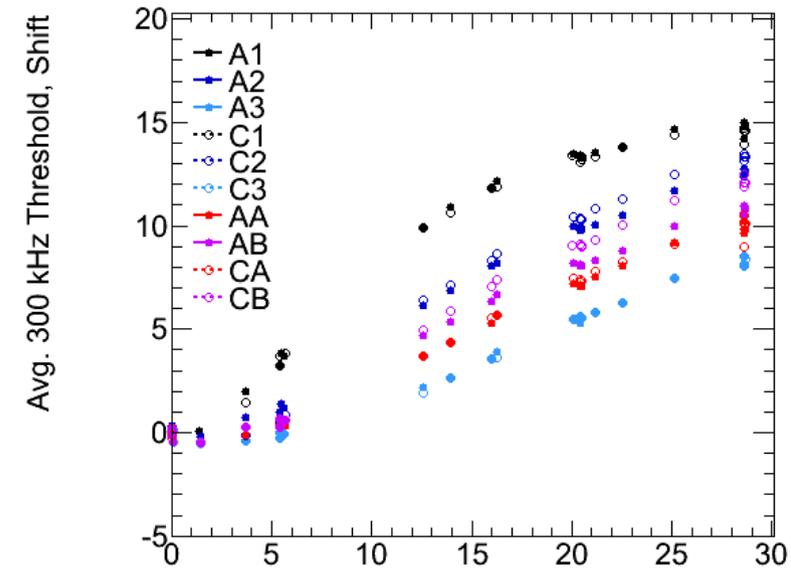
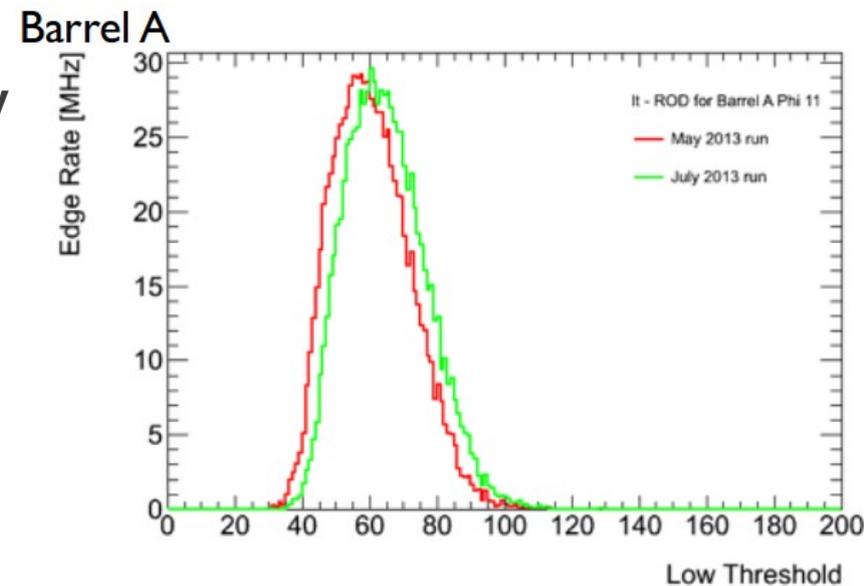
- radiation effects visible at lower total ionizing doses than expected
- can be seen in calibration scans and high threshold ration efficiencies
- flattening out

- new radiation tests of ASDBLR board in progress: lower rates, lower doses
- additional, abrupt threshold shift for noise/test pulse rates seen in calibration scans between May and July
 - not due to reduced readout
 - changed detector conditions?
 - not understood yet
