HPK EC minies irradiated by protons IV and CV characteristics

Electrical tests of ATLAS12A Endcap mini sensors in Prague – status

Irradiated ATLAS12A EndCap mini sensors in Prague

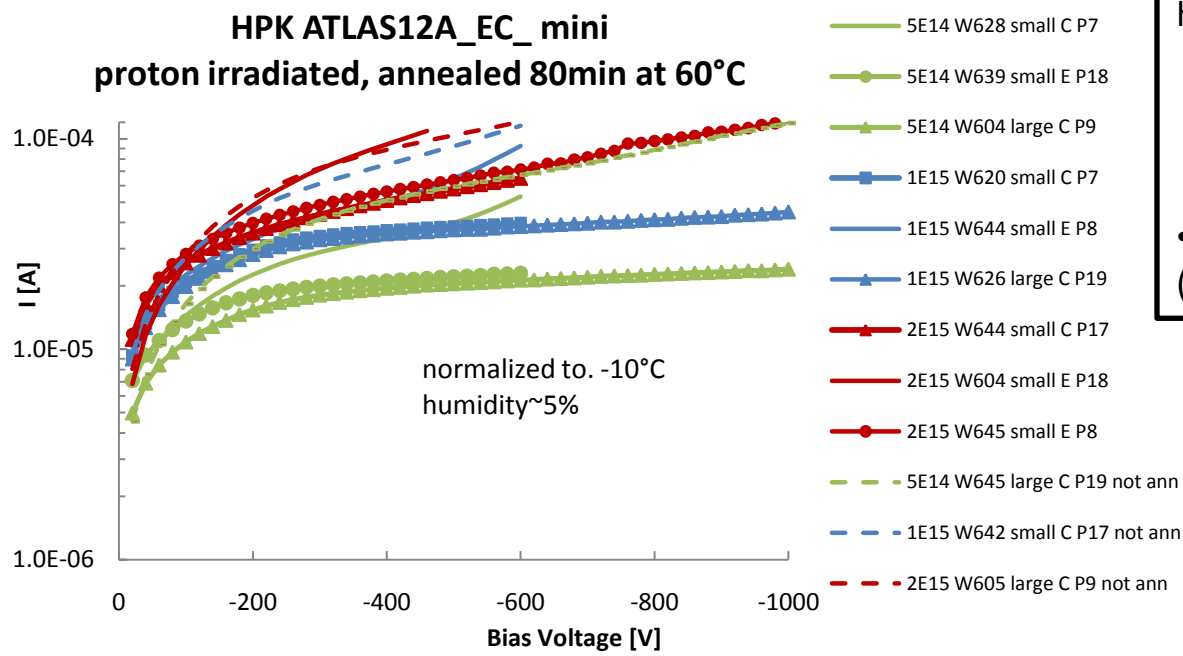
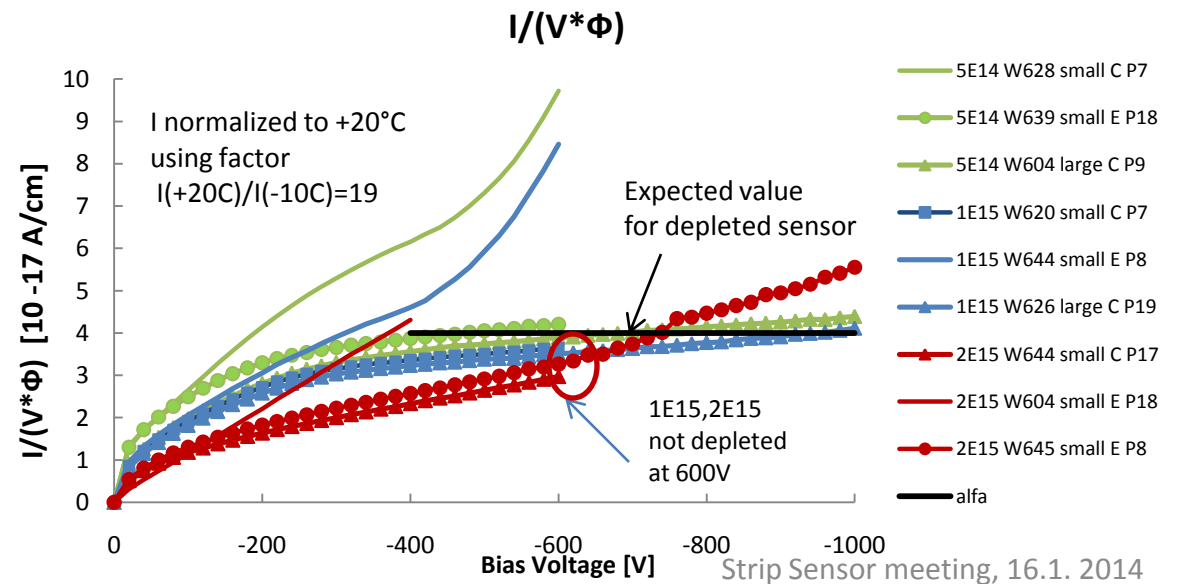
Leakage Current

- only 6 sensors from 12 sensor measured have "good" IV behavior up to 600V/1000V
 - "good": line with marker in the plot
 - "bad": just line, no marker
 - "bad" not annealed: dashed line
- Some of the "bads" have visible defects (see backup)

Leakage current per 1cm² at -10°C at 600V (average for each fluence)

Fluence [neq/cm ²]	I / A [μA/cm ²]	
	„Good“	„Bad“
Not irradiated at RT	0.004	
5E14	32.2	88
1E15	56.8	151
2E15	99.2	>> 160

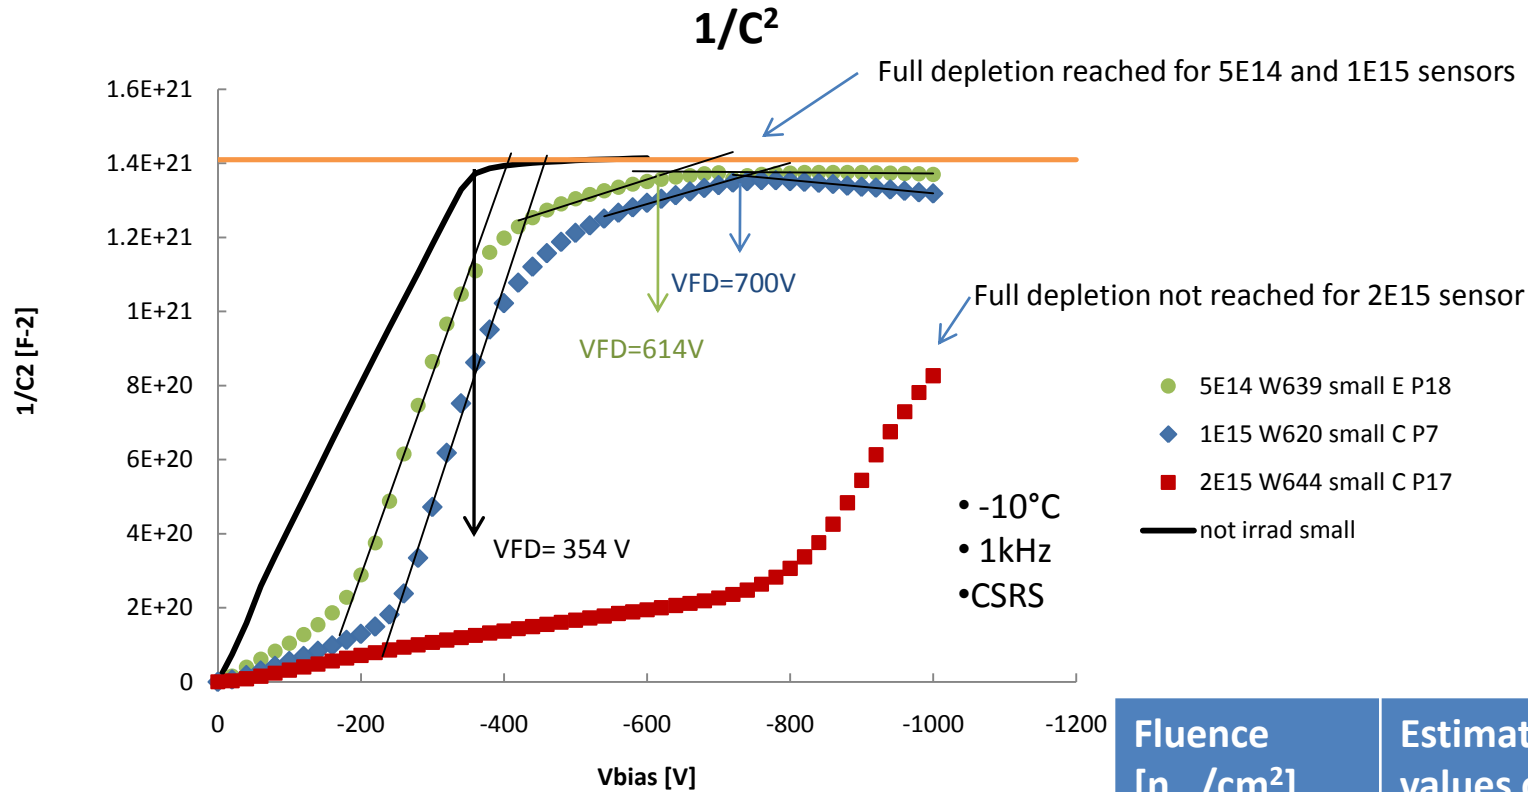
Full Depletion Voltage Determination

- Plot shows CV of “good” sensors only according to IV characteristics
- FDV extracted as crossing of the linear rise $1/C^2$ and the saturated value
- For sensors irradiated by 5E14 and 1E15 it's difficult to estimate FDV from CV measurement. It depends on a part of the linear rise which is fitted.
- For 2E15 sensors of 300um thickness it is impossible

Fluence [n_{eq}/cm^2]	Estimated values of V_{fd}	
Not irradiated	354 V	
5E14	614 V	360 V
1E15	700 V	440V
2E15	> 1000 V	> 1000V

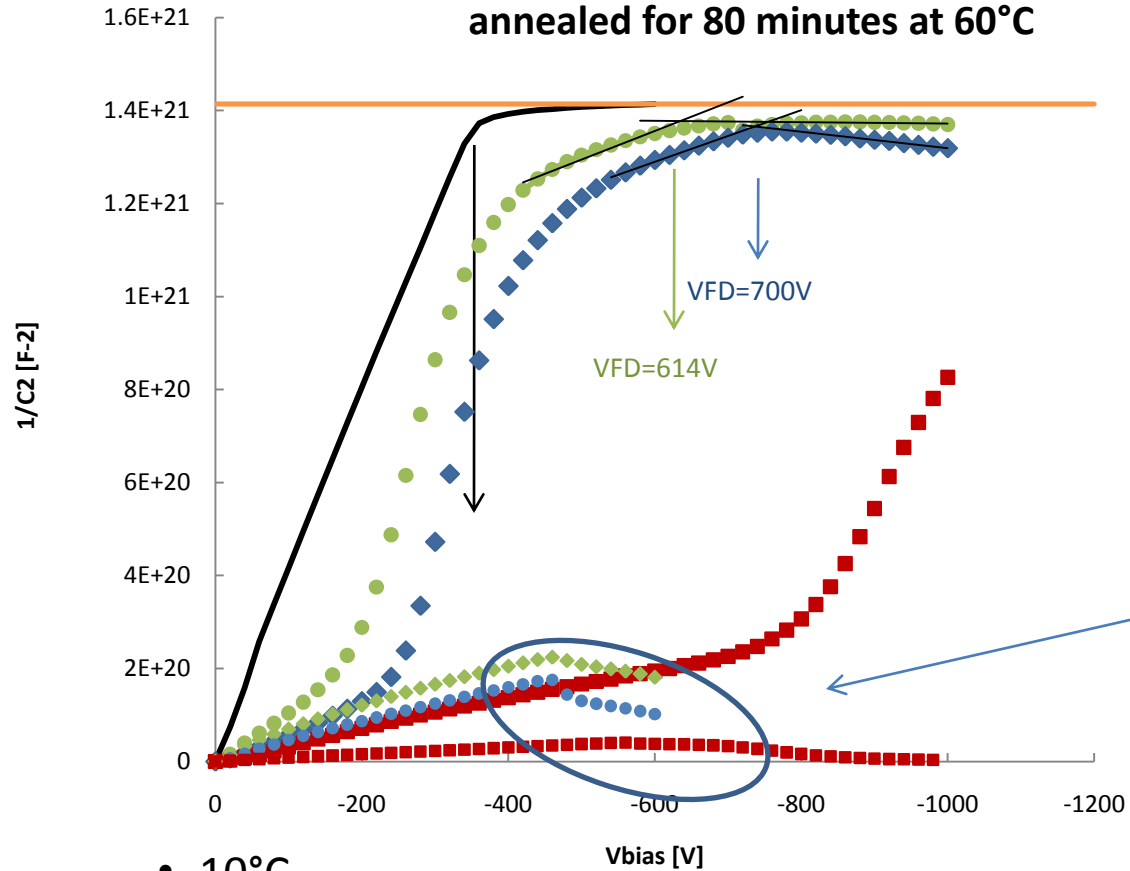
CV: Proton irradiated EC minies,
annealed for 80 minutes at 60°C

The plot includes also CV of “bad” sensors
with high leakage current

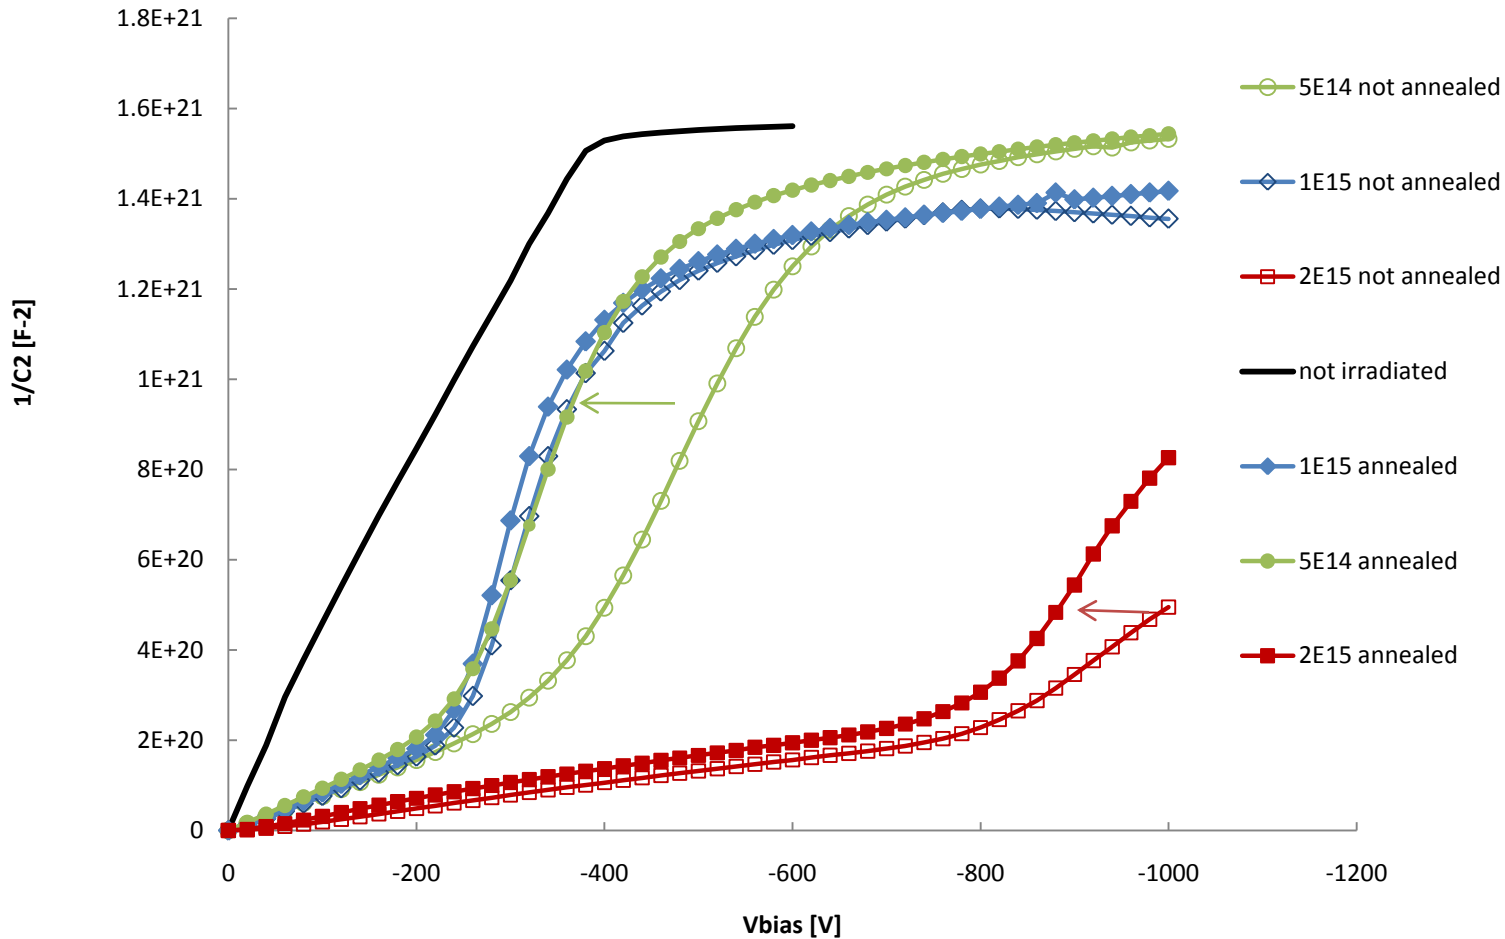
CV before and after annealing 80 minutes at 60° C

- Annealing shift of CV characteristics is visible on sensors irradiated by **2E15** and **5E14** n_{eq}/cm^2
- sensor irradiated by **1E15** looks like already annealed before controlled annealing

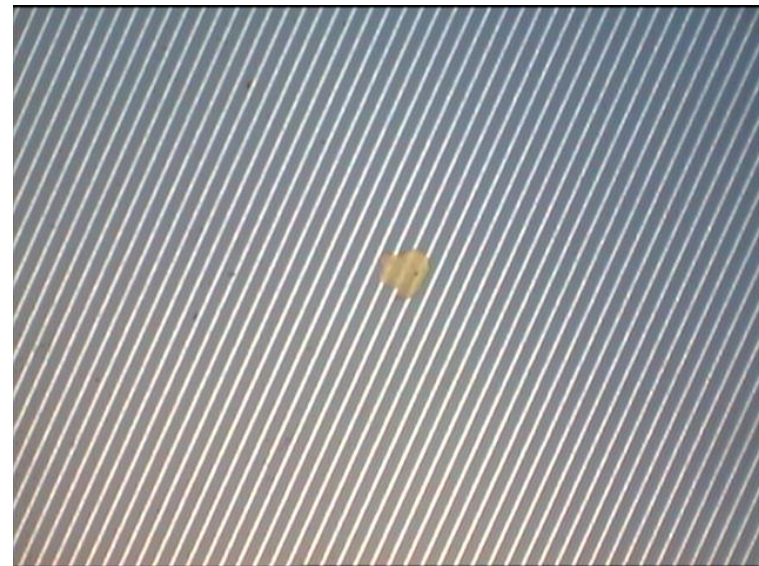
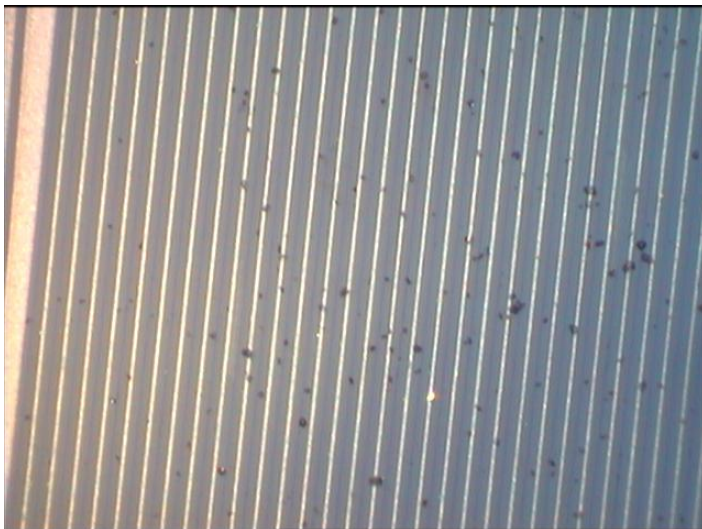
W605_EC_large pitch_C_P9
Possibly condensation of humidity?
