# Possible Noise Sources in the PS Modules

M. Johnson  
June 2015

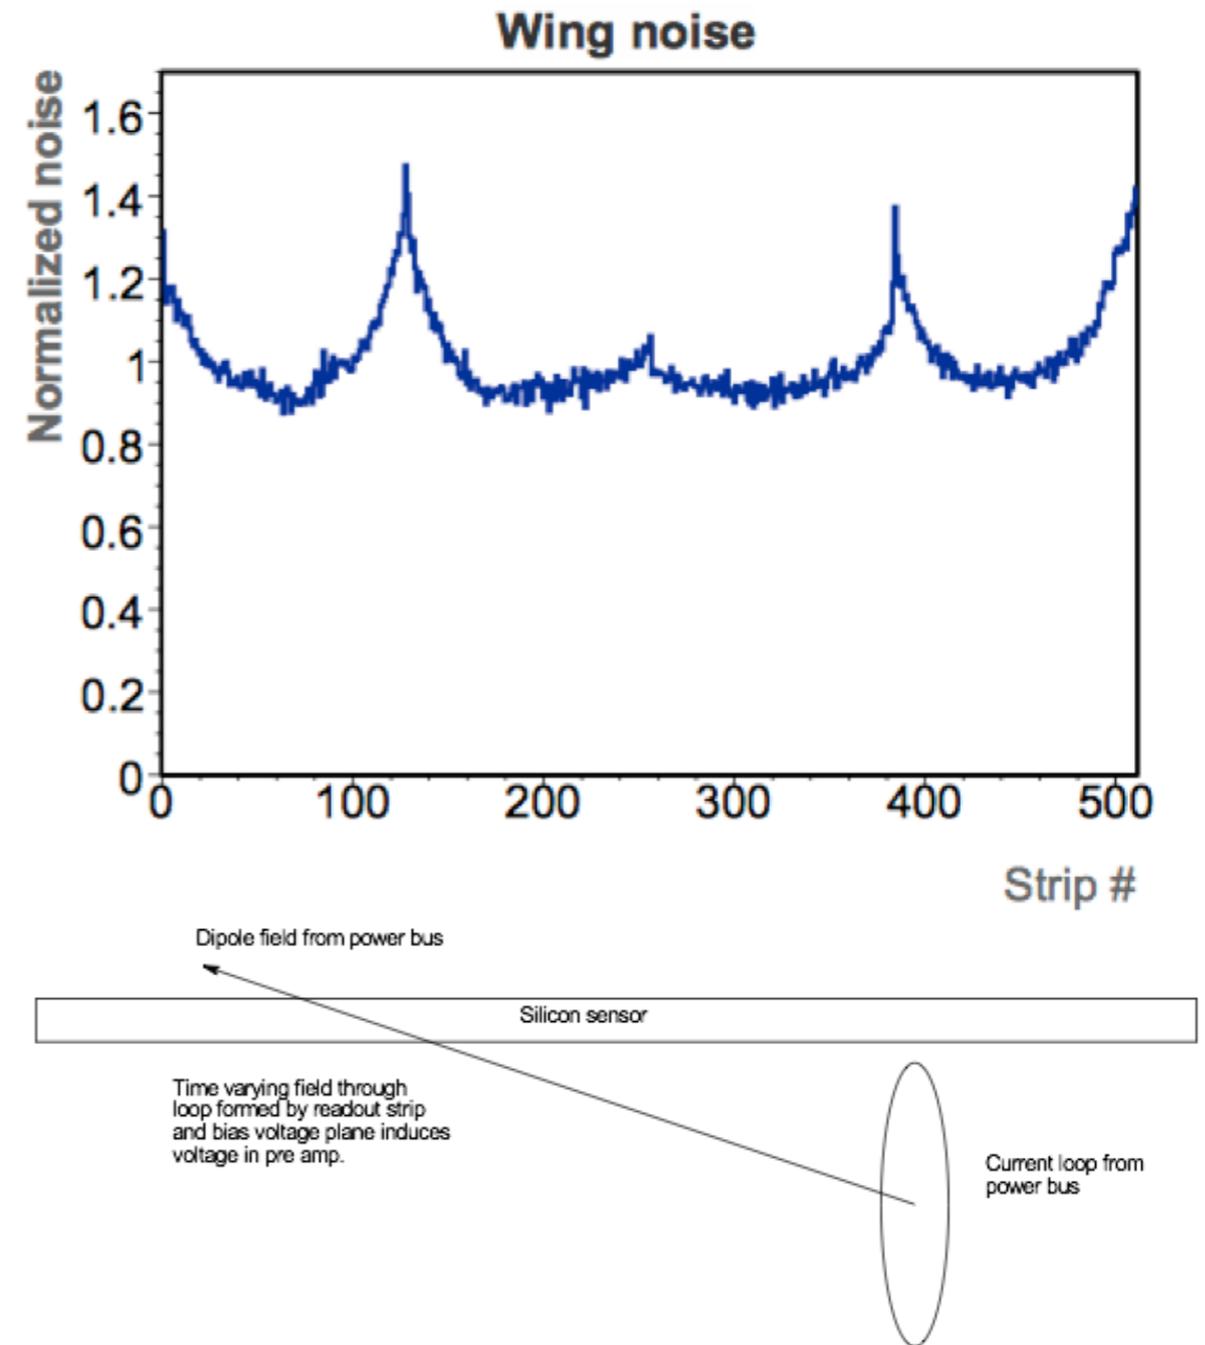
# “Wing” Noise in 4 Chip Sensor

- Noise is concentrated on the 2 outer chips and the outer edges of the 2 center chips
- Model is that the noise is from magnetic coupling of the dipole field created by source and return current on the two power buses

- Wing noise was eliminated from most of the detector by adding capacitors on the powerlines at PP1 to sink the noise to the CMS magnet and also grounding the cooling pipes to the magnet at patch panel 1
- This fixed all but 7 of 569 rods
- The capacitors and grounding were checked to be correct on the 7 failures
- This indicates that the grounding to these 7 rods was incorrect and also that grounding was a very important part of the fix

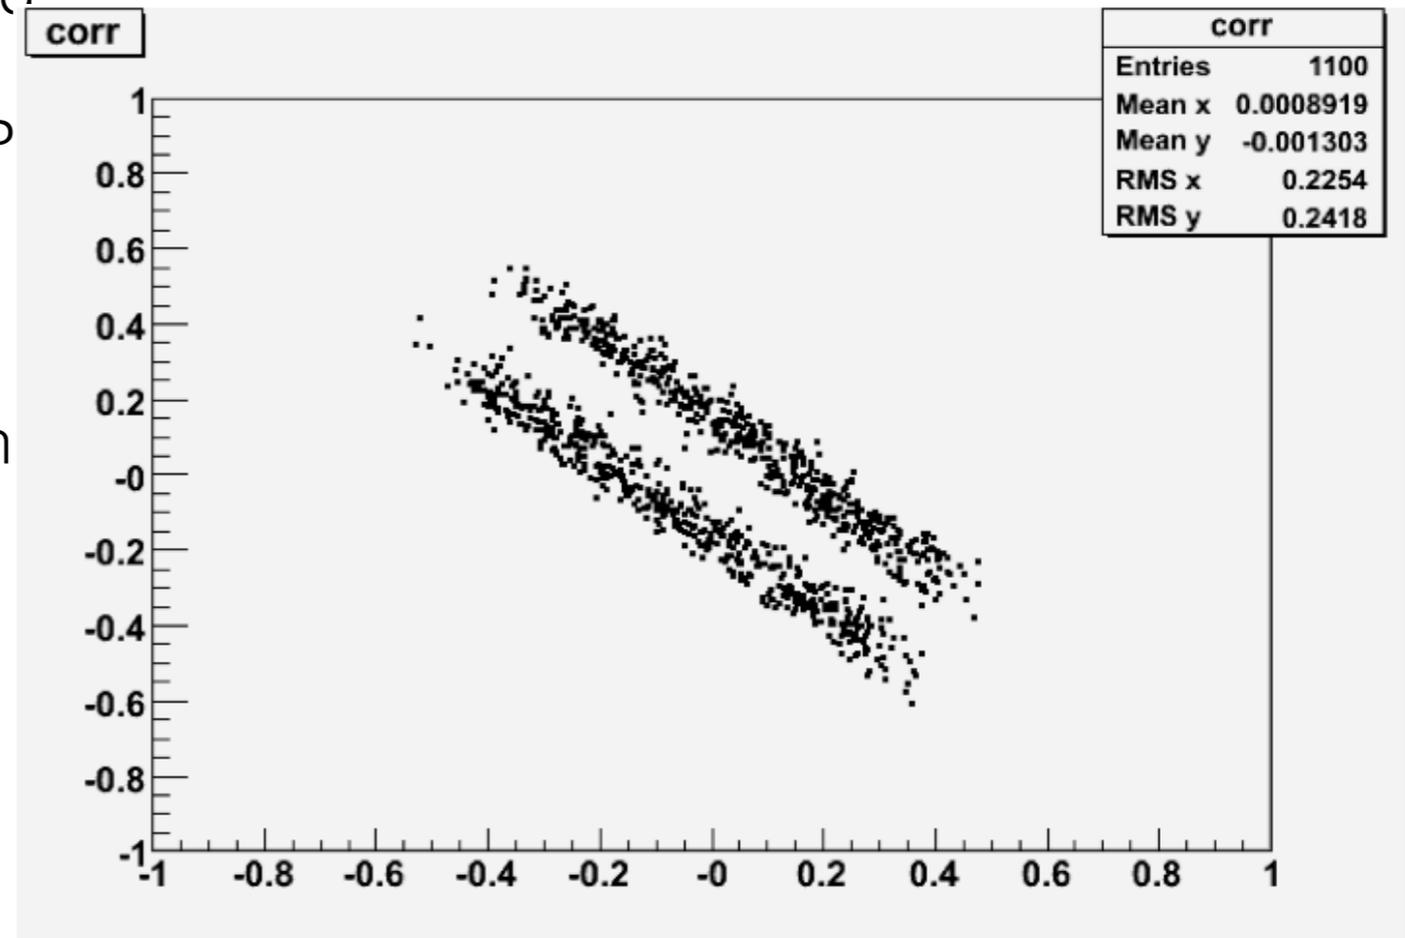
# Noise Signal on left and right edge chips is highly correlated

- Plot is from the 6 chip sensor located next to the flange: the Y axis is the APV6 signal and the X axis is the APV1 signal
- Positive signal on APV6 corresponds to negative signal on APV1
- If the signal were from capacitive coupling, then the signal should be the same sign on both sides of the sensor
- The two signals correspond to dipole fields from the 2.5 and 1.25 volt busses

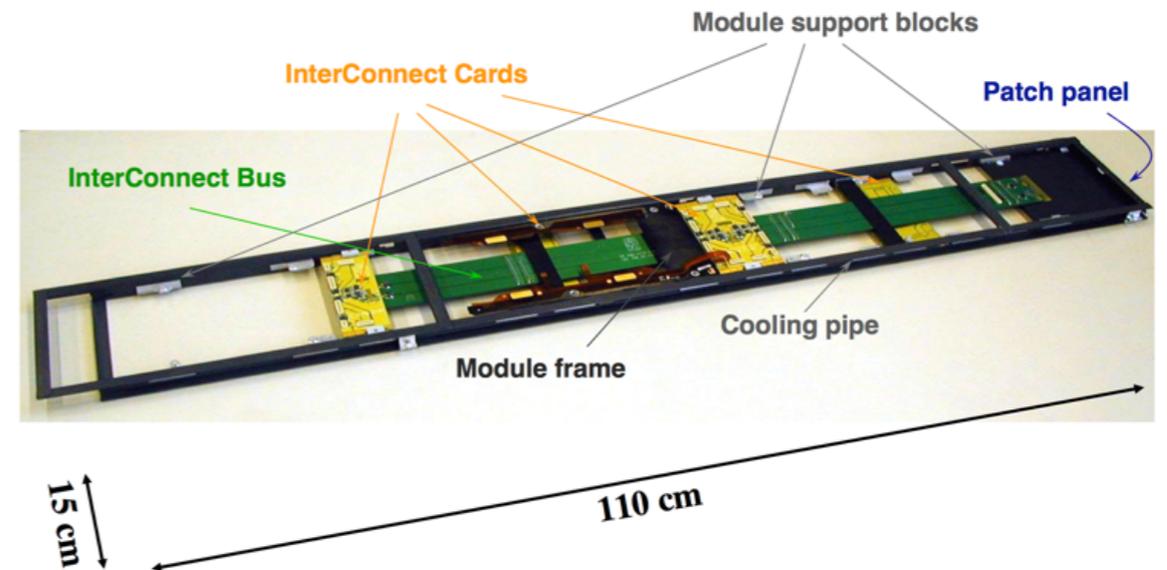
# Rod Grounding

- Rod is grounded by a wire at the patch panel end
- Also grounded through the cooling pipe
- Ground failure could be a damaged or broken wire or resistance at the cooling pipe to rod connection
- Important to test ground connections during production

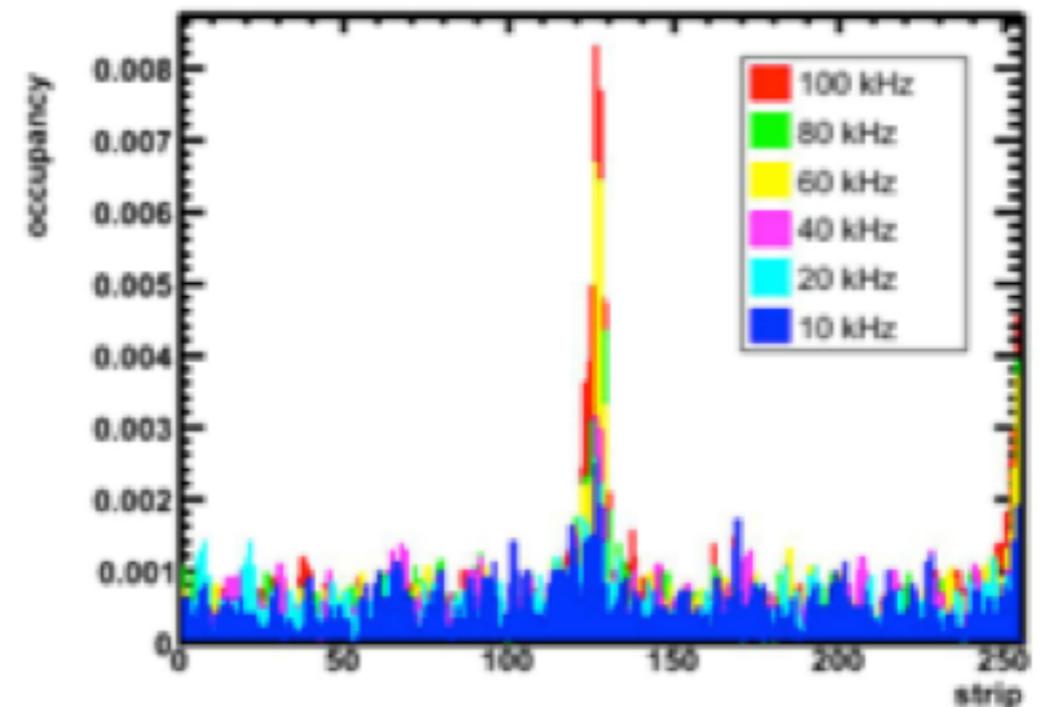
# APV25 Wire Bonds

- Plot shows edge channel noise on APV25 chips as a function of trigger rate
- APV25 2.5 volt power bonds were next to channel 127 and the ground bonds were next to channel 0
- When a second trigger event occurred at the same time as the start of readout of the current event, there was a small switching current generated on the power bus
- This current coupled magnetically from the wire bonds
- We removed the pitch adapter and sensor connections on channel 127 and we still saw about 1/3 of the noise signal
- The noise signal disappeared when we removed the wire bonds
