**TE-MPE-EP: REVIEW**

## LS1: "Yellow racks" activities.

Protection of 1232 dipoles and 392 quadrupoles

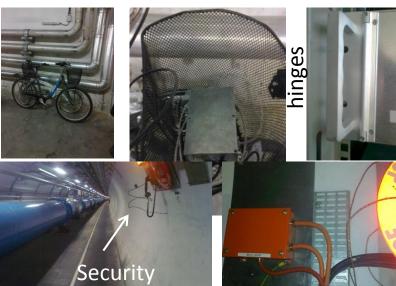
#### A few illustrations of unexpected events

Programming station misplaced and then found after LS1

Patch missing

Lift/mad/pad
