SLAC FPC Cleaning and Assembly Process

Jeff Tice

June 23, 2015

TTF3 Coupler Overview:

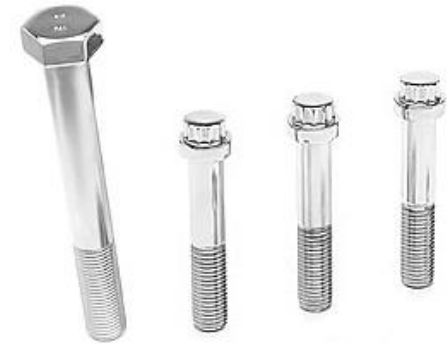
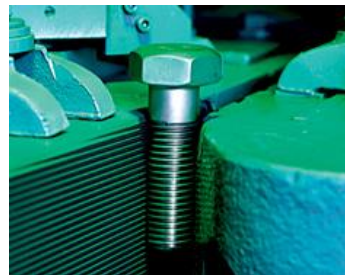
Galling of S.S. hardware & contamination control:

- All of the hardware was changed from the 316 S.S. to Nitronics 60 do to galling between the hardware.
- Nitronics 60 Magnetic Permeability is as follows:
 - Annealed 1.003
 - 25% Cold Drawn 1.004
 - 50% Cold Drawn 1.007
 - 75% Cold Drawn 1.010
- Contamination tests performed on cut bolts vs. rolled bolts showed an order of magnitude of less particles on rolled bolts. Tests done with both bolts being electropolished.
- All bolts are Nitronics 60 electropolished then UHV degreased and ISO 4 cleaned before use.

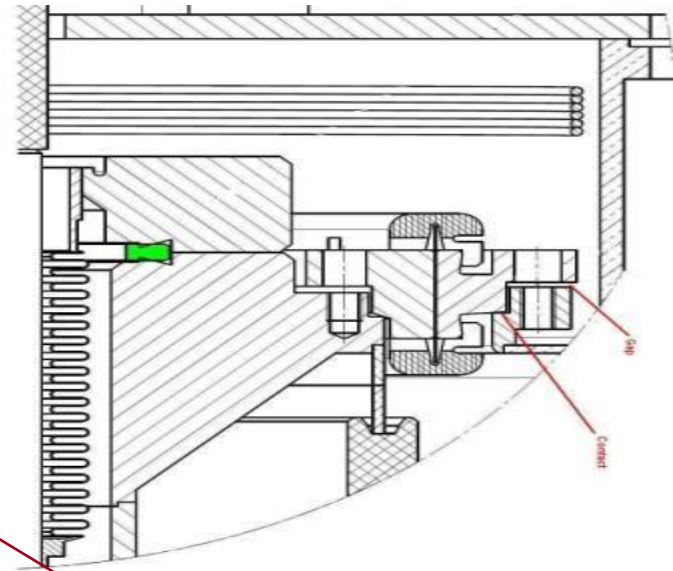
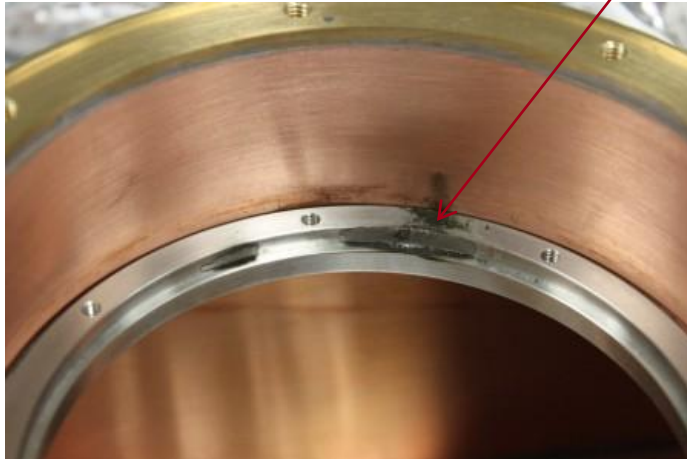
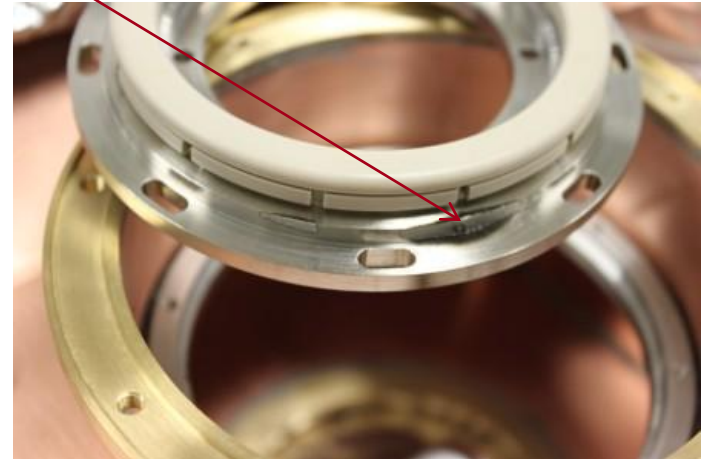
TTF3 Capacitor arcing:

- Waveguide to warm assembly arcing was observed in several couplers.
- Out of tolerance gaps between waveguide and 'capacitor.'

Designed a more flexible mating assembly using 304 S.S. outer and inner rings and a thin Cu middle ring to seal gap (does not allow HV bias)

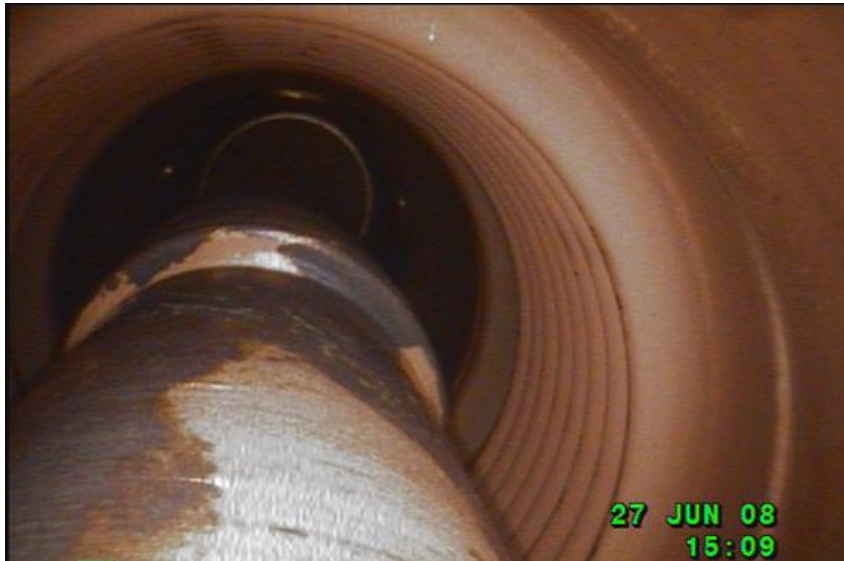
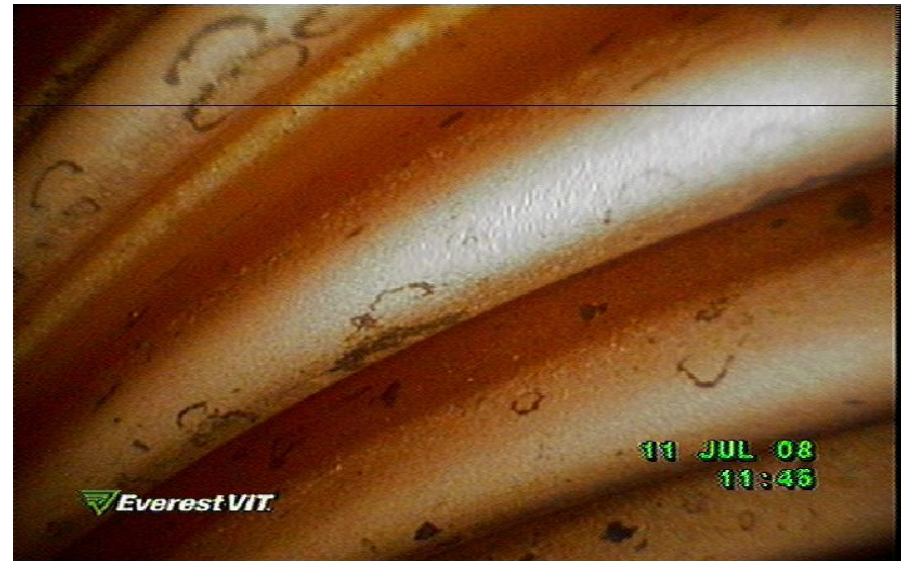
Some couplers that failed incoming inspection:

Warm inner conductor with extensive oxidation (two different couplers).

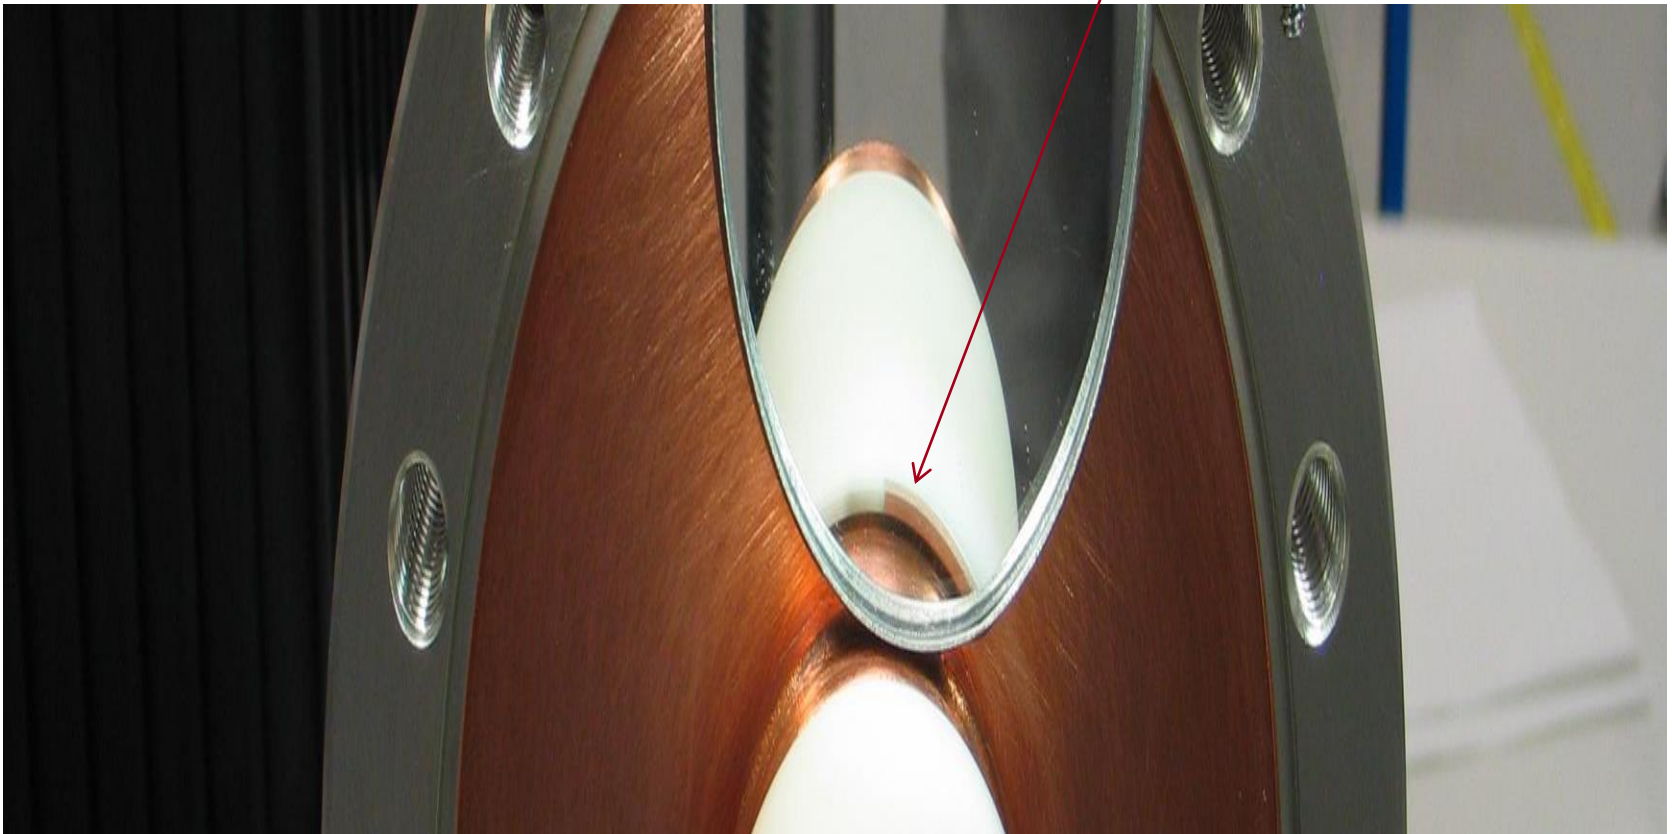
Here the window has copper plating on the ceramic, which must be free of metallization.

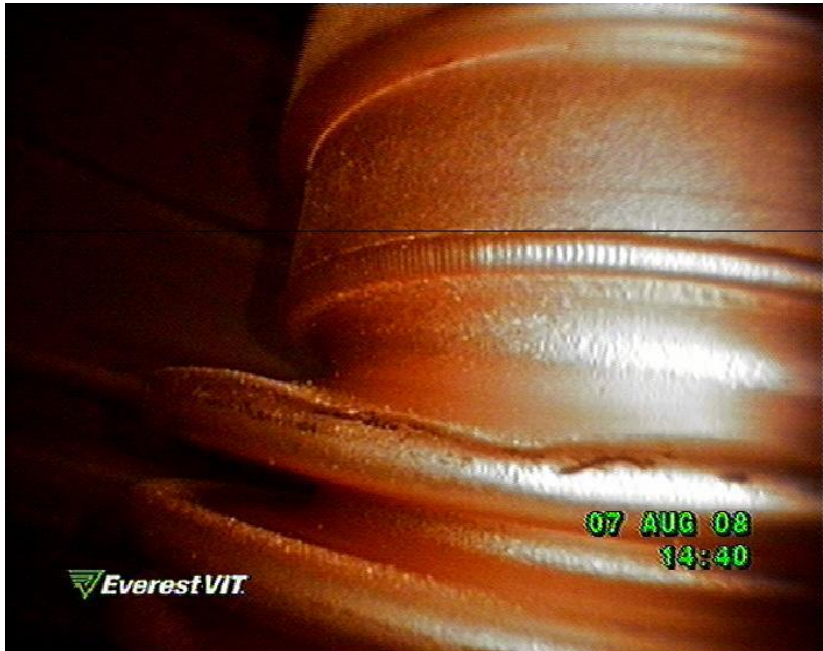
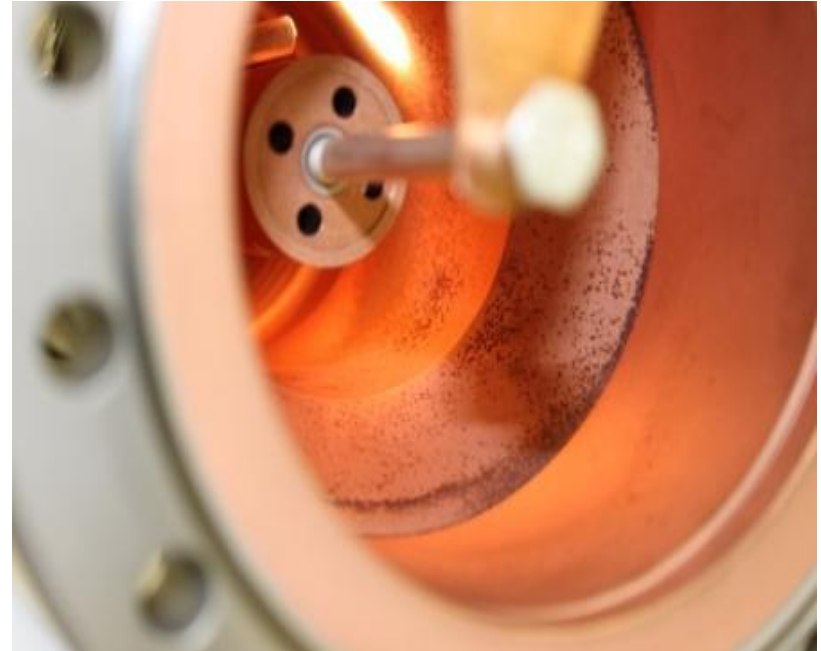
- Badly dented bellows on Warm section
- Oxidization on Warm outer wall copper plating.

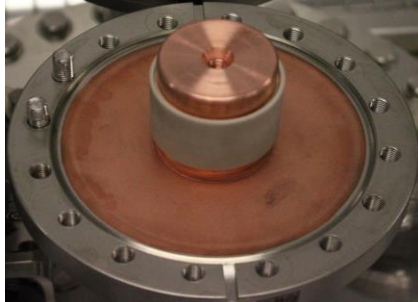
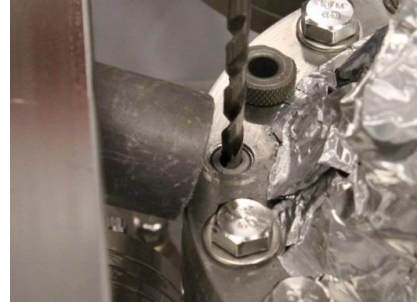
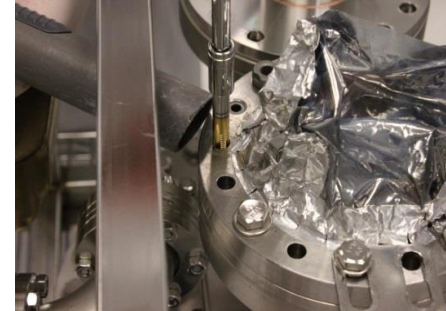
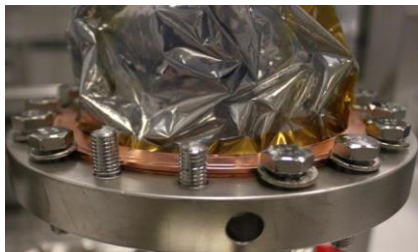
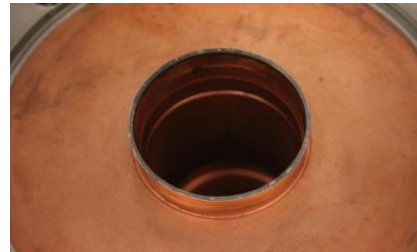
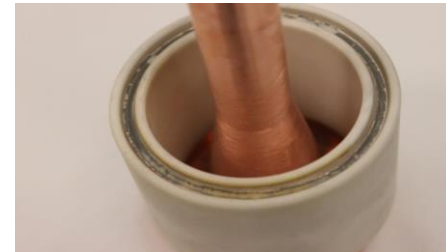
M8 holes had insufficient holes tapped on several CF-100 flanges (Colds). During removal of bolts (drilling) the window delaminated from the copper ring assembly. Analysis of de-metallization is still under investigation.

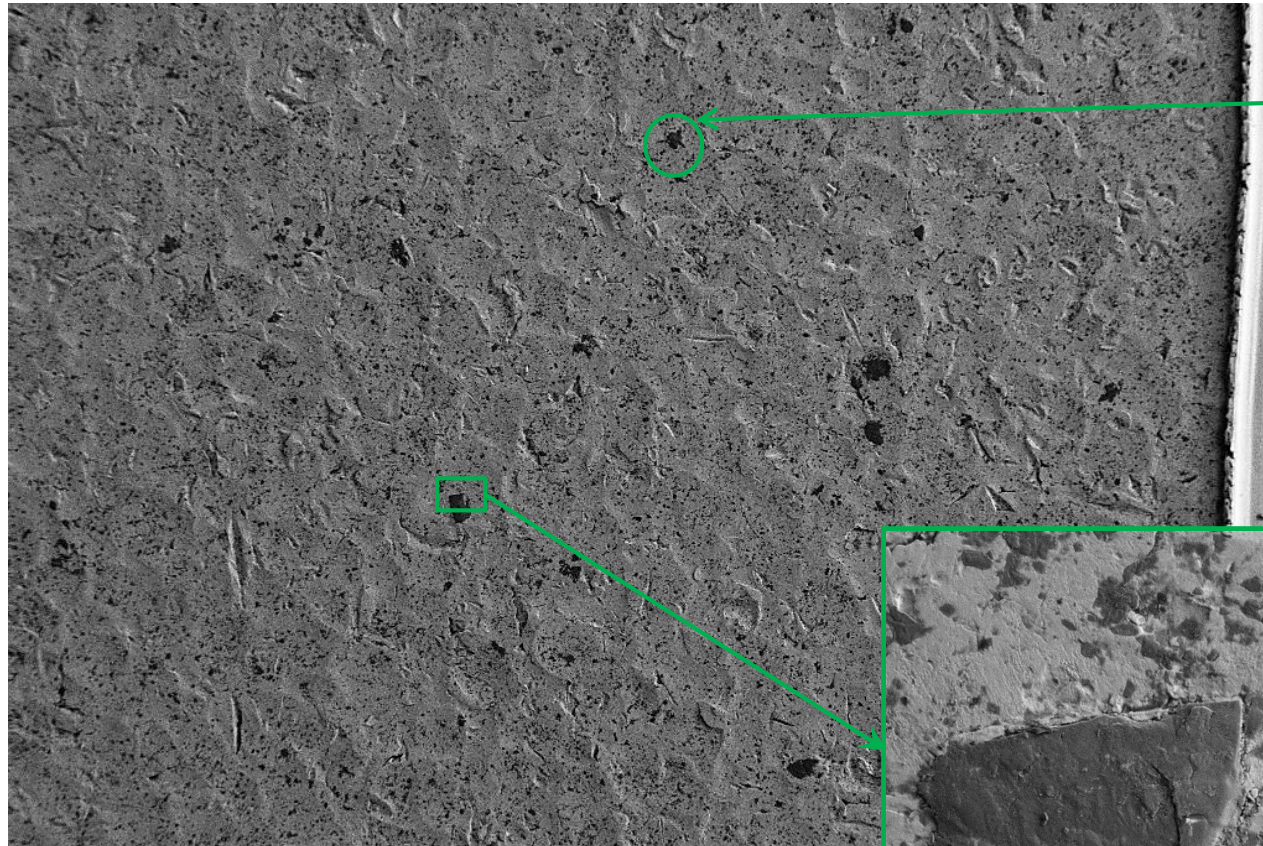
Vendor – 10 microns, Bead blasted, ISO 4 cleaned

~10 μm sized
“glass” inclusions

Also large numbers of
~ 1 μm sized “glass”
particles embedded in
surface

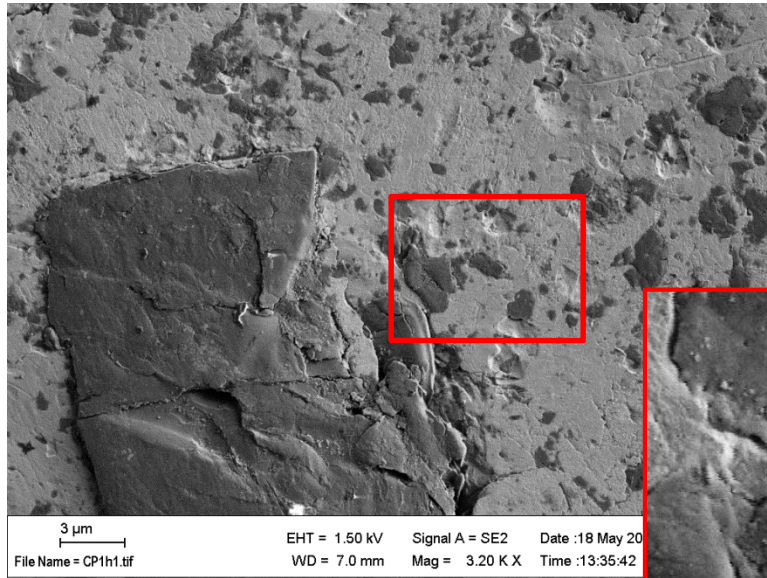
Vendor – 10 microns, Bead blasted, ISO 4 cleaned

Close examination reveals areas where embedded particles may have been removed by ultrasonic cleaning

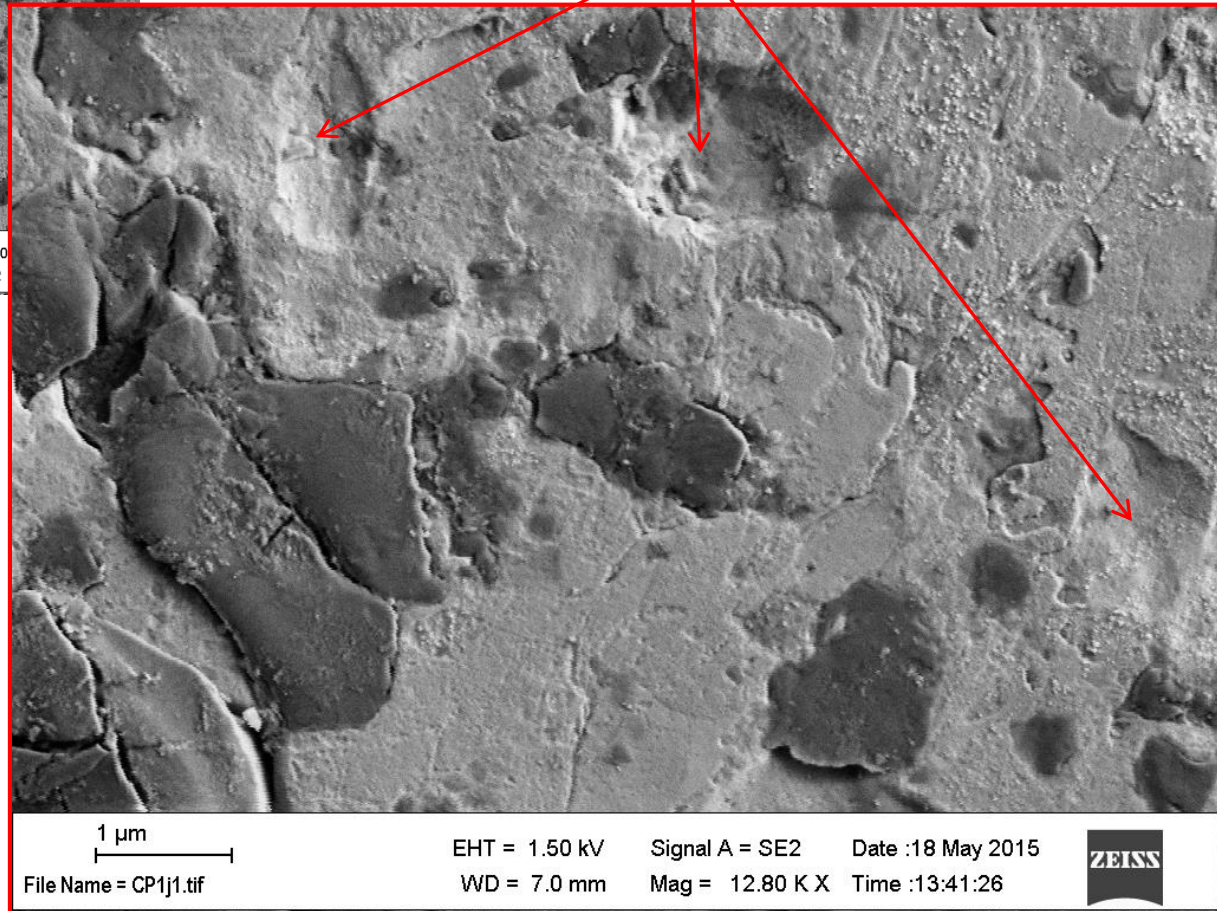
Many sub-micron embedded particles and also present

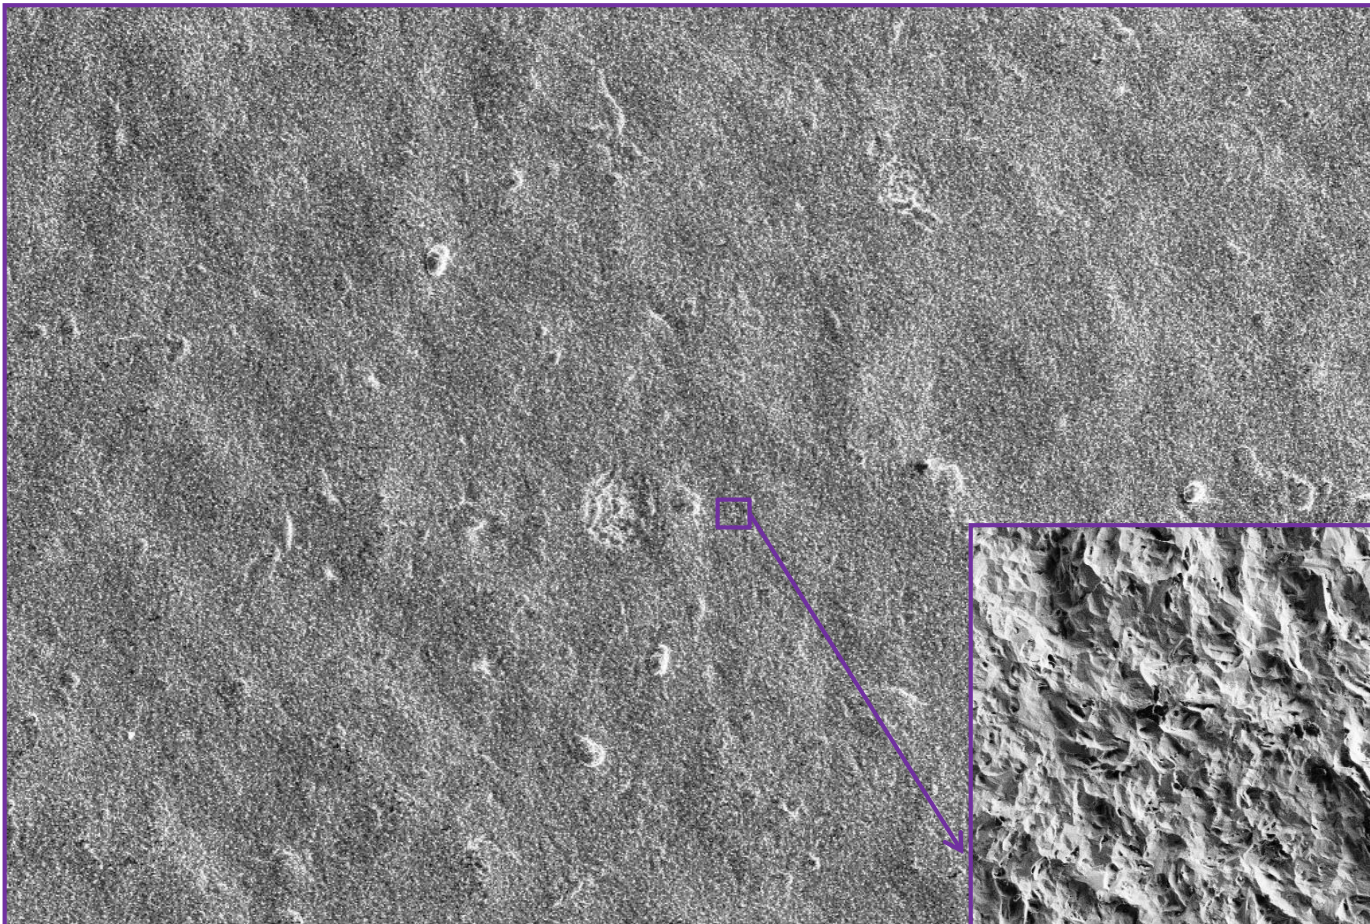
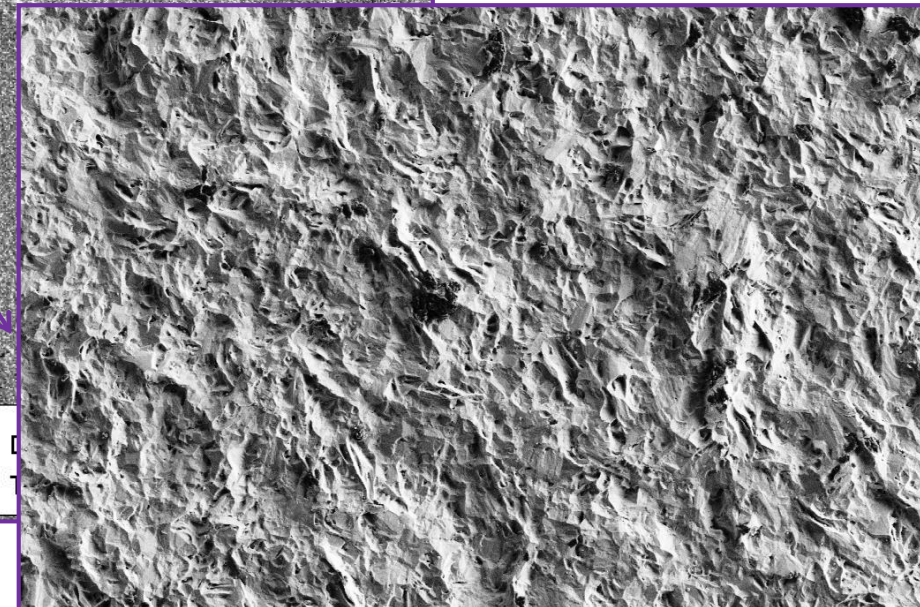
Vendor – 10 microns, **Not** Bead blasted

Surface appears
“Unusual”
for
as-plated surface
