SLAC FPC Cleaning and Assembly Process

Jeff Tice

June 23, 2015

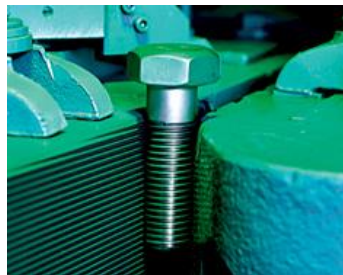
Galling of S.S. hardware & contamination control:

- All of the hardware was changed from the 316 S.S. to Nitronics 60 do to galling between the hardware.
- Nitronics 60 Magnetic Permeability is as follows:
 - Annealed 1.003
 - 25% Cold Drawn 1.004
 - 50% Cold Drawn 1.007
 - 75% Cold Drawn 1.010
- Contamination tests performed on cut bolts vs. rolled bolts showed an order of magnitude of less particles on rolled bolts. Tests done with both bolts being electropolished.
- All bolts are Nitronics 60 electropolished then UHV degreased and ISO 4 cleaned before use.

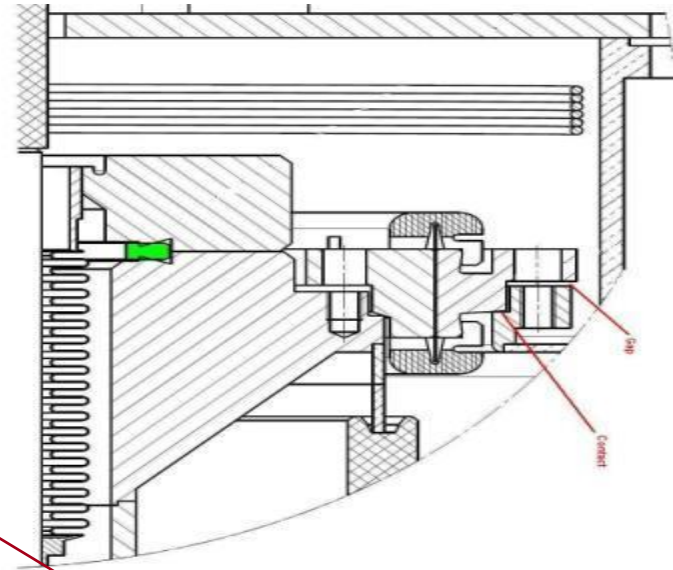
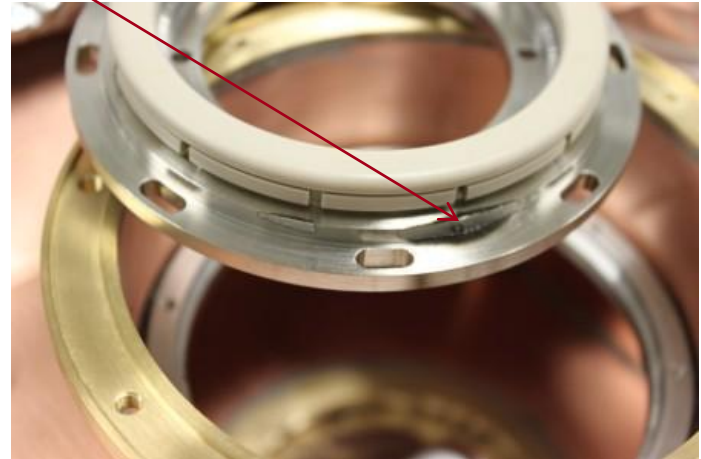
TTF3 Capacitor arcing:

- Waveguide to warm assembly arcing was observed in several couplers.
- Out of tolerance gaps between waveguide and 'capacitor.'

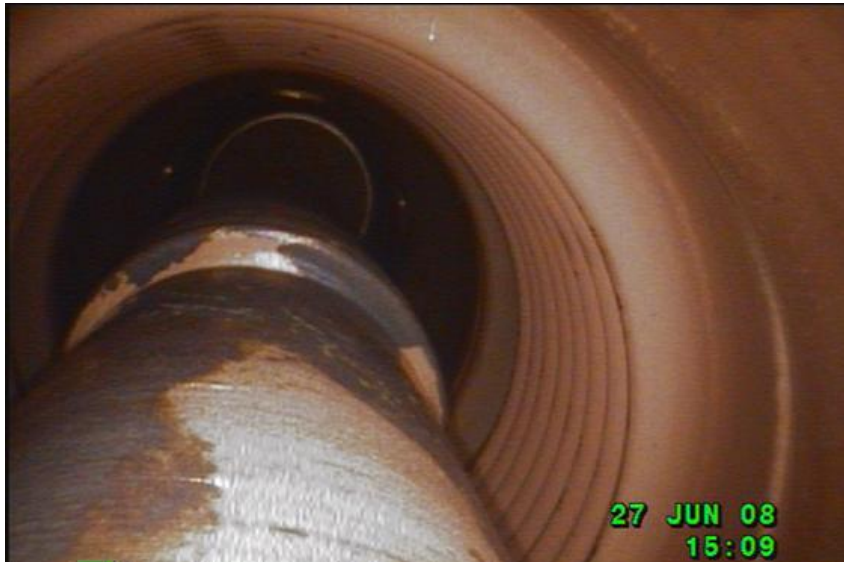
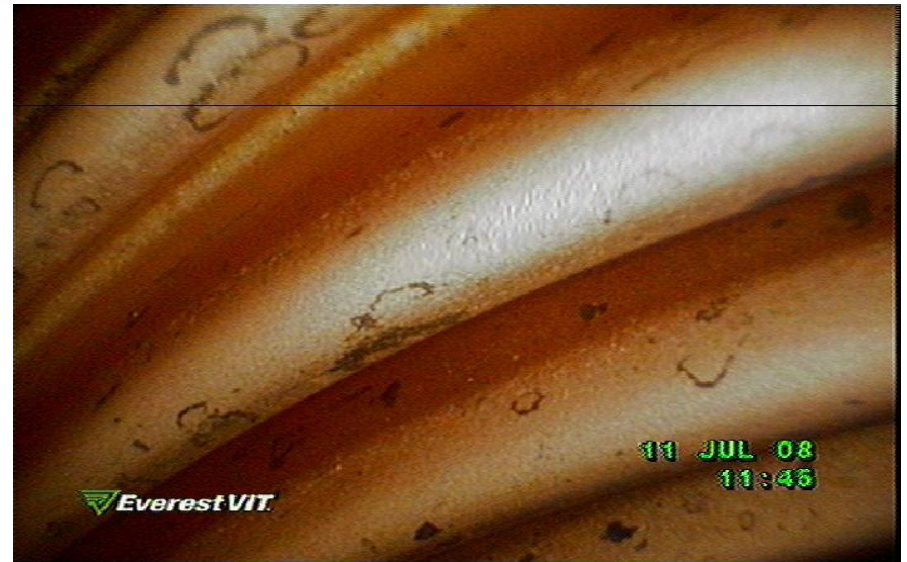
Warm inner conductor with extensive oxidation (two different couplers).

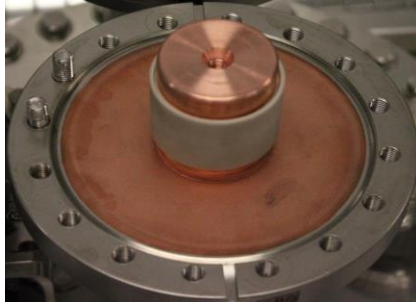
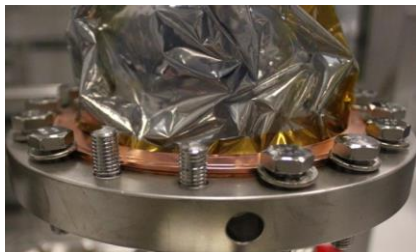
M8 holes had insufficient holes tapped on several CF-100 flanges (Colds). During removal of bolts (drilling) the window delaminated from the copper ring assembly. Analysis of de-metallization is still under investigation.

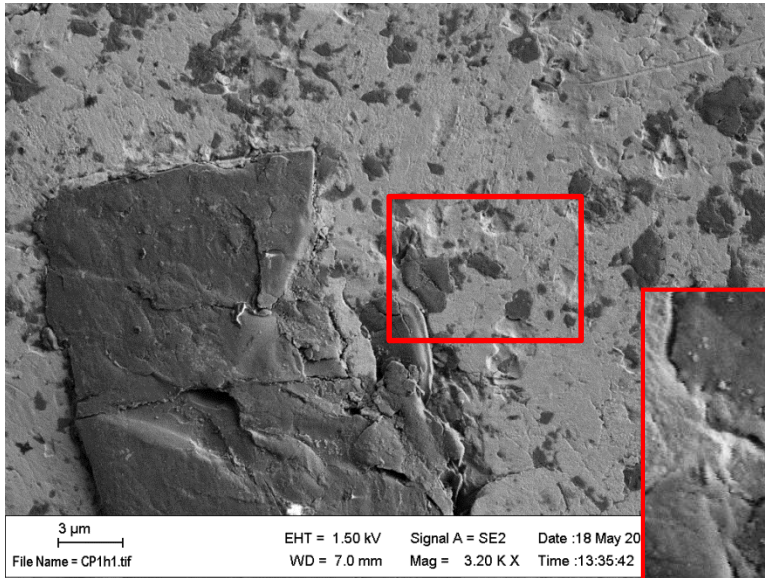
Vendor – 10 microns, Bead blasted, ISO 4 cleaned

Close examination reveals areas where embedded particles may have been removed by ultrasonic cleaning

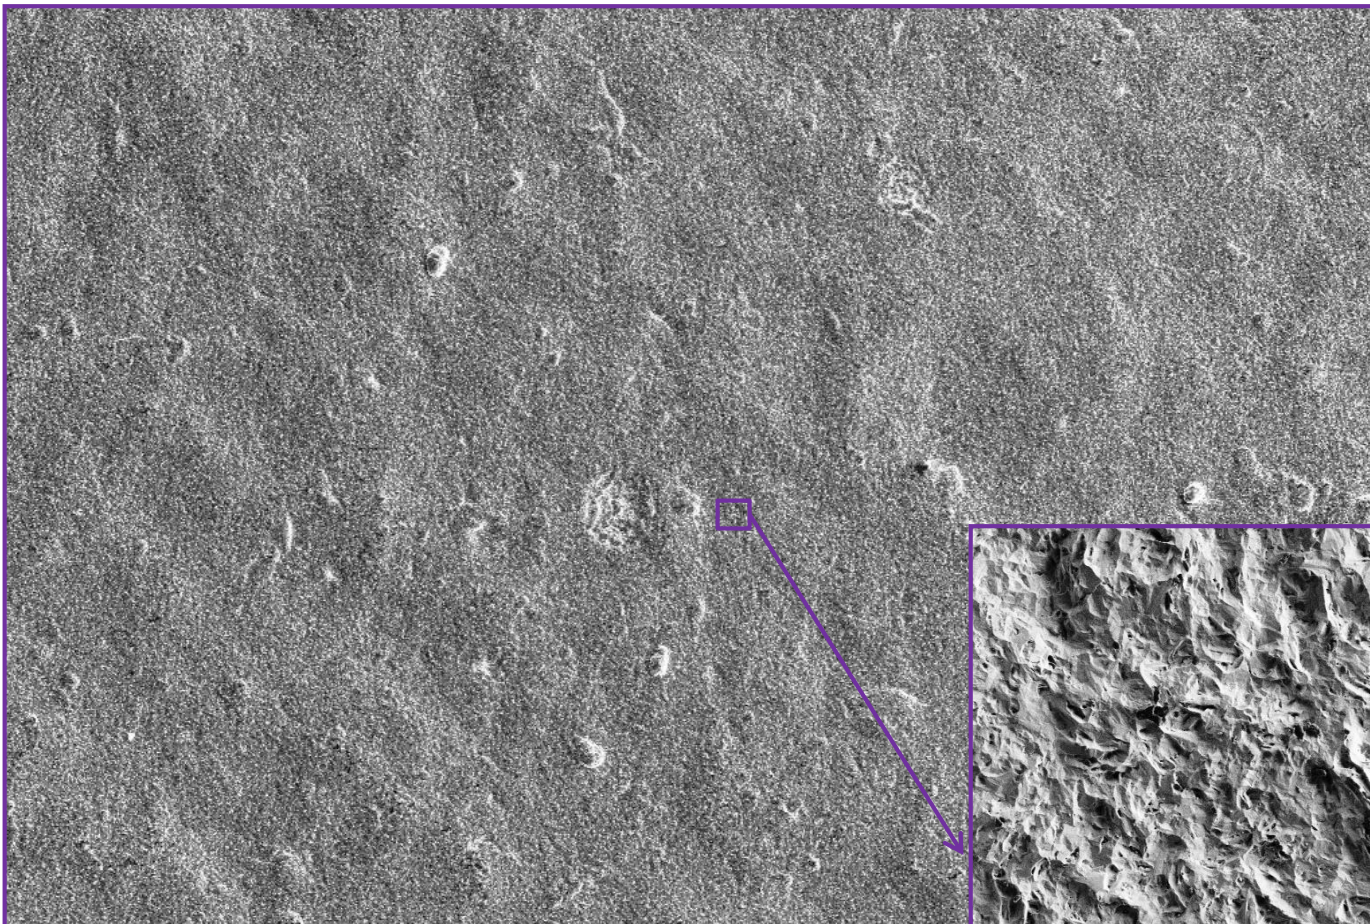
Vendor – 10 microns, **Not** Bead blasted

Surface appears
“Unusual”
for
as-plated surface
