# CONSOLIDATION ON CIVIL ENGINEERING AND TECHNICAL INFRASTRUCTURE

**P. Alves, M. Nonis, P. Pepinster, W. van Baaren**

6<sup>th</sup> ST Workshop – March 2003

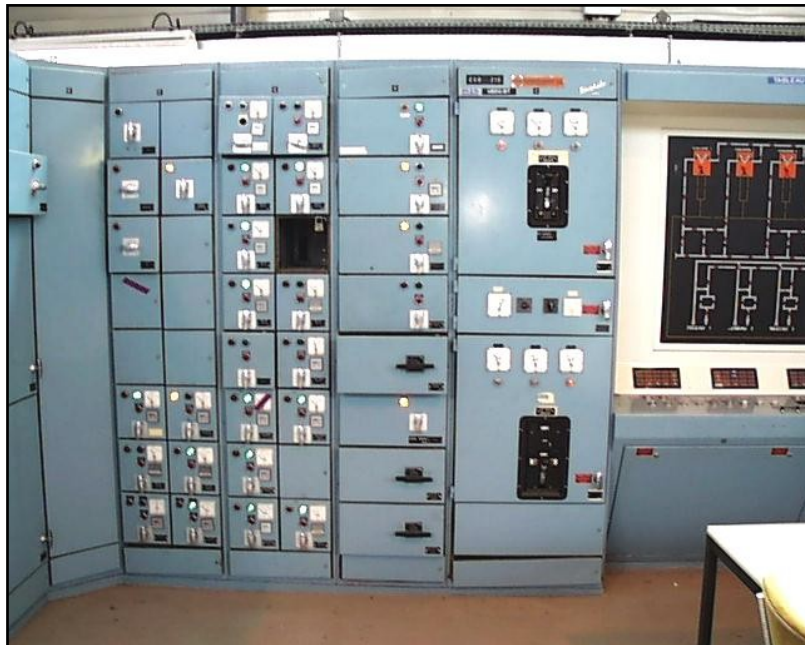
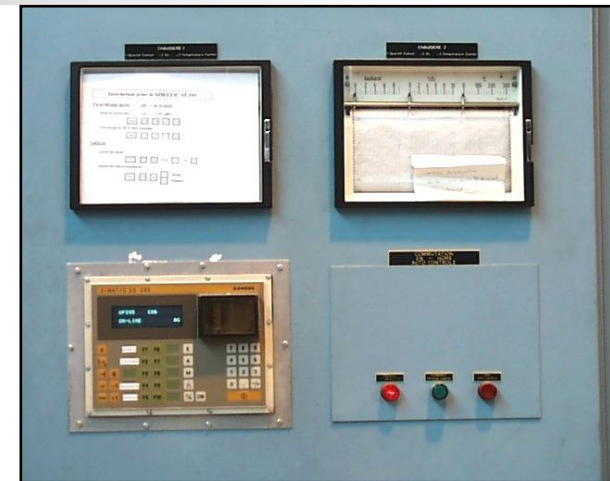
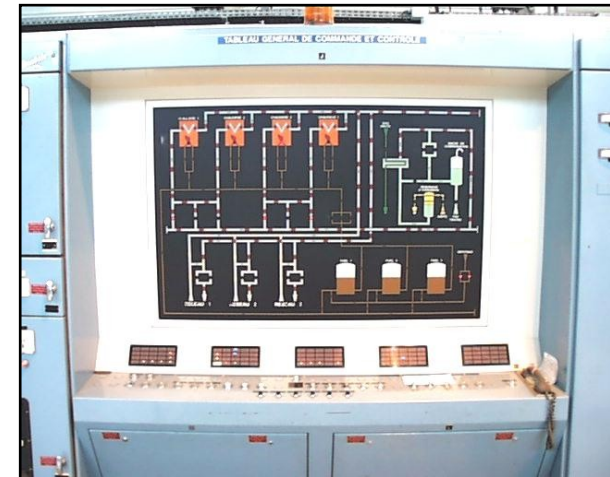
# Building 860 Preveessin

Heating Plant Preveessin  
Compressed air plant SPS, NEA  
Estimated cost: 1 MCHF

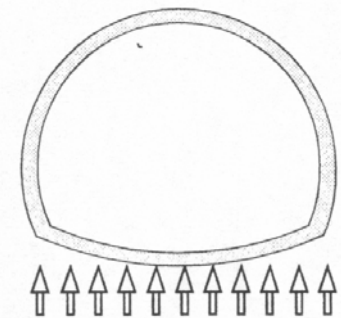
- Water problem
  - LEP Jura – RE38 > finally watertight (?)
  - Maintenance program of drainage system needed
- Ground pressure on headwalls
  - UX45, UX85: OK - UX65 still to come? (800 kCHF)
- Tunnel heave in swelling rock
  - During LHC construction (TI2, UD68)
  - In existing tunnels (TT20, ...)
