- (1) production of new ASIC-PCB (DNF)
 - PCB shows 'problems' during assembly

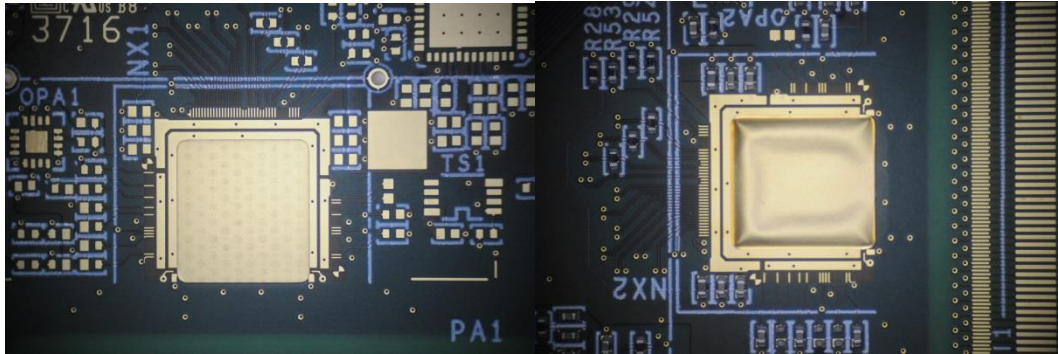
LEFT: PCB in good condition. RIGHT: copper layer for ASIC is "uplifted" after assembly

→ HH will ask HMP for an update

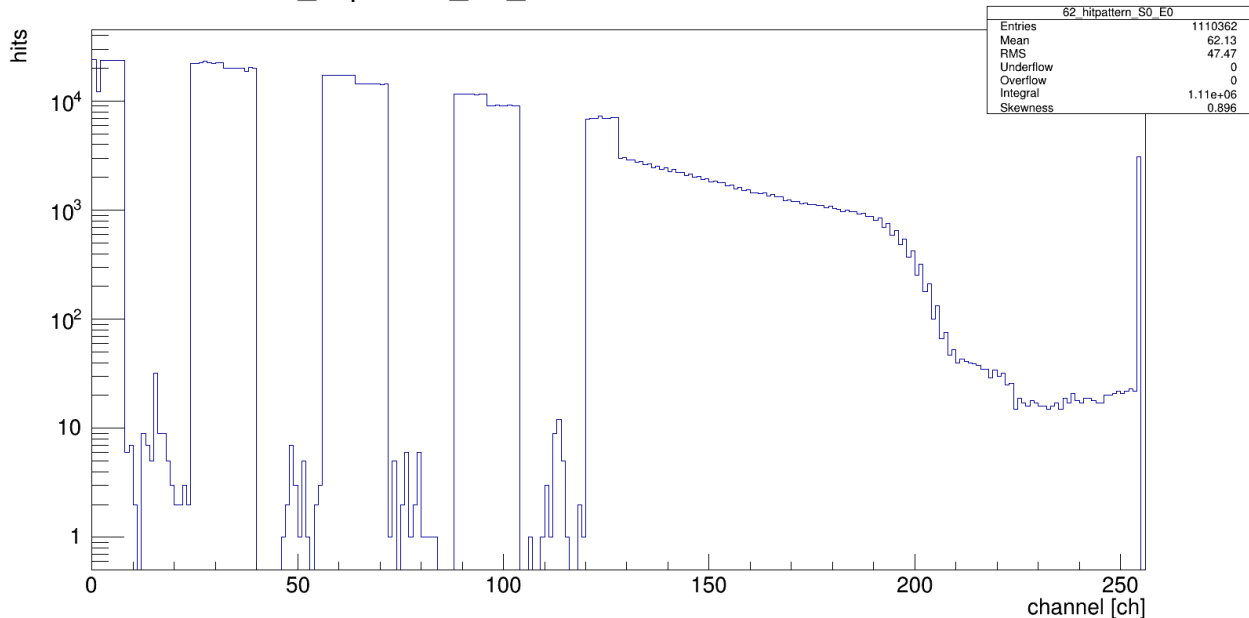
62_hitpattern_S0_E0 16:09:13 2016-06-17

- (2) investigate problems found in beam time:
 - (2.1) 'wrong' ch IDs on 2 ASICs

Example GMX005 from beam time june 2016:

Detailed analysis with test trigger mode
(Mask channels) is needed
