# CLIC TD26CCR1 prototype fabrication

Daniel Gavela, Fernando Toral  
(CIEMAT)

10th International Workshop on Breakdown Science and High Gradient Technology  
Valencia (Spain). 15/6/2017

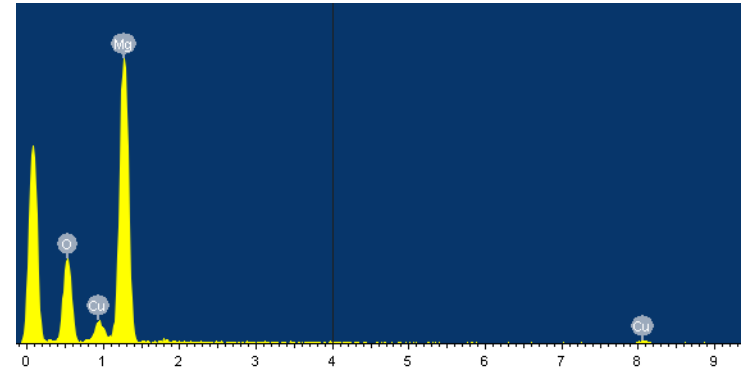
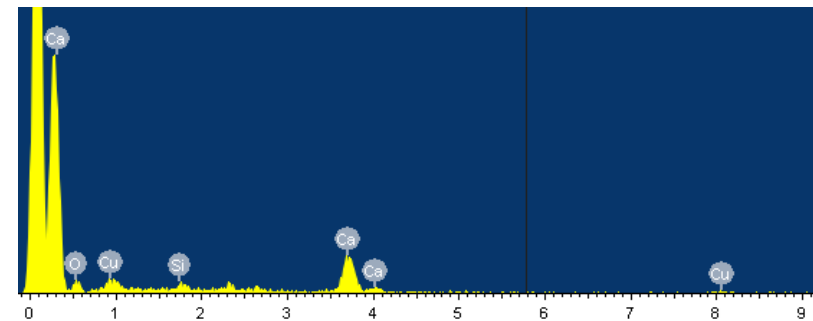
- Thermal cycle in the furnace with witness copper discs in hydrogen atmosphere (few mbar pressure)
- SEM qualitative contamination analysis before / after the cycle
- One candidate furnace close to the machining company did not pass the qualification due to apparition of Mg and Ca particles
- Ongoing furnace qualification with a second candidate

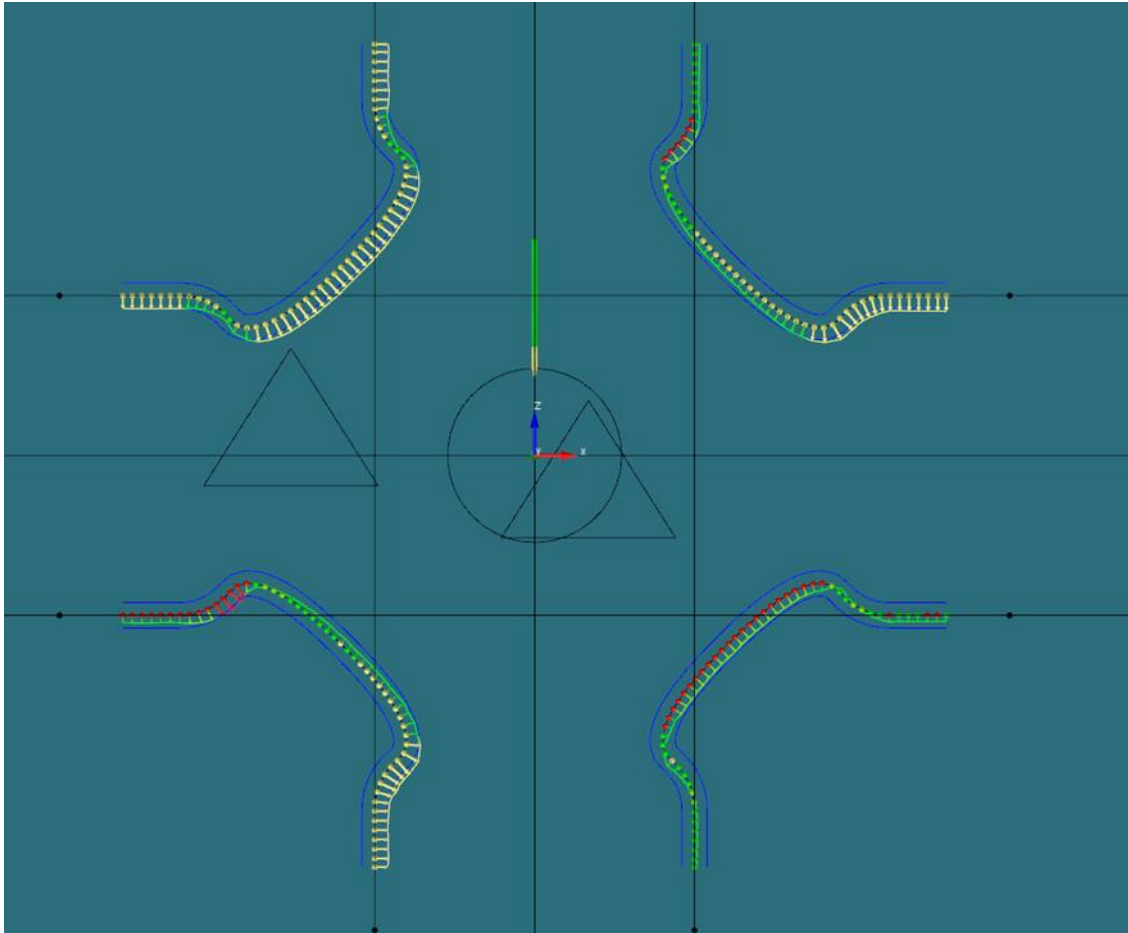
2nd trial disk (#13)

Profile displaced:  
about  $2\ \mu\text{m}$

Trying to understand  
if it is a systematic  
deviation

Shape is within  
tolerances

Only problems with  
positioning

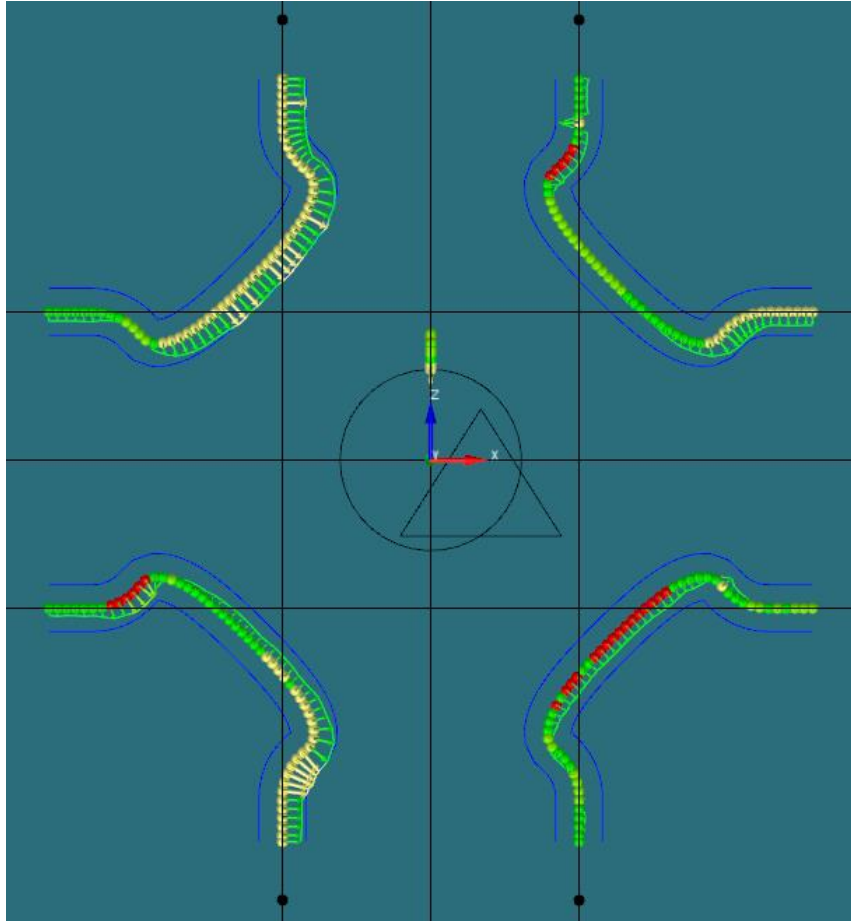
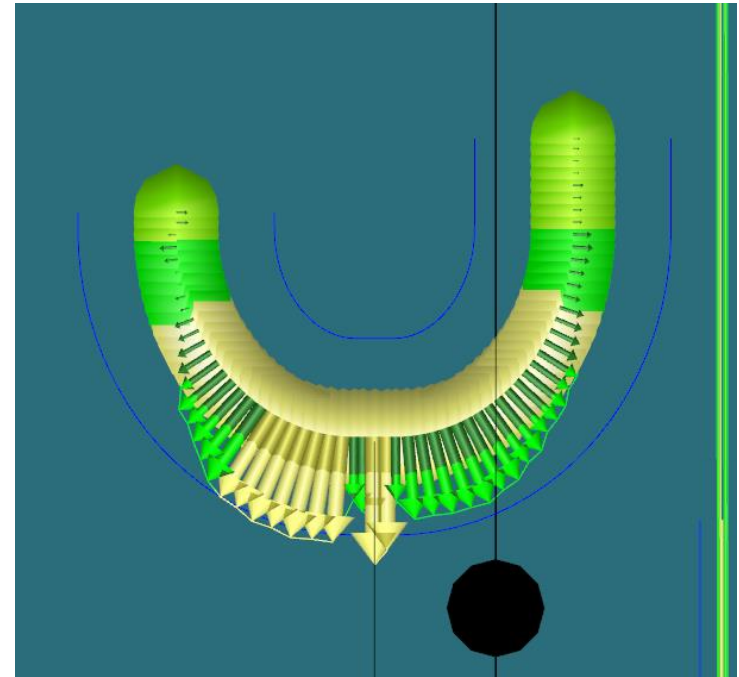
3rd trial disk (#2)

Waveguide nose shape is fine,  
slightly off-position

Iris shape tolerance is fine, but  
0.3 micron off-position

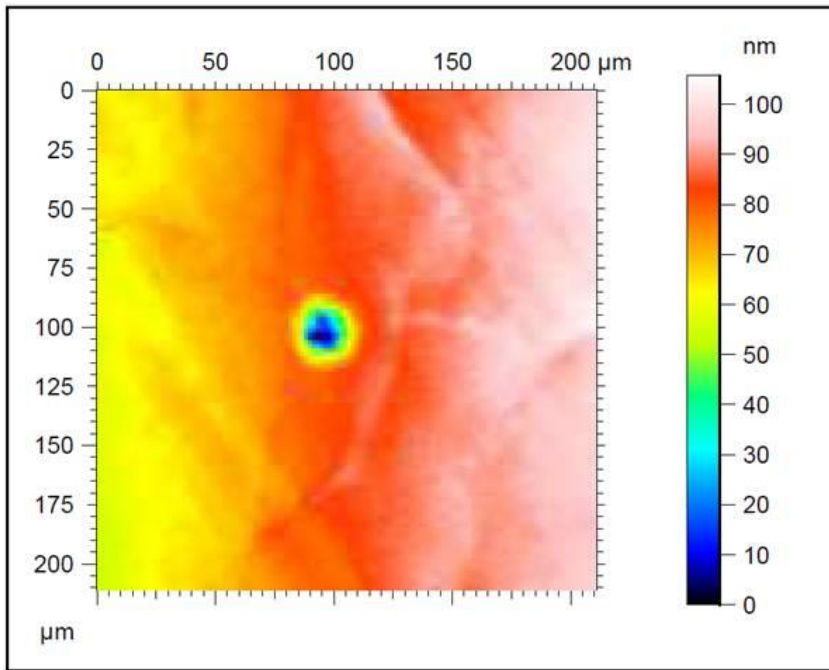
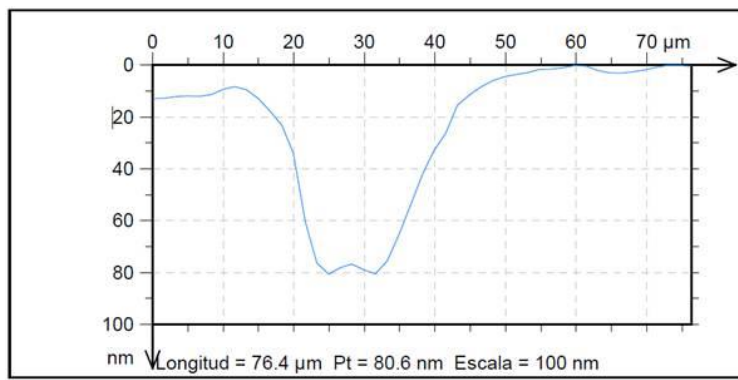
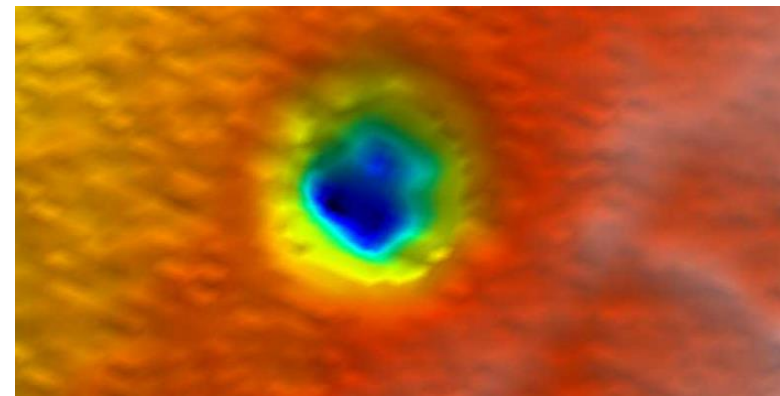
- Leitz Infinity 3-D coordinate measurement machine uses ultra-low force gauge
- The depth of the deformation is about 80 nm
- Measurements on series discs under discussion, likely the iris profile will not be measured
