# Report from EATM

Experimental Areas Technical Meeting

COMPASS TB meeting

# SM2 power converter.

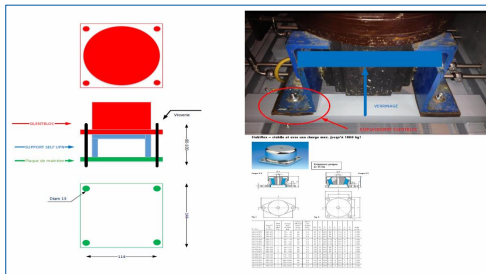
This glitch was due to an transient opening of the water pressure sensor of the filter chokes.

This contact opening was caused by the strong vibrations of the chokes.

Short circuit of the water pressure contact on the chokes

1. Installation of specific Silent Bloc underneath the two coils to decrease the vibrations of the power converter.
