Table 1: Pressure at failure or maximum pressure reached

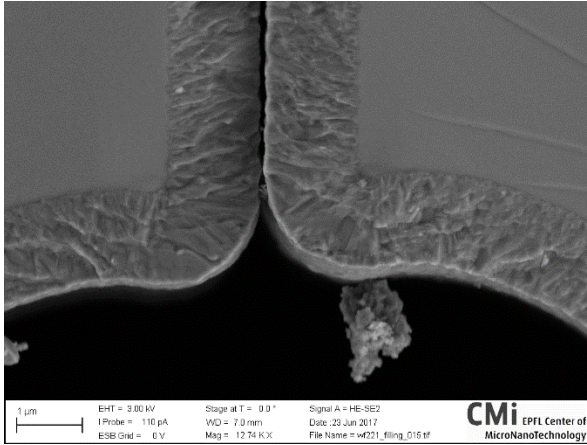
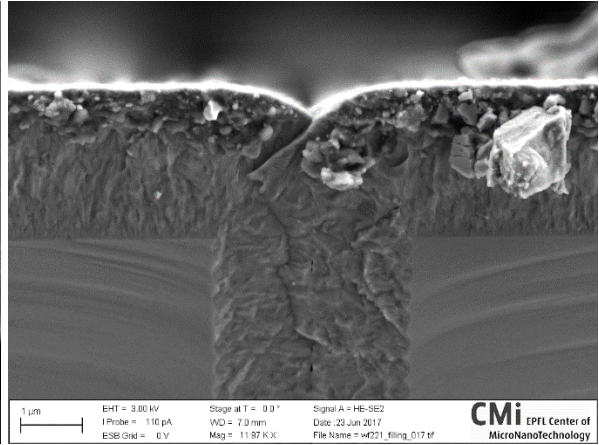
Wf221

Figure 1: image of trench for three closing types. Wf 221: No oxide, no mask Wf 220: Oxide + mask Wf 214: Oxide, no mask

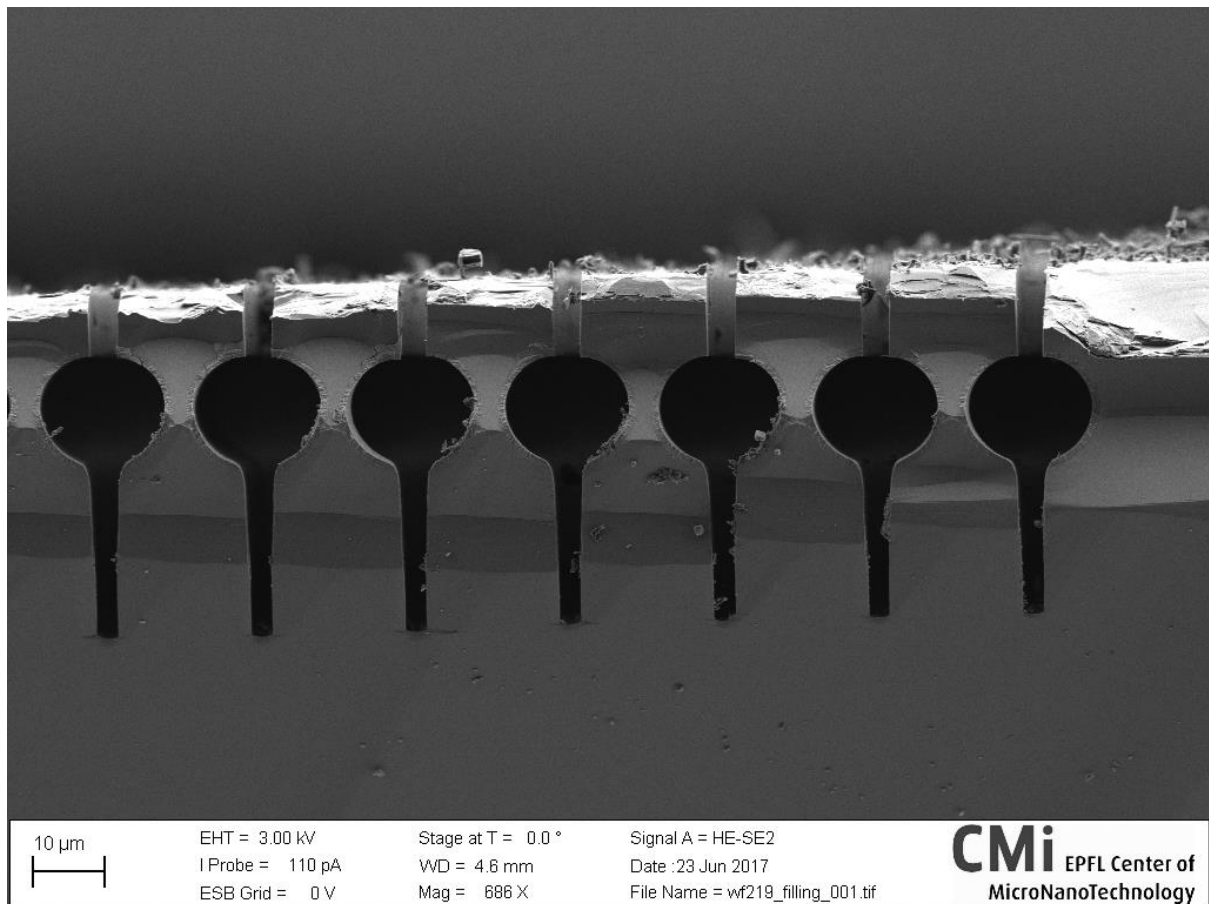
The inlet of Wf 219 were etched with the wafer glued with quickstick to a support wafer. After the etching and PR stripping, weird stripes were visible on some parts of the wafer and could not be removed by O2 plasma. The trench observation revealed that these stripes were due to PR not protecting the wafer probably because of overheating.

Figure 2: trench observation of Wf219: some parts of the sample have been exposed during the inlet etching
