Update: Thermal Imaging

WILLIAM HEIDORN
IOWA STATE UNIVERSITY
ISU WEEKLY STAVE QA MEETING
MARCH 21, 2018

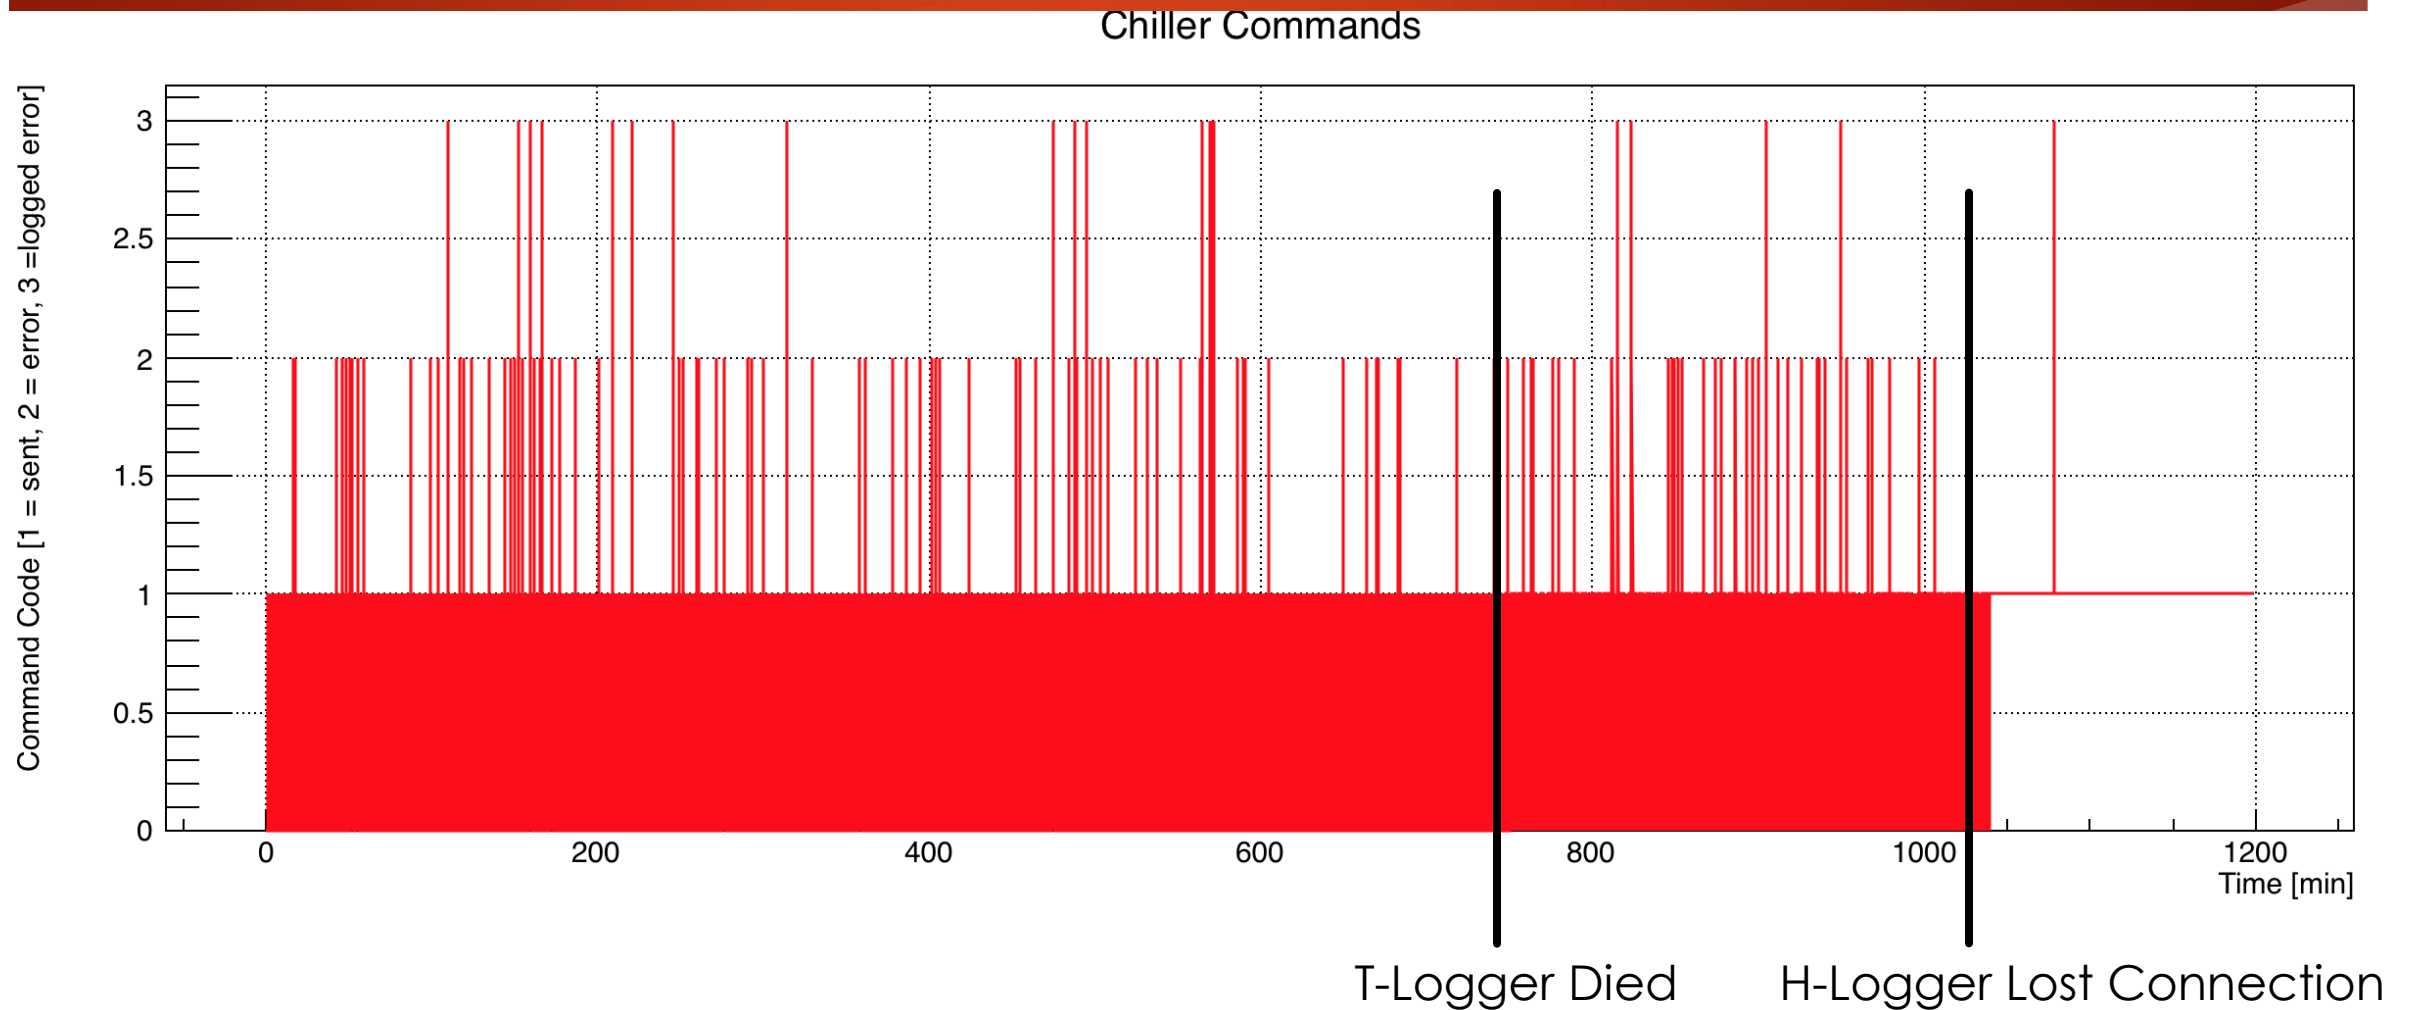
Chiller Communication Issue (cont.)

- ▶ Created a way of plotting the errors. On the next slide you will see the best example plot of the errors.
 - ▶ Errors seem to be randomly dispersed
 - ▶ 1-2% of all errors are garbled responses from the chiller
 - ▶ Normal Response: OK<ret>F076=+000000.!
 - ▶ Example Error Response Chunks: O[, _K, oK, OO and N076=+000000.!, G076=+000000.!
 - ▶ The rest of the errors seem to be related to the sending and receiving
- ▶ When all of the other things the computer is talking too, stop talking to it, it gets much fewer errors... Computer Issue???
- ▶ Also noted today that the chiller changes configuration port when restarting the computer...

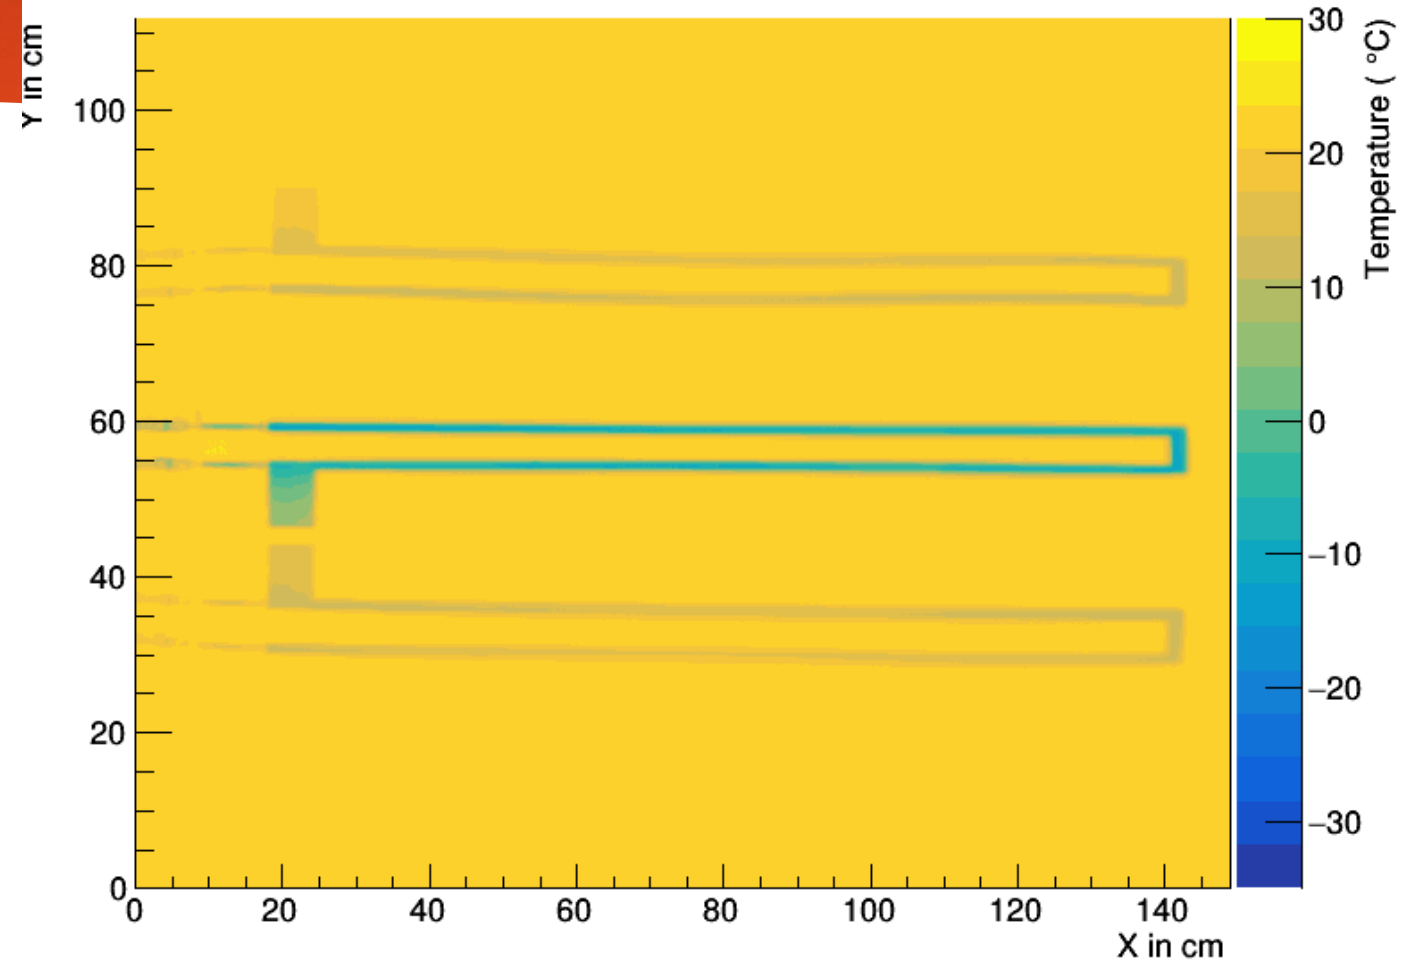
PipeFoam Preliminary Measurements

- ▶ Have taken data of the PipeFoam Stave. Still working on creating a thermal shock video.
 - ▶ Ran into problems with the pipe finding algorithm.
 - ▶ Had to edit it substantially to get it to work on this
 - ▶ Took it from a simple Gaussian fit to an offset Gaussian with different initialization.
- ▶ First thing to notice is it is not flat at all. It has a structure that is related to the foam assembly

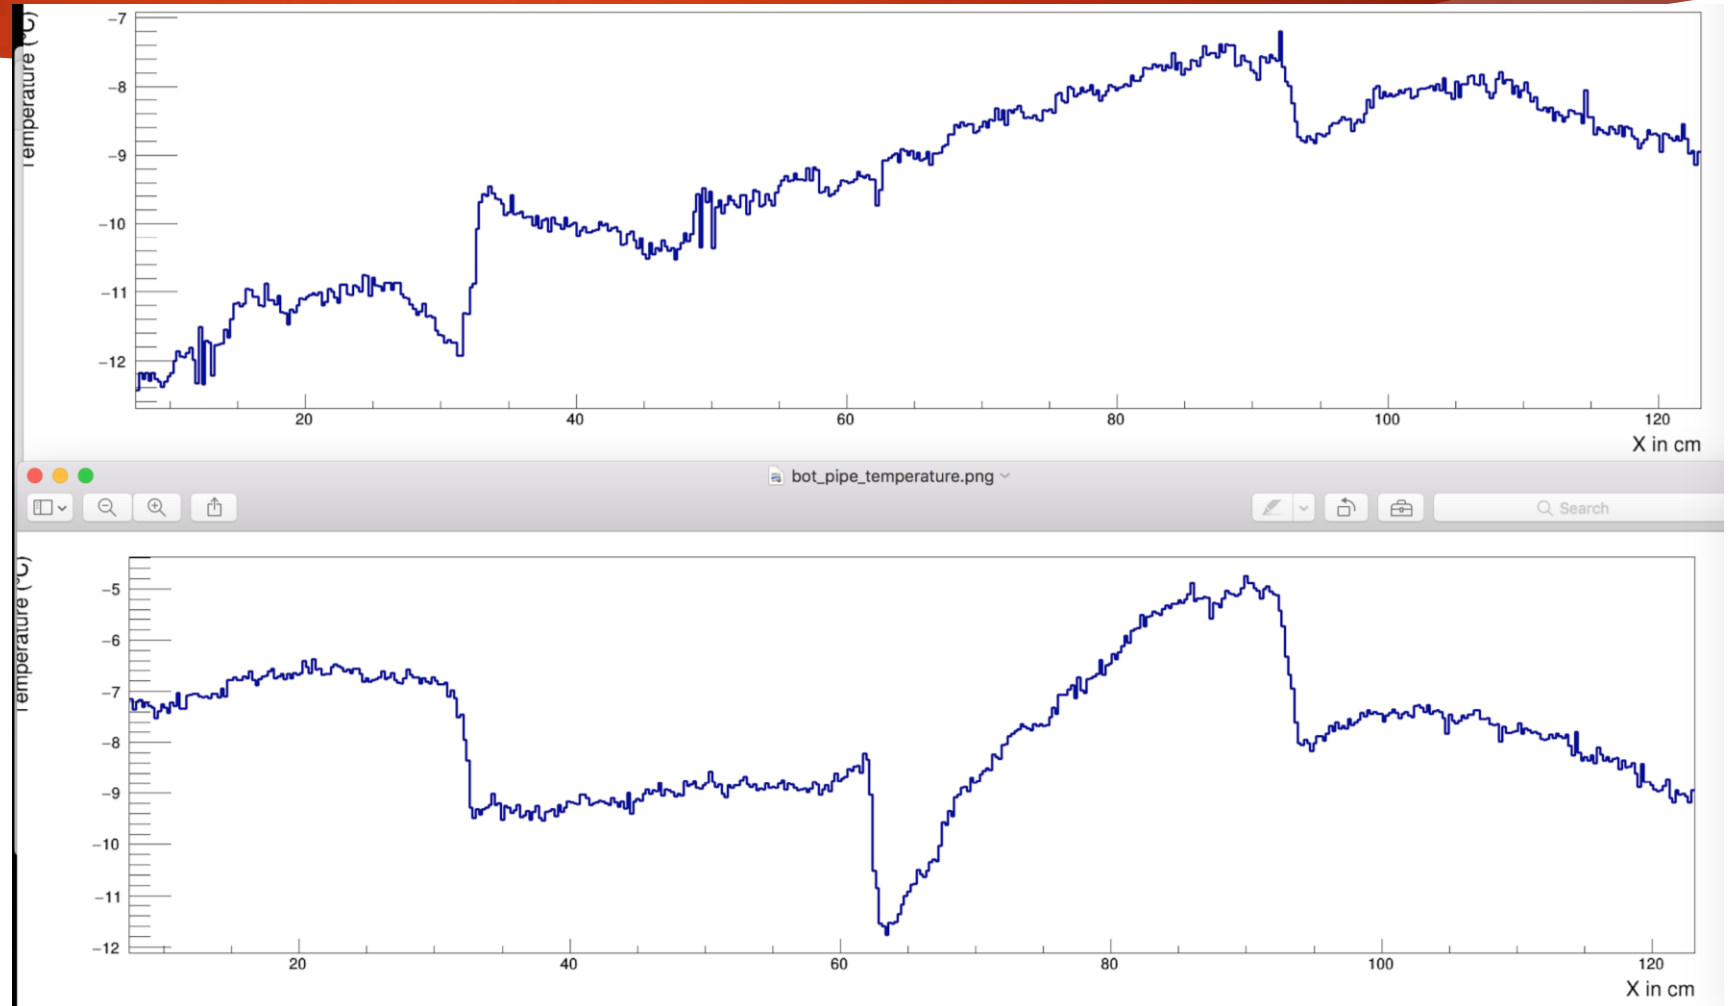
PipeFoam Preliminary Measurements (cont.)

- ▶ You will notice that the structures that are seen are significant with temperature jumps of a few C.
- ▶ This may be observable on the stove and may be a part of the background of any temperature spectrum
