Fabrication of GEM foils in Mecaro (Korea) for the CMS GEM projects

2018 / 02/21

RD51 Mini-Week @ CERN

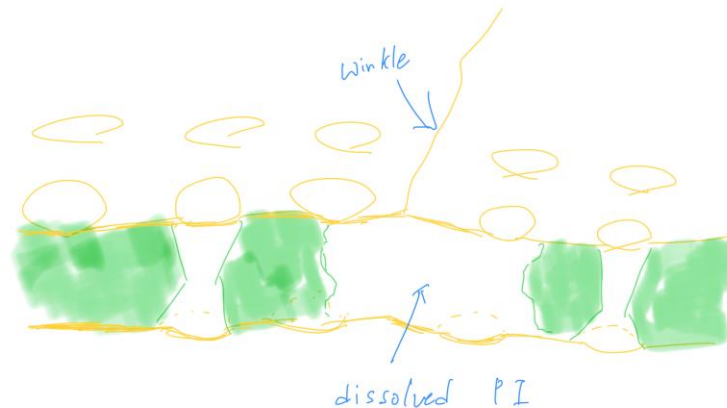
- Quality of hole size and hole uniformity is checked by Rui.
 - Via eye and microscope inspection, no major problem was found.
- Several minor defects.
 - 1) Soldering quality of SMD resistor.
 - 2) Dirty or even cut HV line: solved by thicker DFR for 2nd Cu etch.
 - 3) Strange PI dissolution problem: not observed in batch #2 foils.

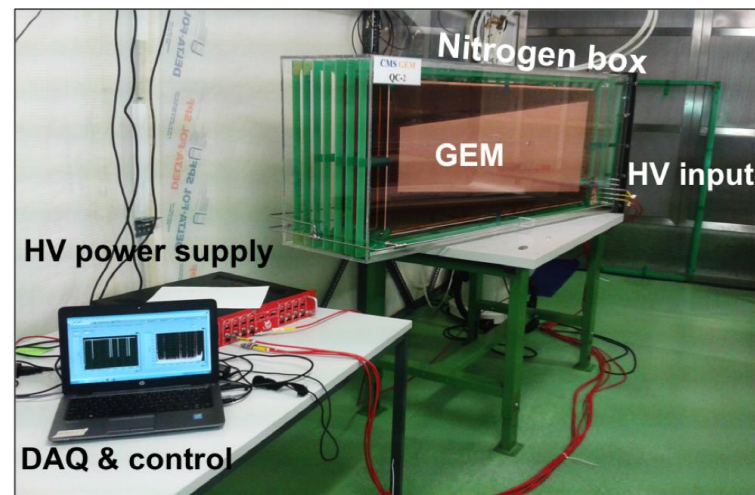
- Major problem: low QC2-Long pass prob.
- QC2-Long: long term (6h) leakage current measurement at high HV.
 - Procedure: ramp HV gradually up to 615V with $RH < 7\%$.
 - Goal: no short, no or a few discharges, leakage current $< 3\text{nA}$.
- At first, every batch #2 foils became short.
With intensive “electroburning”, 3 foils passed.
The 6 foils were recleaned @ Rui’s lab.
- We suspect cleaning process of Mecaro is not enough.
 - For batch #1 foils, Prob. $\sim 70\%$.

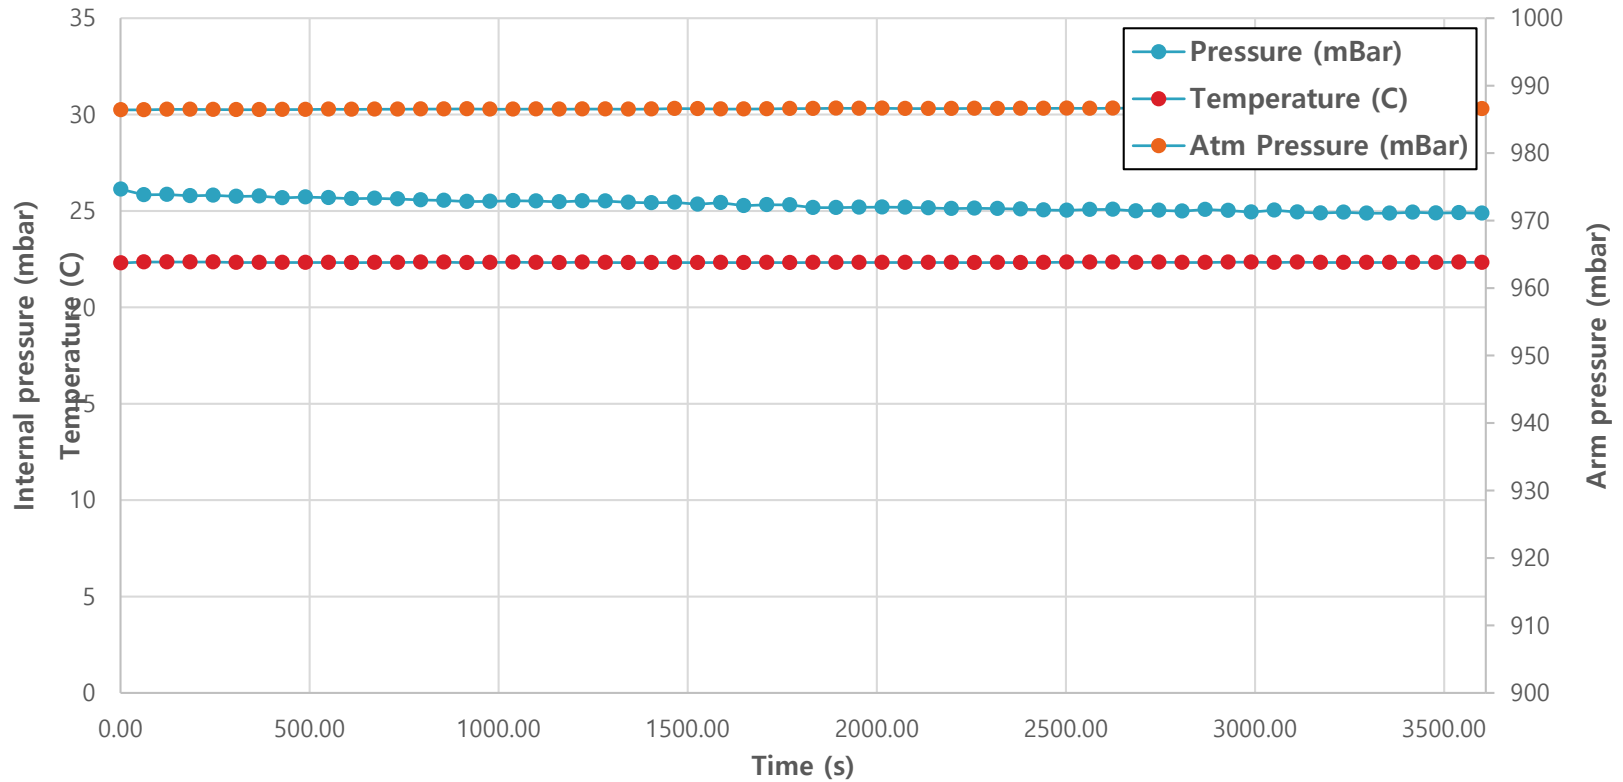
4 QC3, gas leak test on the Korean GE1/1 chamber

- 1 mbar drop was observed for Korean chamber.

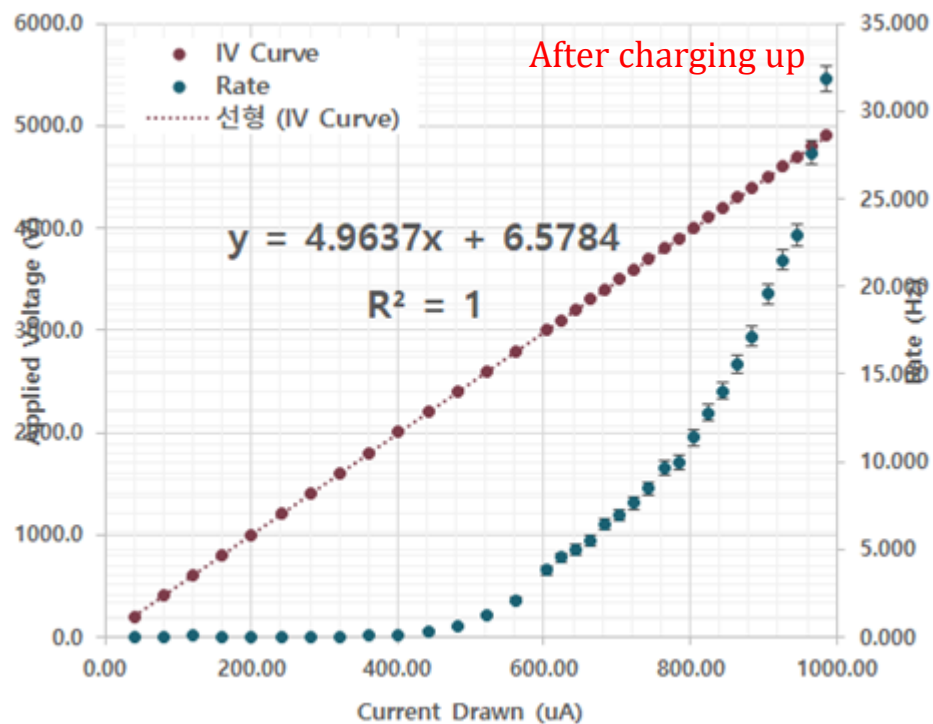
5 QC4, I-V curve and noise rate measurement

- I-V curve was ok. No discharge was observed up to 5kV.
- Noise rate was also ok after charging up.

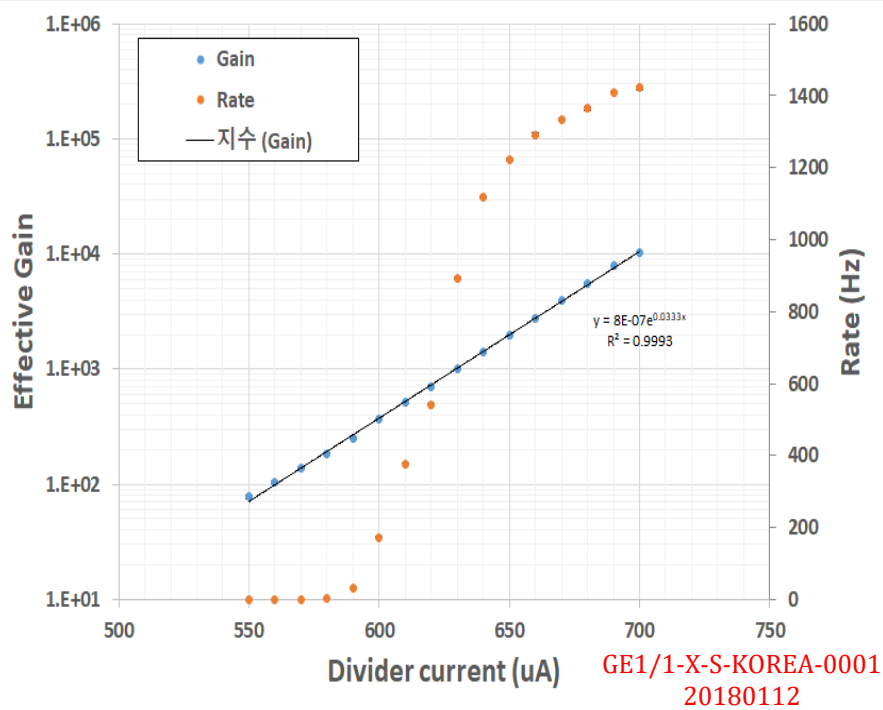
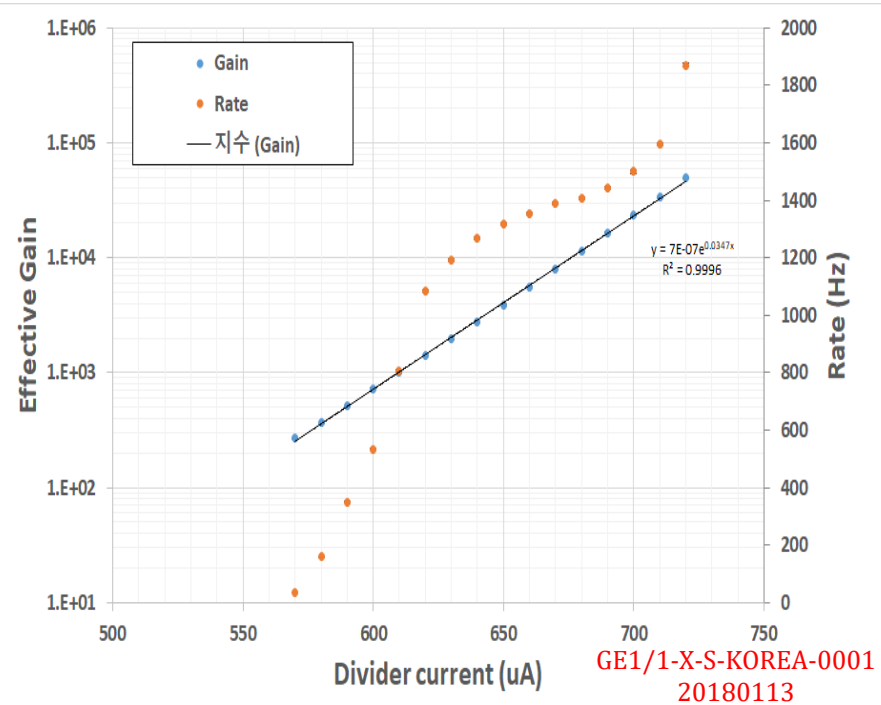
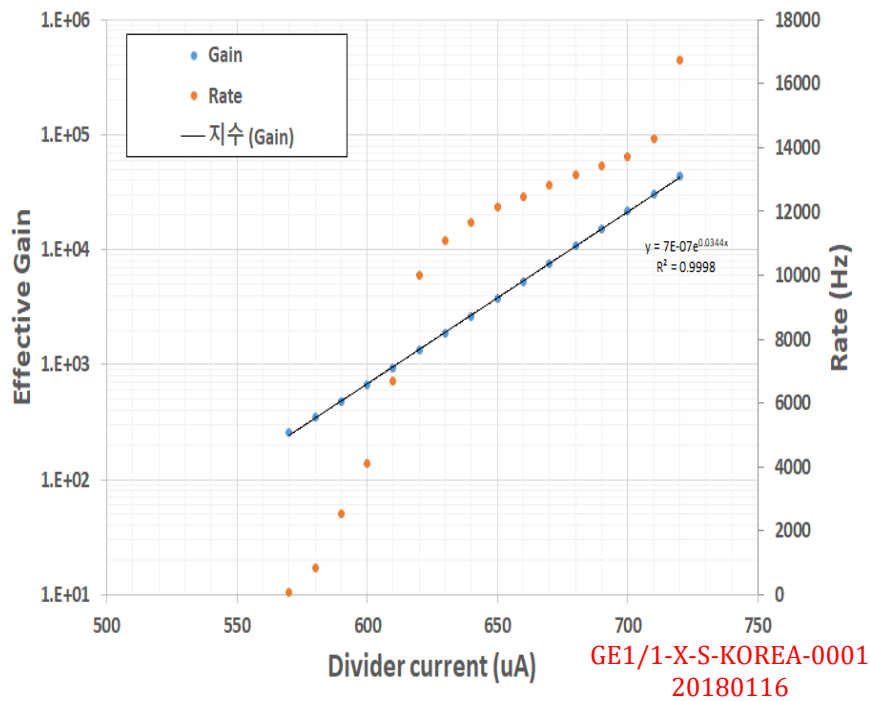
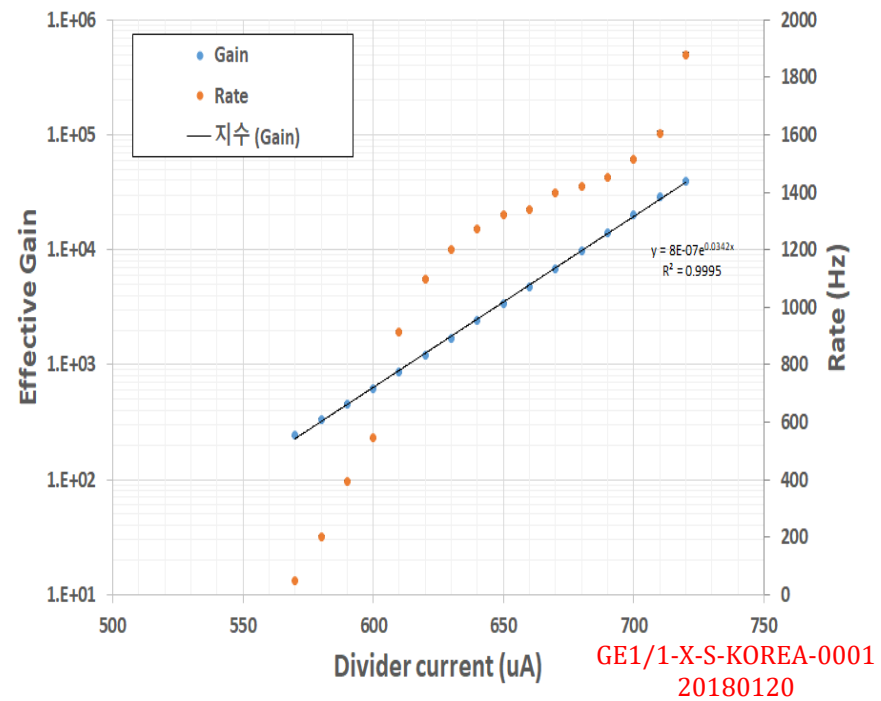
5 QC5 – the effective gain measurement

- The gain curves were measured 4 times.
 - The first measurement (Jan. 12th) shows 2 times lower gain than CERN chamber.
FYI, typical gain of CERN chamber 2×10^4 @ $700\mu A$.
 - The other measurements show consistent result with CERN chambers.
- We are trying to understand the reason of low gain was observed. However exact clue isn't found yet.
 - mistake or environment factor ??

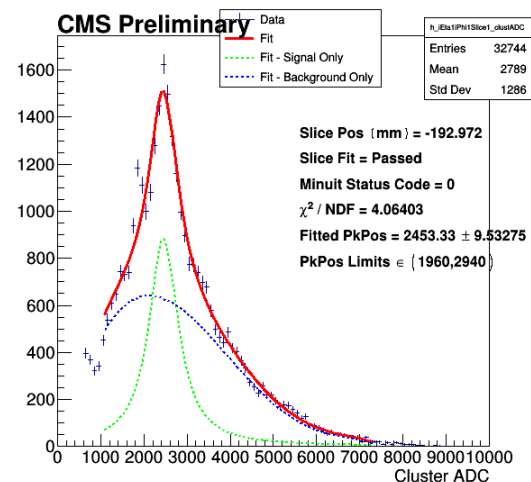
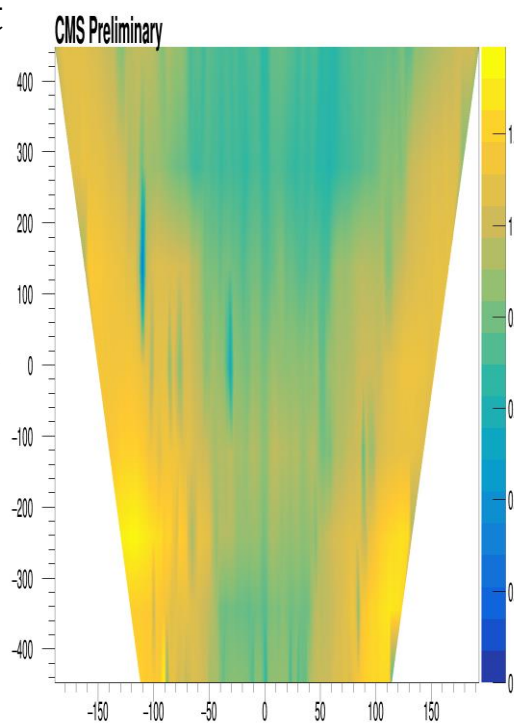
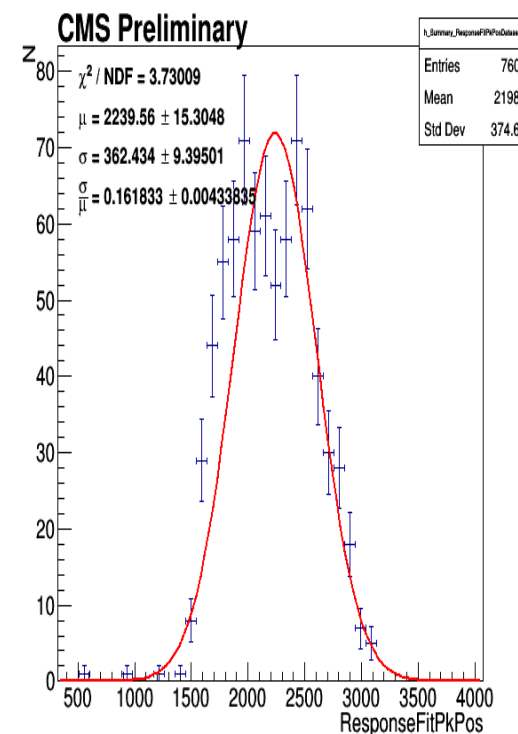
5 QC5 – the gain uniformity measurement

- Gain variance: 16%.
 - Slightly above TDR requirement (15%).
- The result doesn't imply the quality of foil is bad.
 - Key factor: not only foil quality but also PCB bending and foil sagging.
 - Many CERN chamber also show a bit higher gain variance.
- Further study i.e. hole size variance map will be done.

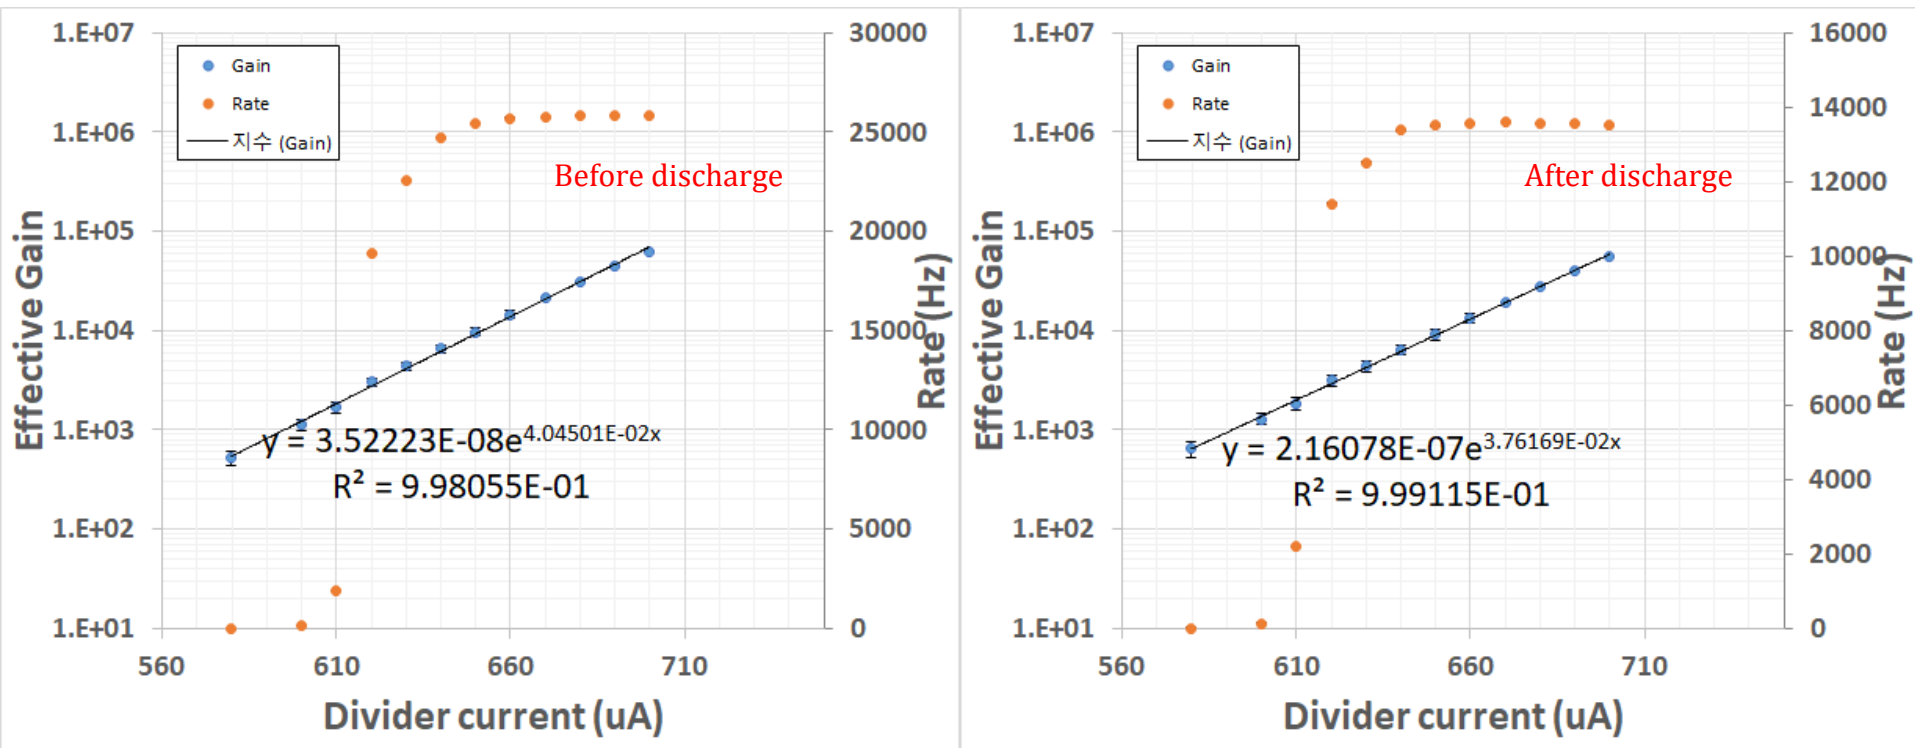
- During the measurement, we've observed at least 15,000 discharges. However no degradation of chamber performance is observed.
