Activities of WIB/FELIX Readout for ProtoDUNE-SP @ BNL

July 4, 2018

Warm Interface Board (WIB)

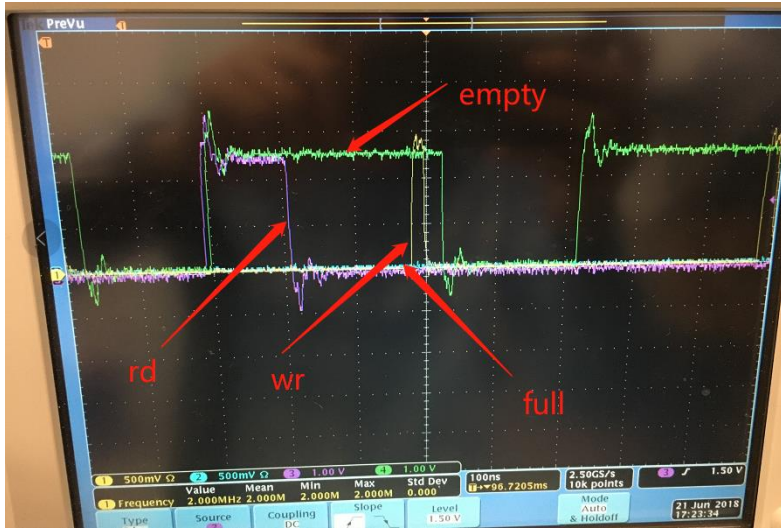
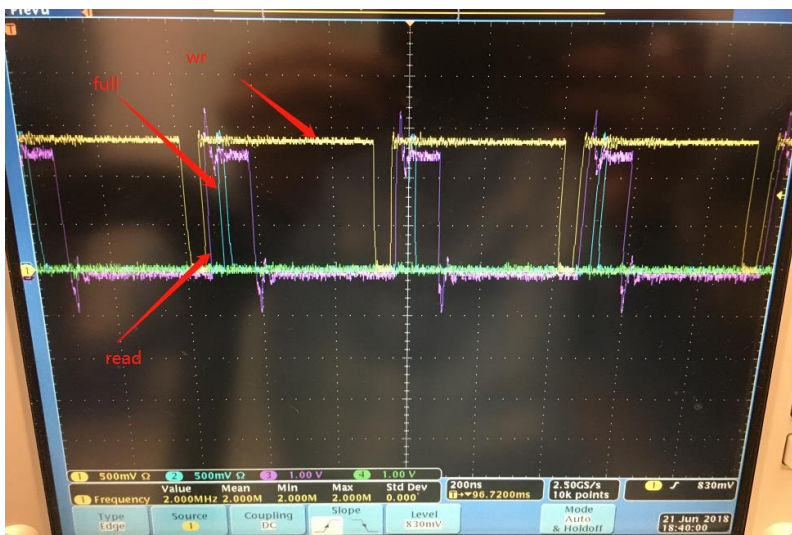
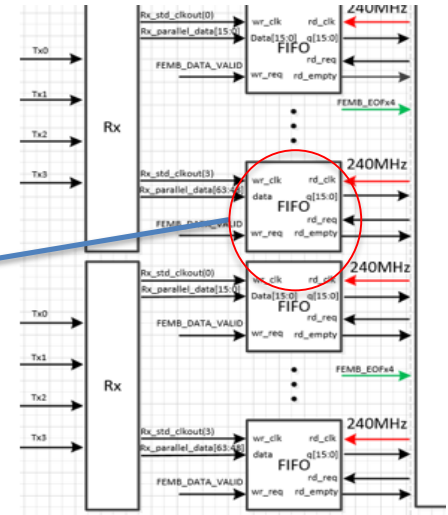
A bug found and fixed.

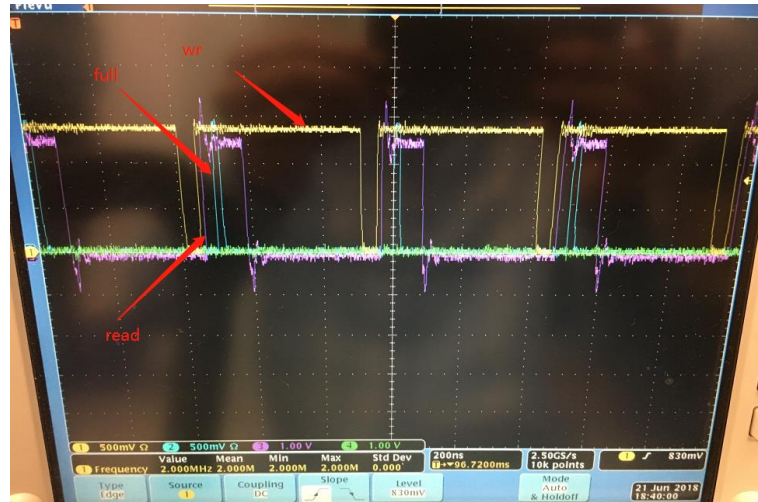
Now the fifo write enable signal becomes normal and we get the ADC data, but the full signal should not appear since read process is more faster than write process.

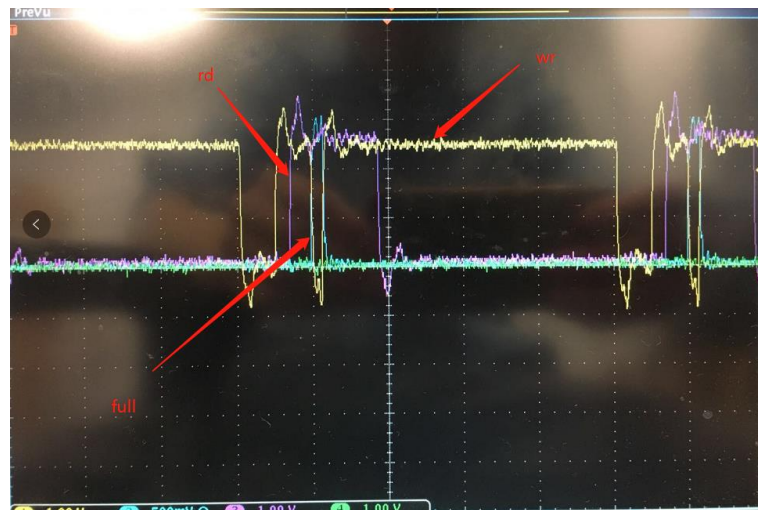
The channel write 29 word into the fifo, but the eventbuilder only read out 28 words. The fifo will full sooner or later.

A bug found and fixed

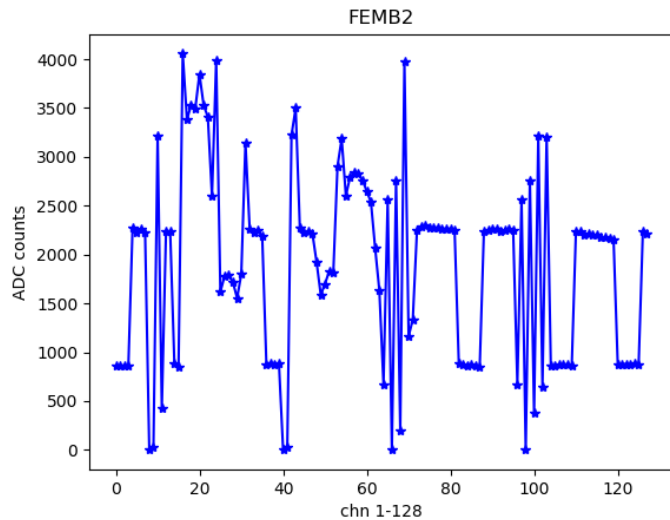
We met this issue before in BU firmware. Data are not aligned. It turns out to be the **configuration issue**.

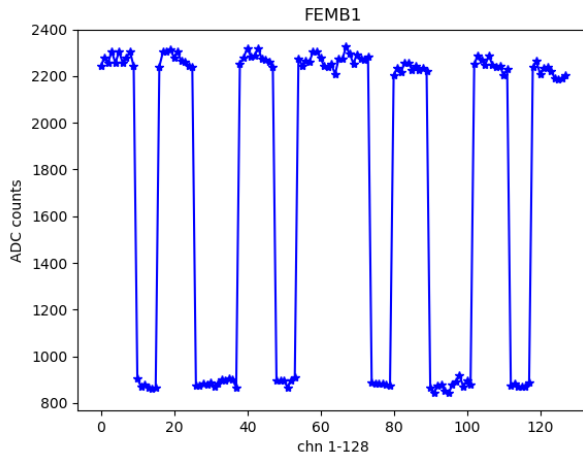
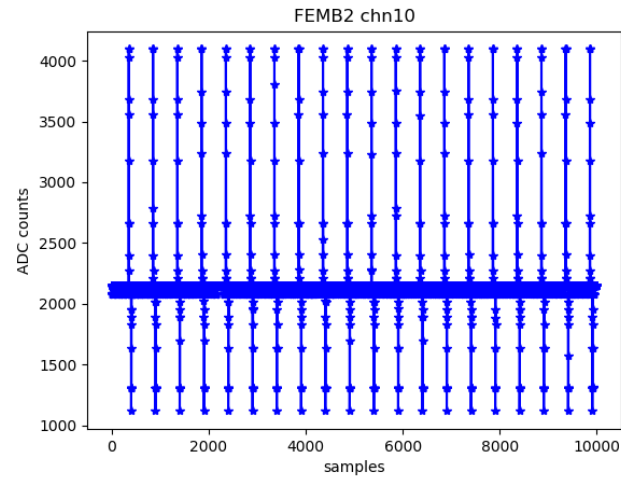
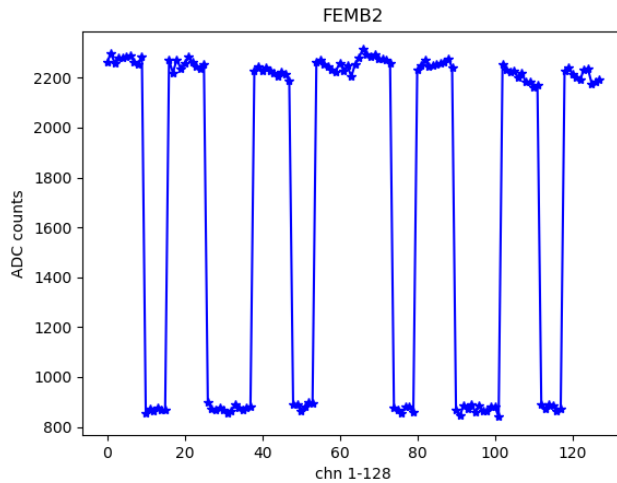
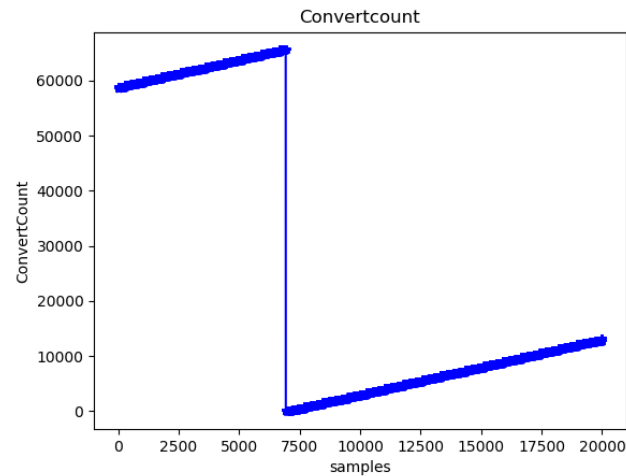
All plots are OK
