Beam Tests and Commissioning of Low Emittance Storage Rings

Lessons Learned from the
MAX IV 3 GeV Ring Commissioning

Pedro F. Tavares

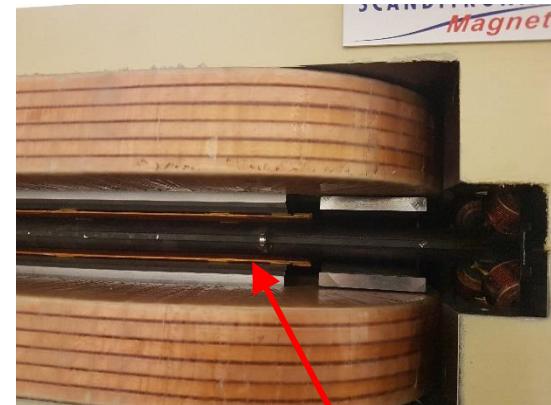
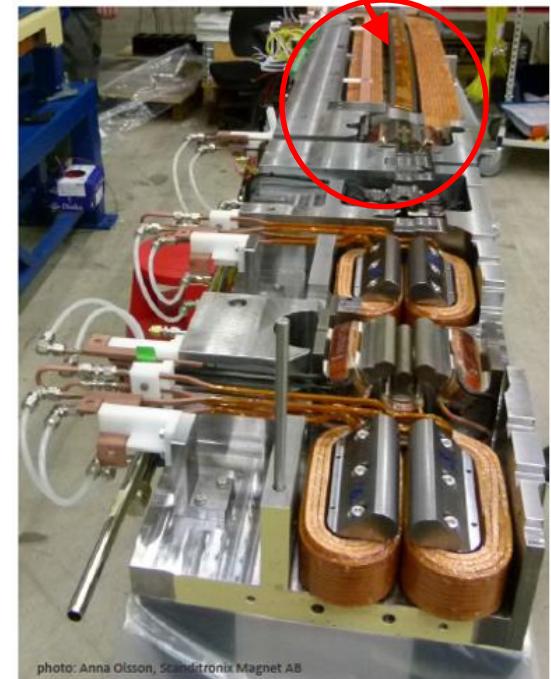
Short-circuited pole-face strips

- A number of pole-face windings were shorted to ground
 - Insulation was not thick/robust enough and was damaged during assembly.
 - Not noticed at the manufacturer (tests without chamber).
 - Only noticed when all magnets were in place and connected to ps.
 - Quick solution was to improve insulation with kapton foils.
 - In some cases, the magnets had to be open.
 - Fortunately, no chambers had to removed (which would have delayed the start of beam commissioning).

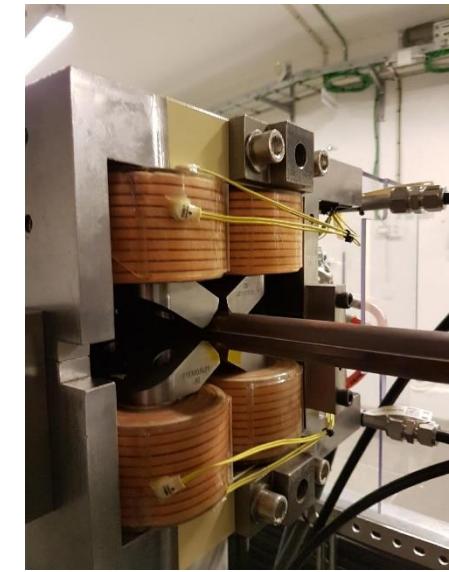
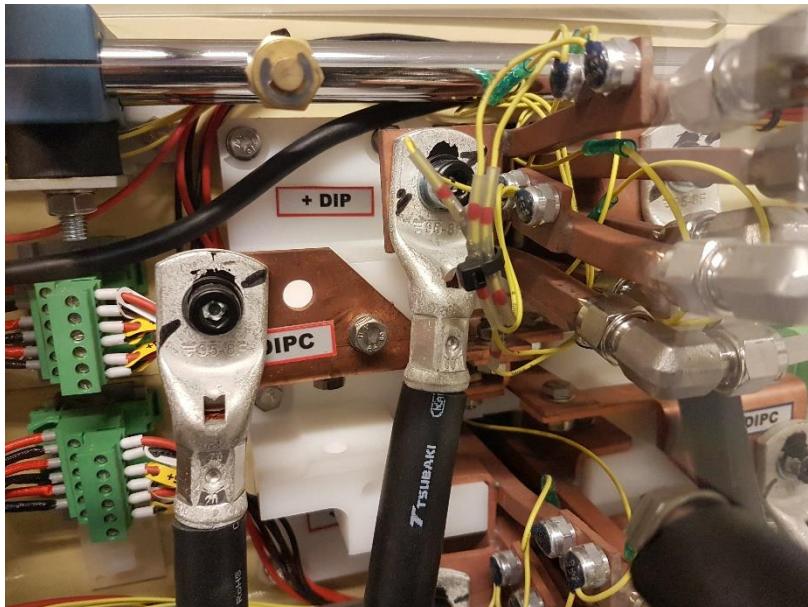
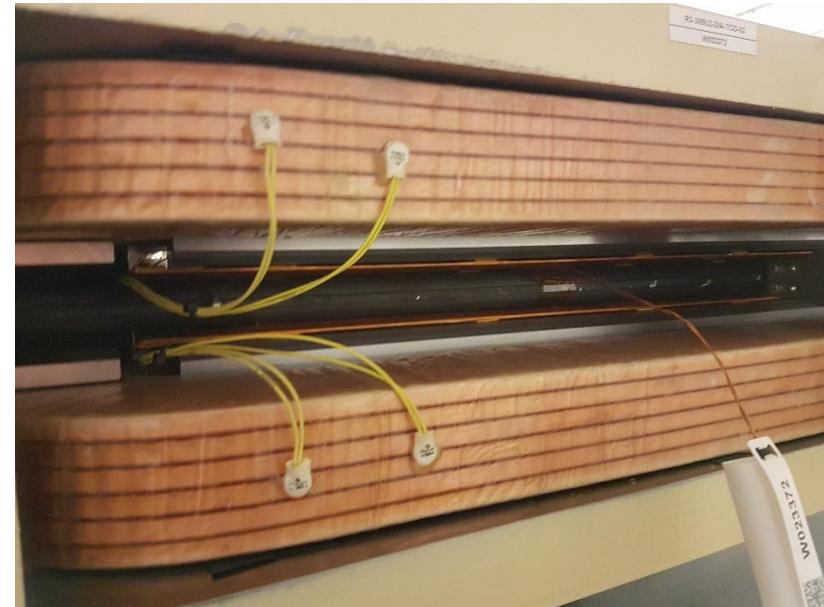
Misplaced thermal sensors on magnet coils

- Thermal switches on coils were found to be almost insensitive to the coil temperature (switches would not open even if water cooling was removed with full current flowing in the coils).
- Problem was that the long and thick cables acted as a heat sink and created a large temperature gradient between the coil body and the coil leads (where the sensors were located).
- A number of solutions
 - Quick fix: implement on-line verification of circuit resistances on high-level alarm system (implemented in Tango).
 - Permanent fix: change positions / replace sensors on all magnets (this took several months)

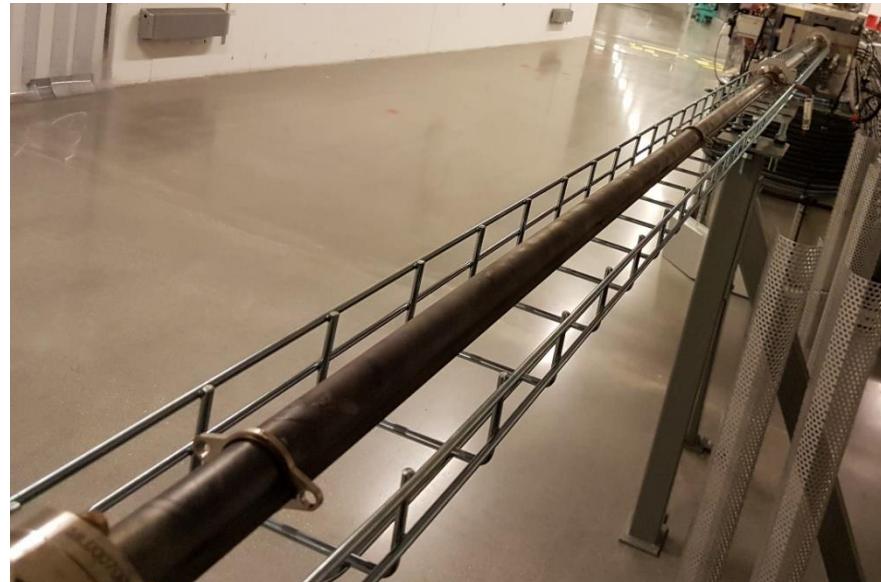
Misaligned Vacuum Chambers

- We focussed on getting the chambers in the right place inside the magnets (given the very tight margin – 0.5 mm), but missed to do proper alignment of the dummy chambers in the long straights.
- Consequences:
 - Early commissioning : after getting the first few tens of turns, progress was hampered by grossly missaligned chambers as revealed by visual inspection.
 - Later, finer chamber alignment problems were the cause of chamber hot spots.

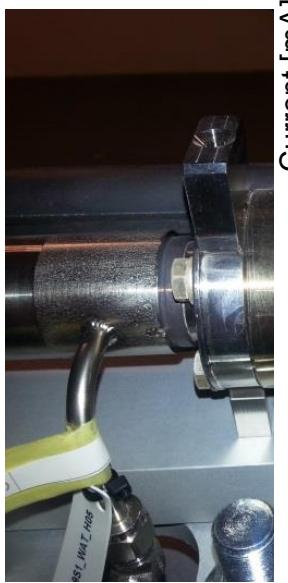
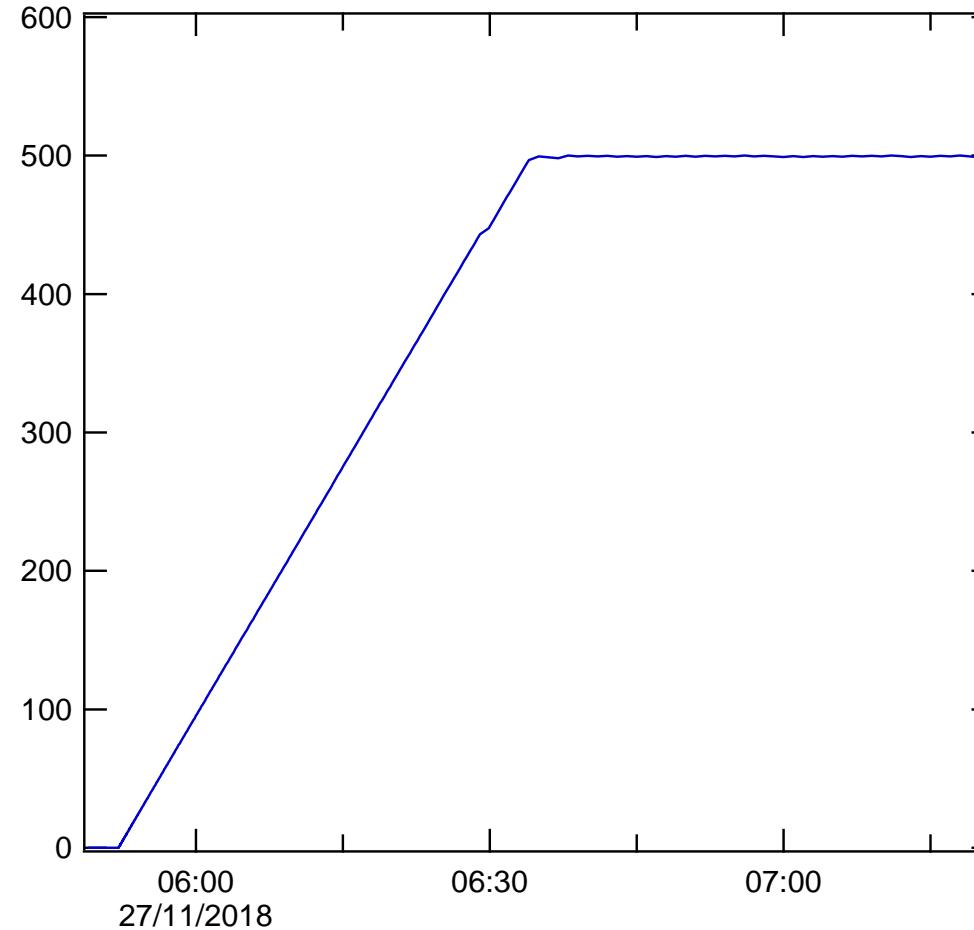
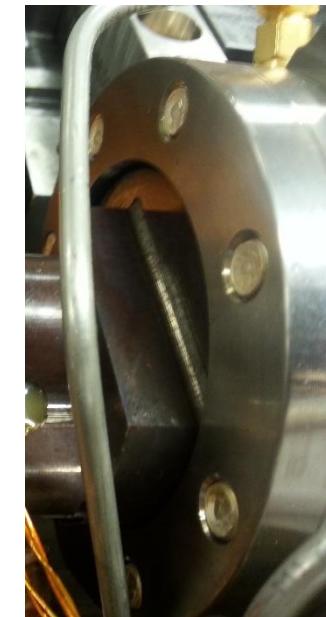
Chamber hot-spots

Local heating from synchrotron radiation from dipoles

In Ach 8 M1, a chamber was damaged
little too much thermocouple glue. MAX IV

In Ach 4 S1, replaced an absorber
(outside mechanical tolerances).

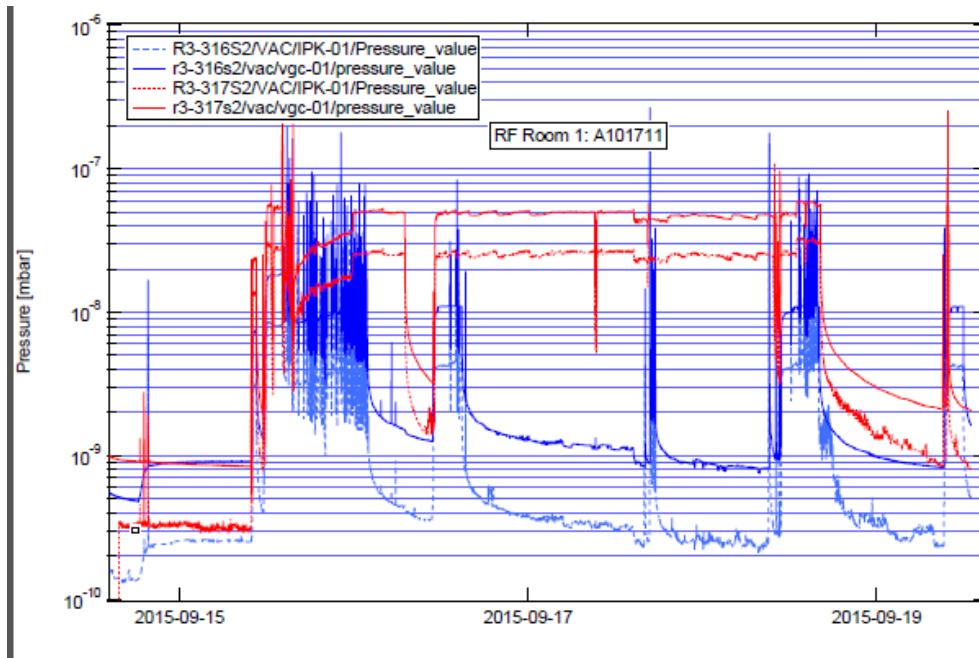
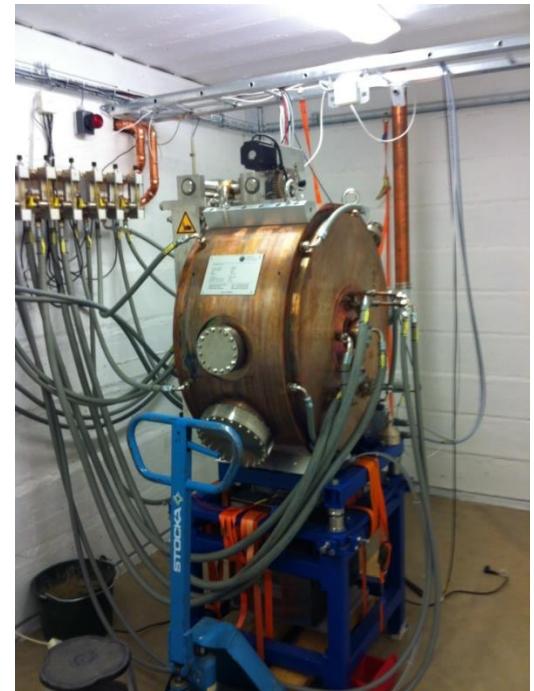
RF cavity conditioning

- Main and Harmonic Cavity conditioning done prior to installation proved insufficient:
 - limited power available
 - limited conditioning time
 - not possible to condition high power feedthroughs at full power

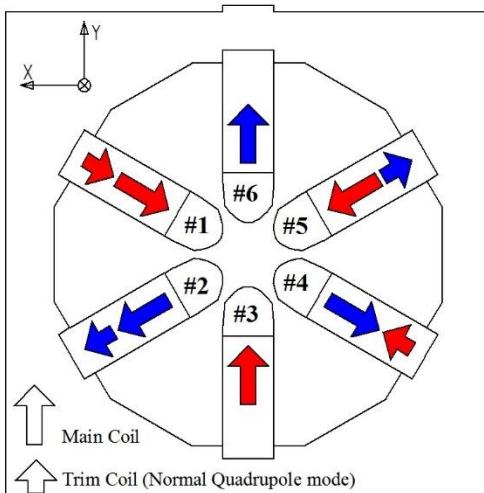
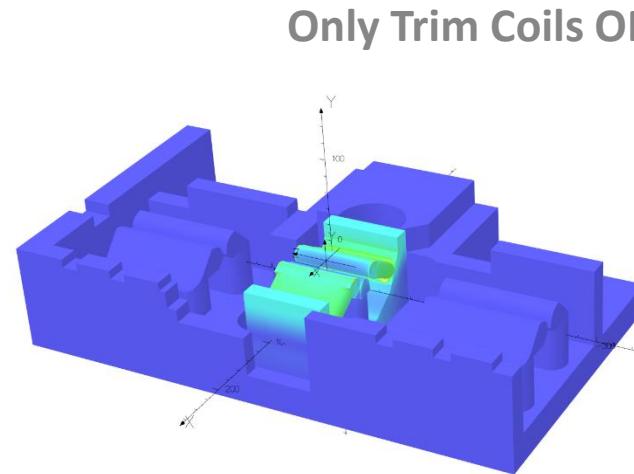
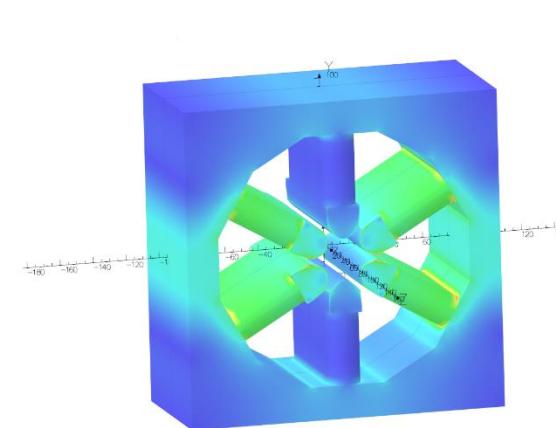
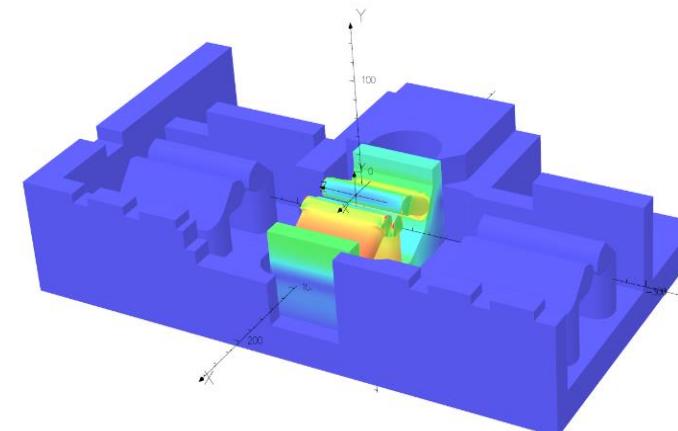
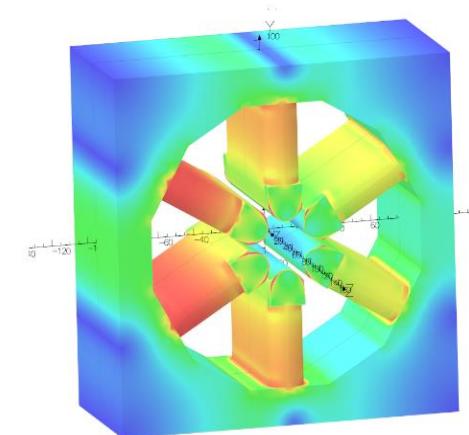
Beam-based BPM calibration and magnet saturation

- At MAX IV, BPM based calibration is done with respect to nearby sextupoles.
- Trim coils are used to generate a quadrupole field on a sextupole yoke
- Early during commissioning a dependence of the measured offsets on the excitation of the sextupole main coils
- Magnet saturation was suspected early on, but 2D simulations could not explain the magnitude of the effect
