BPM Performance at AWAKE

Spencer Gessner
12 December, 2018

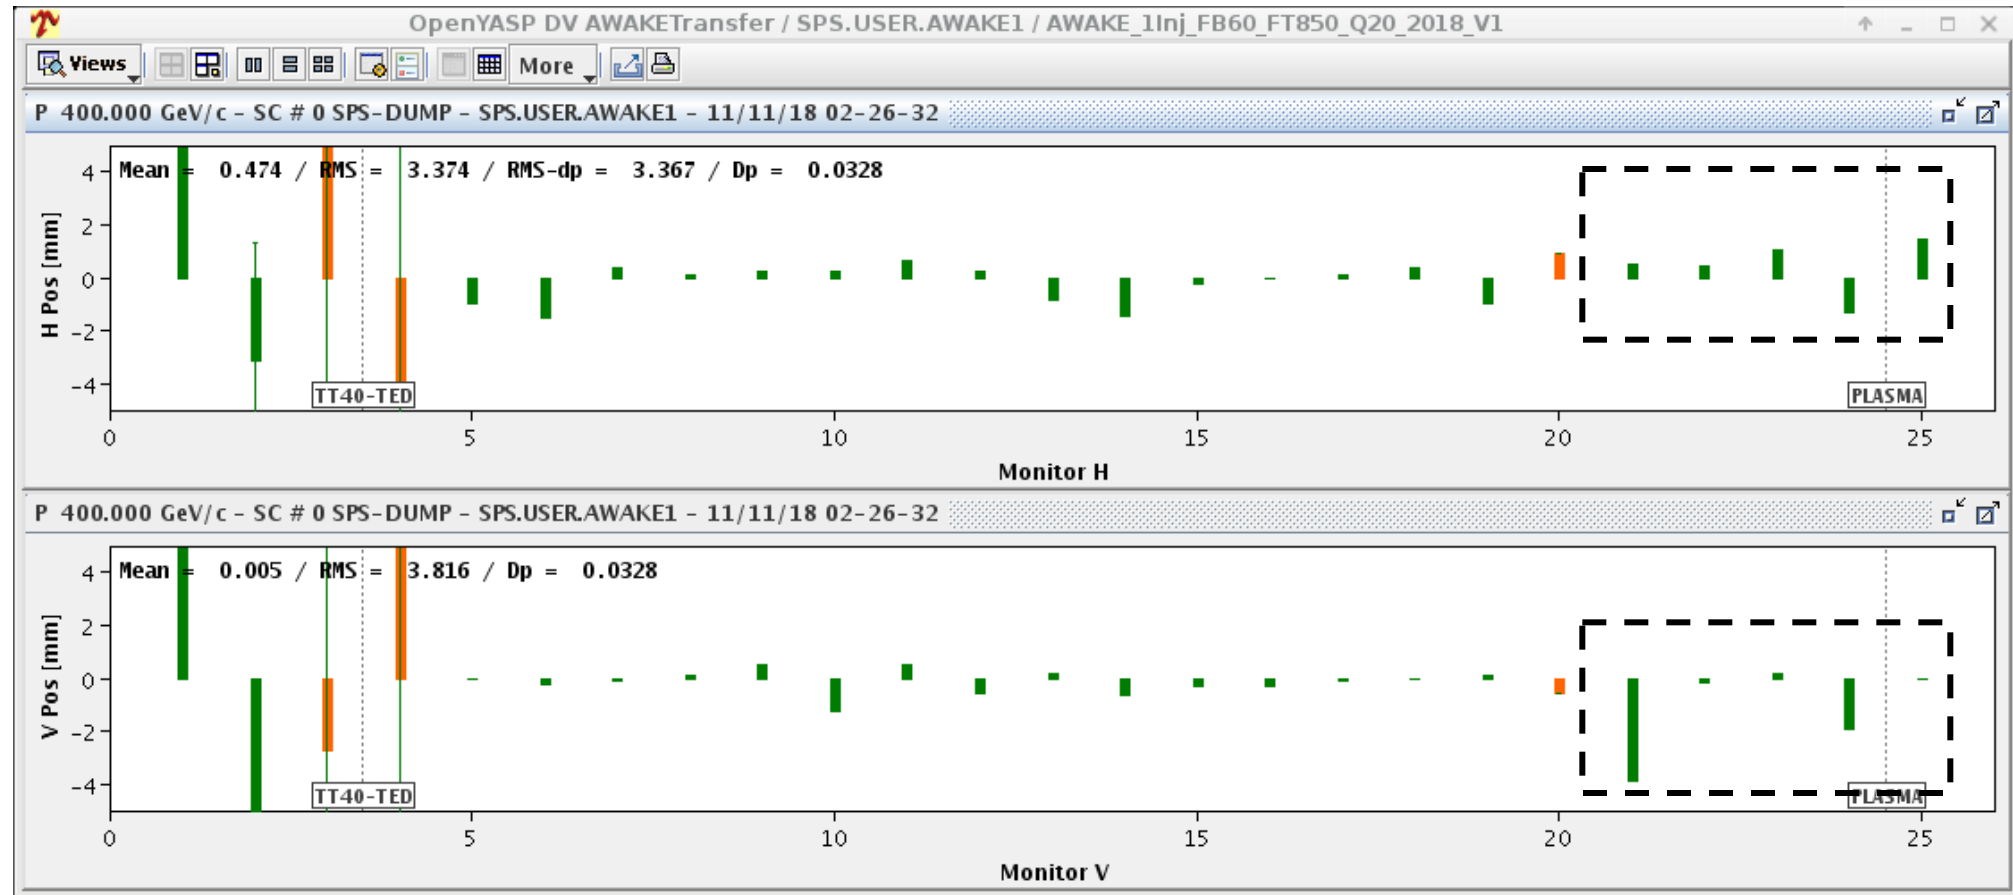
“Bad” BPM readings

“Downstream” BPMs give “bad” readings in the following conditions:

1. High density Rb vapor in the line.
2. Electron beam present.
3. Proton pre-bunches.

Bad readings are obvious, unphysical deviations of the beam trajectory. All 5 downstream BPMs are affected, but the final 2 are most strongly affected.

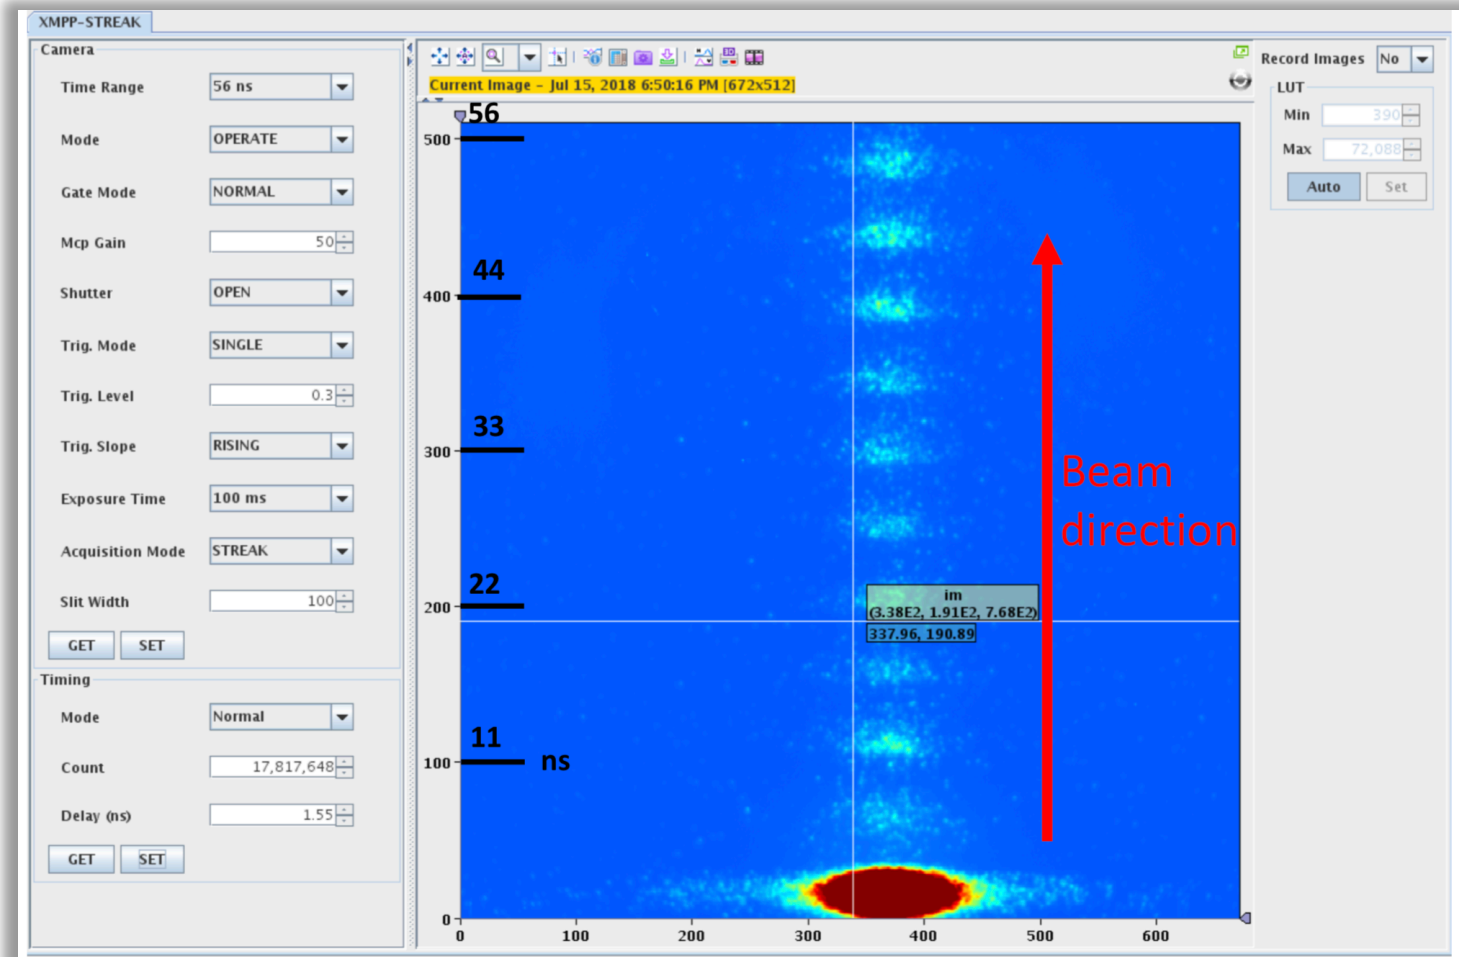
Proton Pre-bunches

In July, Livio observed significant charge ahead of the main pulse.

This also led to bad BPM readings. We alerted SPS OP and they changed RF voltage and kicker timing to avoid this problem.

Was this an exceptional case/accident? Do we need a pre-bunch monitor?

Manfred also adjusted the self-trigger threshold for the BPMs.

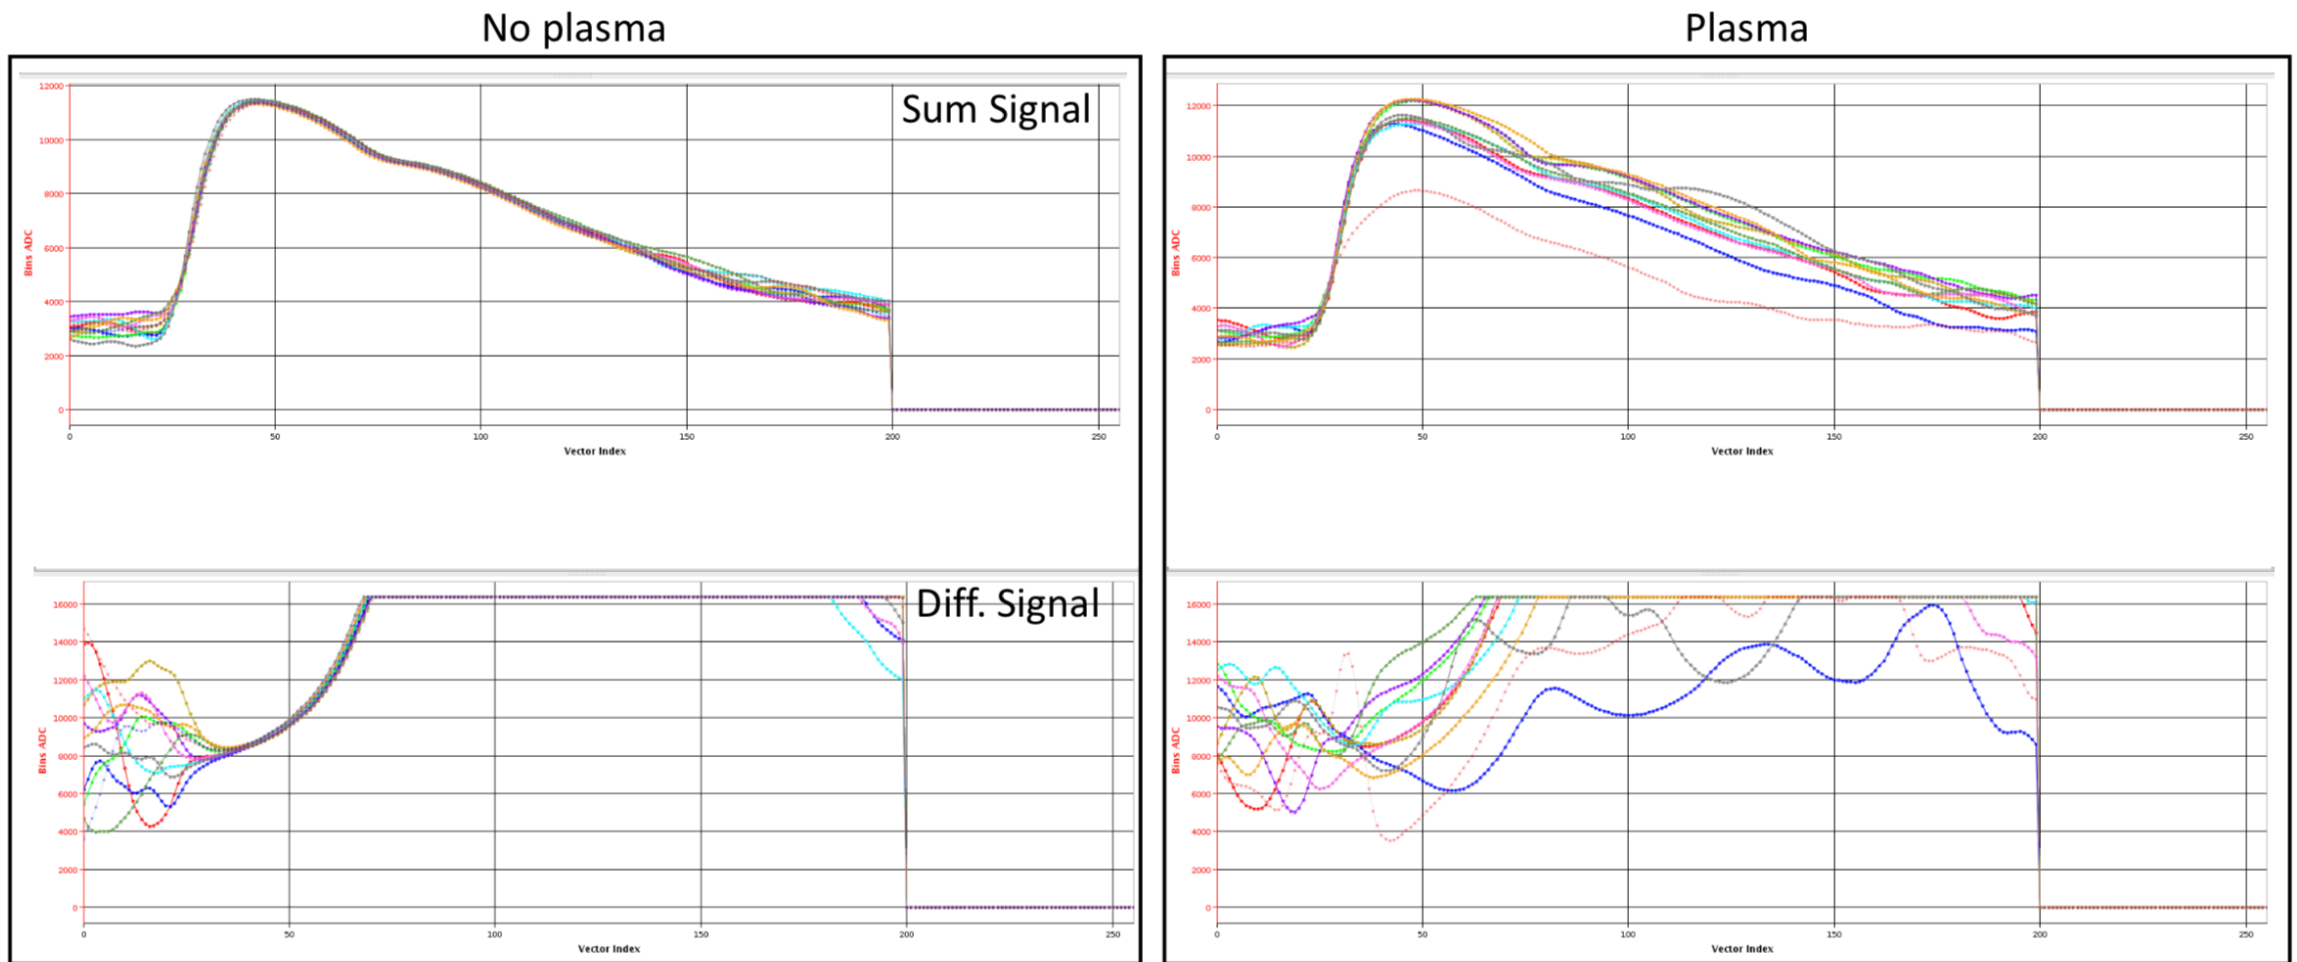
Plasma Effect on Proton BPMs

Since April 2017, we have observed the effect of the Rb vapor/plasma on the AWAKE BPMs. Manfred proposes to use stripline BPMs instead.

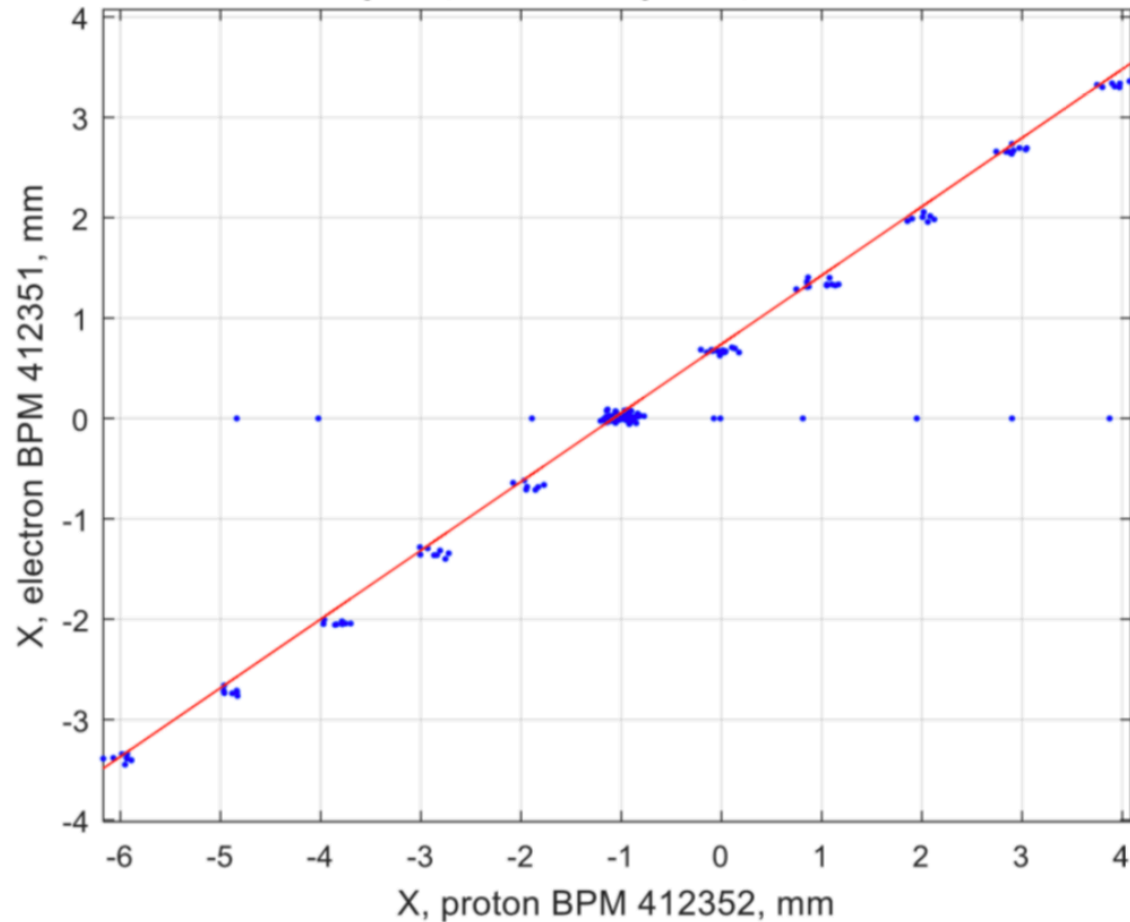
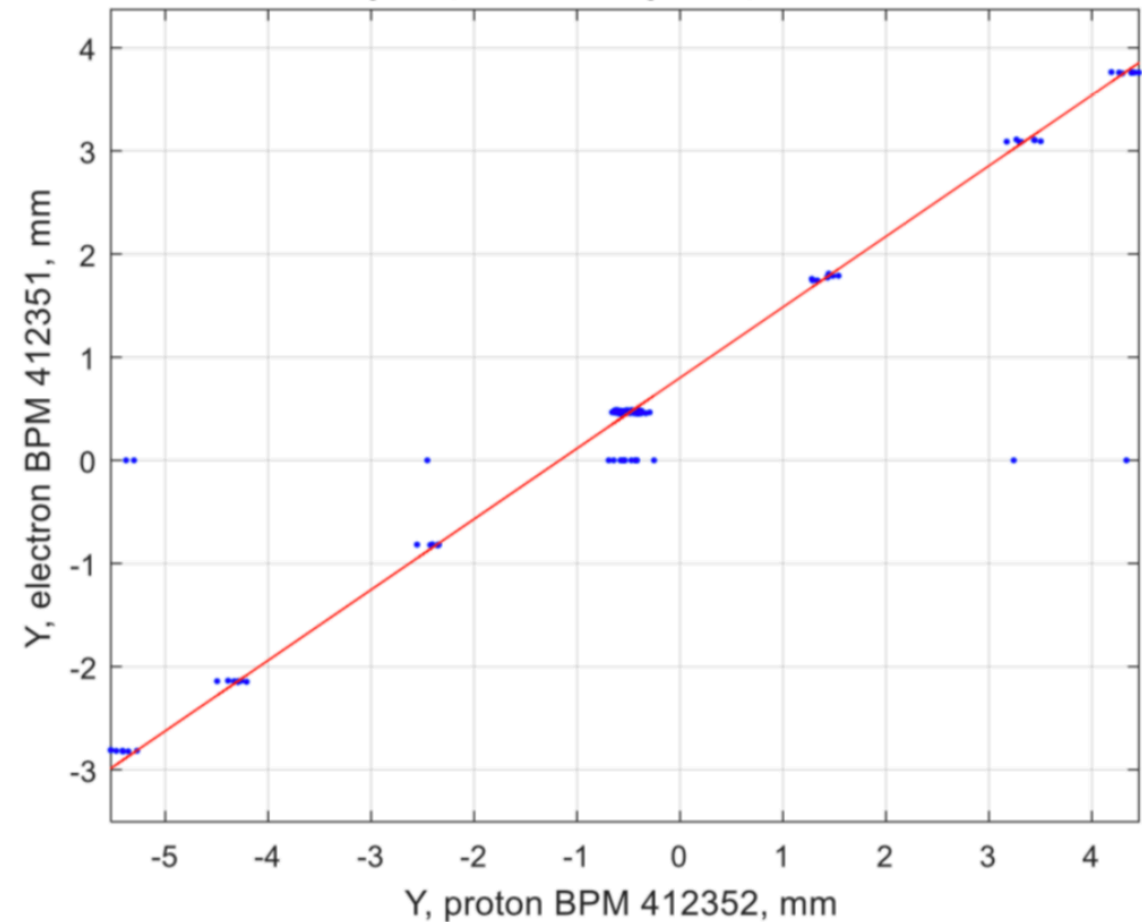
Electron-Proton BPM Correlations

Misha, Shengli, Lars, Michal, did cross correlations on electron and proton BPMs. This was extremely useful and should be part of system validation in the future.
