AD collector: repairs in 2018 and mechanical considerations

AD Electron Cooler Consolidation Review

26/03/2019

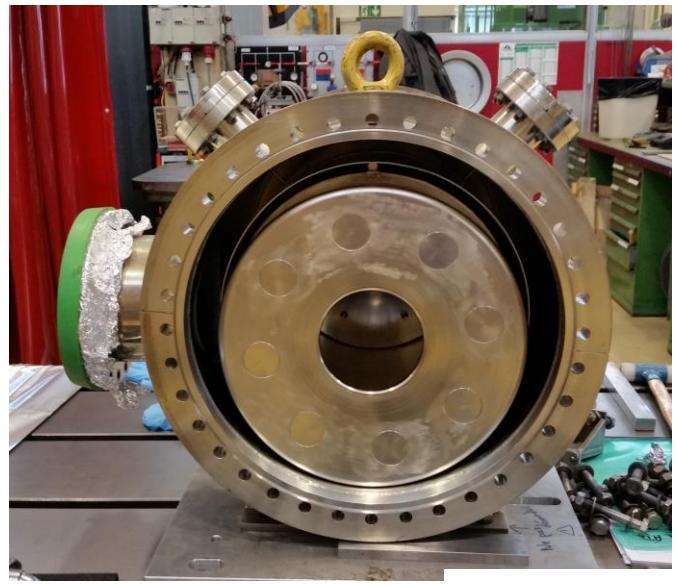
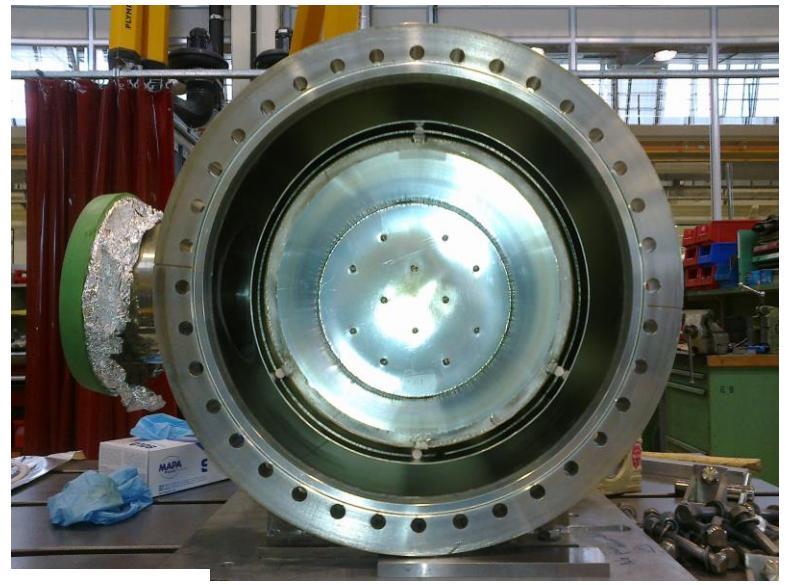
- 23rd July 2018: water leak to vacuum in the AD collector, replaced with a spare unit
- 6th September 2018: same issue to the spare collector.
- 21st September 2018: original unit repaired at the EN-MME workshop and made available to BE-BI
- 28th September: leaking spare unit replaced with repaired original collector

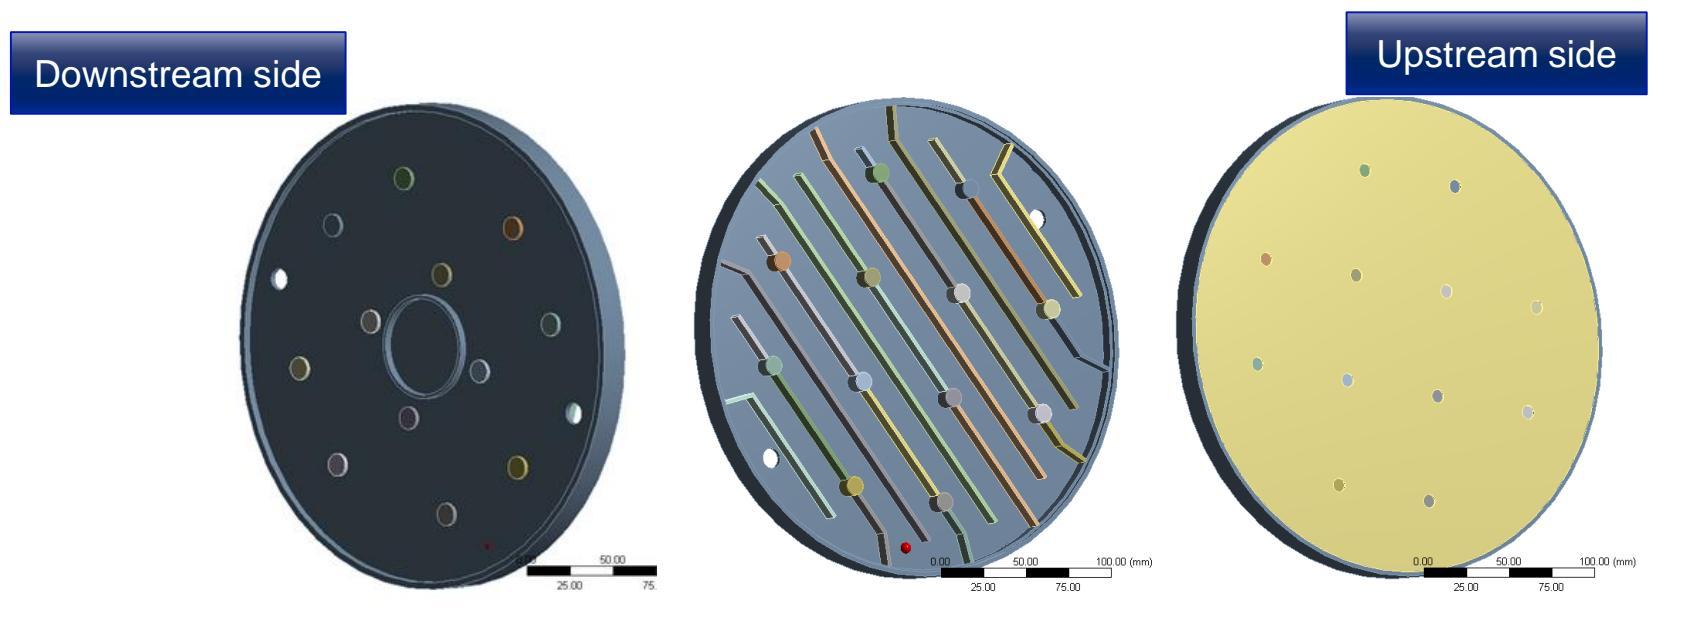
Collector design: end cover

- Two-walled cover, walls made of 316LN, welded circumferentially (upstream side: impacted by the electrons; downstream side: not impacted by the electrons)
- Cover is water cooled, at a pressure of 3.2 bar
- Cylindrical stiffeners added to decrease stresses and deformations on the two walls
- Stiffeners are EB-welded to the two sides of the cover (12 welds per side)
- Material of the stiffeners could not be determined with certainty (austenitic stainless steel, but which one?)

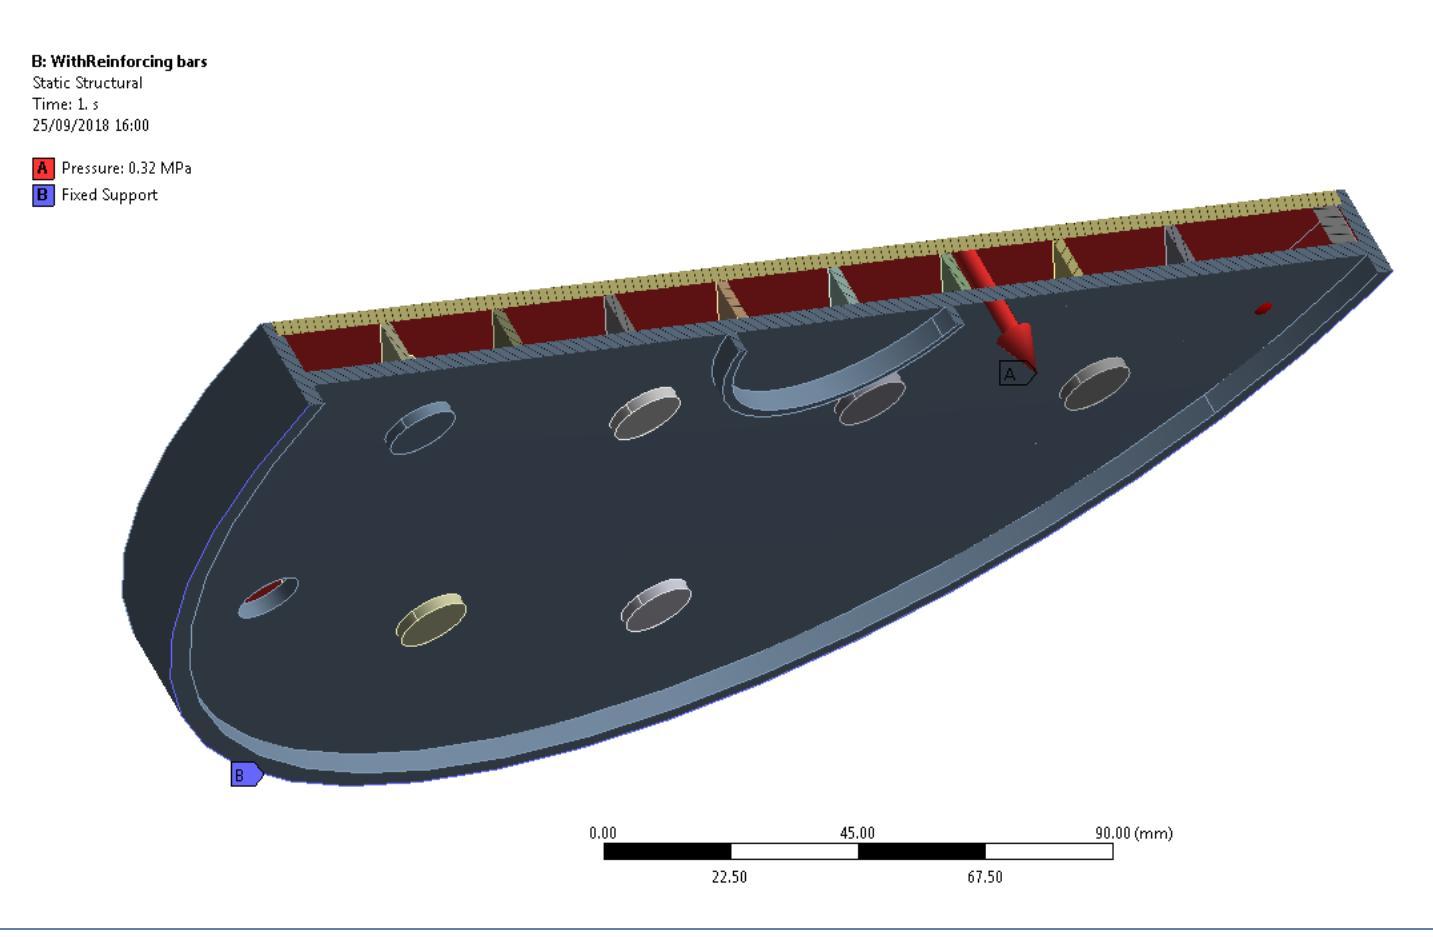
- Weld penetration assumed: 1.5 mm (original welds)
- 3.2 bar water pressure

Cover deformation in the order of 0.5 mm

Safety factors on stiffener welds not very reassuring, considering that only water pressure is taken into account and room temperature properties considered...

Comparable stresses on both cover 	Top Cover/Bottom Cover	10	5
sides and on all stiffeners	Top Cover/Outer Pin	67	37
 Lowest safety factor is found at the position where the leak developed 	Top Cover/Inner Pin	83	47
	Bottom Cover/Outer Pin	95	38

- Decision to repair all the stiffeners/cover welds on the accessible side
- Weld repair duration: 1 day (in total ~1 working week for disassembling, leak detection, welding, reassembling).
- Weld penetration depth: 2.5 mm (the old one was 1.5 mm)
- Electron beam welding parameters:
