Update on activities

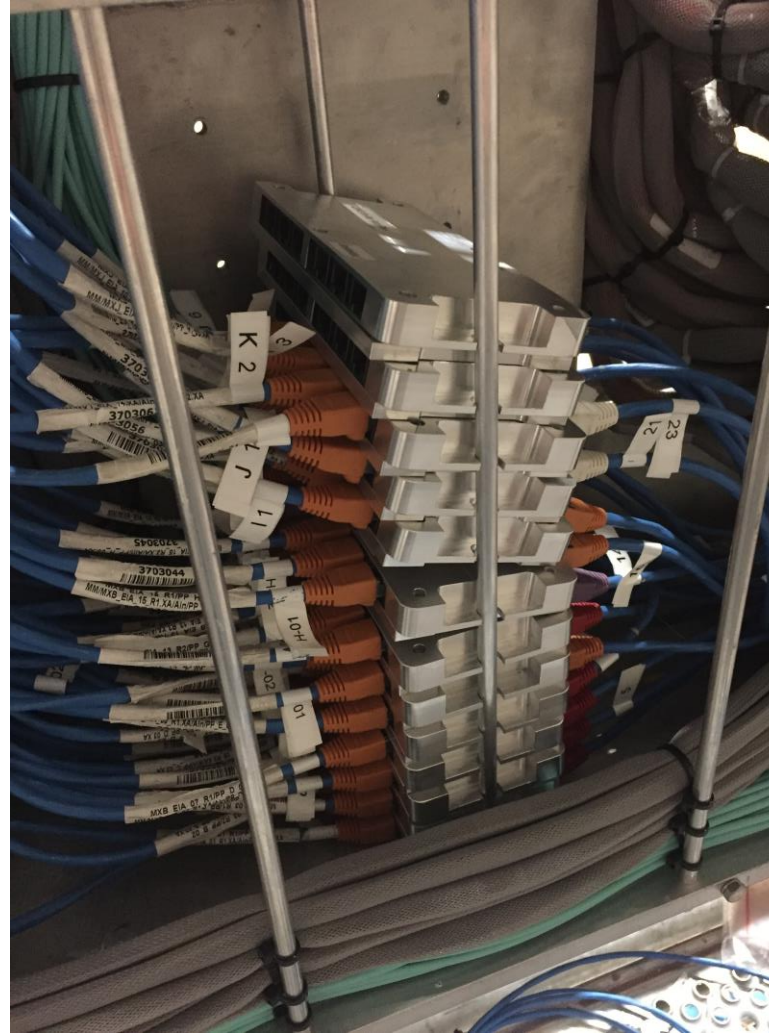
Isolation of one repeater with two foam spacers .

Run position of repeaters with both foam spacers at the bottom .

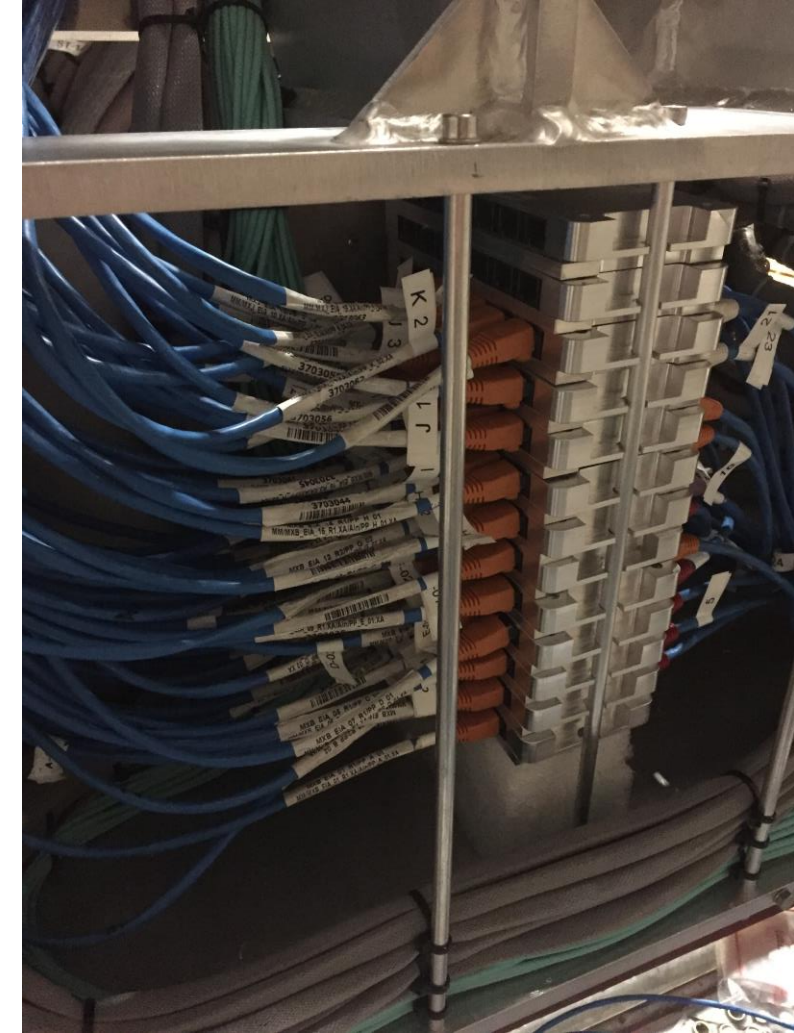
Cables a bit short for the upper four repeaters .

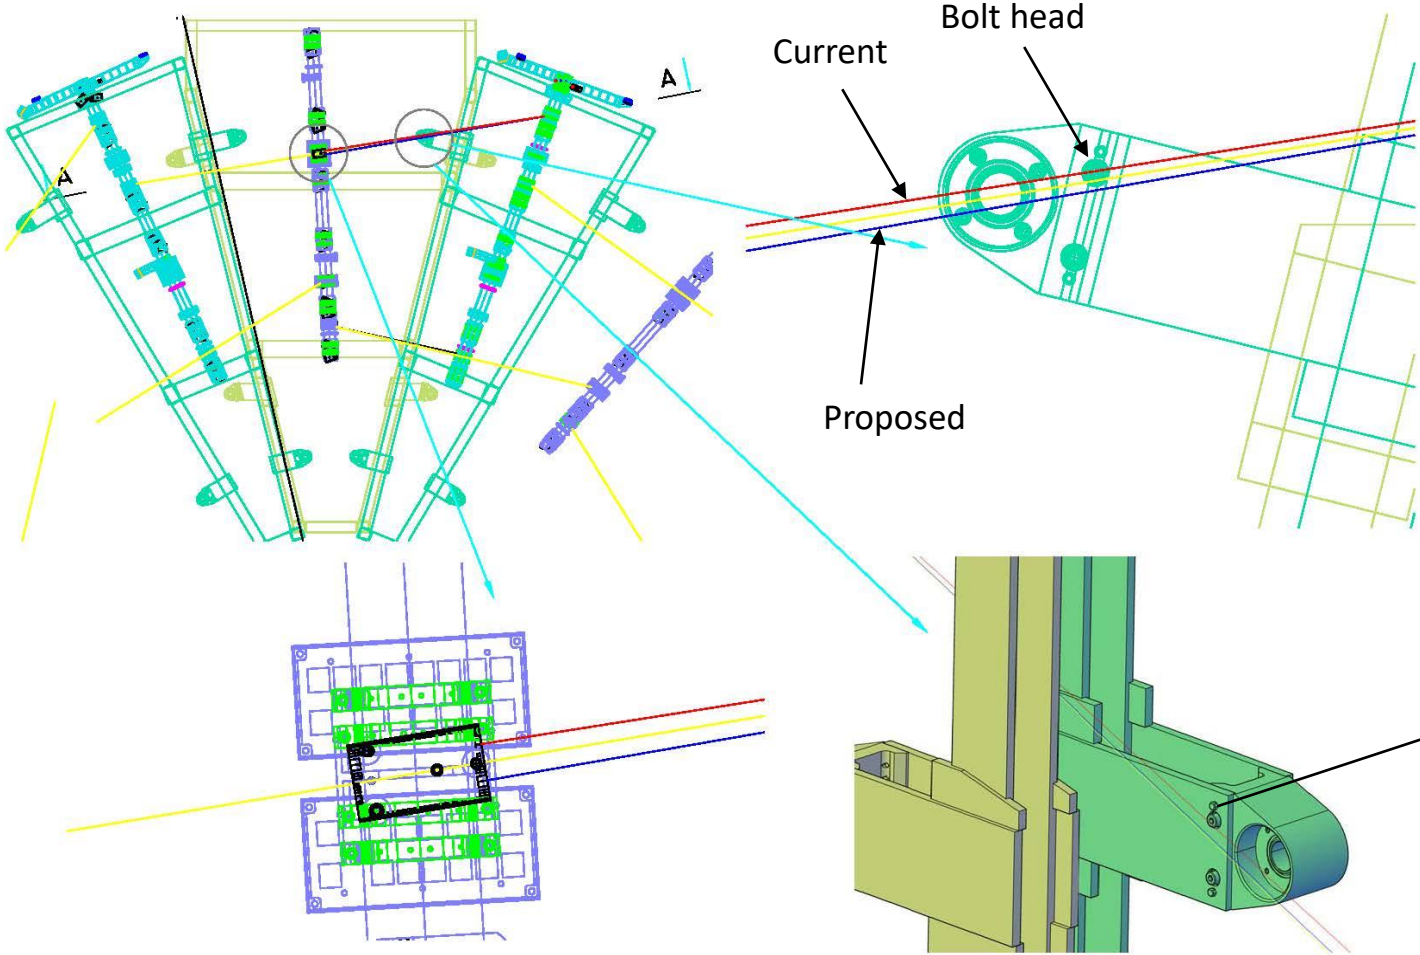
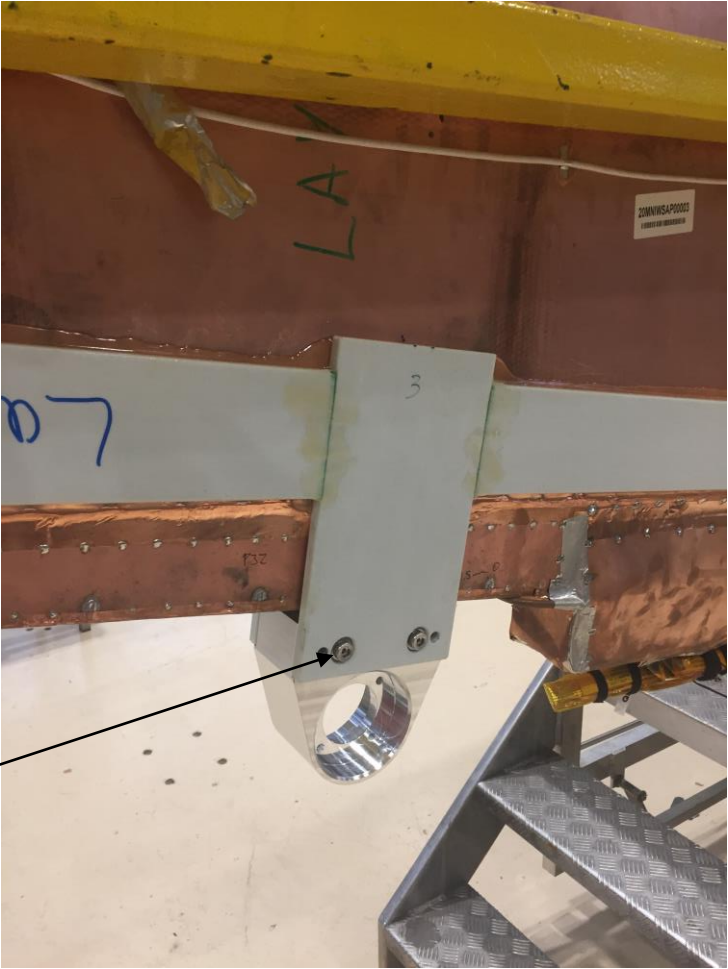
Potential problem with azimuthal line.

Small distance (about 3.5mm) from L-S azimuthal line to the bolt head. Replace D-BCAMs on all small bars with the different color ones.

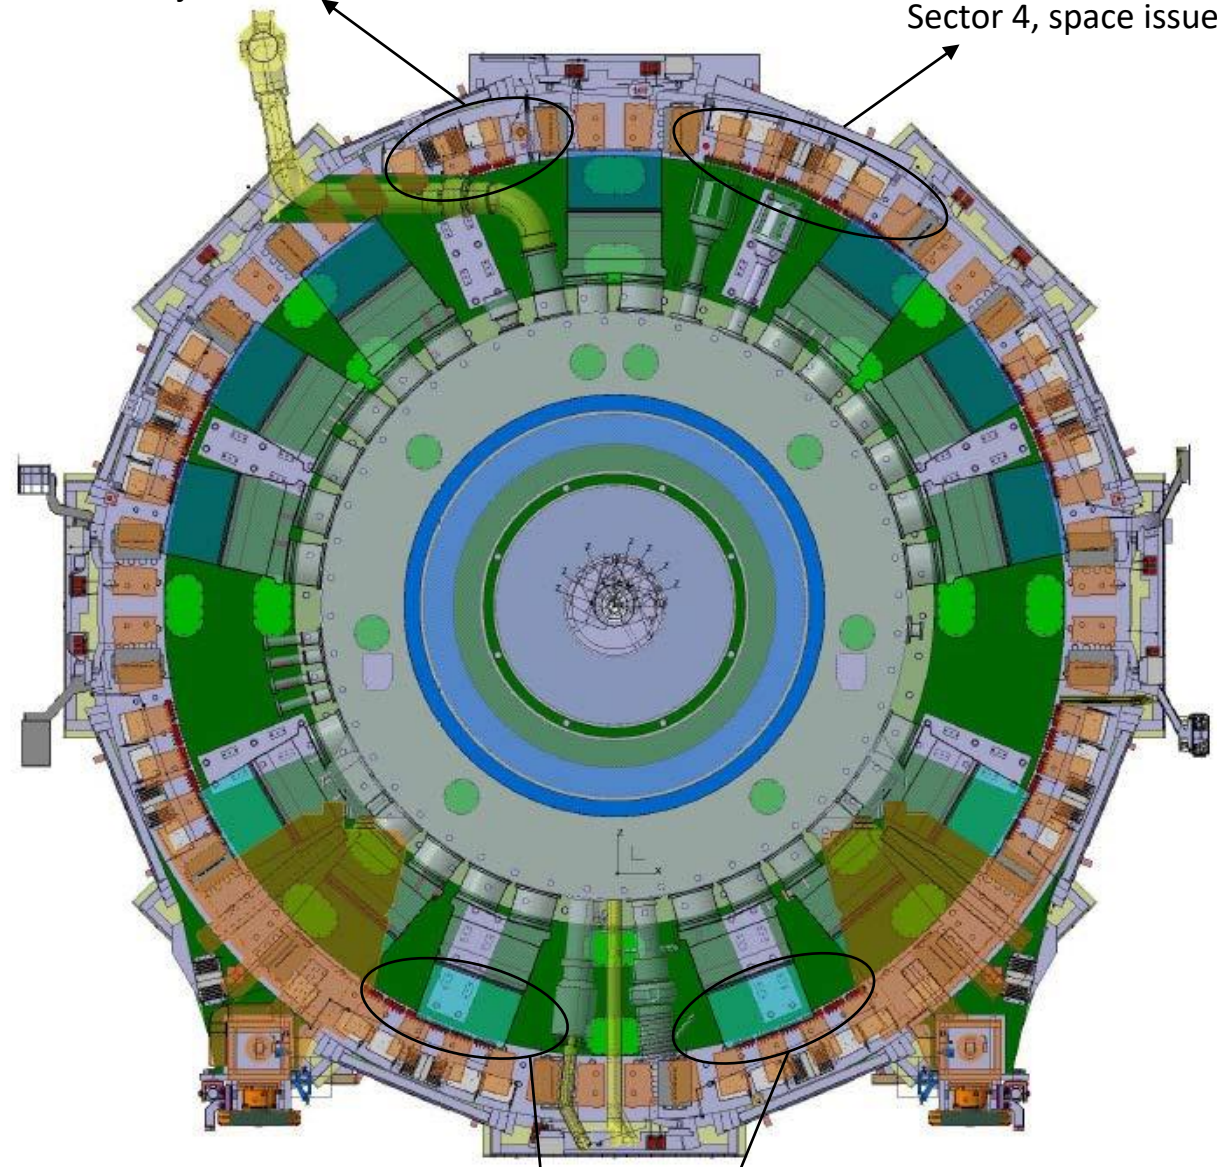
Sector 4, space issue

Sector 6, missing two injectors

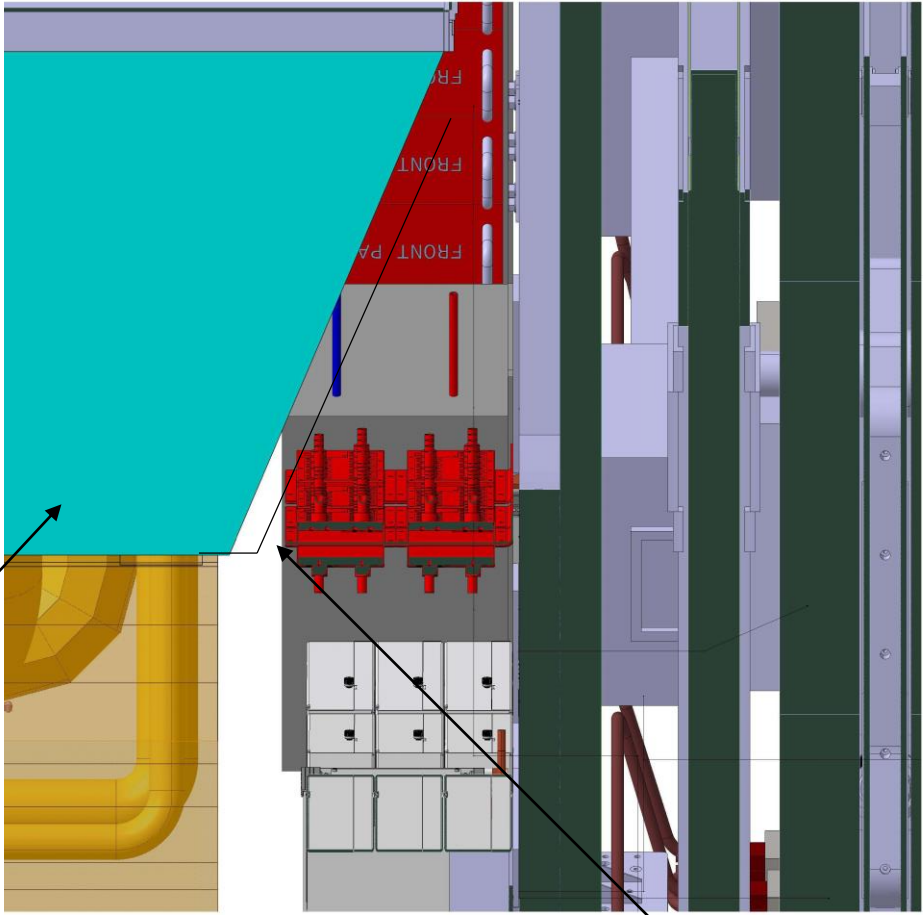
Protecting cover in sectors 12 and 14 as of today

Covers in two sectors, 12 and 14, interfere with injectors. Will be rebuild by the calorimeter team.
