Report: 24

Activity: SPS

*Chiara Pasquino,
Meeting 02/03/2020*

LS2

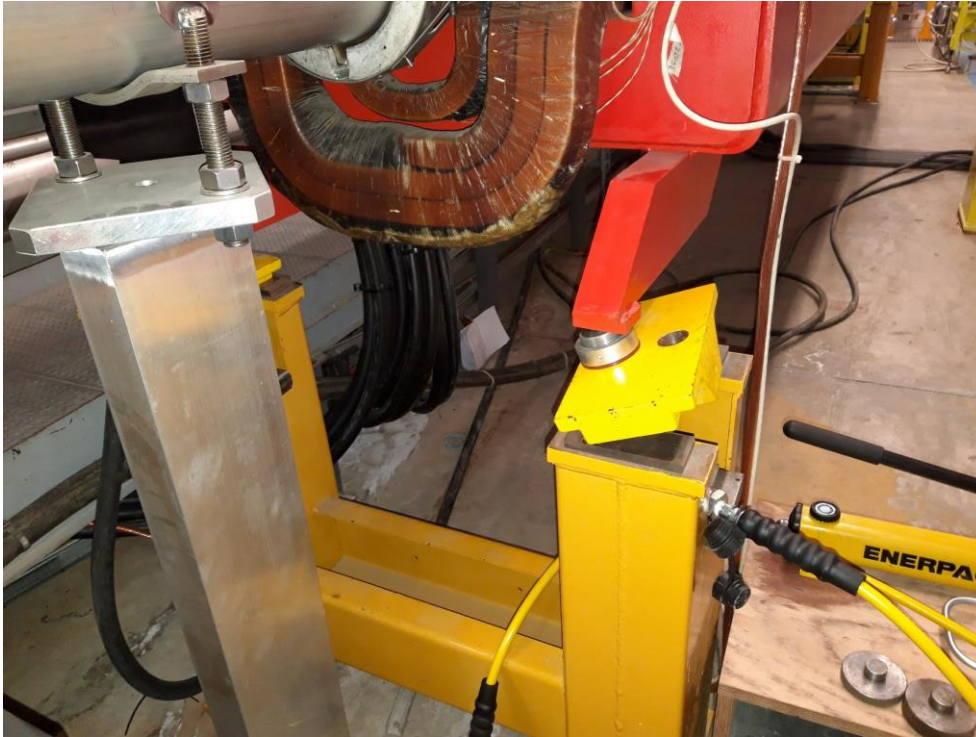
TT66 – HiRadMat
Survey smoothing
campaign..
Sector vented, flanges
disconnected, waiting for
different type of supports
from MSC to replace the
old ones. 4 magnets
involved in this
exchange.

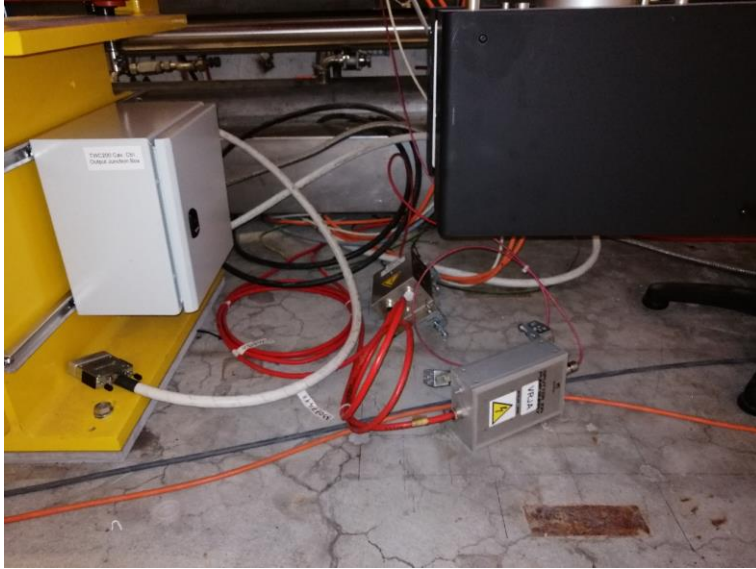
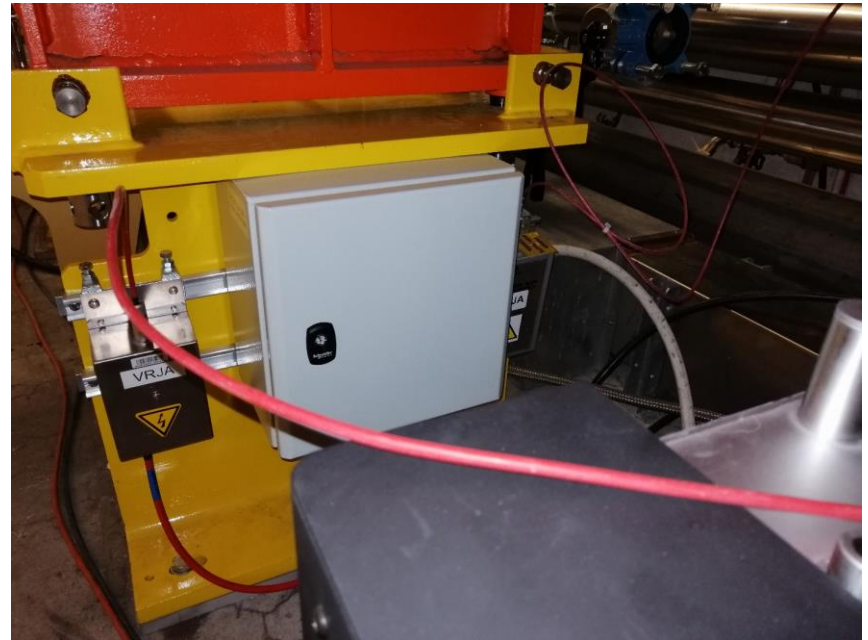
ION PUMPS AND SAFETY..

Abel reinstalled them, BE-RF is warned about it.

Position of the ion pumps local boxes discussed in situ with integration and BE-RF... still someone removed them while being powered!

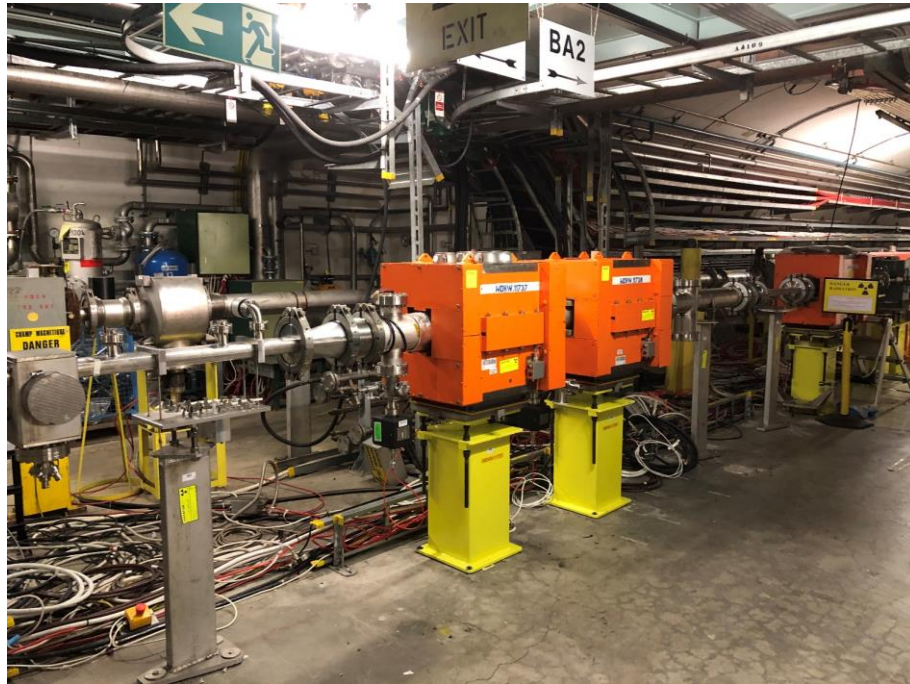
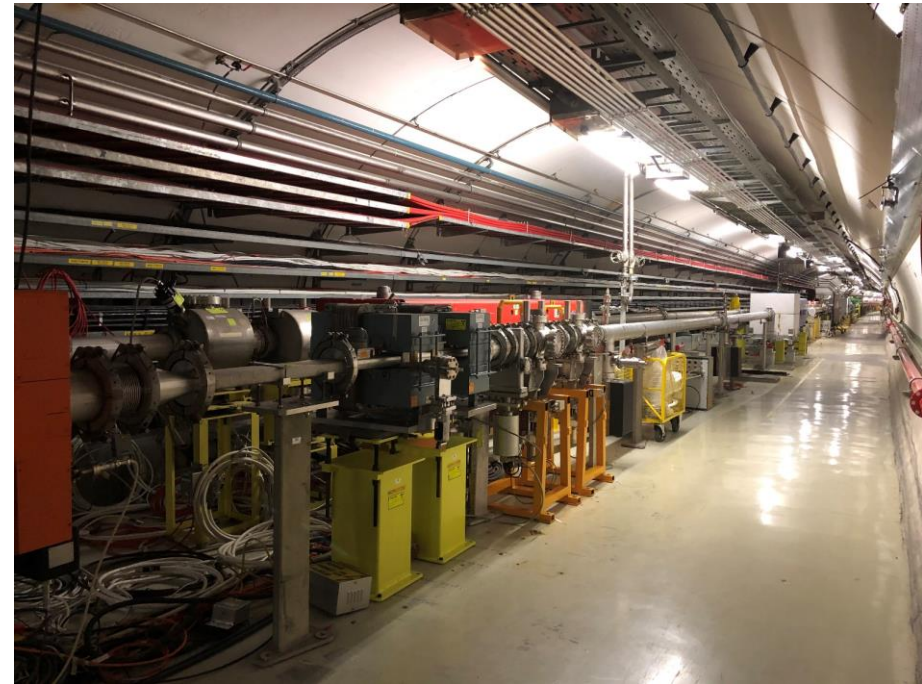
LSS1 installation

- S135 – mechanically closed, pumping down (leaks!)
- S136 – sector valve position to be modified then ready for final connection
- S142 – vacuum drifts and instrumentation are installed, waiting for final alignment of the mask to complete the mechanical installation

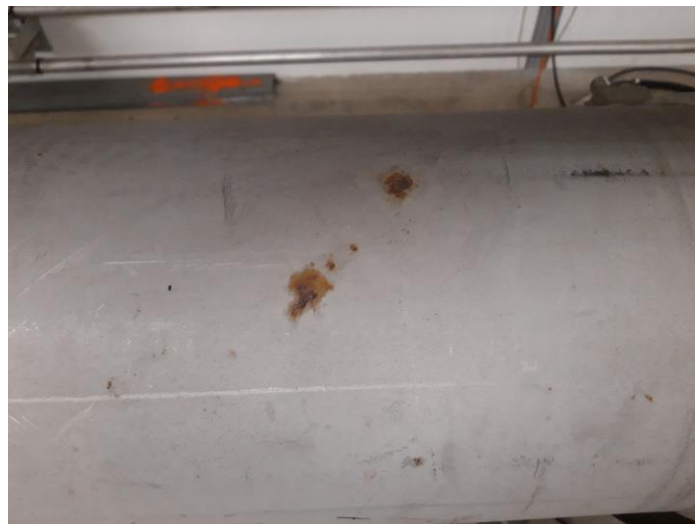
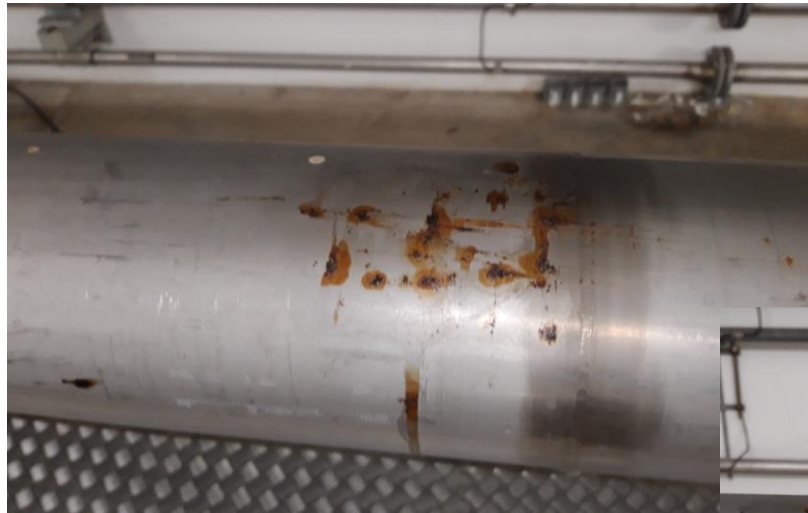
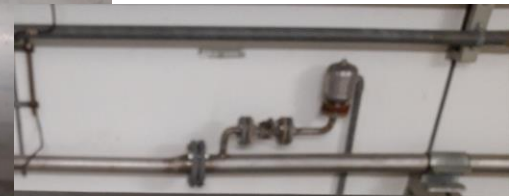
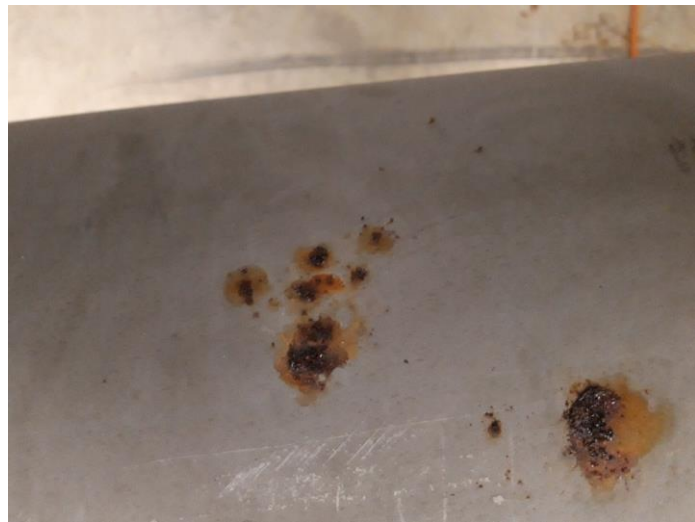
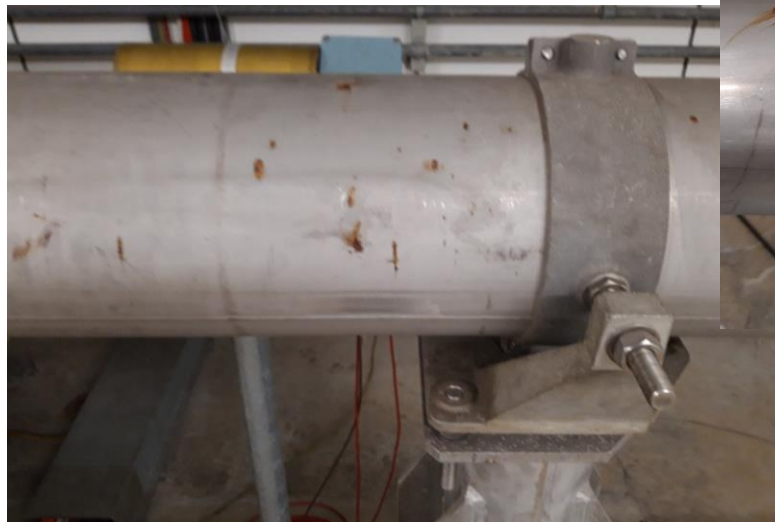
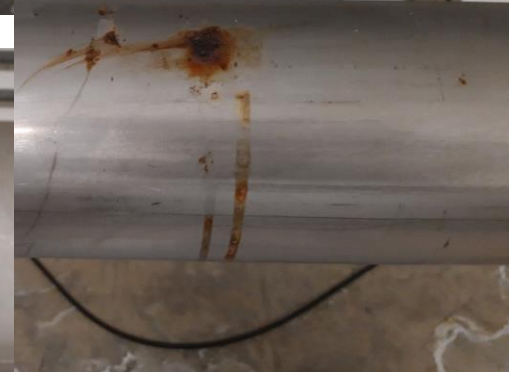
TDC2 tunnel inspection

- First Collimator exchange;
- Exchange of the vacuum chambers downstream both sets of splitters due to corrosion (≈ 10 chambers).
- Needs an ECR cause some chambers have been welded in place at their first installation.
- Sector with Splitters 2 will have to be vented (risk of opening existing varnished leaks).

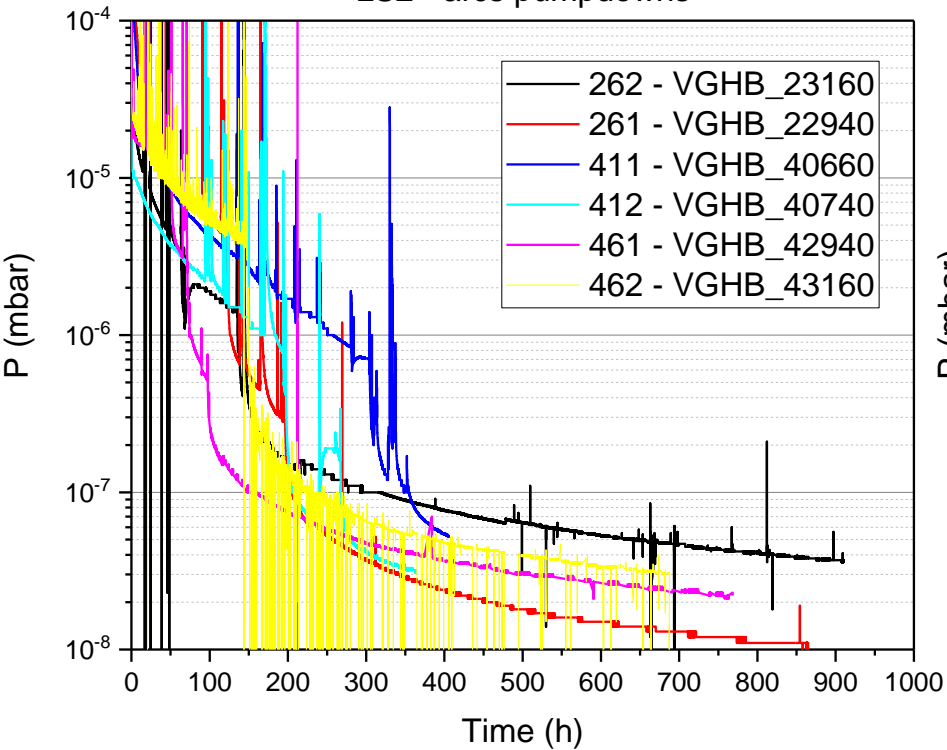
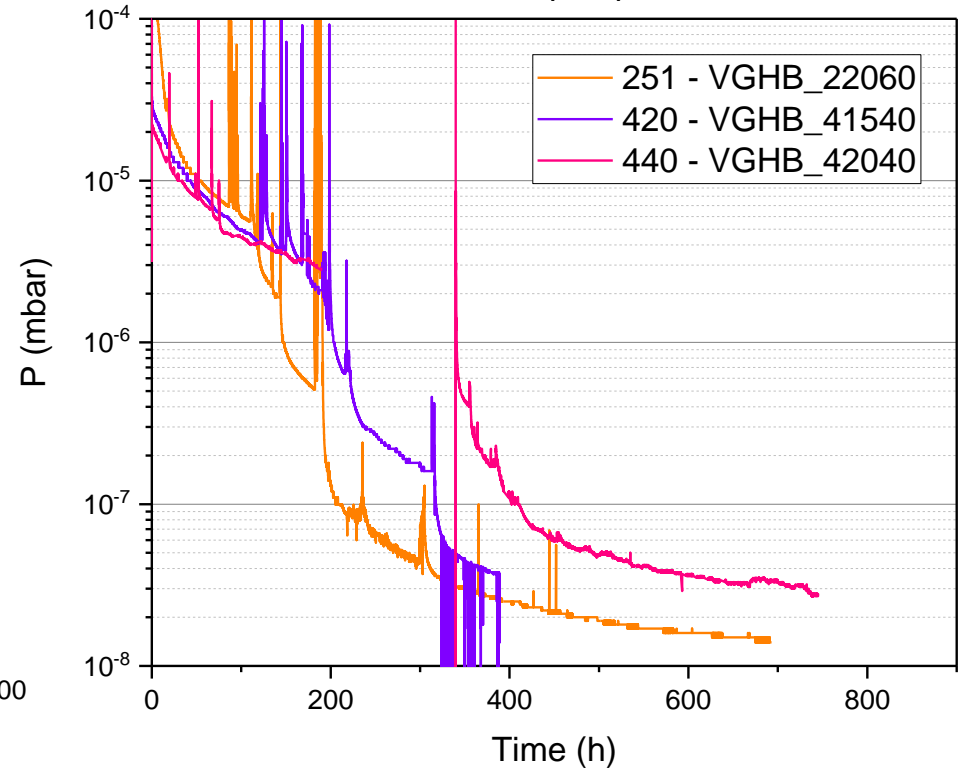
Lengthy pumpdowns (ion pump flashing) – arcs/DS are behaving all similarly.

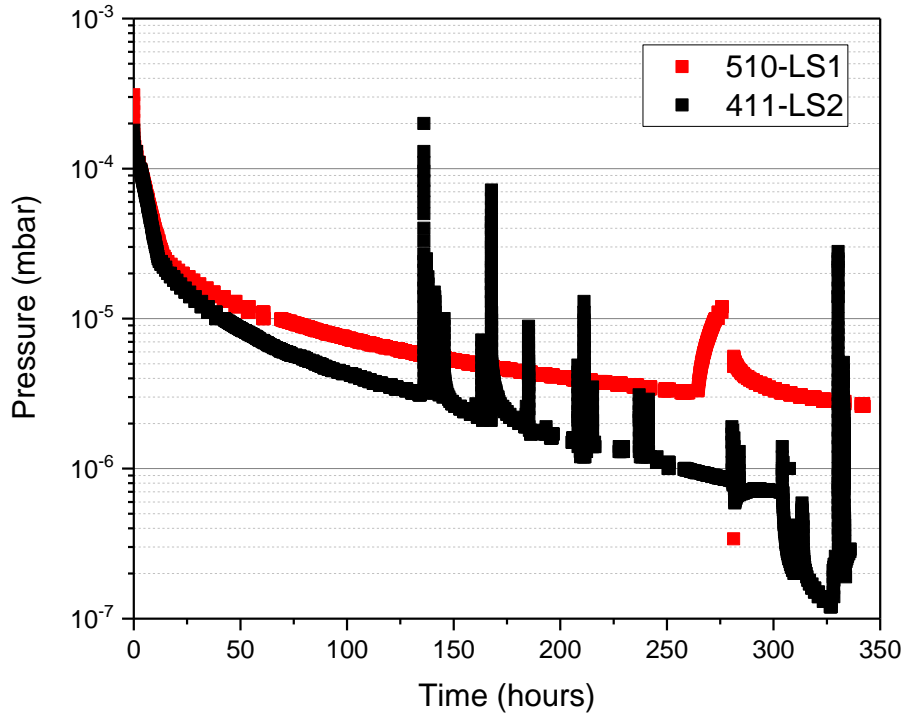
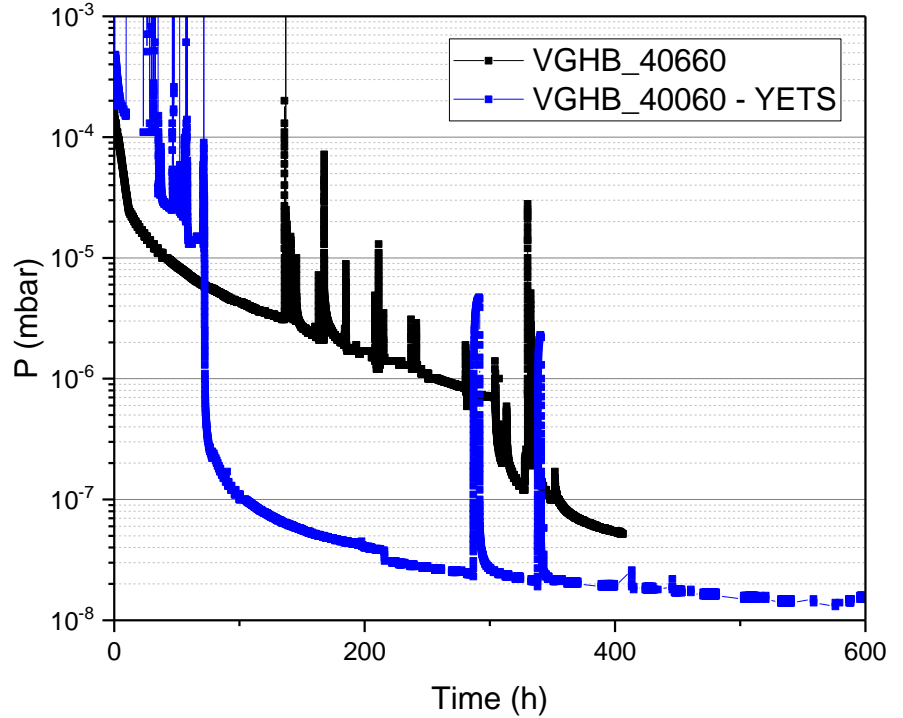
Lengthy pumpdowns in LS1 too, very similar pumpdown considering we are comparing 1 arc with an half arc (double pumping speed).
For info: 510 – LS1 1 year exposure;
411 – LS2 3 months exposure;

Longer exposure --> difficult flashing.
