VSC Follow-up meeting 6th of July 2020

LHC Machine Experimental Beam Vacuum Project

On behalf of the experimental team
Josef Sestak

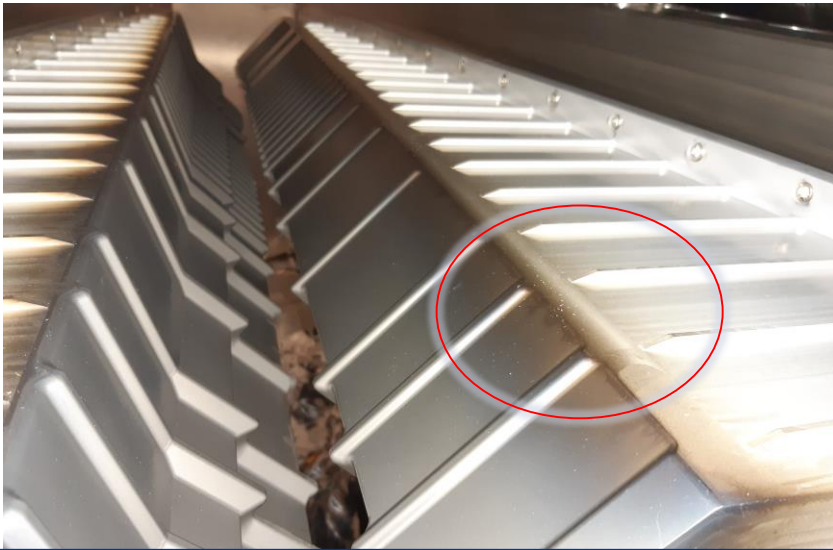
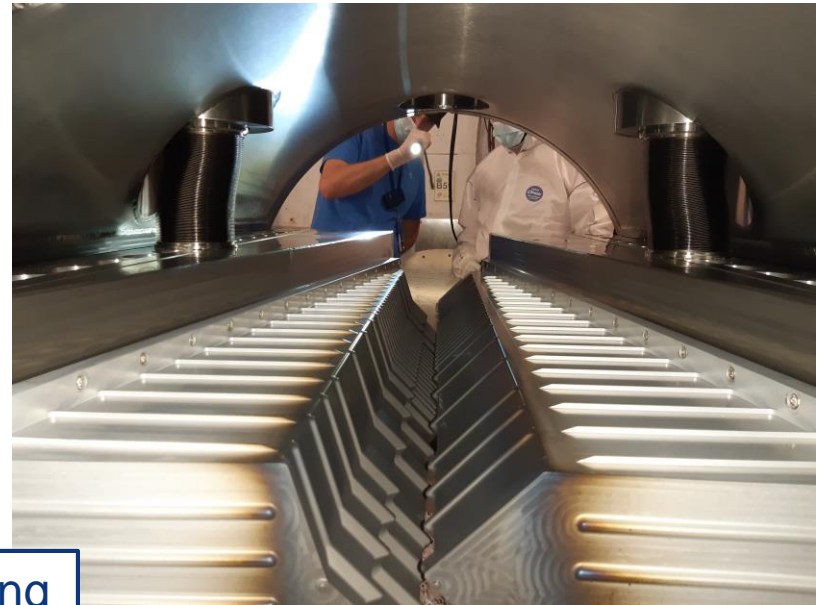
- Removal of the operational supports inside the dipole.
- Assistance with post-installation cleaning of the dust from RF foils (performed by Nikhef).

Dust-size particles from the installation tooling

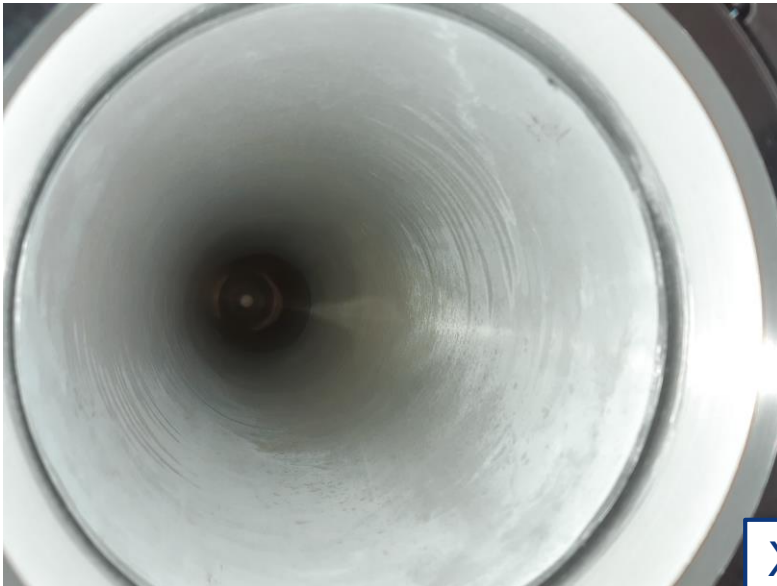
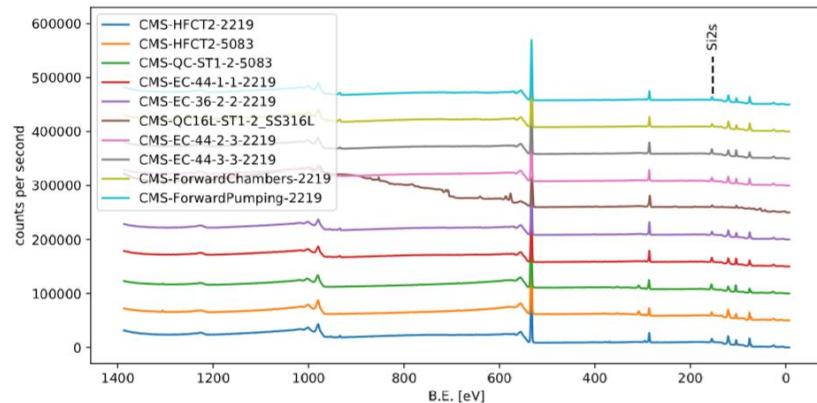
Figure 1: survey spectra for all samples, indicating Si peak at 153eV binding Energy

Surface marks observed on local parts of both HF-CT2 and End-cap chambers (etching mandatory)

XPS on witness samples shows presence of Silicon (Si) on the surface $\approx 10\%$

- Preparation for the etching operation before the NEG coating (applicable for End-Cap and HF-CT2 chambers).
- Tooling for circulation etching being prepared by BVO.

Etching of 1st HF-CT by week 30 – then NEG coating

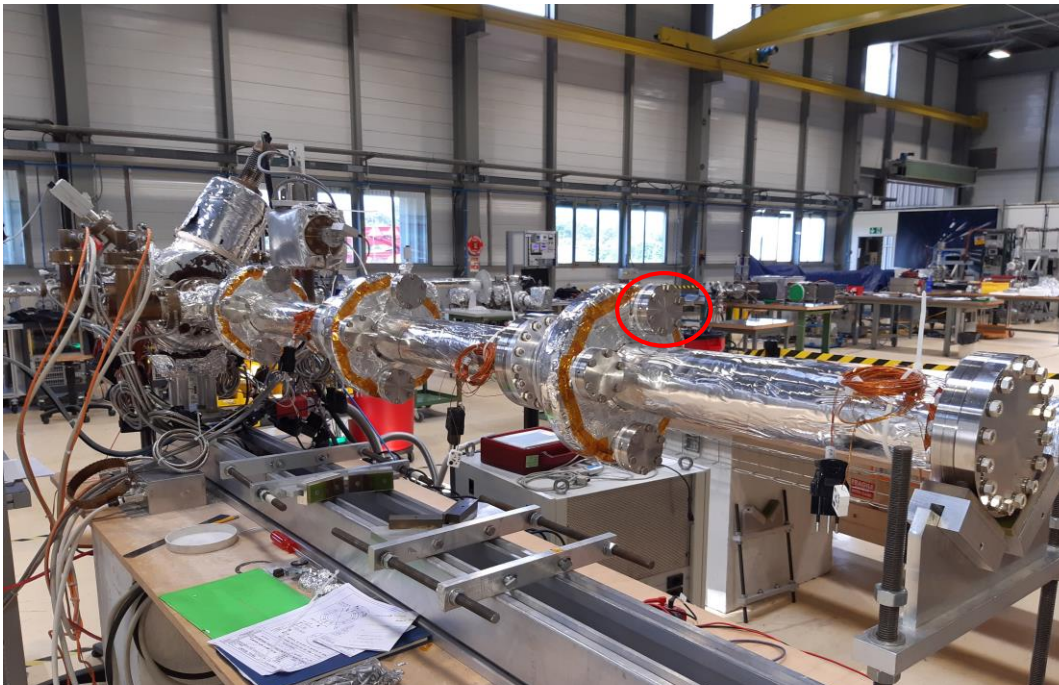
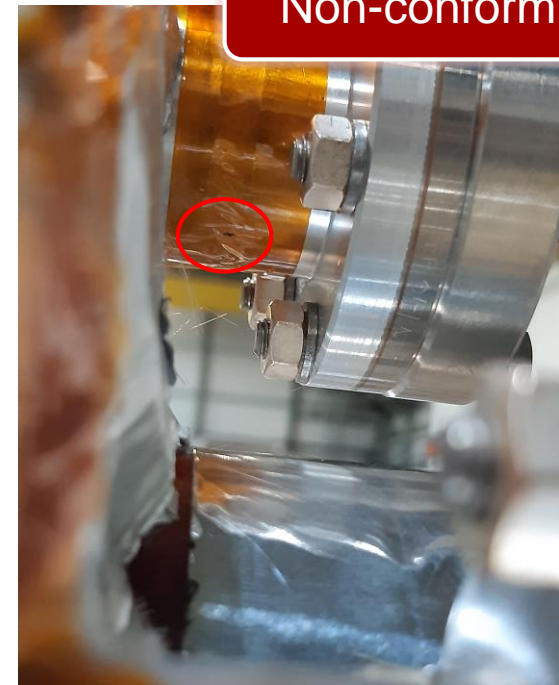
Non-conformity

Leak $1\text{e-}8 \text{ mbar}\cdot\text{l}\cdot\text{s}^{-1}$ observed on the weld between the CF40 bimetallic flange and body of the chamber. Two chambers OK – continuing for the test.

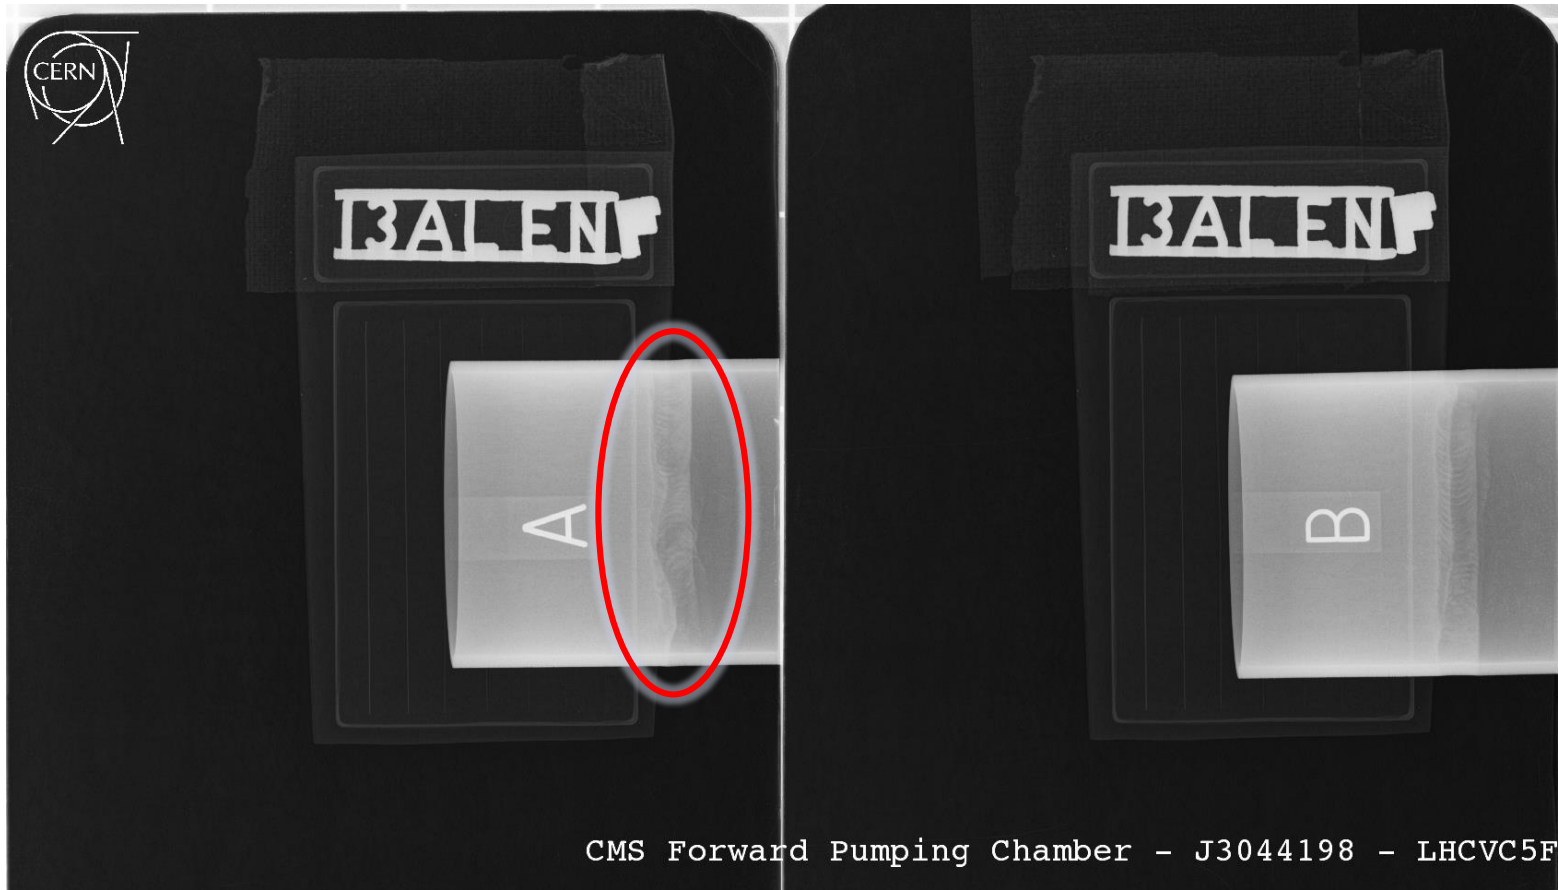
Weld was not repaired during the production however probably experienced problem with arc stability (intermediate leak detection did not revealed the issue)
Reparation ongoing – EN MME (AP) – chamber will be likely spare one.

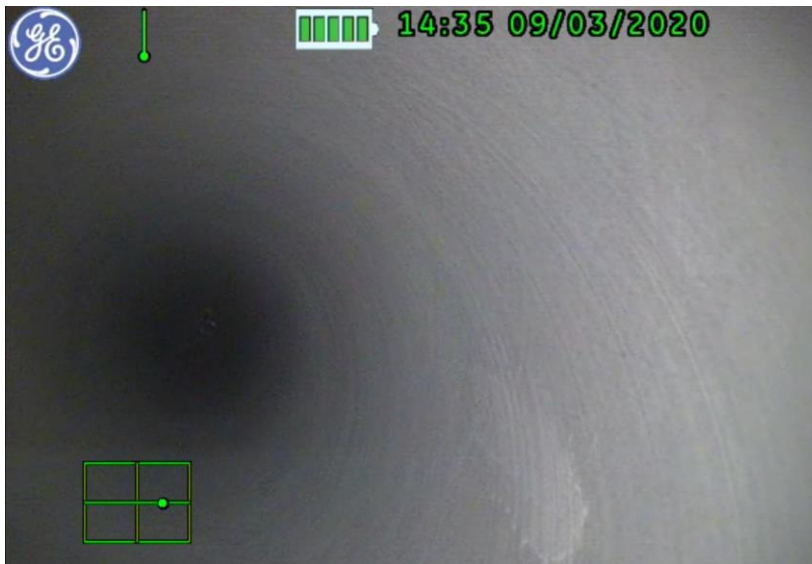
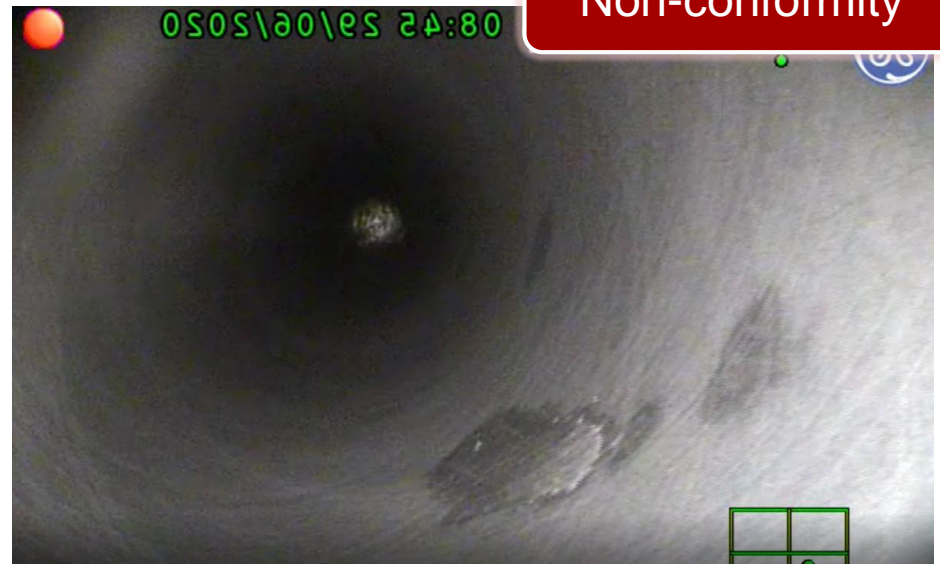
Inspection after NEG coating showed a discoloration on a light mark observed before NEG coating ($\approx 2\text{m}$ inside on the Beryllium part) – **no peel-off**.

- NEG acceptance test ongoing – **followed by another endoscopy;**
