Front-End Board Version 1 or Version 2 ??

23<sup>rd</sup> Jan 2020

Mark McLean

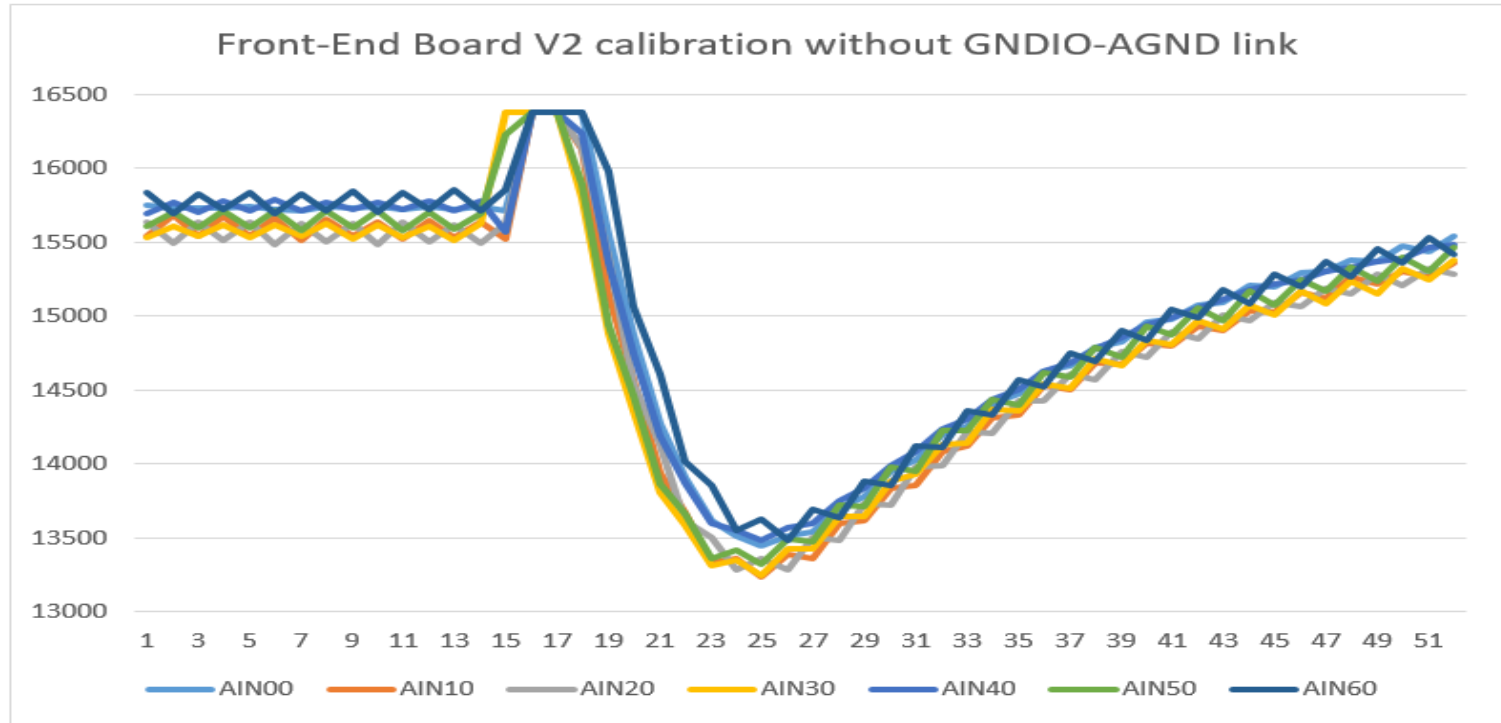
Calibration waveforms

# Oscillating regulators

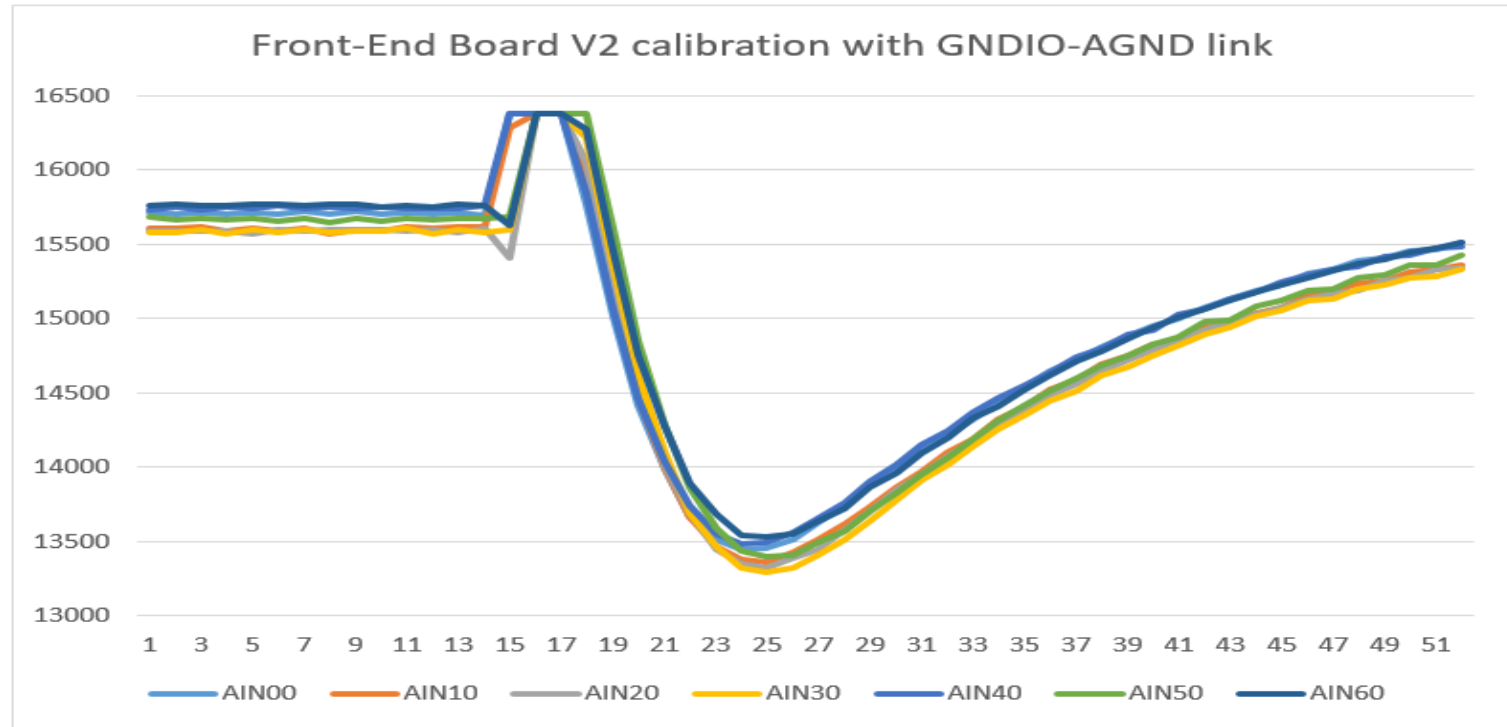
Calibration waveforms

# Oscillating regulators

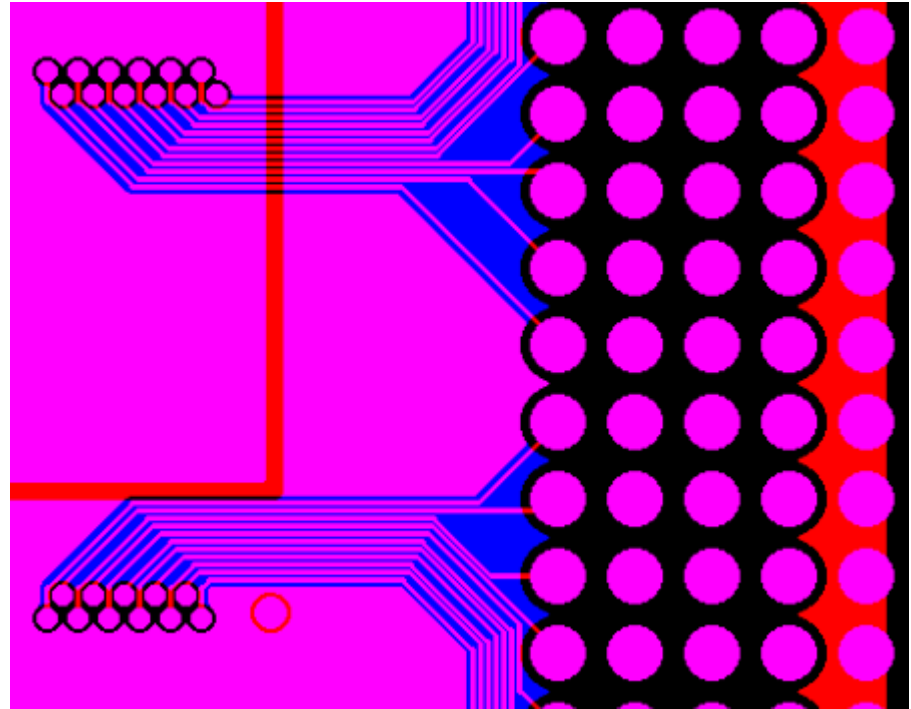
- It turns out that in V1, all the signal tracks were on the top or bottom layers of the board and were adjacent to a ground plane.
- But in V2, half the signal tracks are on a buried layer and the adjacent layer is a power plane.
