Front-End Board Version 1 or Version 2 ??

23rd Jan 2020

Mark McLean

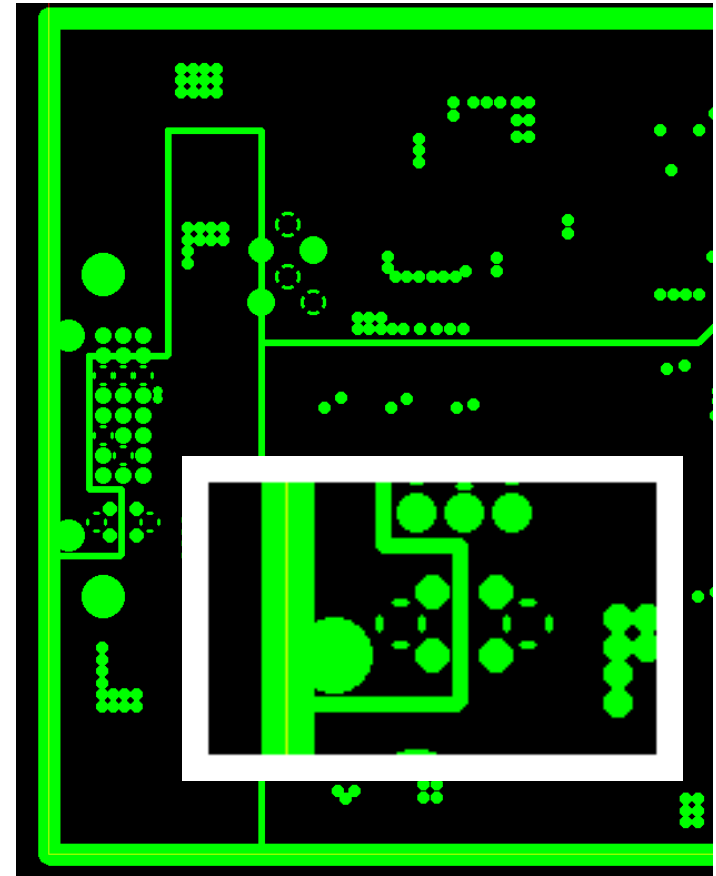
Oscillating regulators

- V1 had an error which caused AGND and GNDIO to be connected. This made more capacitance available to the regulator and reduced the amount of noise at the power input connector.
- Thus the amplitude of the noise spread to the rest of the board was reduced in V1, and the problem was not noticeable.

- Changes needed to V1 are:
 - Change the oscillating regulator to LT1962EMS8-5
 - Remove the GNDIO-AGND connection but add a link
 - Remove the trimmer
 - Make the LEDs different colours
 - R43 = 309R
 - C312 = 10k resistor
 - R80 = 1k
 - Q1 and Q2 replaced with BCM847
 - Ensure LT1964BYP used
 - Make provision to connect the ASIC pad to -2V

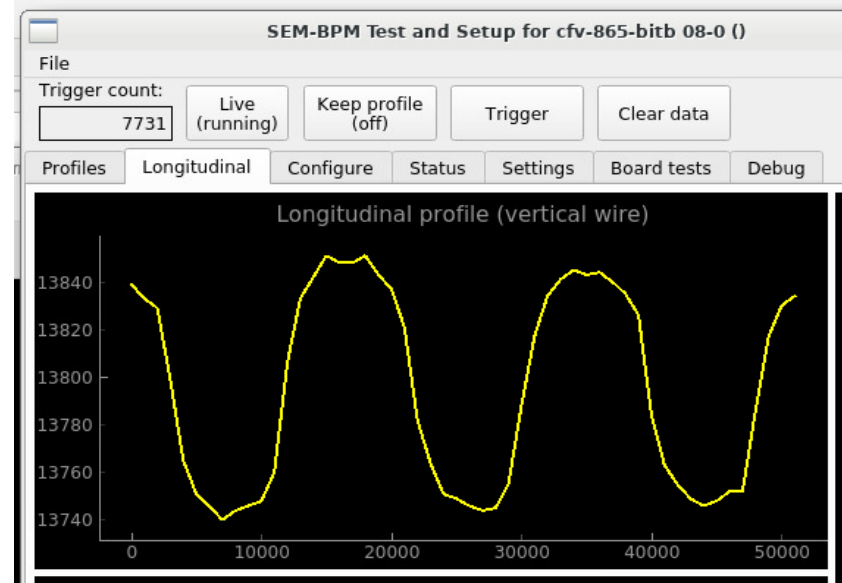
Nature of remaining noise

- The big clue came from comparing the amplitude of the signal from different inputs, particularly while the cleaner was using a vacuum cleaner nearby!

Input	PCB Layer	Noise amplitude
AIN01	Un-bonded	<10 bits
AIN20	Layer 1	20 bits
AIN21	Layer 10	100 bits
AIN35	Layer 10	100 bits
AIN36	Layer 1	30 bits
AIN58	Un-bonded	<10 bits

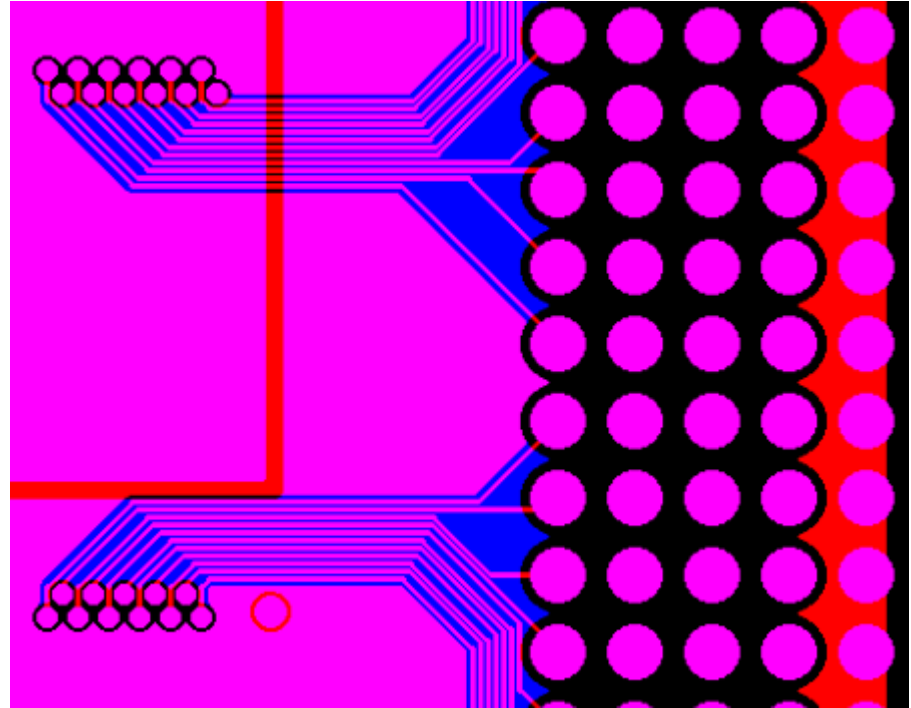
Nature of remaining noise

- It turns out that in V1, all the signal tracks were on the top or bottom layers of the board and were adjacent to a ground plane.
- But in V2, half the signal tracks are on a buried layer and the adjacent layer is a power plane.
