PS Hardware Commissioning

HWC week 48

HWC week 49

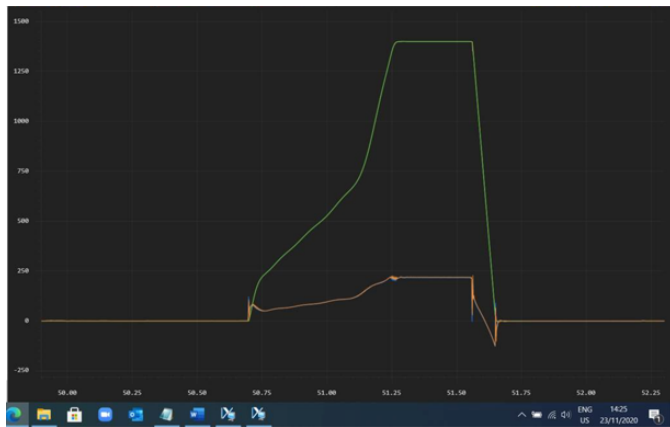
W8L function

- First time pulsing all circuits together.
- Some MU have a noise coming from the Low Energy DHZs (backleg winding). New insulation type is more flexible and hits the vacuum chamber during MU pulses. Not critical and TE-MSD will work on an fixation improvement.
- Additional strange, bizarre noise, like fast pulsing magnet. Could be identified from the W8L circuit. The programmed function (pre-LS2) has singularities. FGC63 regulation follows the function, which results in big overshoots. No easy fix as this has an impact of the Working Point. To be followed up with SMWG, ABP, and OP

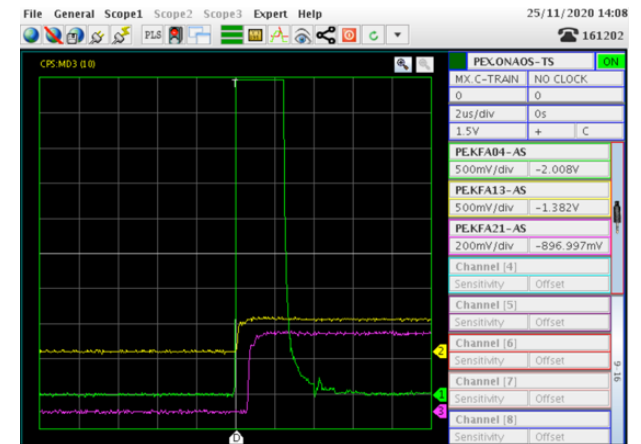
KFA pulsing

- DR KFA4, 13, and 21
 - KFAs are pulsing.
 - KFAs have a minor issue with Acquisition timing.
 - KFA4 Oasis signal saturated. Solved
- KFA45 FESA class ready
 - Update WS
 - DR to be followed
- PS Orbit application
 - Bucket selector is working
 - strange H8 definition on RF user SH16
