Summary project

CW 2

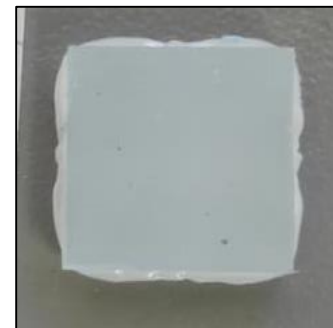
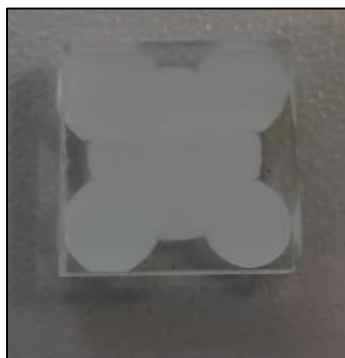
Cured in jig:

Still not sure why

Possible options:

- Shim bends?
- Burr because of cutting? -> edges deburred

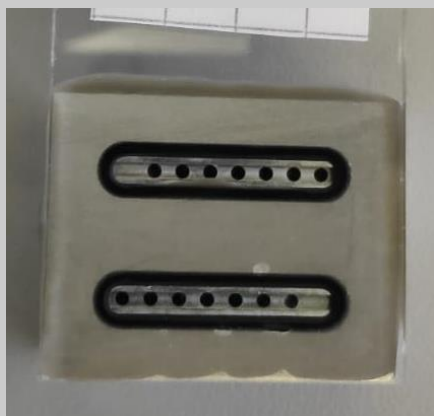
Test 1: Stencil 3; reused connector

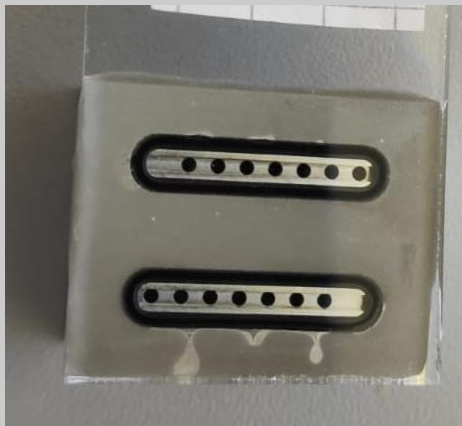
Test 1: Stencil 3; reused connector

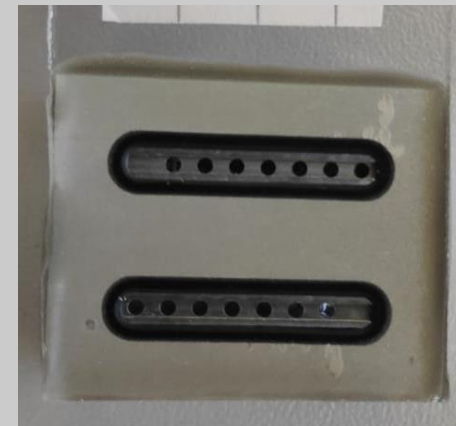
Test 2: Stencil 4; reused connector

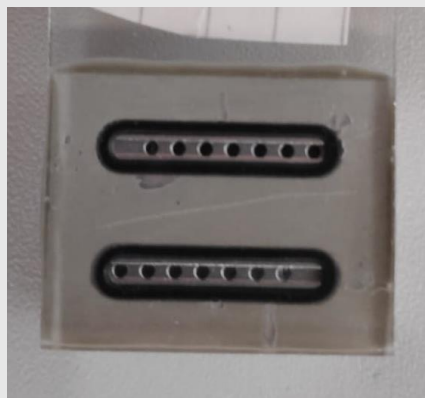
Test 3: Stencil 3; connector sandblasted at 1bar

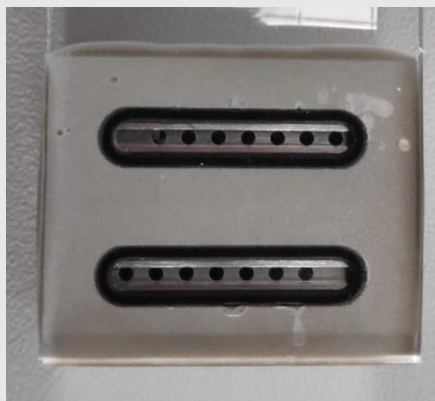
Test 4: Stencil 3; new connector

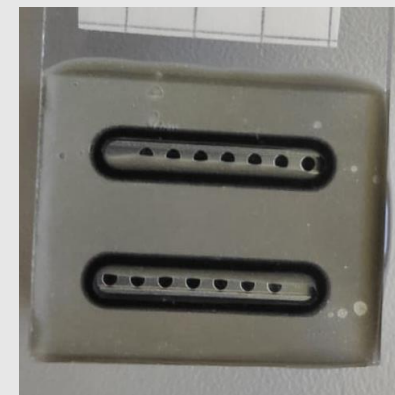
Test 5: 2x Stencil 3, reused connector
