Splice Consolidation:

What we will do: status of main technical solutions.

January 24th 2011

Presented by P. Fessia

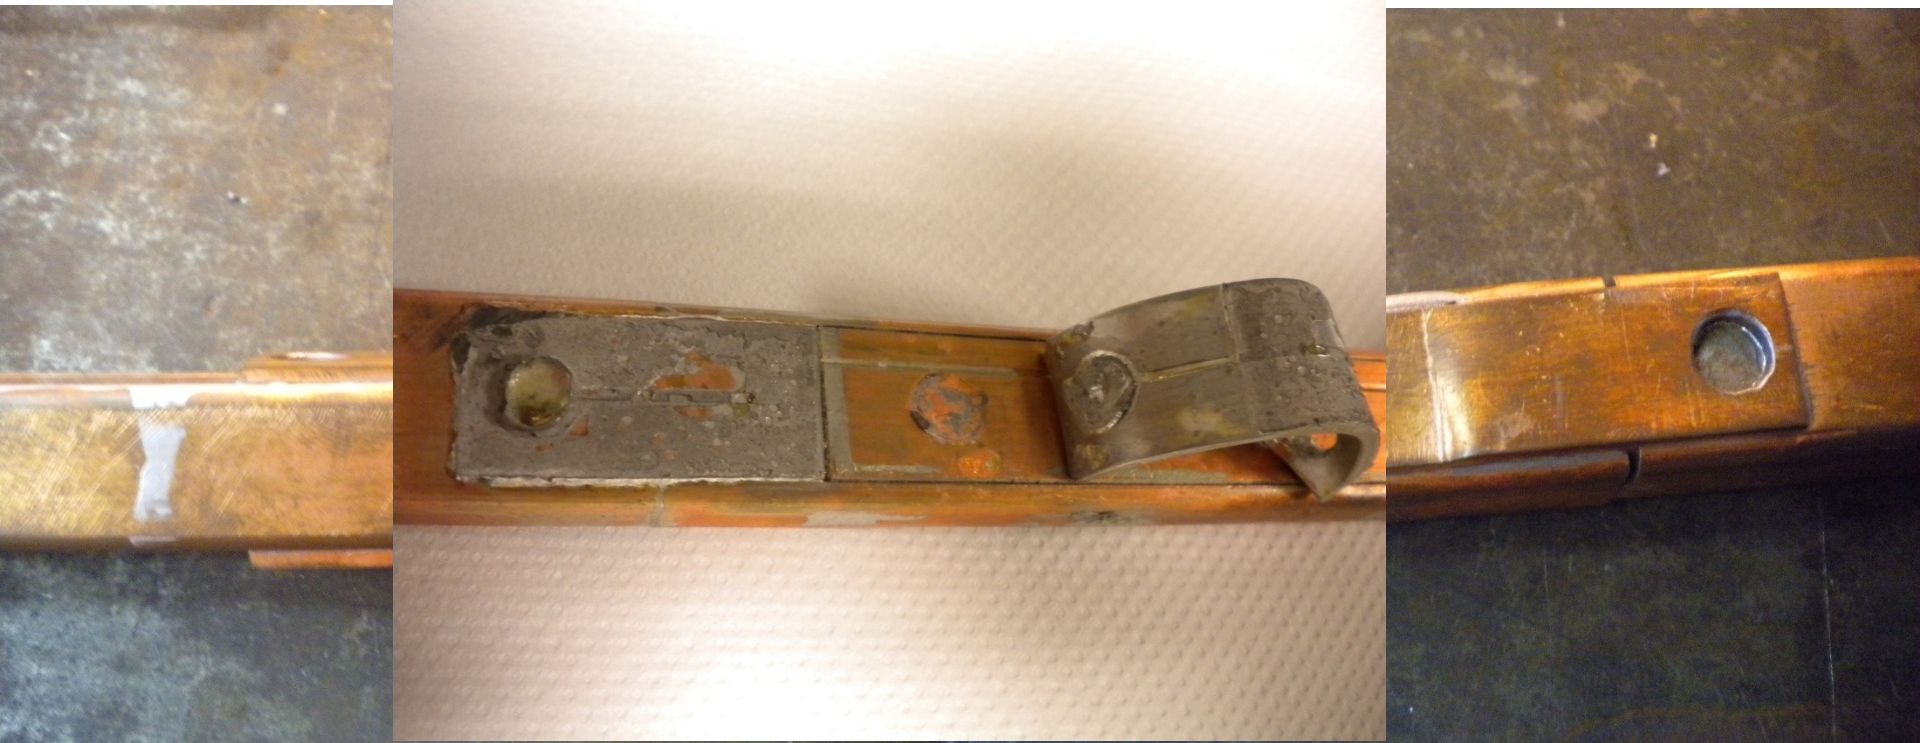
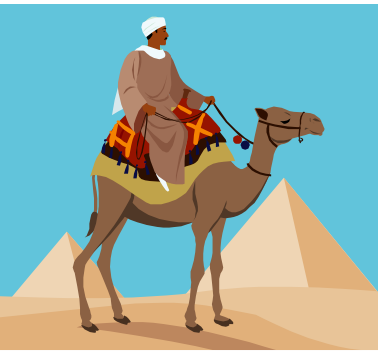
Adapting the shunt to the surface, *Mahomet goes to the mountain*

Interconnection geometrical defects:

- Shift between the surface
- Tilt between the surface
- Superficial irregularities

Interconnection geometrical defects strongly reduce the quality of the fitting between the shunt and the bus bar affecting the mechanical and electrical quality of the joint. This defect is the sum of 3 types of defects

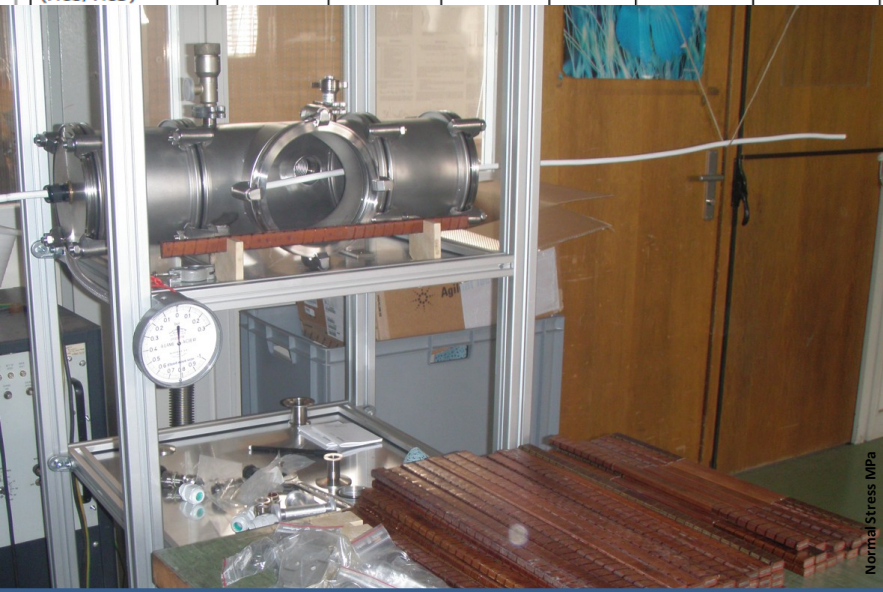
New insulation withstand between 3.3 kV and 6.8 kV a 1 bar He. In next future we will try improvement to increase margin on the lower bound

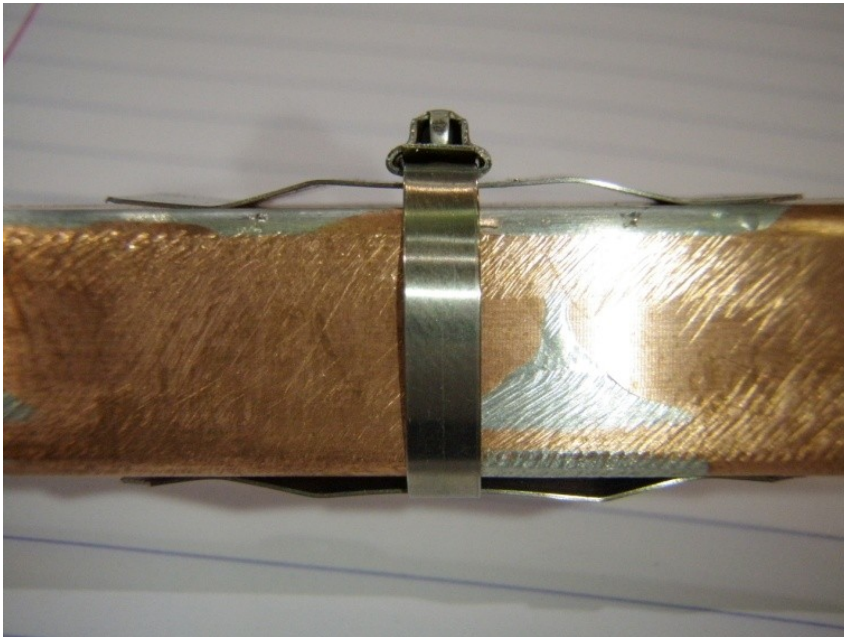
13 kA connection

We would use a steel cable tie with a spring blade the possible longitudinal movement will be blocked by the insulation positioning pads

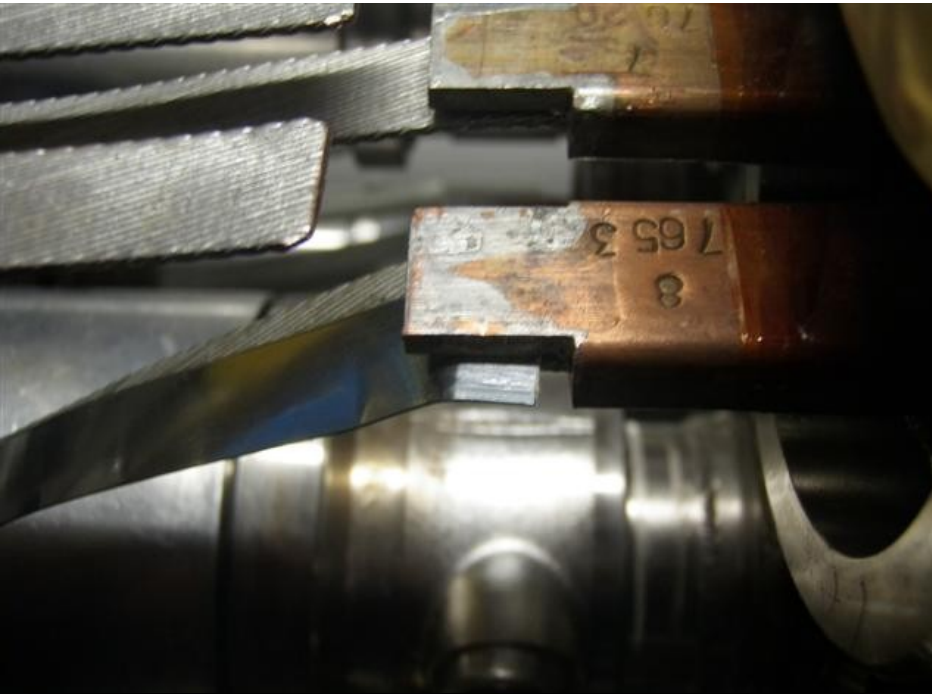
Redundant shunt on quadrupole connection II

Tooling used in the series assembly was pressing on the “tongues” of the bus bar (see marks on left photo) and creating a difference of level that should be machined out i.e. in the γ -ray **1.3 mm**. This would leave only 2 mm of bus bar copper.

Application of redundant quadrupole shunt requires the development of a complete different approach, requiring a different extra production step in the activity and probably not insuring the same quality of electrical contact

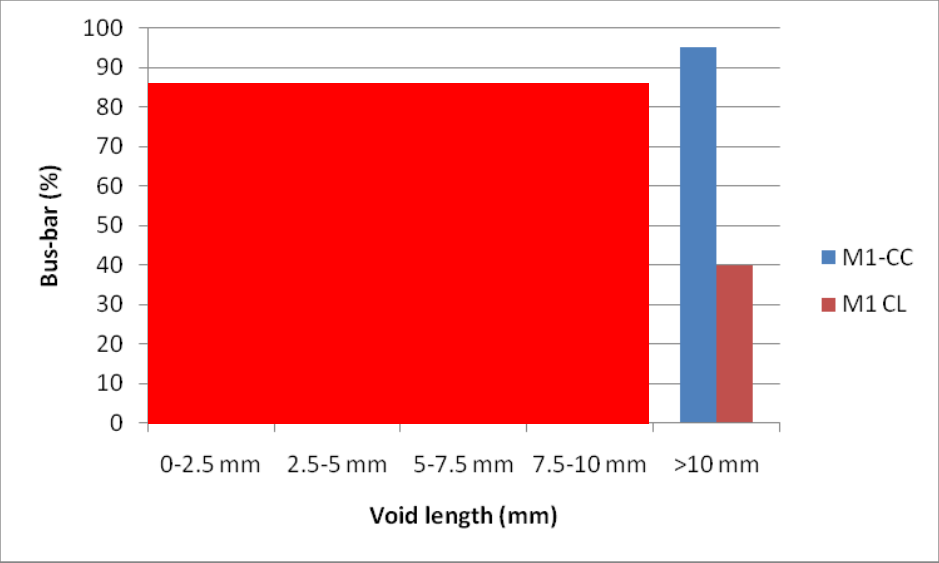
Estimated impact of the optimized soldering process

Data from 21 magnets experiencing problems after 3-4 accident

The void length has been averaged on the two connection sides.

- The overall average of the interconnection that could be affected by the new procedure is about
 - M1 60% CL 5% CC
 - M2 45% CL 40% CC
 - M3 40% CL 8% CC
- Indeed, what it could change is the distribution of connections having a void length below 5 mm for MB and 10 for MQ.

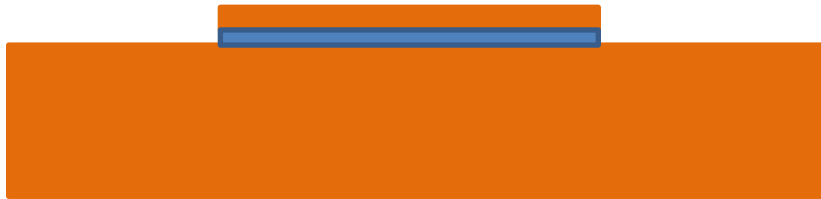
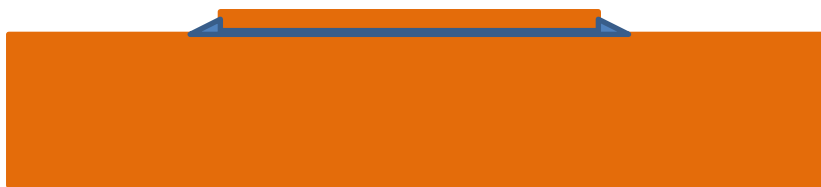
Reflow

- A band of solder is positioned between the shunt and the bus bar and melted in situ

- The melted solder moves as a wave pushing ahead the flux and reducing the risk of trapped flux (Swiss cheese defect)
- Impossible to forget the solder during mass production, quantity of solder pre-determined
- Easier visual inspection (solder comes from the centre so if the fillet on the edge is good the solder has passed by)
- No need to compensate the solder melting mechanically pushing down the shunt

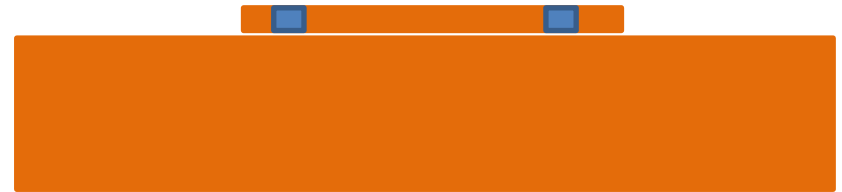
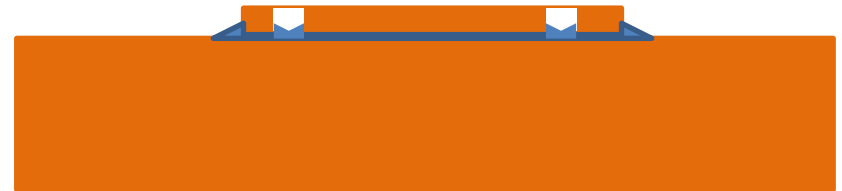
Capillarity

- The solder is contained in 2 “reservoir”, the 2 copper surfaces are in contact and the melted solder migrates and wet the surfaces by capillarity

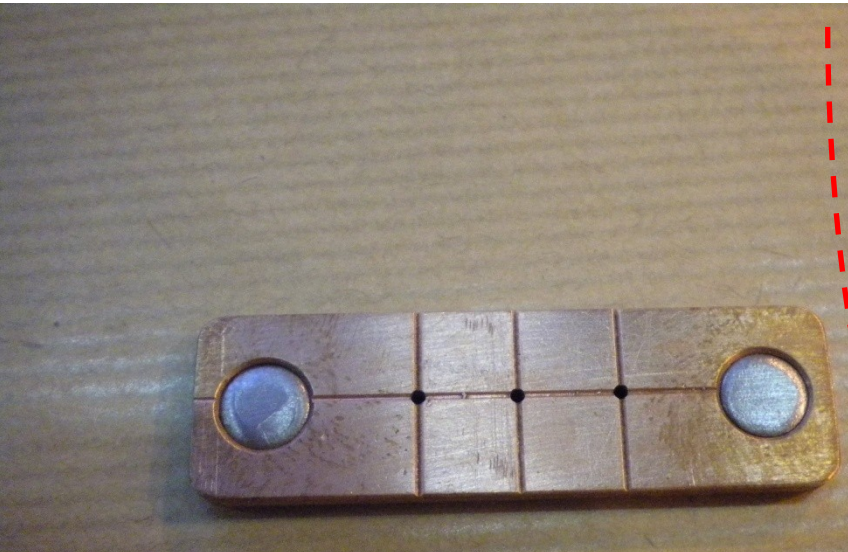
Shunt present configuration and joint quality

Control thermo couple inserted in the shunt (1.5 mm in 1.55 hole) and connected via conductive grease

The 15 mm width was set because of the rounded bus bar edges. It could be that now machining we can enlarge it to 16 mm adding extra contact area and reducing the shunt resistance

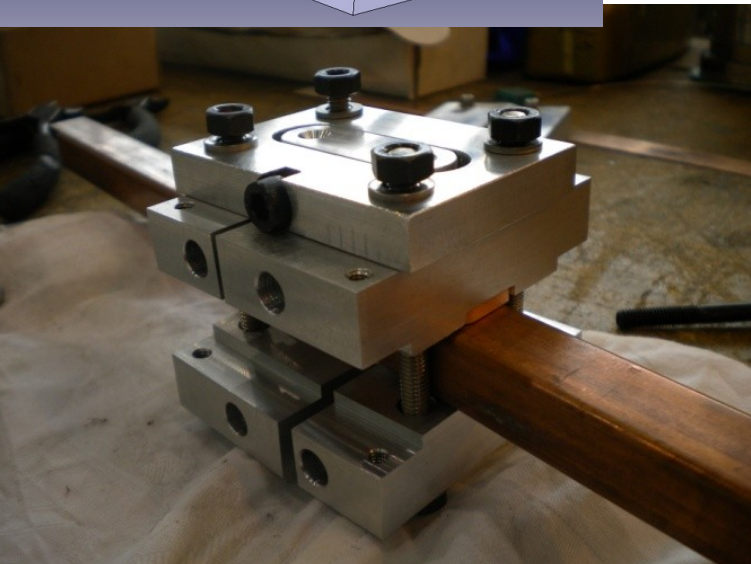
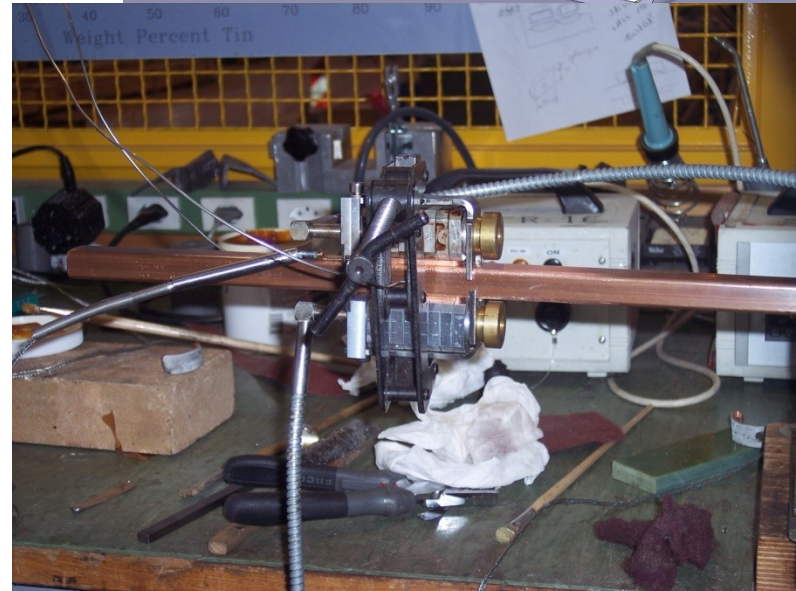
Heating

We tried successfully micro welding techniques, but this technology cannot be used due to the decision of doubling the shunt.

At the moment we have tested successfully 2 types of ovens
And exploring other non contact technologies

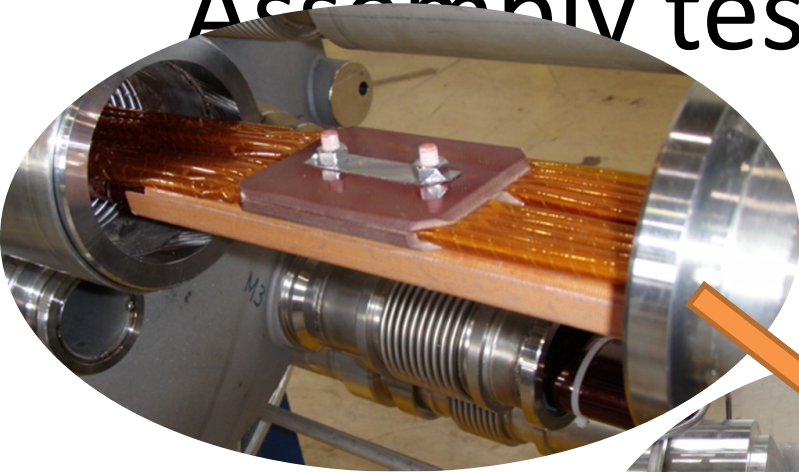
Assembly tests in real conditions

Assembly durations:

Present design	New design
M1/M2	15 - 25'	5 - 10'
M3	10 - 15'	3 - 5'

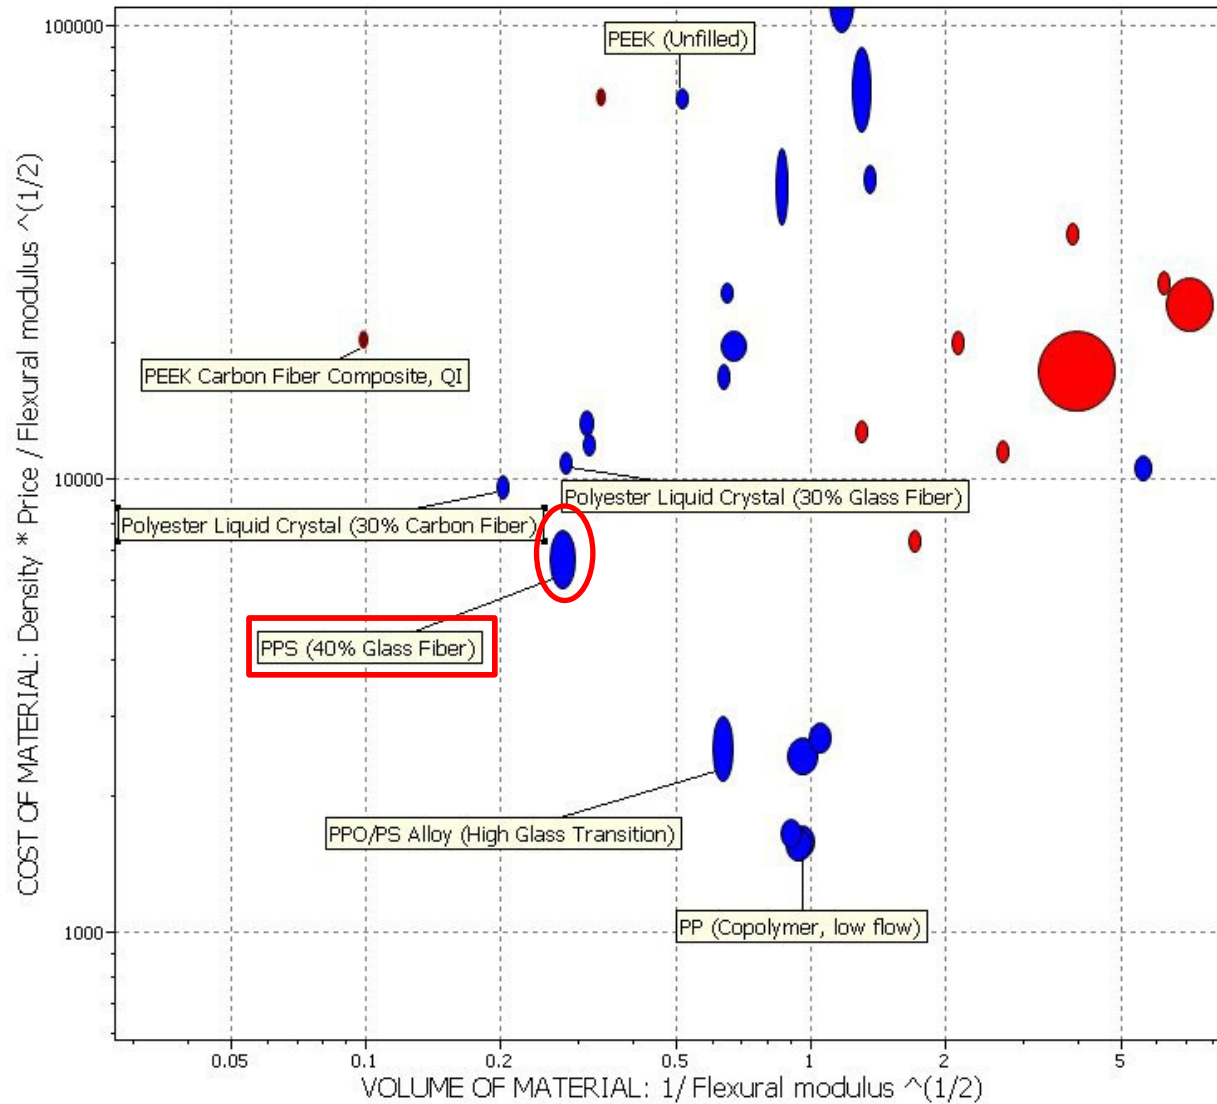
Material selection chart

Comparison with other materials in question:

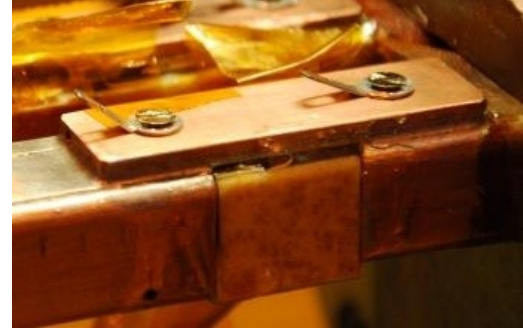
Instrumentation overview

290 Wires :

- ▶ 64 Vtaps (6 from end of Q9 routed using 600A spool cables)
- ▶ 16 for heaters
- ▶ 12 for Temperature
- ▶ 168 for Protection & Acquisition
- ▶ 34 for RRR measurements

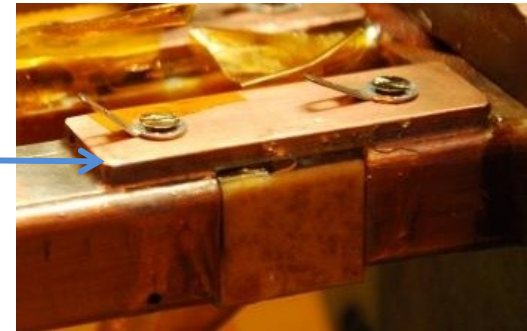
Thermal runaways in the interconnections

busbar temperature calculated from voltage (dashed lines)

Thermocouple measures the temperature of the shunt (solid line)

Busbar is less stable than the interconnection, while the interconnection has a defect

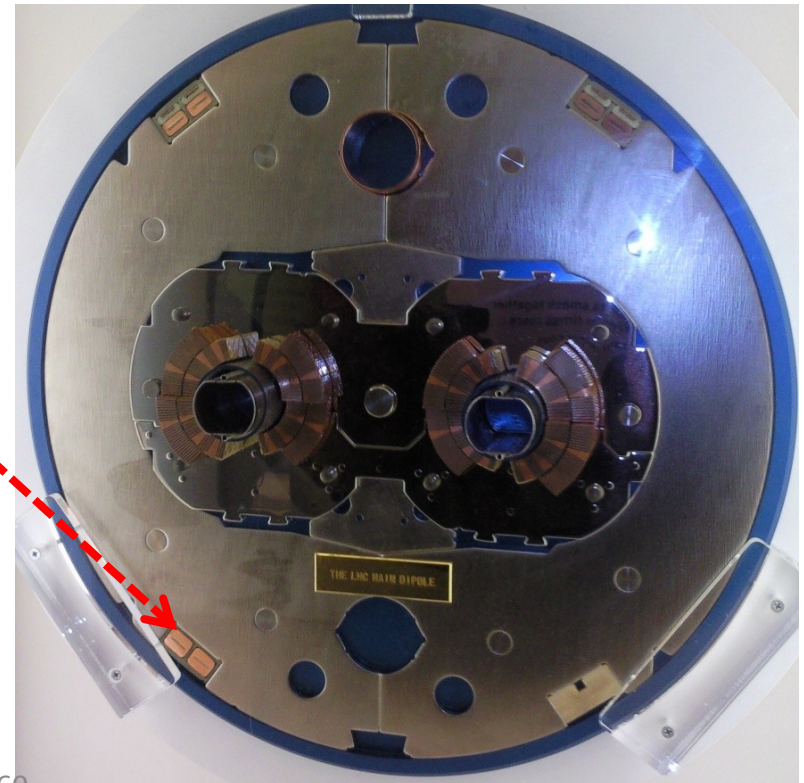
Thermal runaways in the interconnections

Busbar is less stable than the interconnection, while the interconnection has a defect.

Reason: Difference in helium volume available for cooling the busbar in the straight part and in the interconnection.

Very little helium available in the straight part.
