# Flex Status & AID

A.Nomerotski, 27 Oct 2010

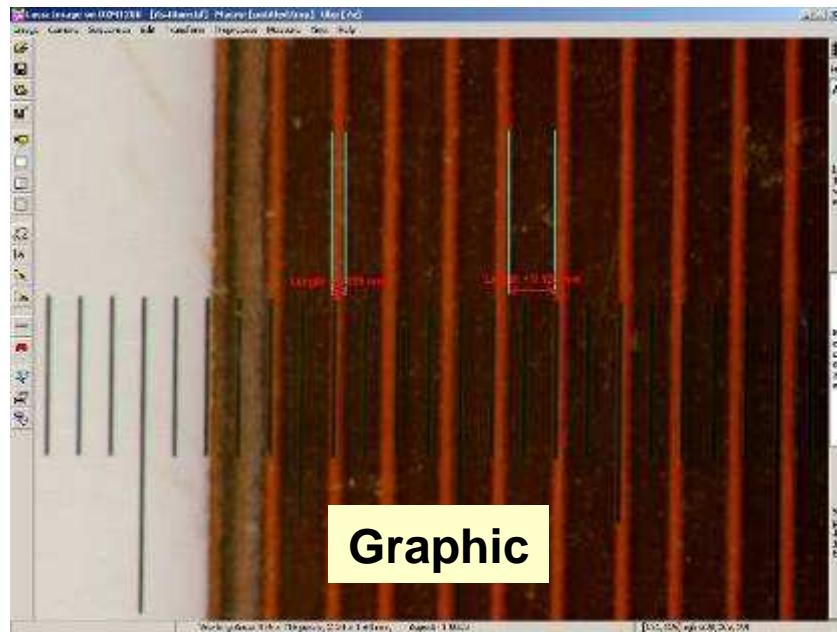
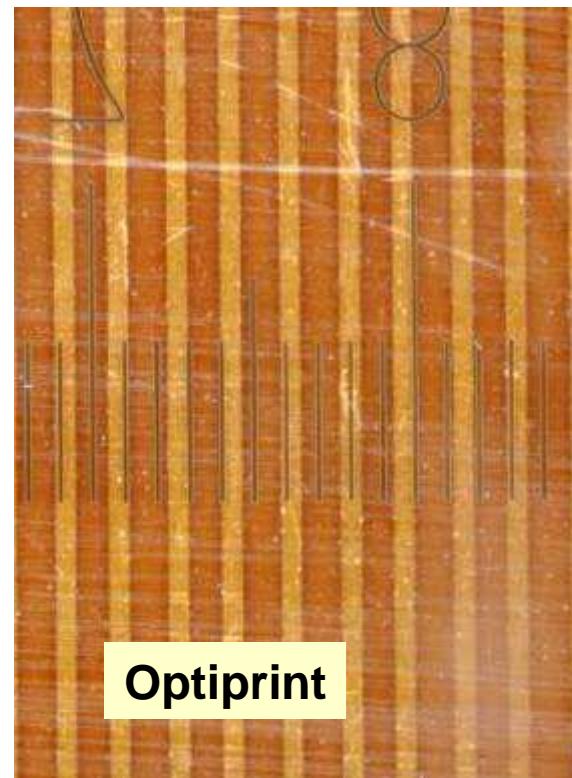
- Graphic: Overetching of lines
  - ◆  $75 \rightarrow 40$  micron, Graphic not forthcoming to fix problems
- Optiprint: good quality, first flex assembled

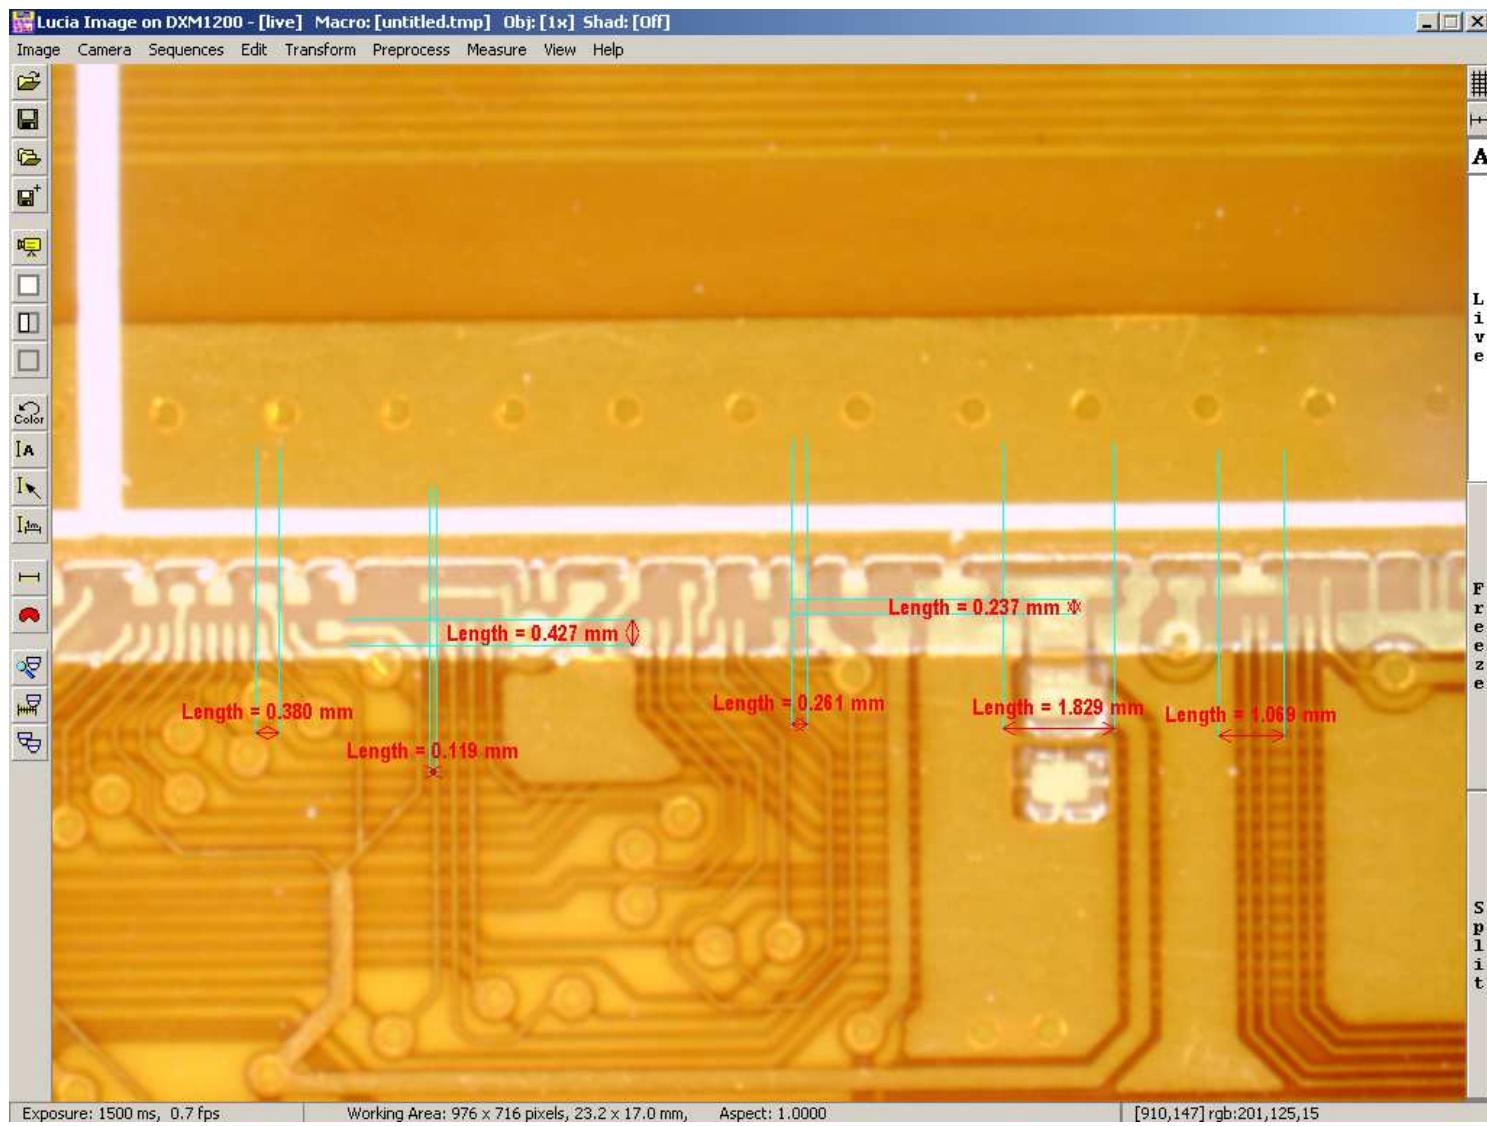
# Optiprint Flex

- 0.14 mm thickness

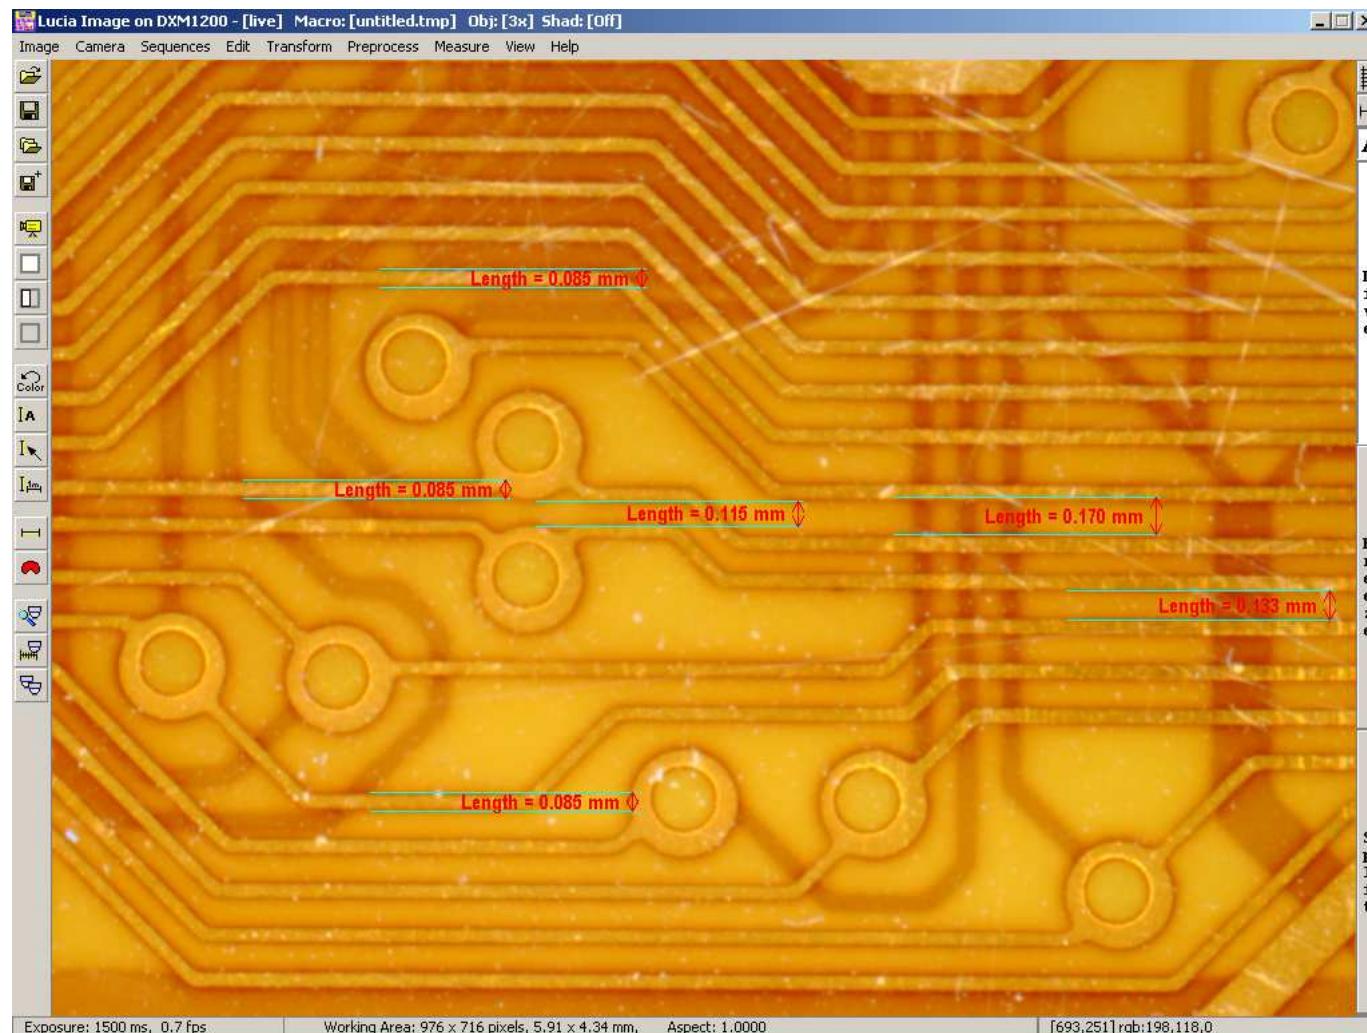
# Optiprint

- 0.14 mm thickness

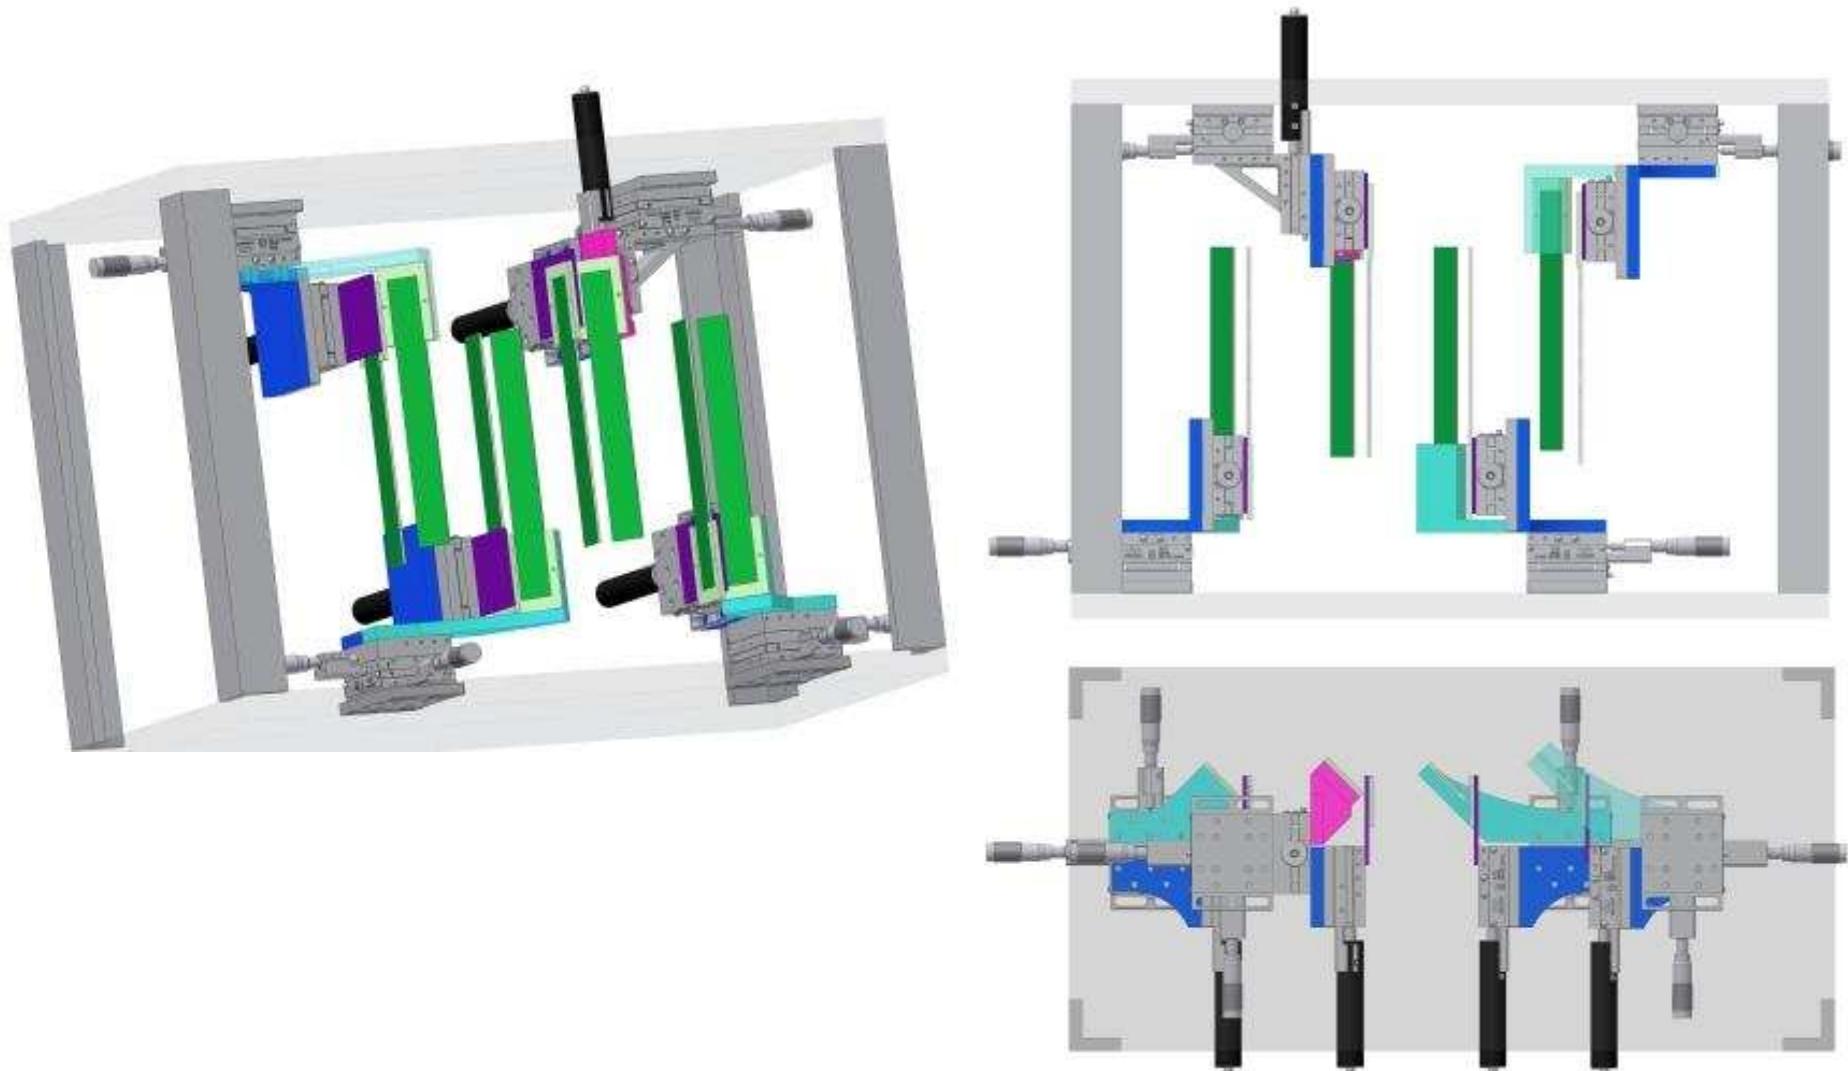
# AID Layout

- Draft 0 prepared by Stephanie Yang

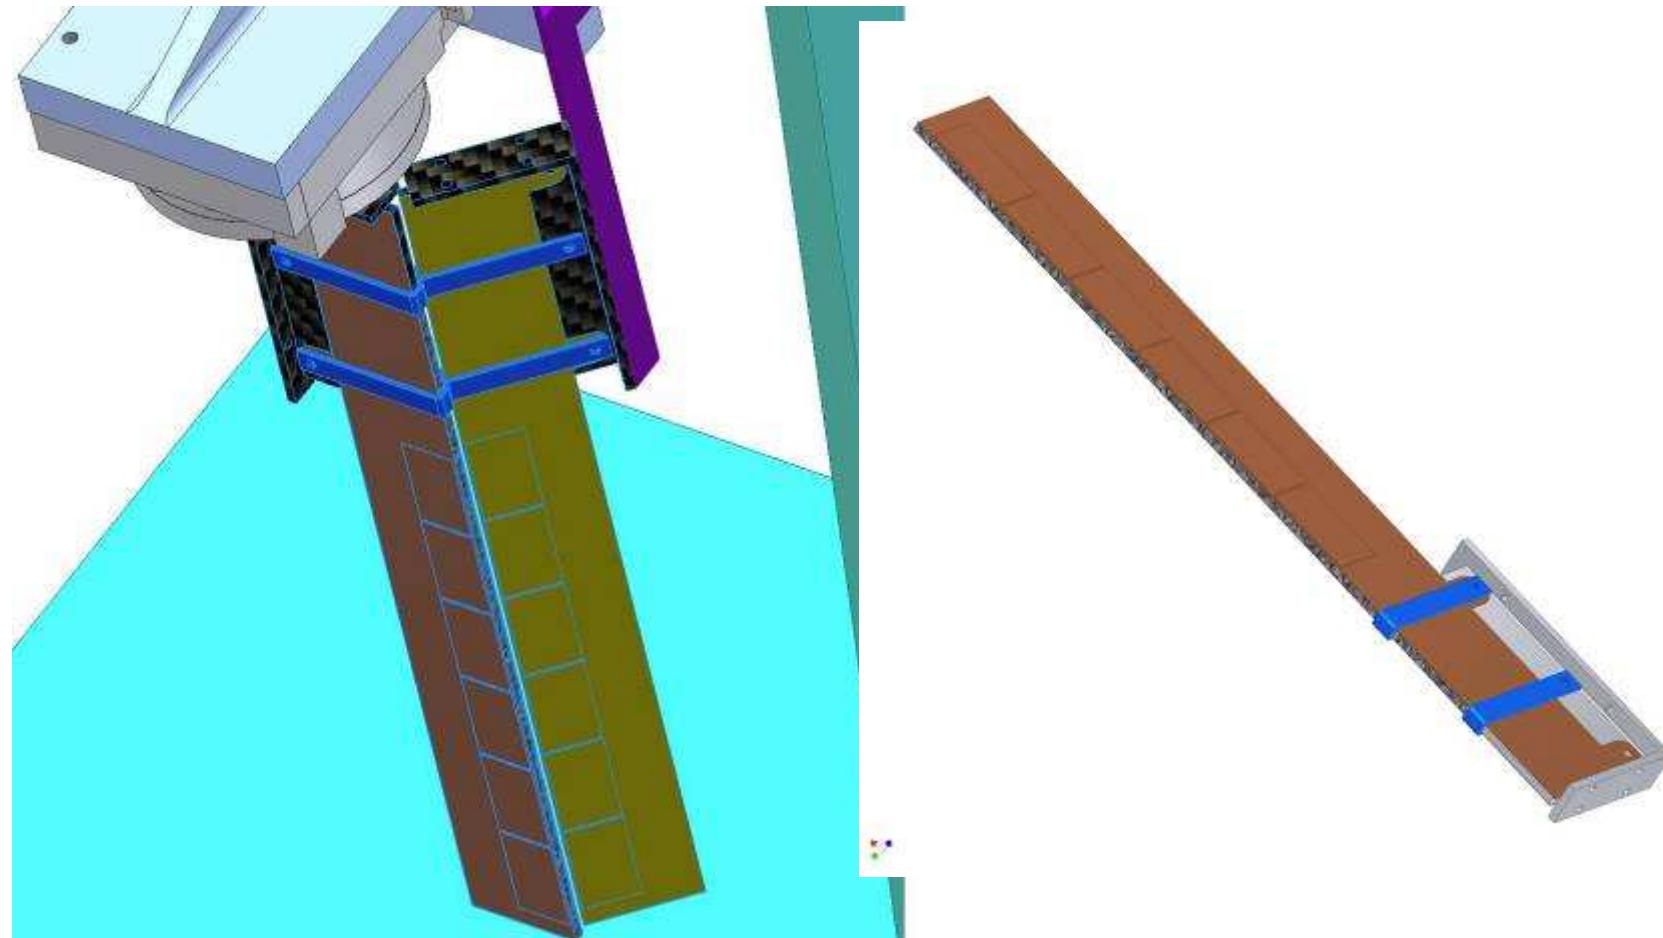
# PLUME ladders in AID

- Support plate of the ladder needs mods

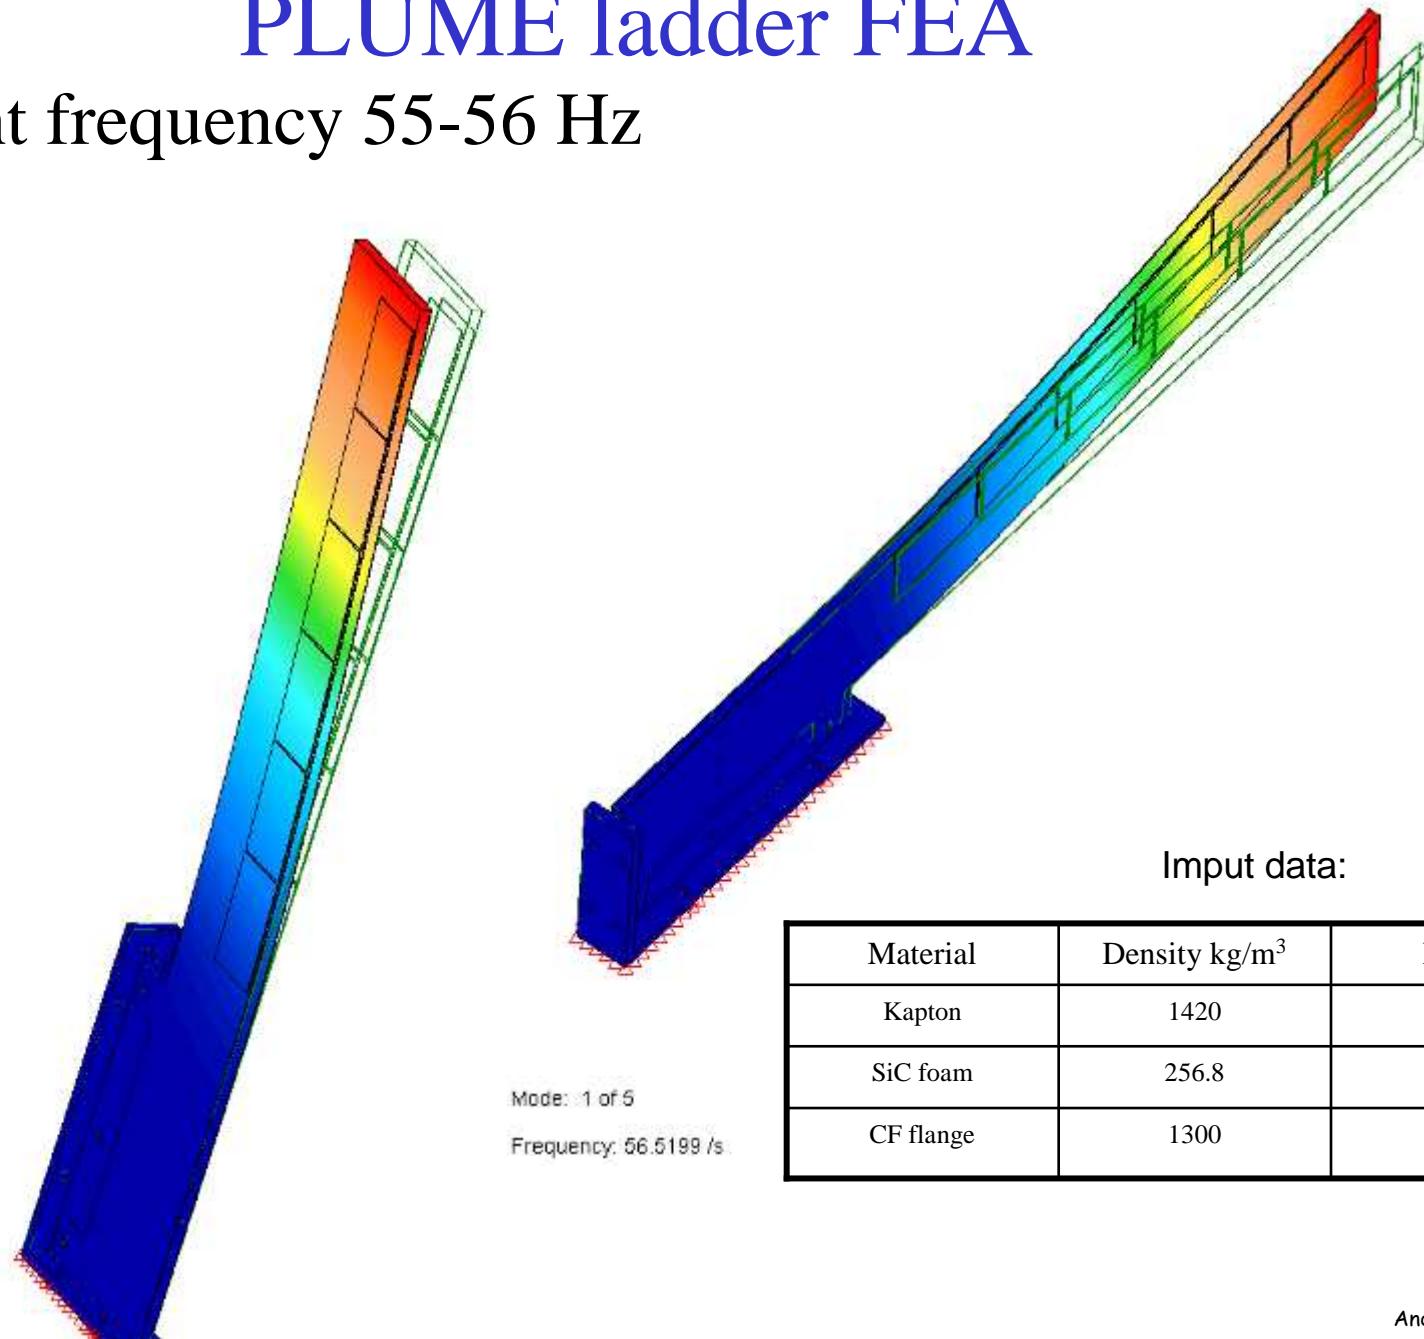
# PLUME ladder FEA

## Resonant frequency 55-56 Hz

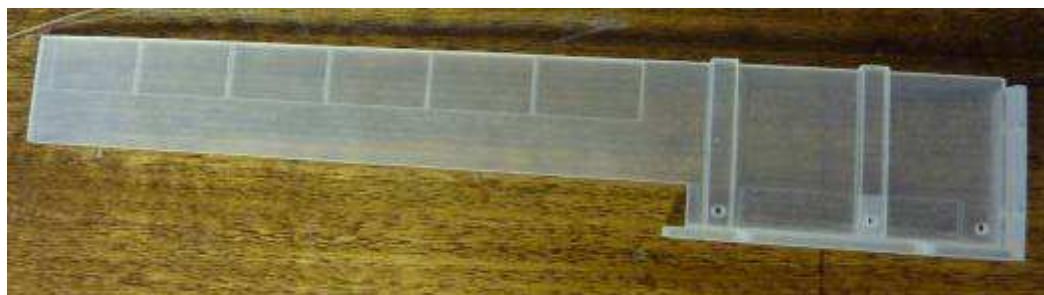
3D Printer in DO

Printed 1:1 scale PLUME ladder
