Status of the MICE Target(s)

Paul Hodgson

The University of Sheffield

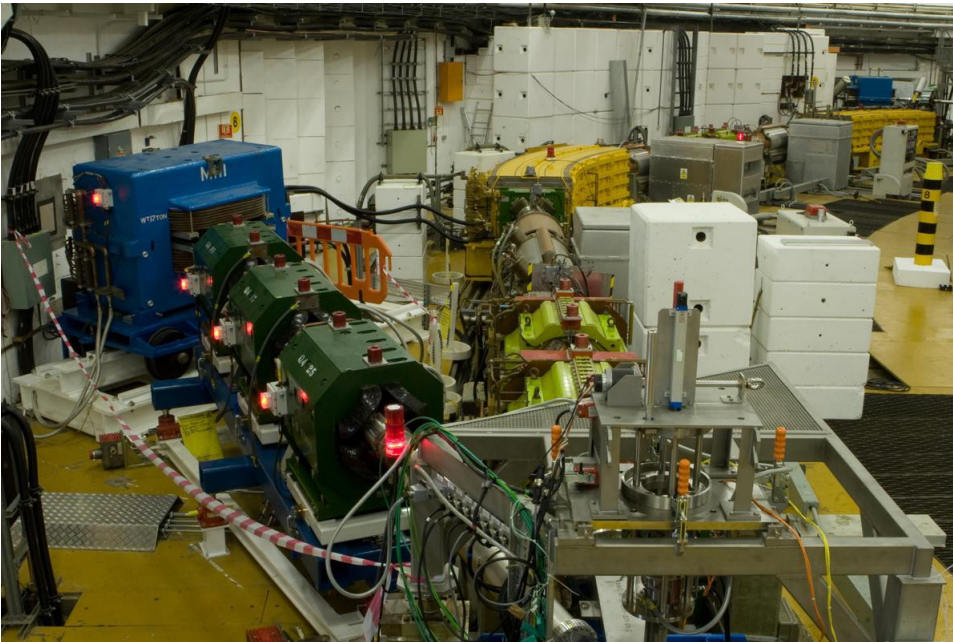
T1 installed in ISIS

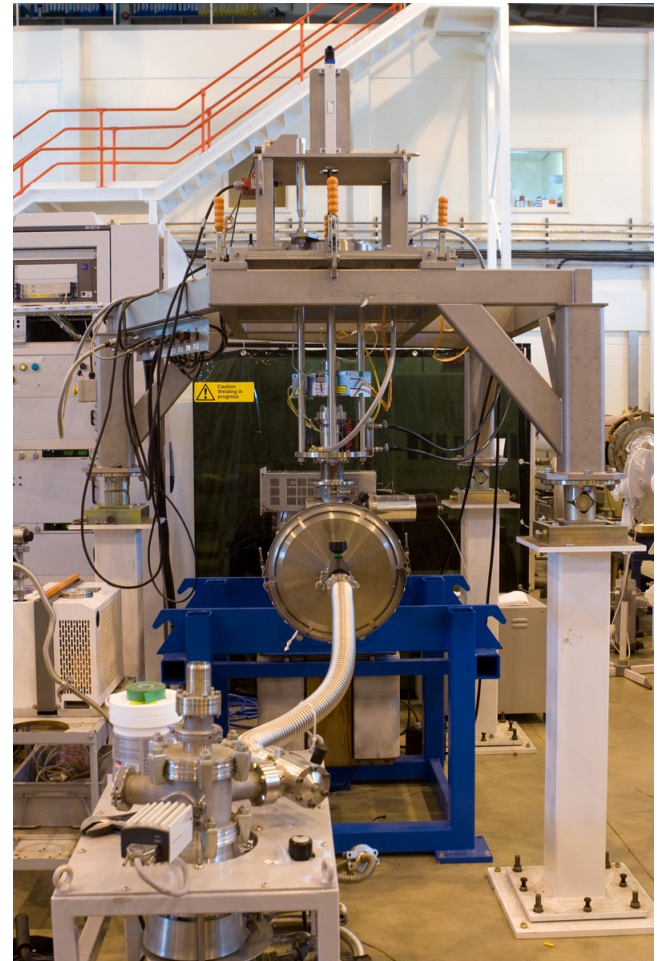
The T2 Test Rig in R78

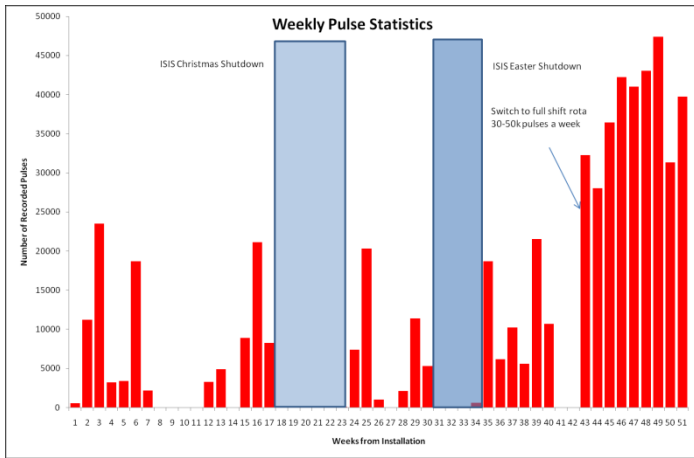
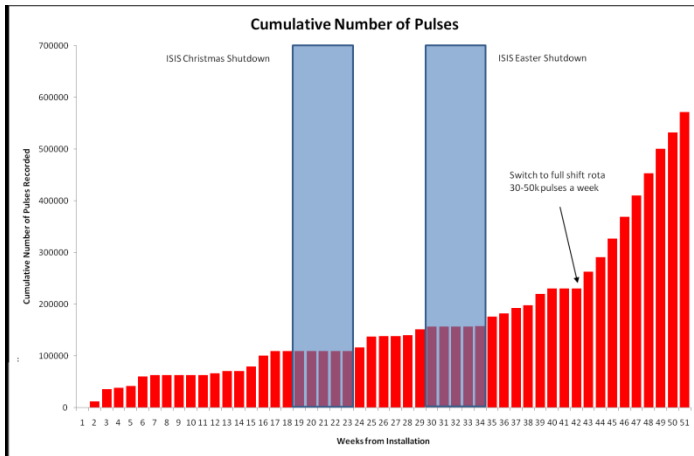
Pulse Statistics

571k pulses in ISIS (620k total)

Decision made to continue using this target during 2011

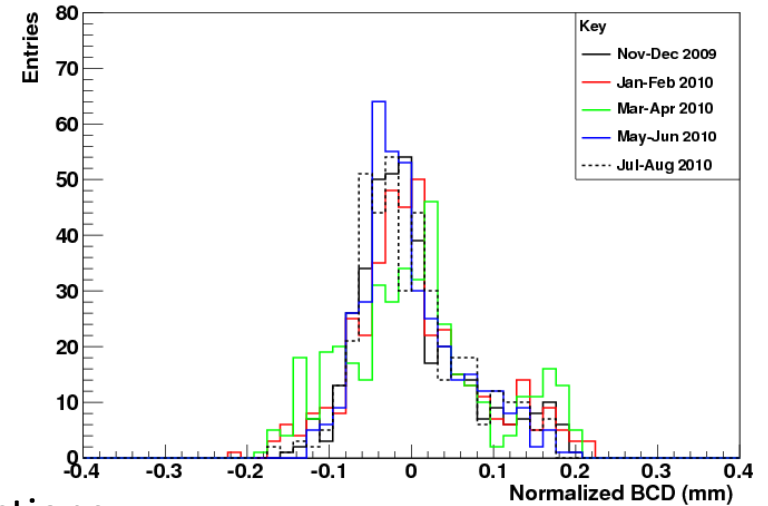
Calibration Plots

Target 1 BCD Calibrations Over Full Operation Period

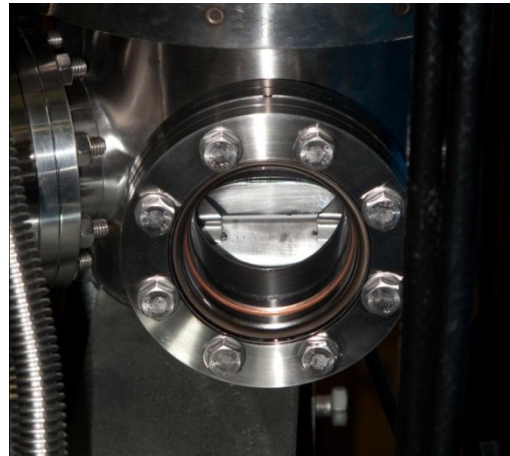
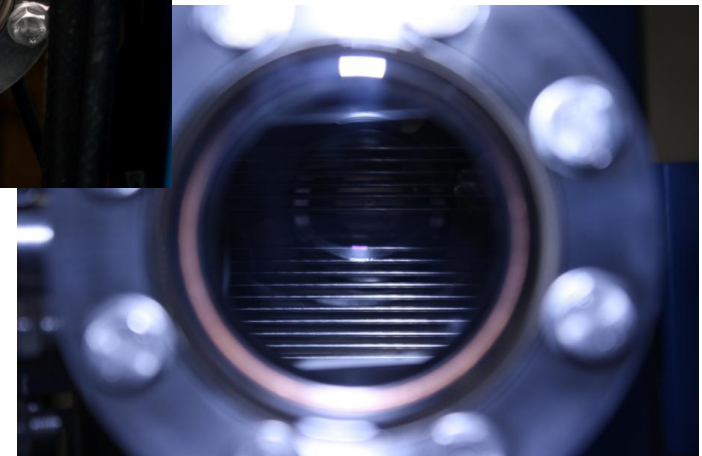
Visual inspections

7th Sept 2009

27th Aug 2010

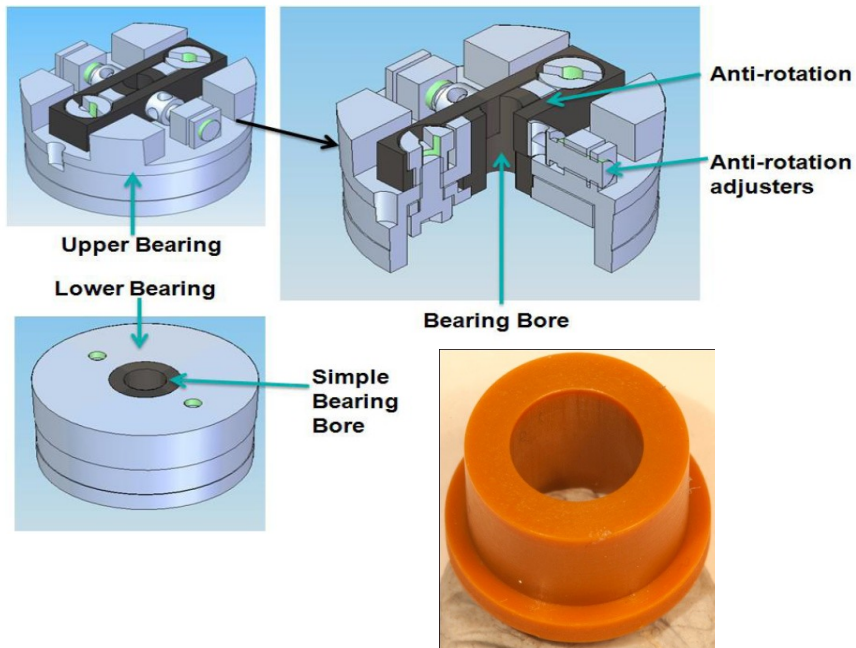
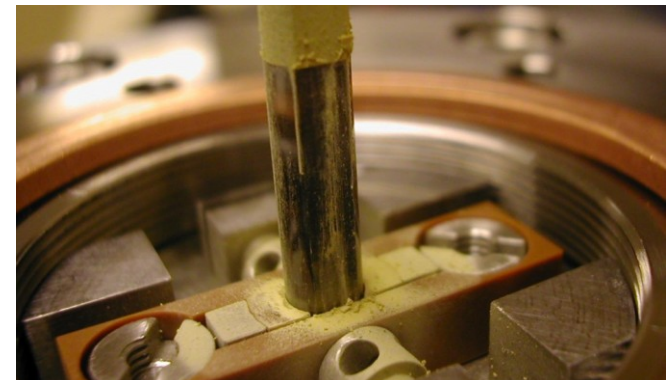
T2.3 Performance

- 2.3 – DLC/Vespel tested early 2010
 - First try with the new Vespel (polyimide) bearings
 - Ran for 2.1 million pulses then stopped for inspection
 - Too much dust produced but otherwise encouraging
 - This was caused by poor finish on one side of DLC coated shaft
 - We had used a poorly finished shaft to allow rapid test while improved shafts were in production

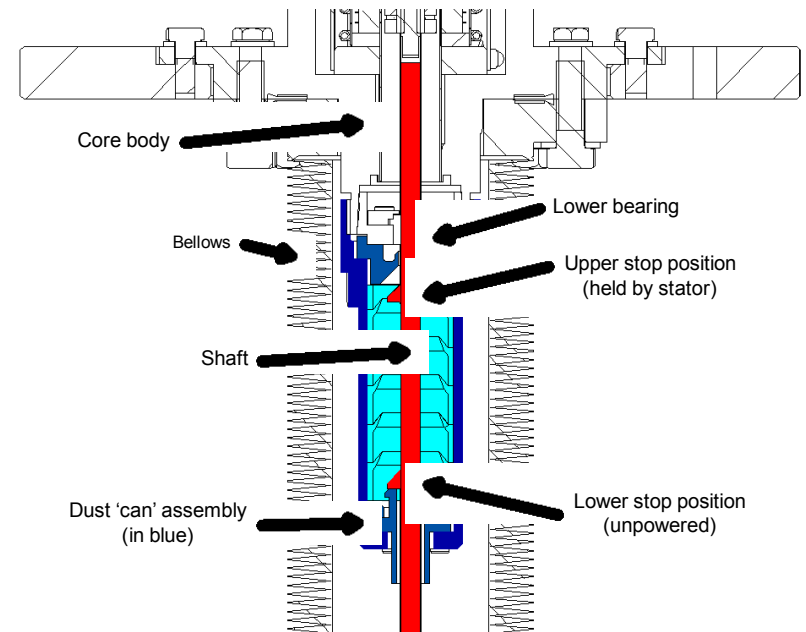
T2.4 Performance

- T2.4 DLC/Vespel – Installed Nov 2010
- Improved surface finishes on shaft and bearings
- Dust Catcher added below bottom bearing
- Ran target for ~1 million pulses
- Inspect weekly (500k)
- Using the new FPGA controller
- Digital data

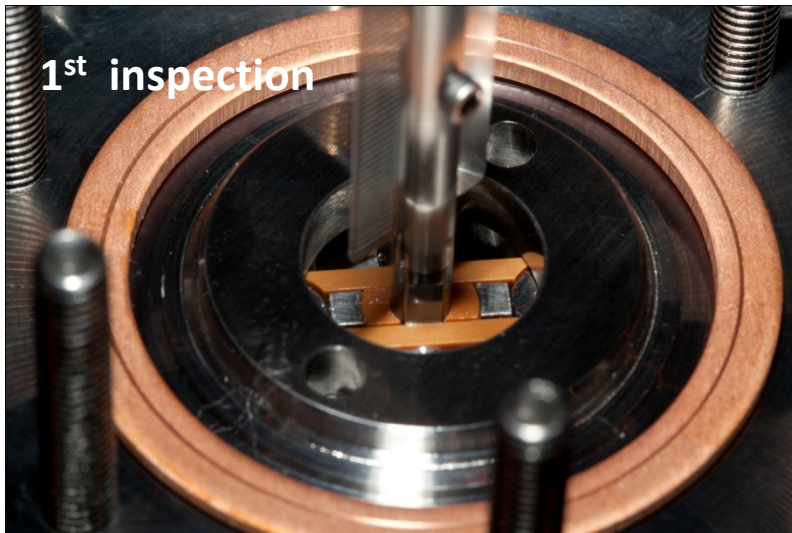
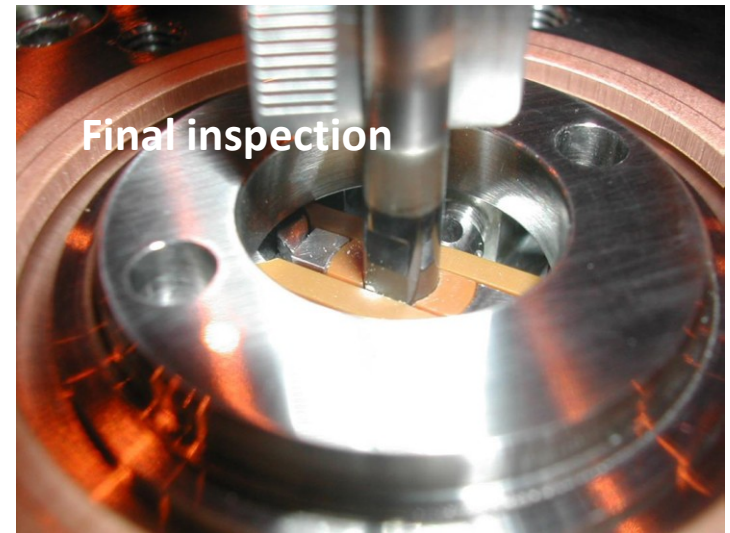
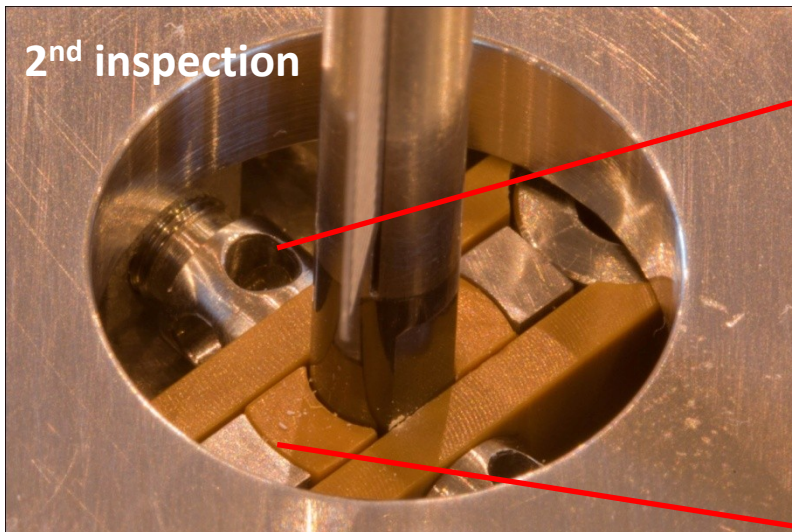
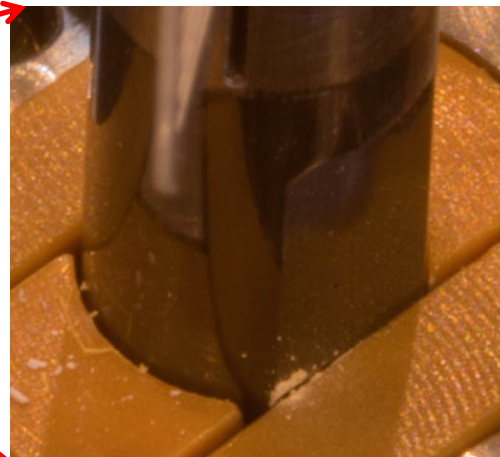
T2.4 Performance

Wear on one corner

Shaft appears to be rotated in bearing

Very little dust seen

- The shaft was operated for approx. 1 million pulses.
- There was very little dust production.
- What material was produced was contained within the stator and the dust catcher.
- There was very little evidence of wear on the VESPEL bearings.
- The target became “stuck” in capture position several times.
- The sticking occurred at the top of the target trajectory.
- This problem now understood and the bearings modified to prevent this happening.

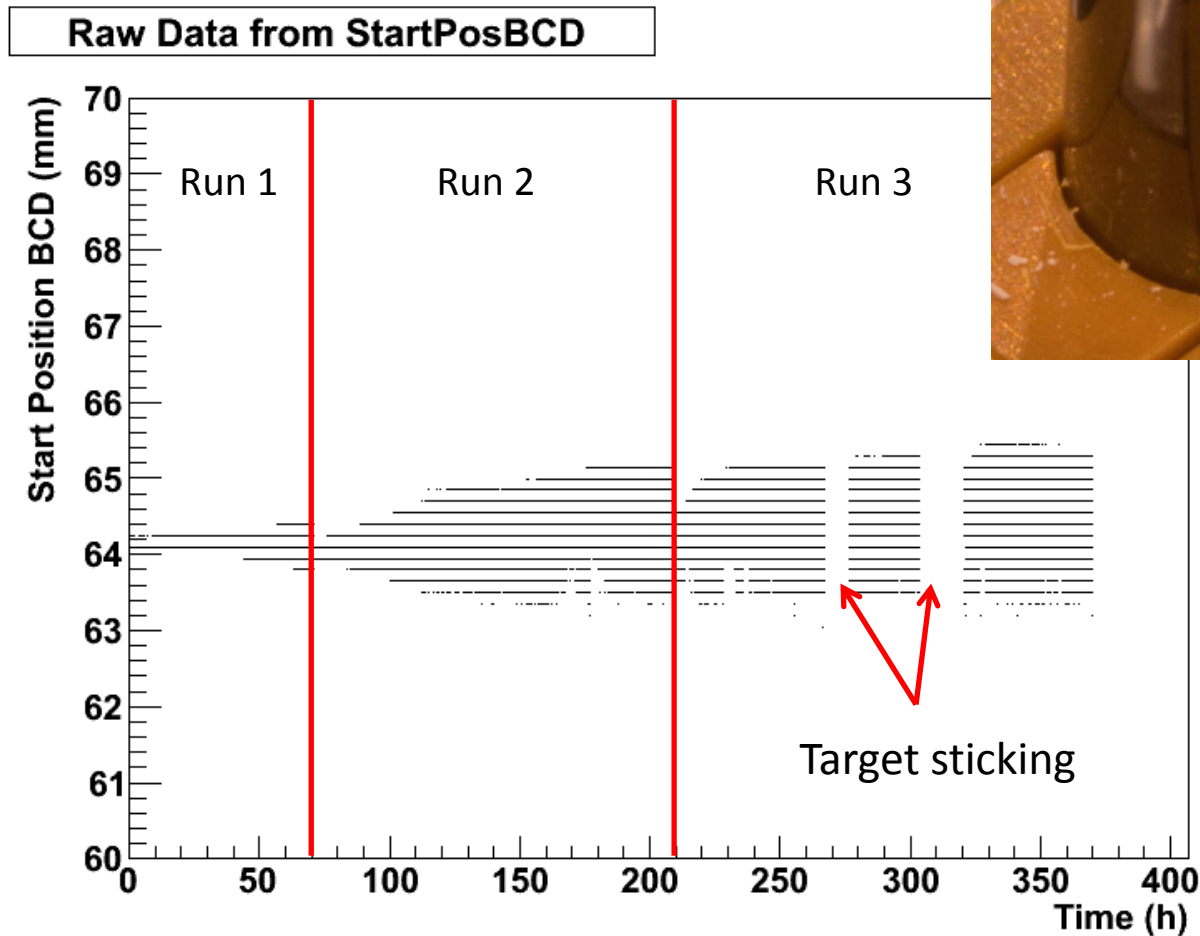
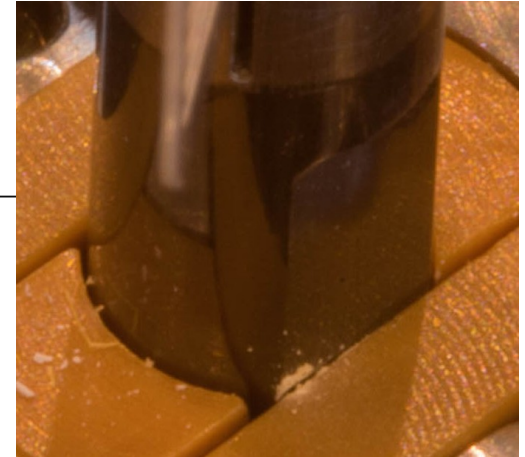
Digital data – exact position from controller

Target became “stuck” several times (8) during run

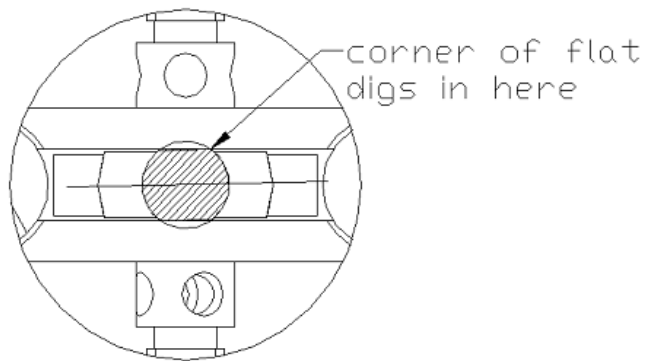
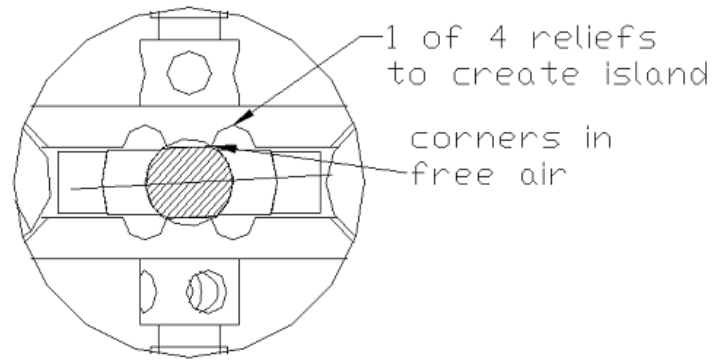
T2.5 Performance

- 2.5 – DLC/Vespel
- Top Bearing Modified

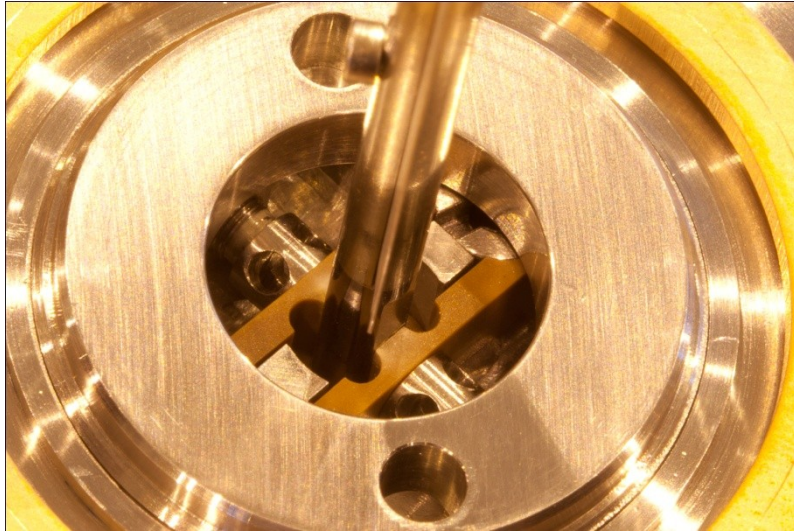
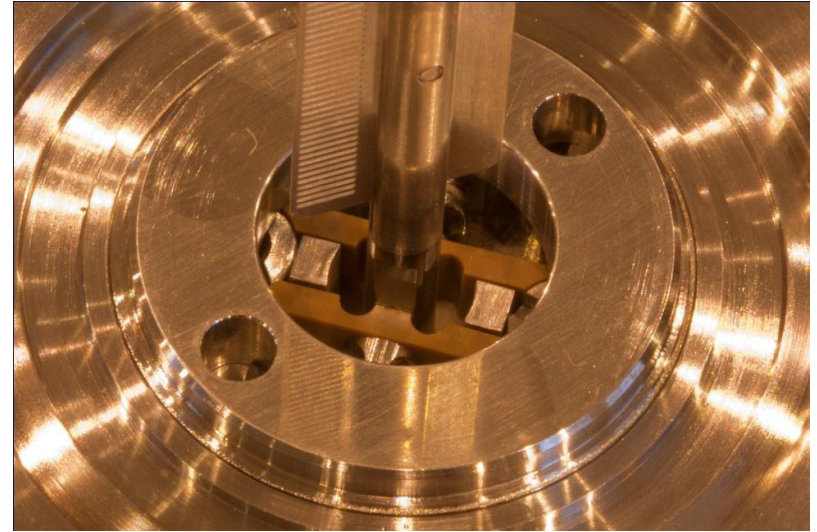
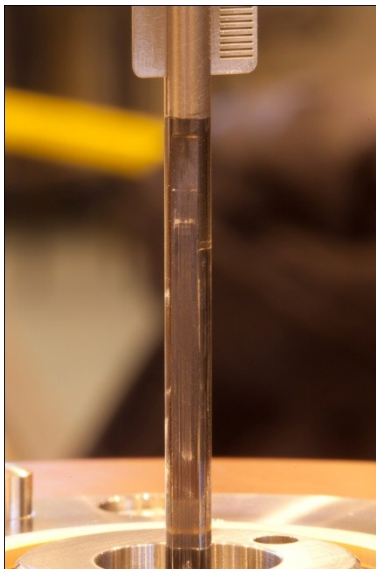
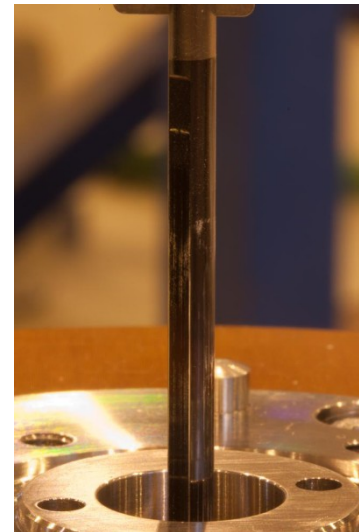
T2.5 Performance

800 hours of running

2.3 million pulses

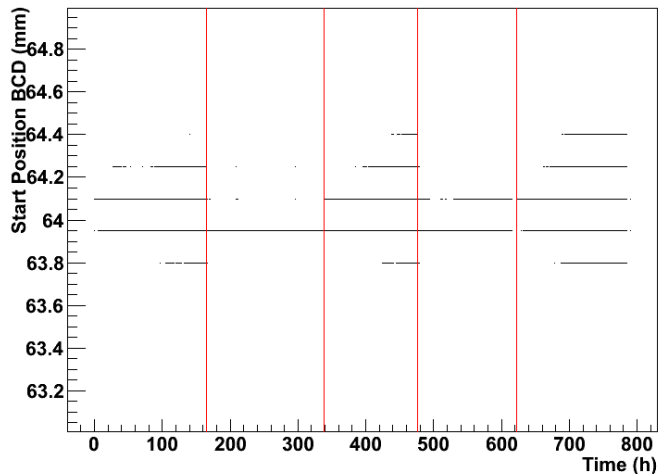
Digital position data for entire run (5 inspections)

Raw Data from Start Pos BCD

No sticking observed

Gradual but slow increase in wear

Estimate target will be good for at least another 2 million pulses
before variation becomes a problem

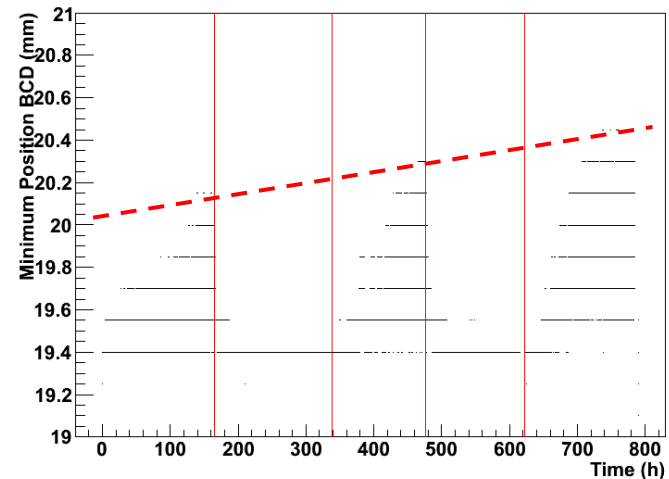
Raw Data from Min Pos BCD

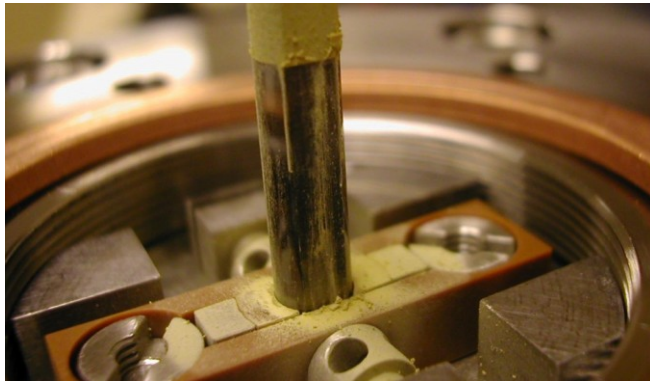
T2.3

2.1 million pulses

A major improvement

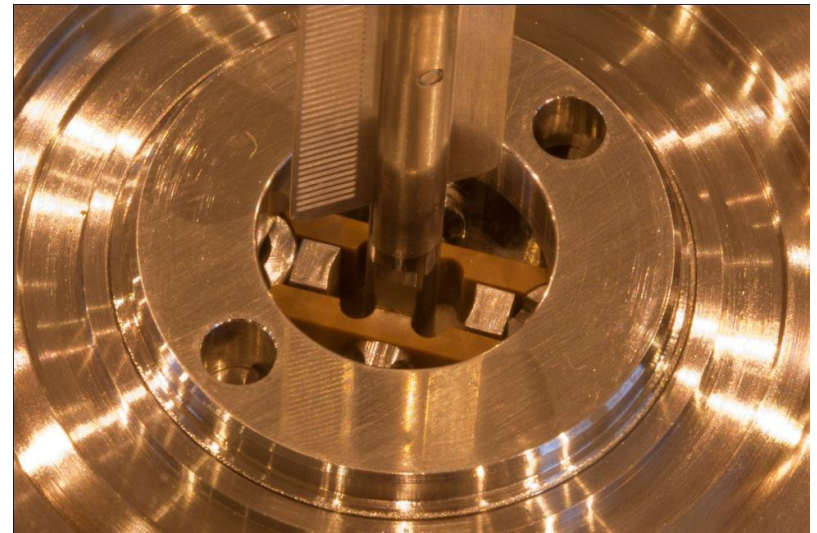
T2.5

2.3 million pulses

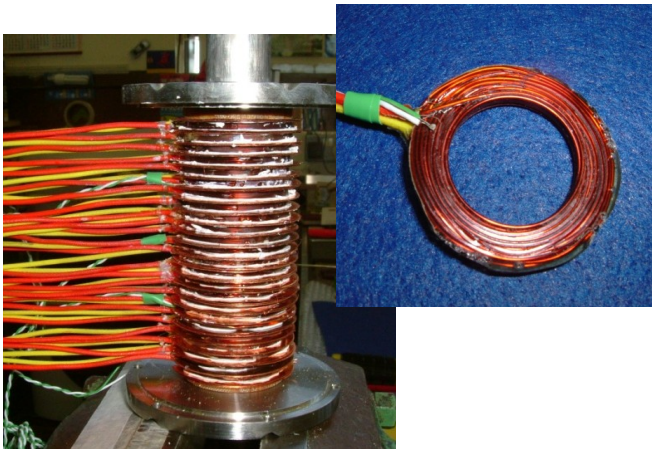
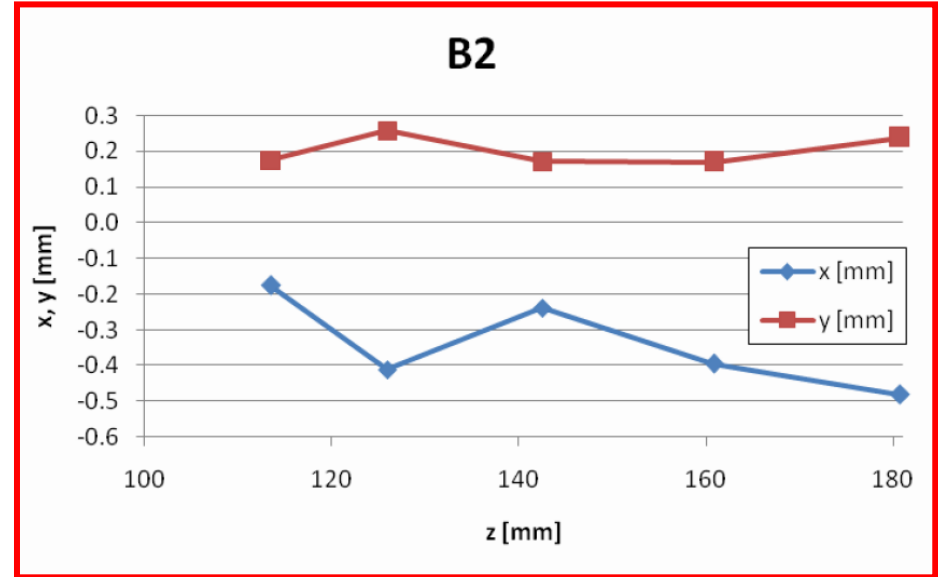
Magnetic axis and mechanical axis not aligned

Discrepancy approx. 300 μm

Old coils individually wound

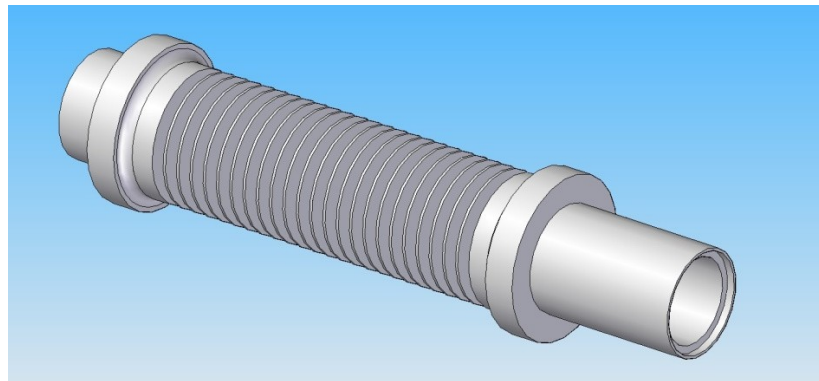
The new design is a bobbin. Coils directly wound into fixed slots. Should give high degree of uniformity

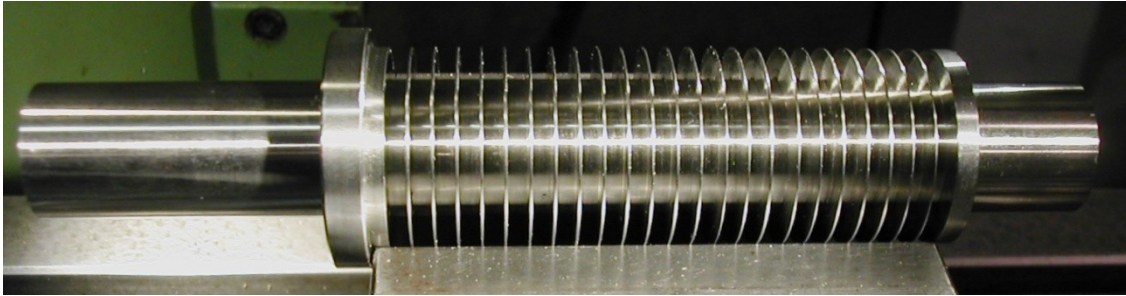
The fully machined bobbin

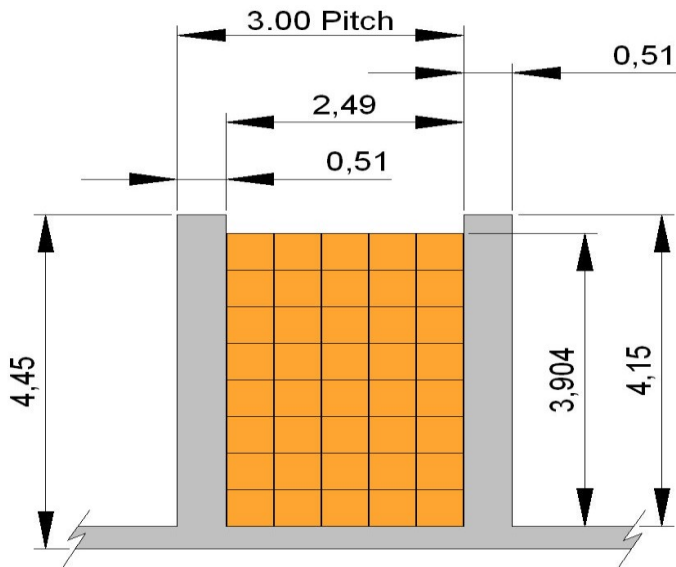
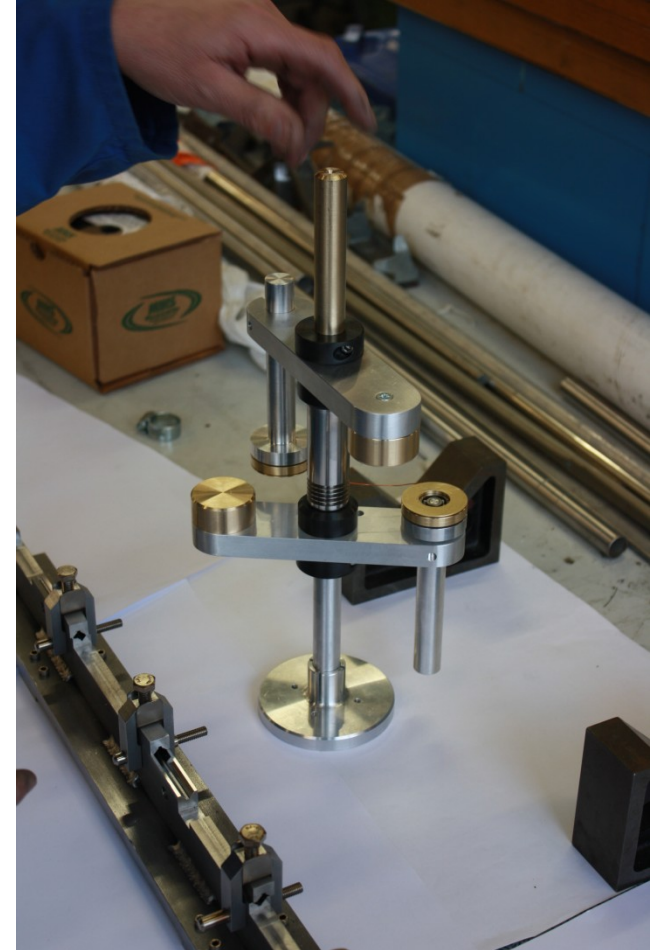
Use square section wire as this maximises packing density

Counter-wind coils

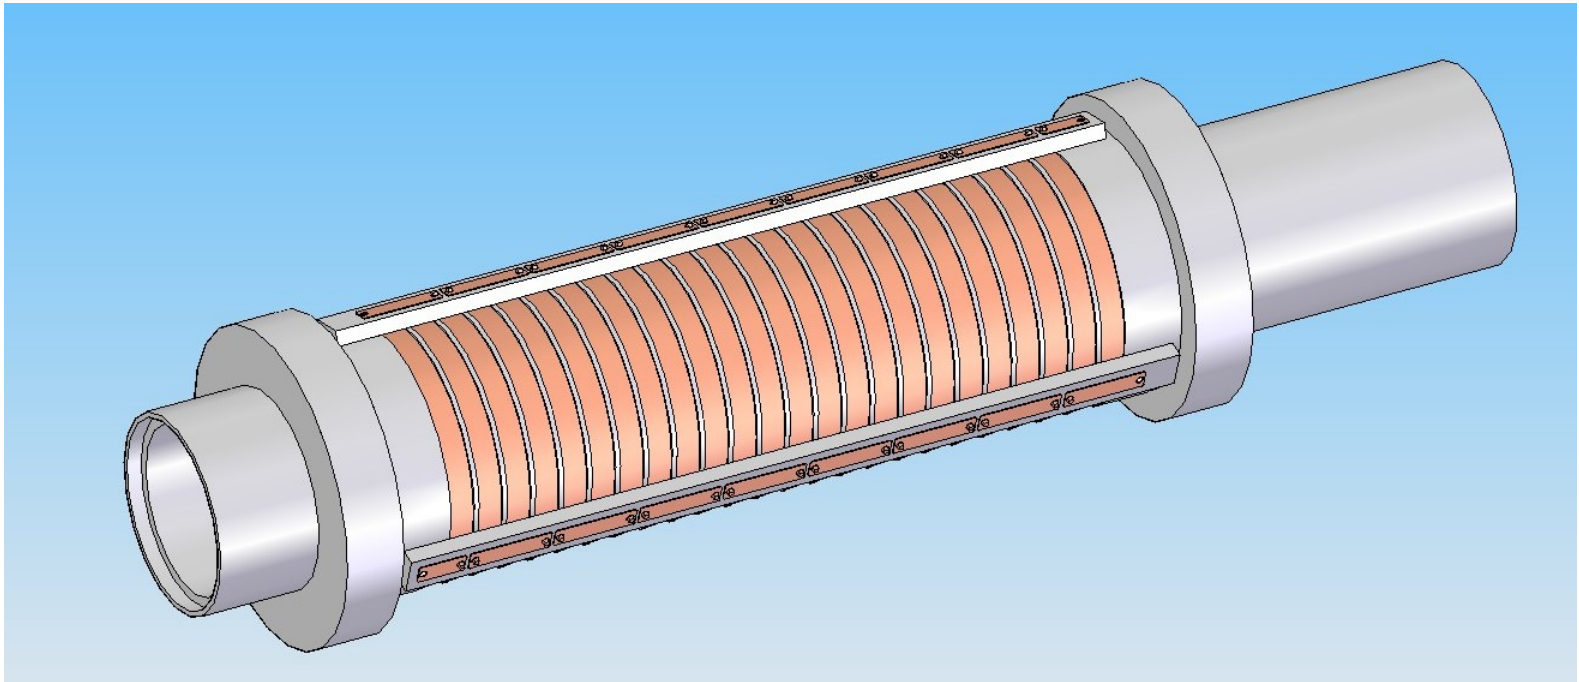
Layout of Proposed Prototype Bobbin

This is a layout showing proposed layout for the new bobbin. It uses PCB bus bars to connect the coils internally. A cooling jacket will be fitted around the bobbin structure which will consist of either 2 or 3 pieces

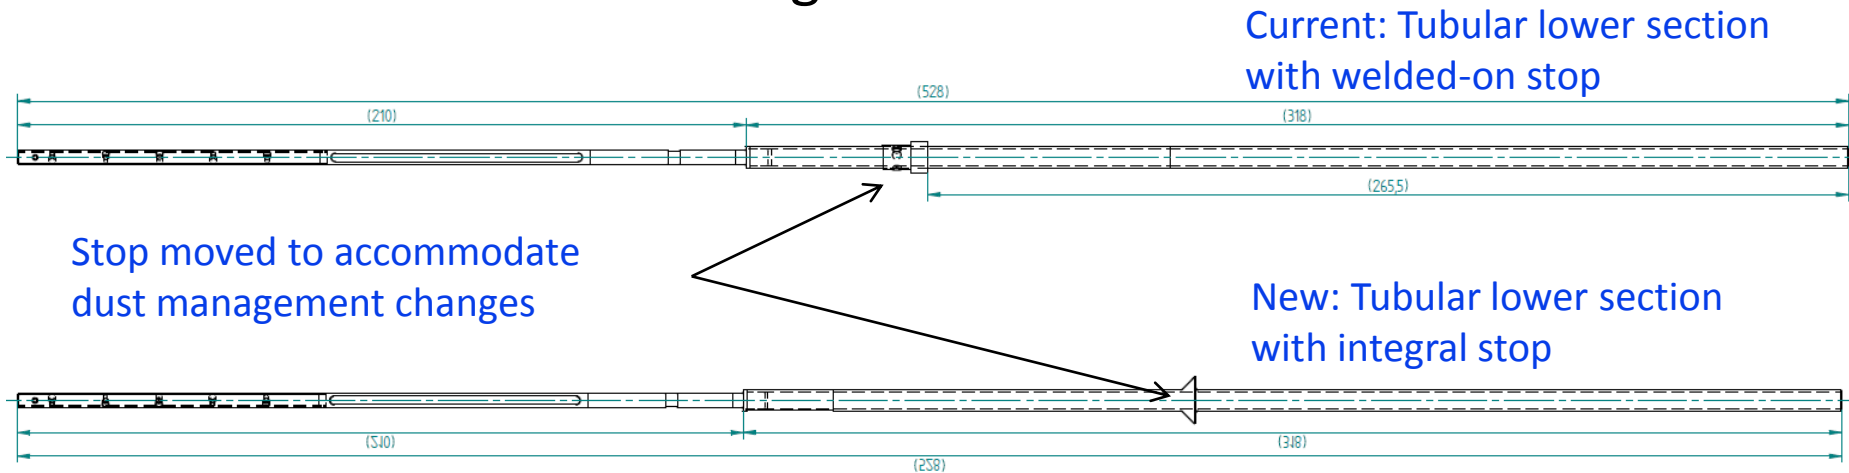
- Continued improvement
 - Current Shaft
 - Welded stop, on lower section, causes distortion to shaft (currently mechanically corrected by bending)
 - Welded stop was shown through testing to fail after several full speed impacts (possible only during a fault)
 - Poor surface finish of ground lower section

Subtle change to design, i.e. integrated stop =
Complex process development =
Improved quality & consistency

- Continued improvement
 - New shaft
 - Integral stop, 1 piece lower (from solid) must retain cylindricity of current shaft (pre welded stop)
 - Manufacture process development using fine machining and electro-erosion processes = highly cylindrical smooth hollow shaft
 - Replace unpredictable mechanical straightening of full length 2 part shafts
 - Developed heat treatment & accompanying jig to straighten the Ti shaft
 - Heat treatment process will ensure repeatability of quality
 - Current production
 - 1 lead shaft to develop quality, processing, inspection etc.
 - 3 production shafts for T3, T4 & 1 spare
 - 6 production shafts for future use
