FIPDiag PSI Radiation test Presentation

Radwg meeting
August 2011

Julien Palluel BE/CO/FE

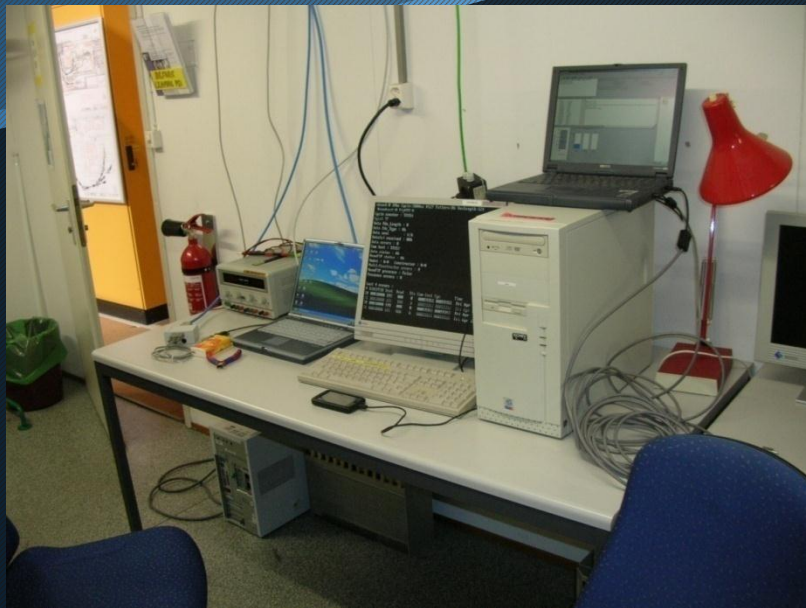
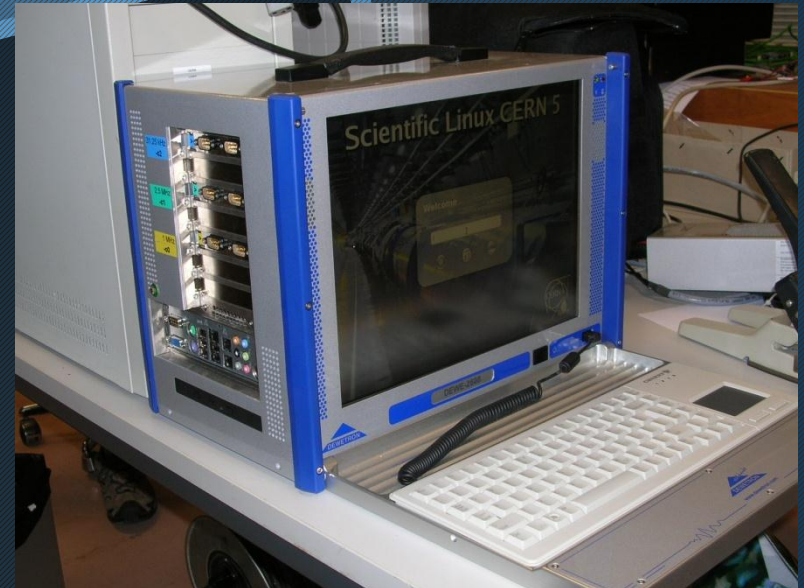
Other devices present in the setup :

- Manager “FIPMOBILE” SLC5 (on surface)
- FIPWatcher (on surface)
- Labview acquisition system (on surface)

FIPMOBILE, BA manager

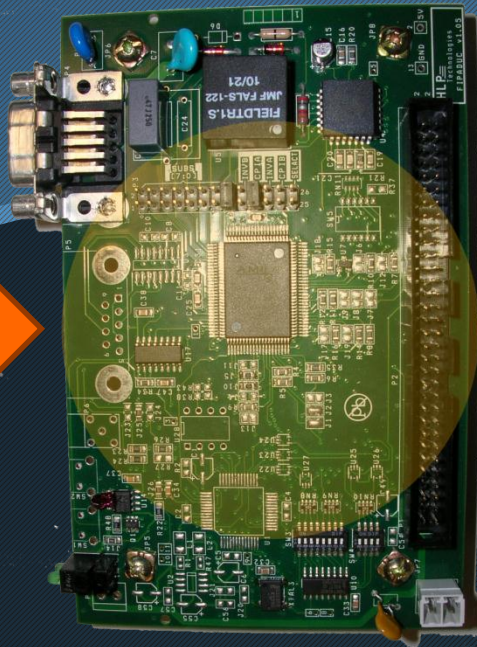
BEAM

Components irradiated :

- Q1 Si3443 canal P
- U13 74HCT32D Quad 2-inputs OR gate
- U17 74HCT123D Dual retriggerable monostable multivibrator with reset
- U6 MICROFIP
- U7 MAX809 Power on reset
- XTAL1 40MHz oscillator

Beam conditions :

- Start 7h22
- End 8h02
- Proton
- Energy : 230 MeV
- Flux $1.60E+08$ P/cm²/s
- Dose rate : 8.6 rad/s (309 Gy/H)
- Collimator : none (=9cm)
- Macrocycle : 100ms

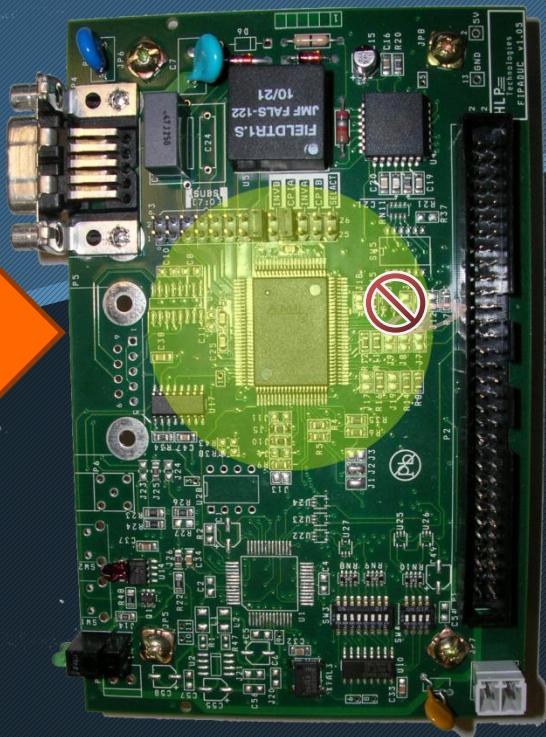
BEAM

Components irradiated :

- U17 74HCT123D (not all)
Dual retriggerable monostable multivibrator with reset
- U6 MICROFIP
- U7 ~~MAX809 Power on reset~~

*NB : The monostable U7 has been disabled
(Thanks to Paul's idea)*

Beam conditions :

- Start 10h57
- End 11h51
- Proton
- Energy : 230 MeV
- Flux $1.60E+08$ P/cm²/s
- Dose rate : 8.6 rad/s (309 Gy/H)
- Collimator : 5cm
- Macrocycle : 15ms

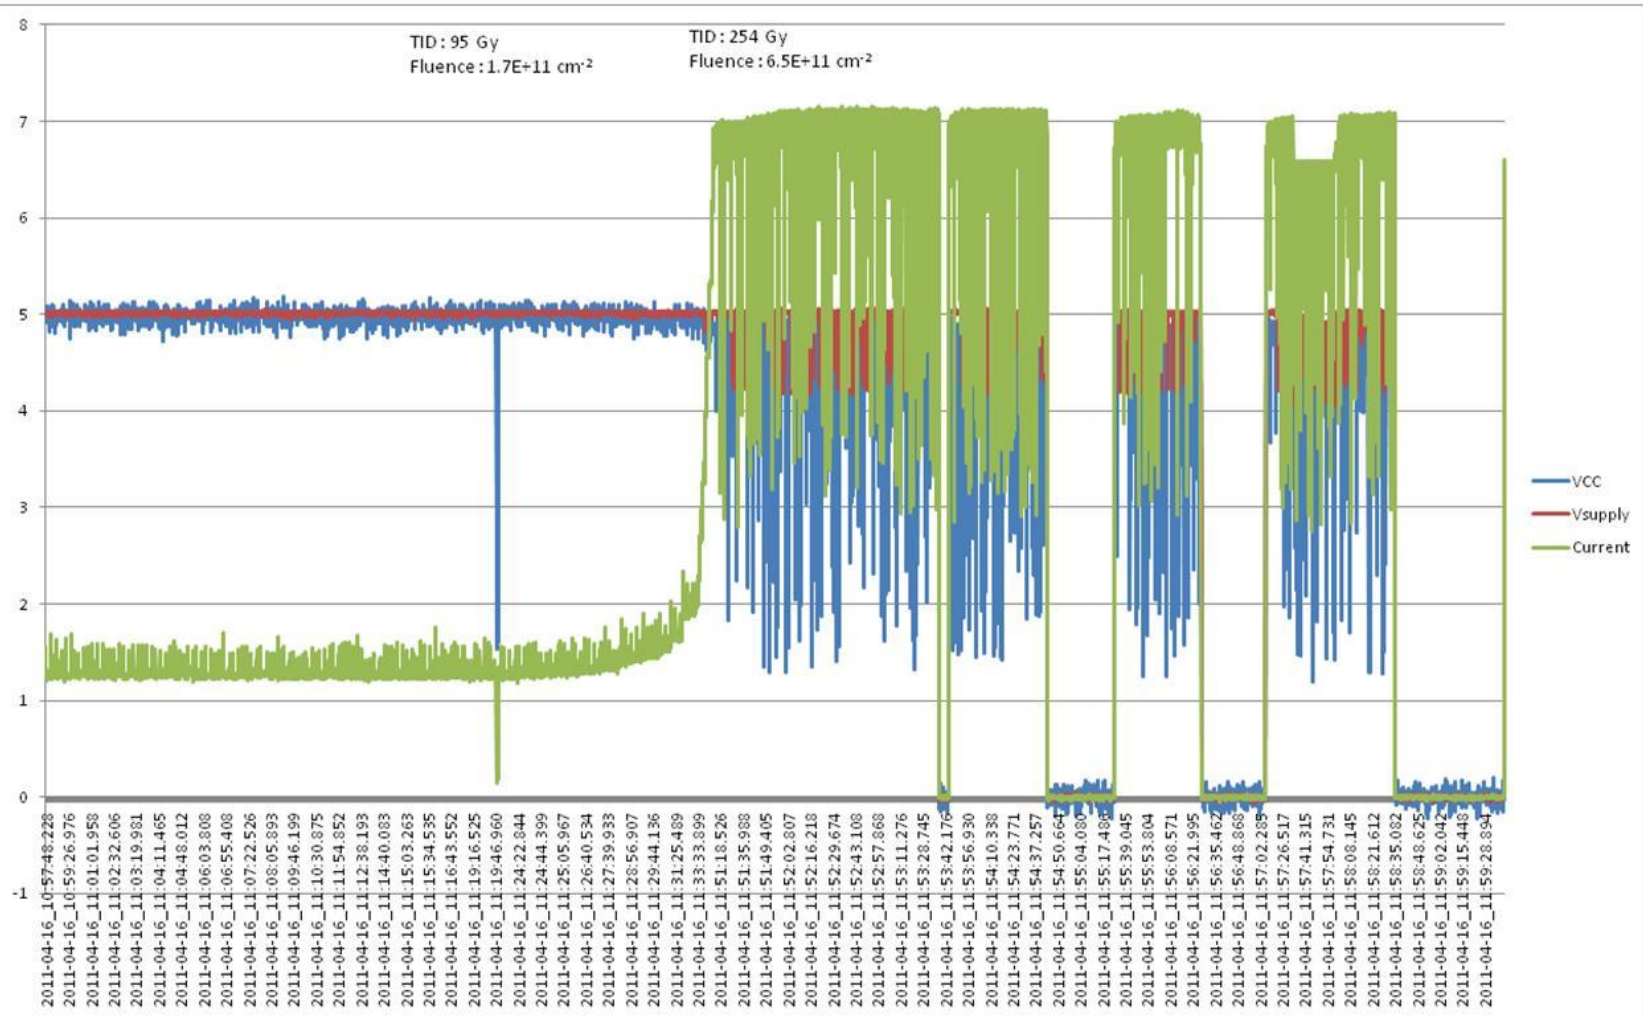
Logging graph :

Failures :
At 11h20

Com lost during 101cycles (1.5sec)

Seems like a SEL on the MicroFIP (or U17). We do not see the current increase but it must be due to the slow logging acquisition (50Hz).

The time of the com lost (1.5sec) match exactly with reset period, and the Vsupply was on.

A huge rise of the current drop down the voltage.

Looks like total dose effect.
We test it again after a long rest
(MicroFIP + U17) and it works
again .

This choice was not appropriate because of the unexpected transom, raise of the current observed, that causes drops in voltage too great and does not guarantee the proper functioning of the 5V regulator.

At the end of the third Run, we tried to compensate the drop of the voltage by increasing several times the 11v supply. Then a lot of data errors and com lost occurs with the current at 700mA.
