# Multi-Wire Proportional Chamber and Gas Electron Multiplier

## Local electronics in TT83

*Radiation issues*

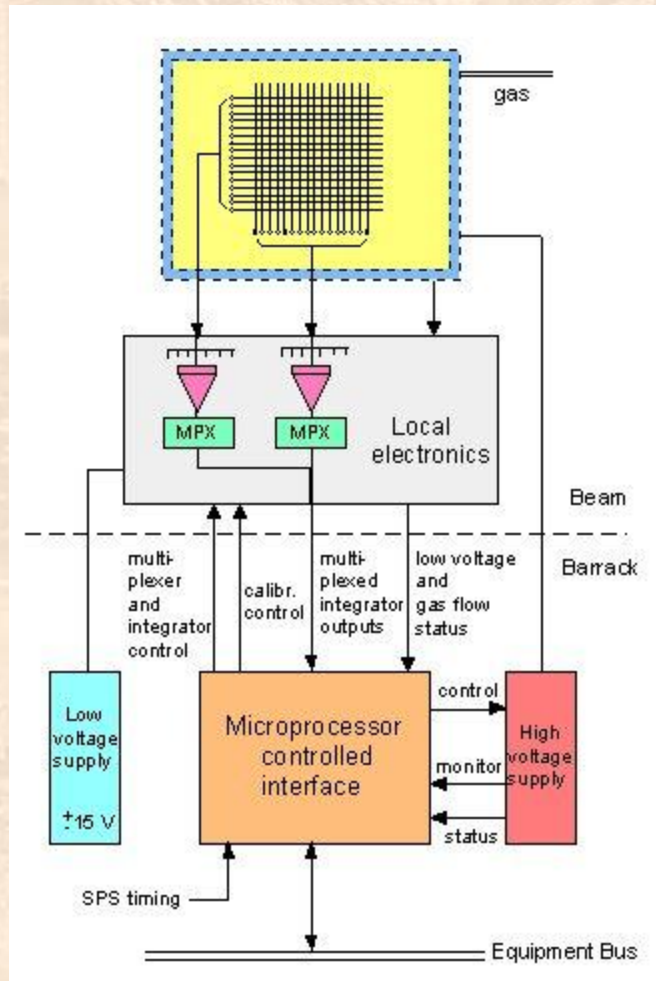
- The local electronics contains integrators for each wire of the chamber and the integrated charge is multiplexed and send to the acquisition system on the surface, often through several hundred meters of cable.

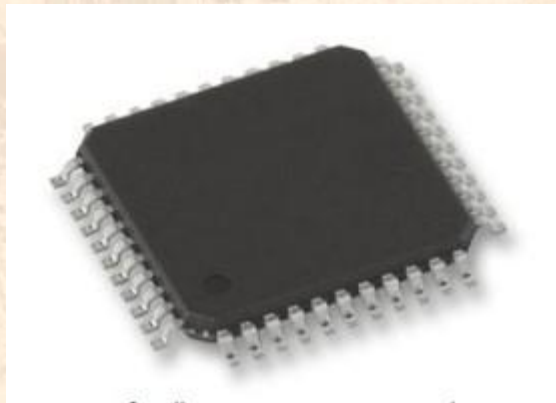
- Triple logic with an XILINX :
- XC2C384 CoolRunner-II CPLD

- Radiation **dose...?**
- No real radiation damage observed.
- But several Single Event Upset observed, needing a reset of the XILINX.
