DESIGN OF LOAD-TO-FAILURE TESTS OF HIGH-VOLTAGE ELECTRIC INSULATION BREAKS FOR ITER'S CRYOGENIC NETWORK

*S.A.E. Langeslag, E. Rodriguez Castro, I. Aviles Santillana,
S. Sgobba, A. Foussat*

*CERN, CH-1211 Genève – Switzerland
Stefanie.Langeslag@cern.ch*

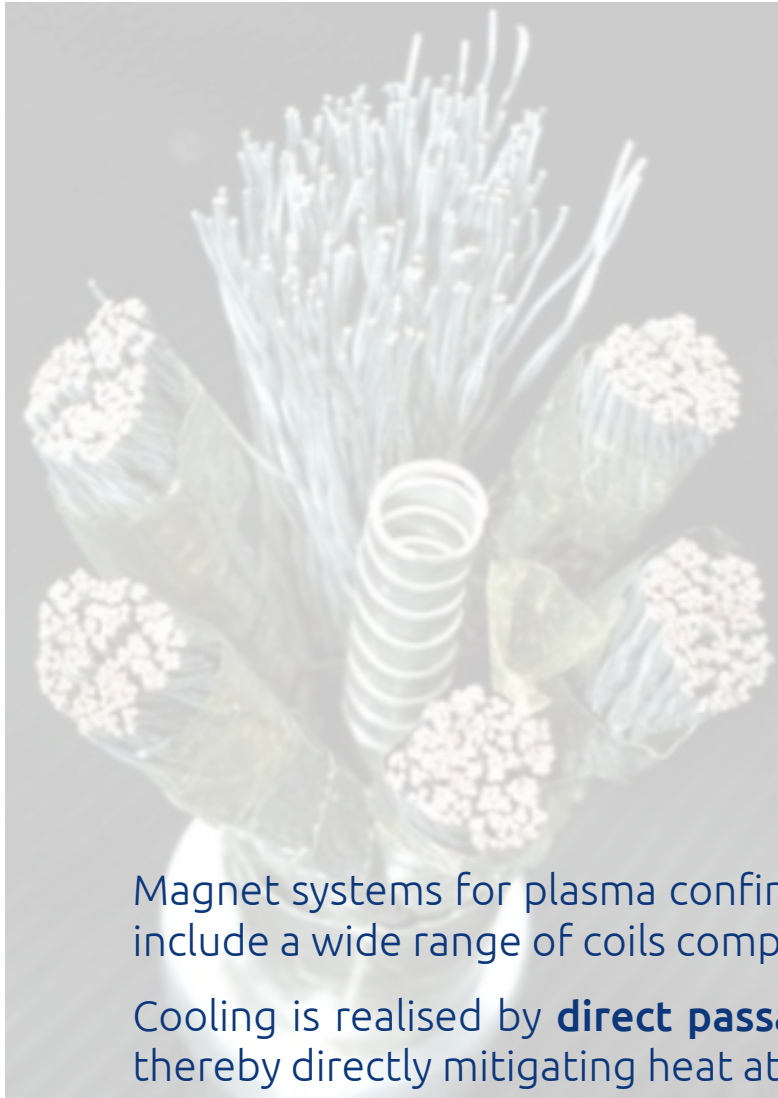
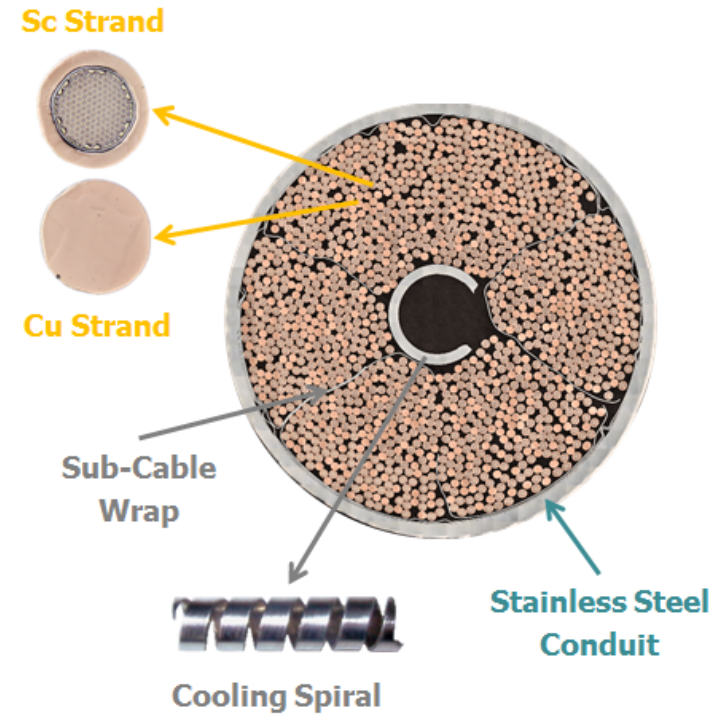
Figure 1: cross-section of one of the many types of CICCs implemented in the ITER experiment

Magnet systems for plasma confinement, in fusion energy experiments such as ITER, include a wide range of coils composed of **cable-in-conduit conductors (CICCs)**.

Cooling is realised by **direct passage of supercritical helium** through the conduits, thereby directly mitigating heat at the superconducting strands.

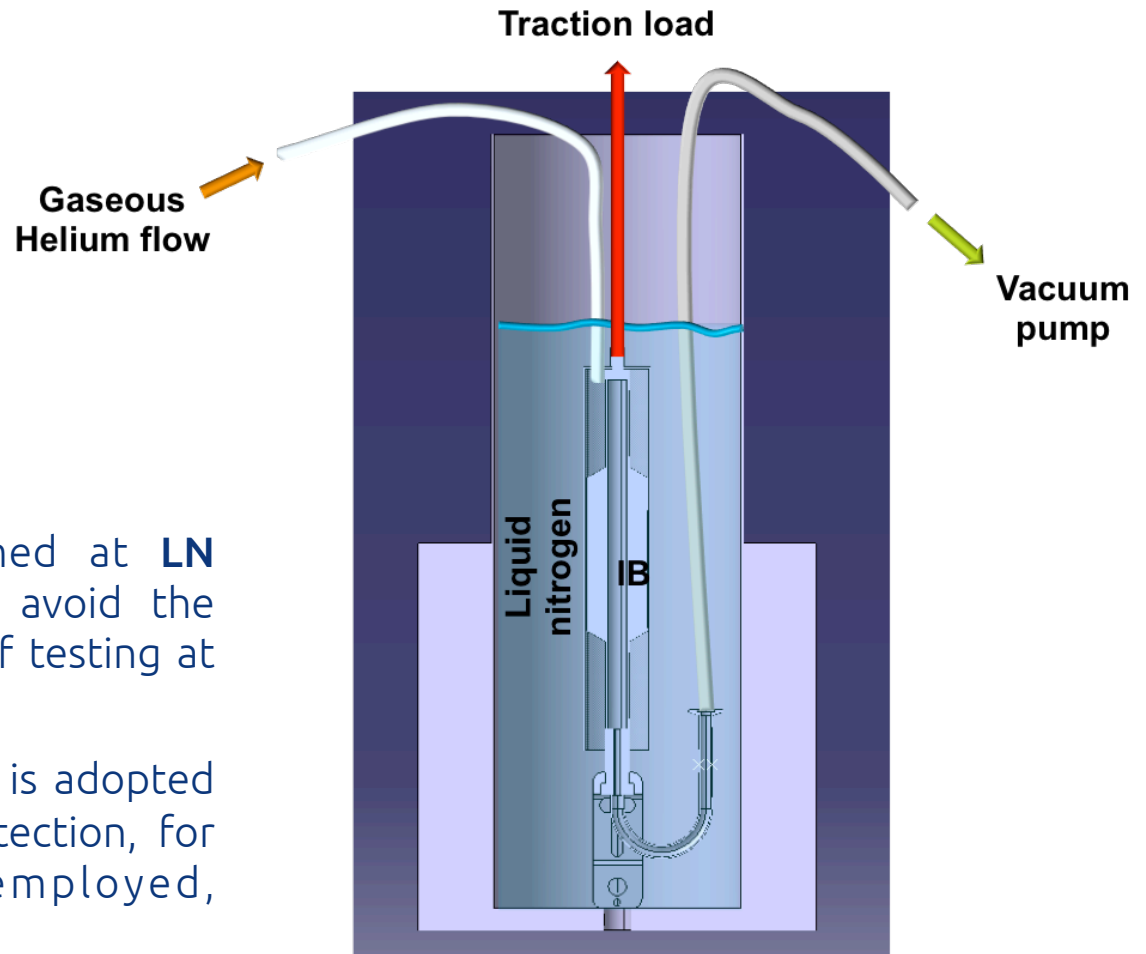
Measurements are performed at **LN temperature** (i.e. 77 K) to avoid the closed-circuit complications of testing at LHe temperature.

Low density **gaseous helium** is adopted as a flow agent for leak detection, for which a gas dome is employed, supported from the IB.

Figure 4: Schematic diagram illustrating the binary test setup design

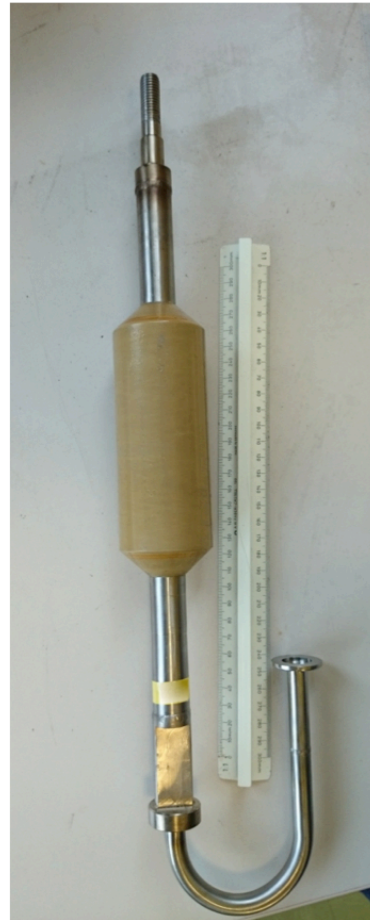
- TIG-welding of a **thread** for load application
- Gyrolok® coupling via a **U-tube** for pumping

Figure 5: Adjusted IB

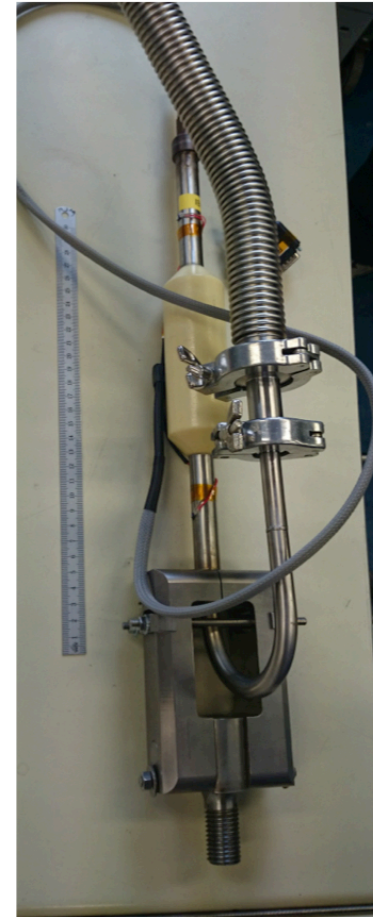
Bottom tooling is designed to grip around a **load bearing ring** on the bottom end, while allowing for the passage of the U-tube.

Figure 6: Adjusted IB including tooling for load and vacuum application

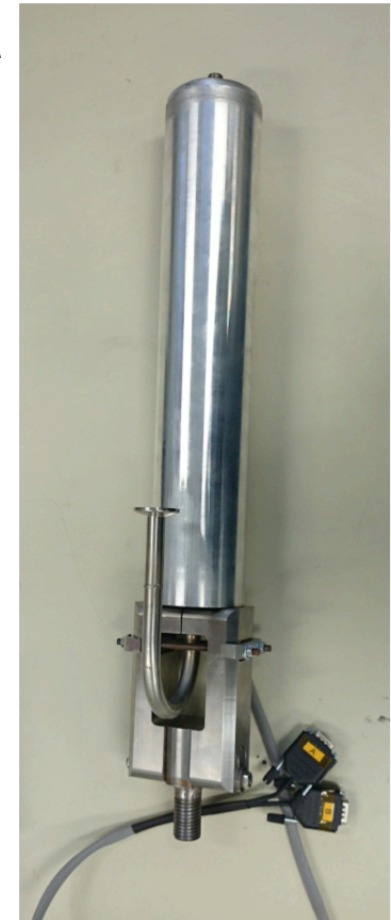
Figure 7: Adjusted IB including tooling for load application and gas dome

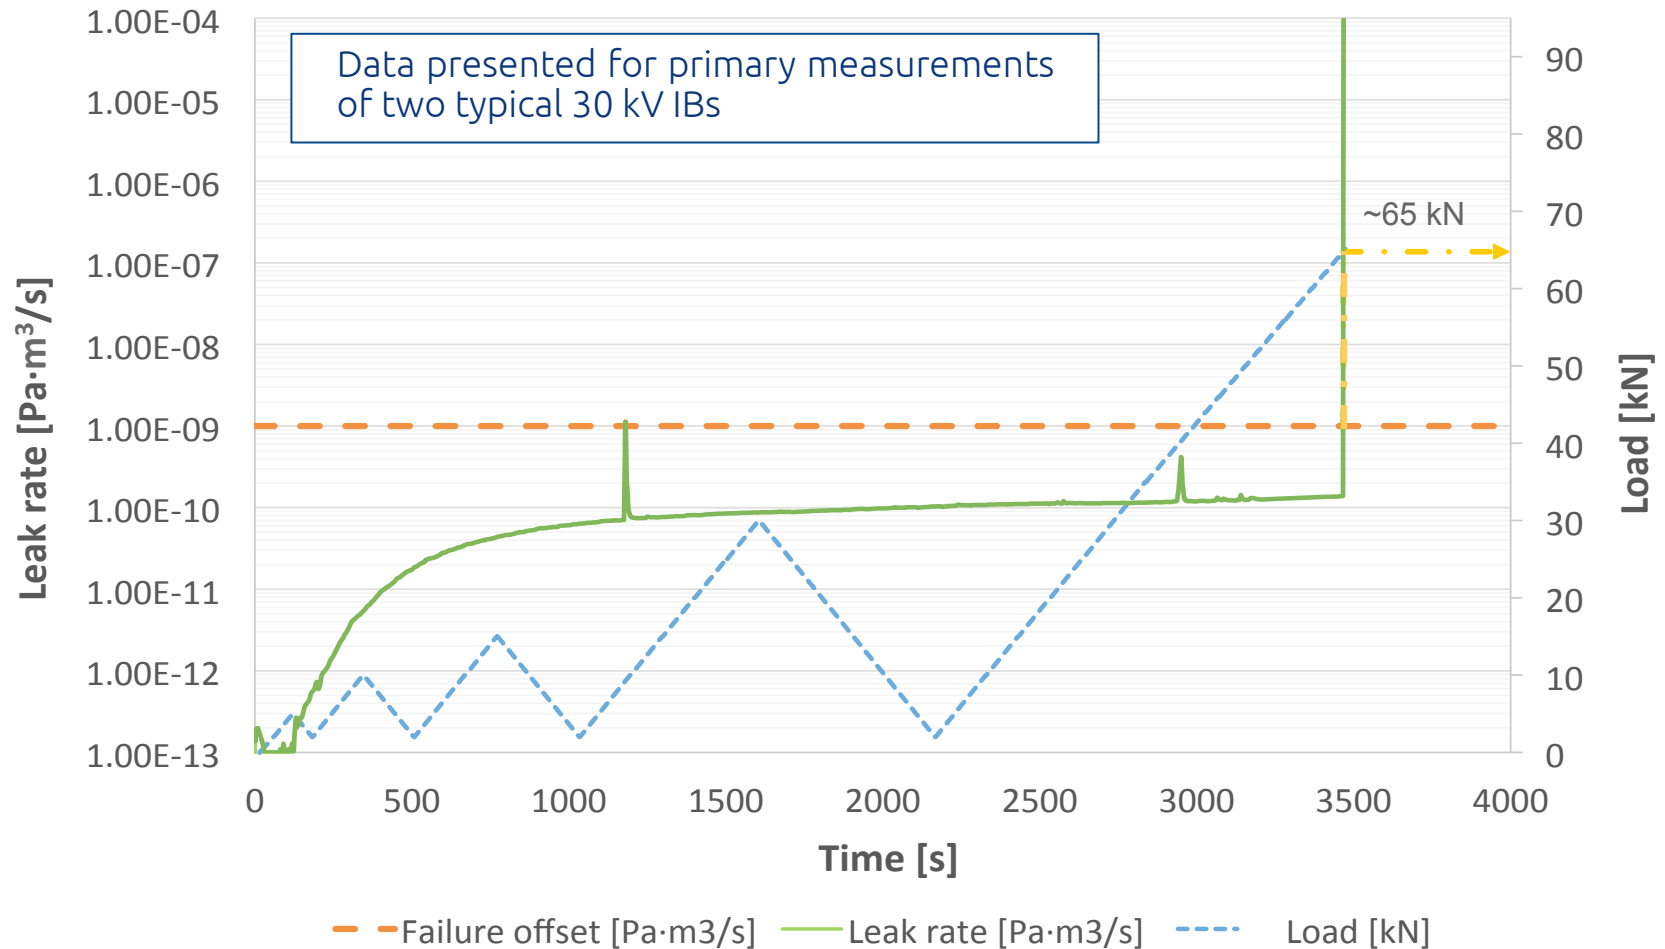
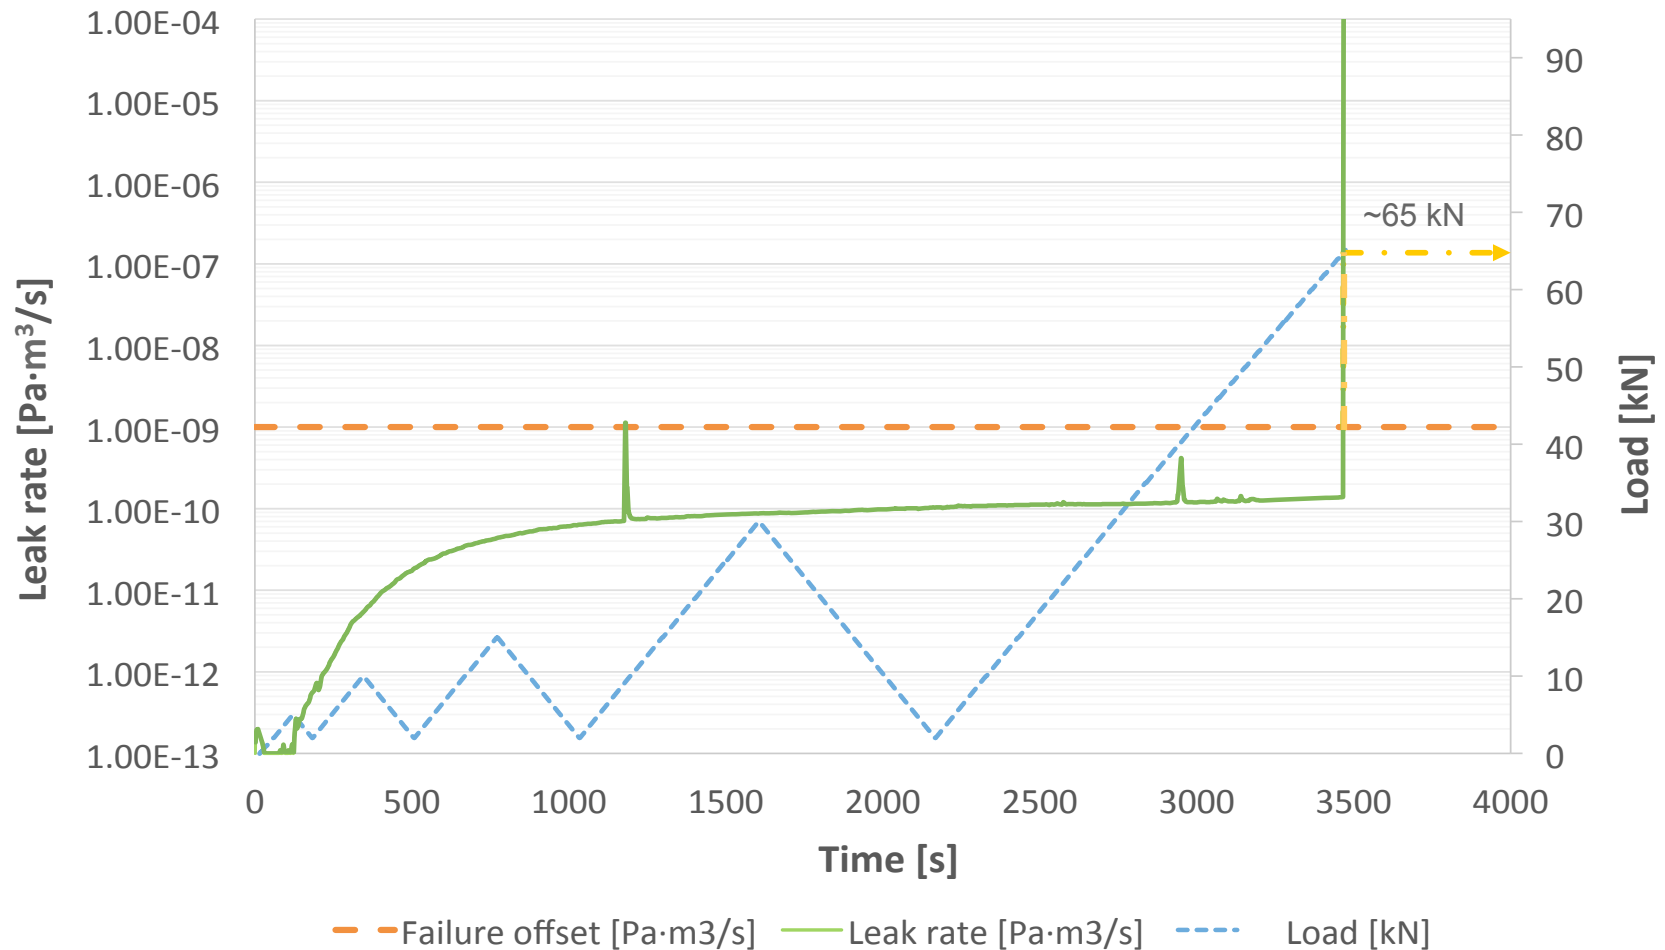
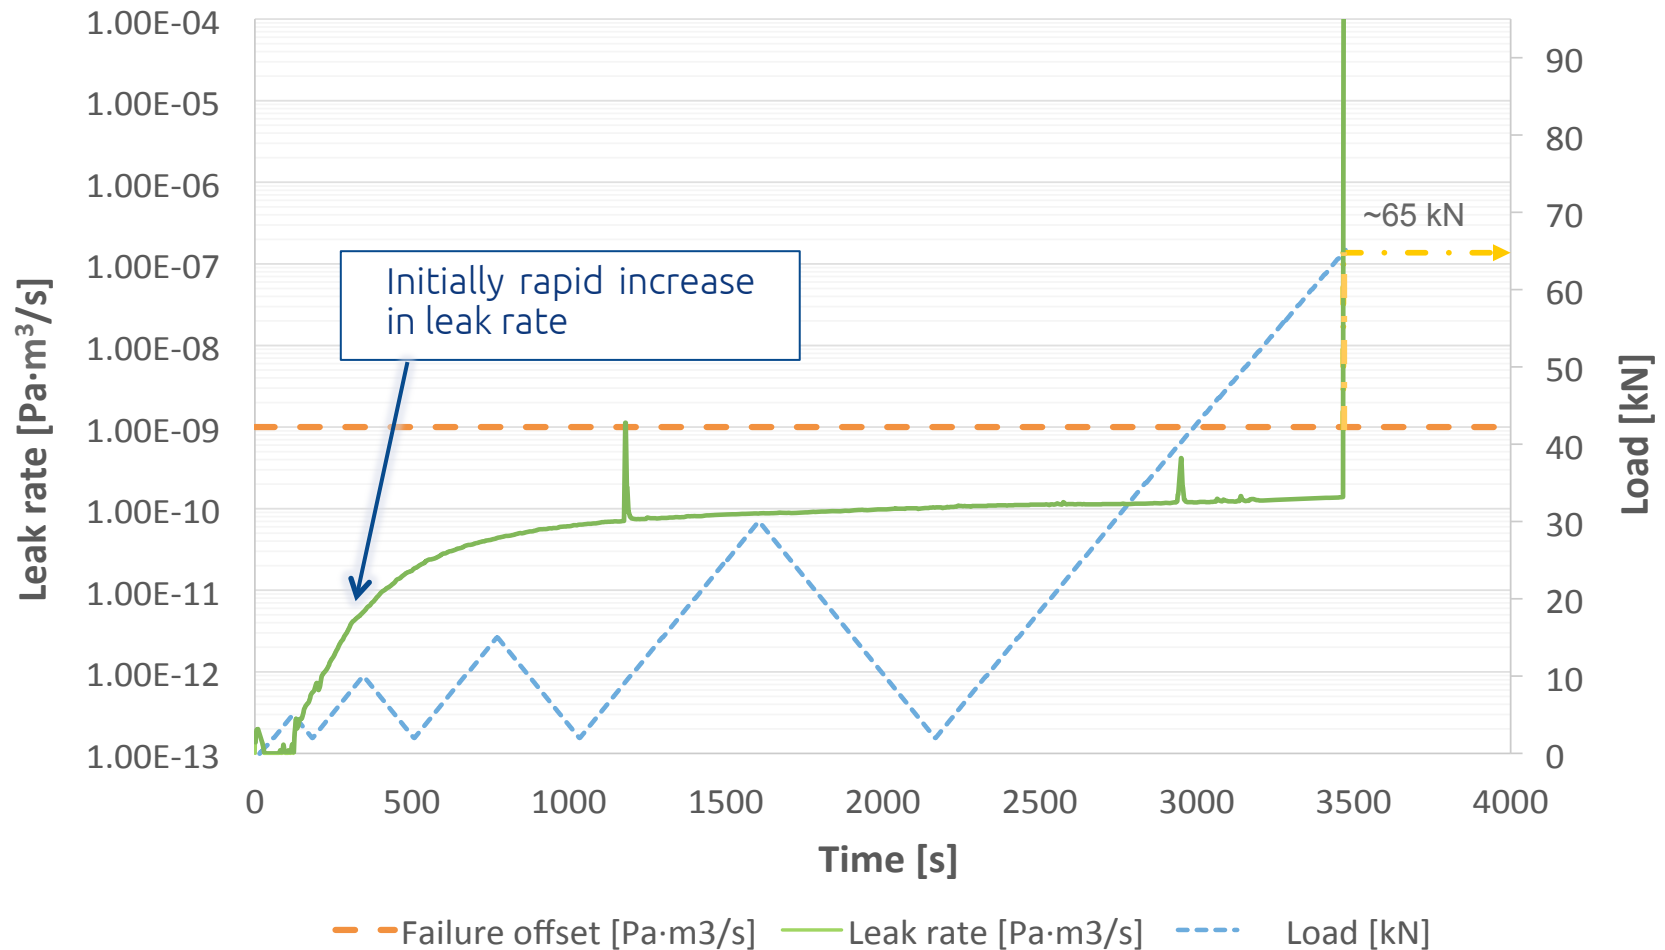
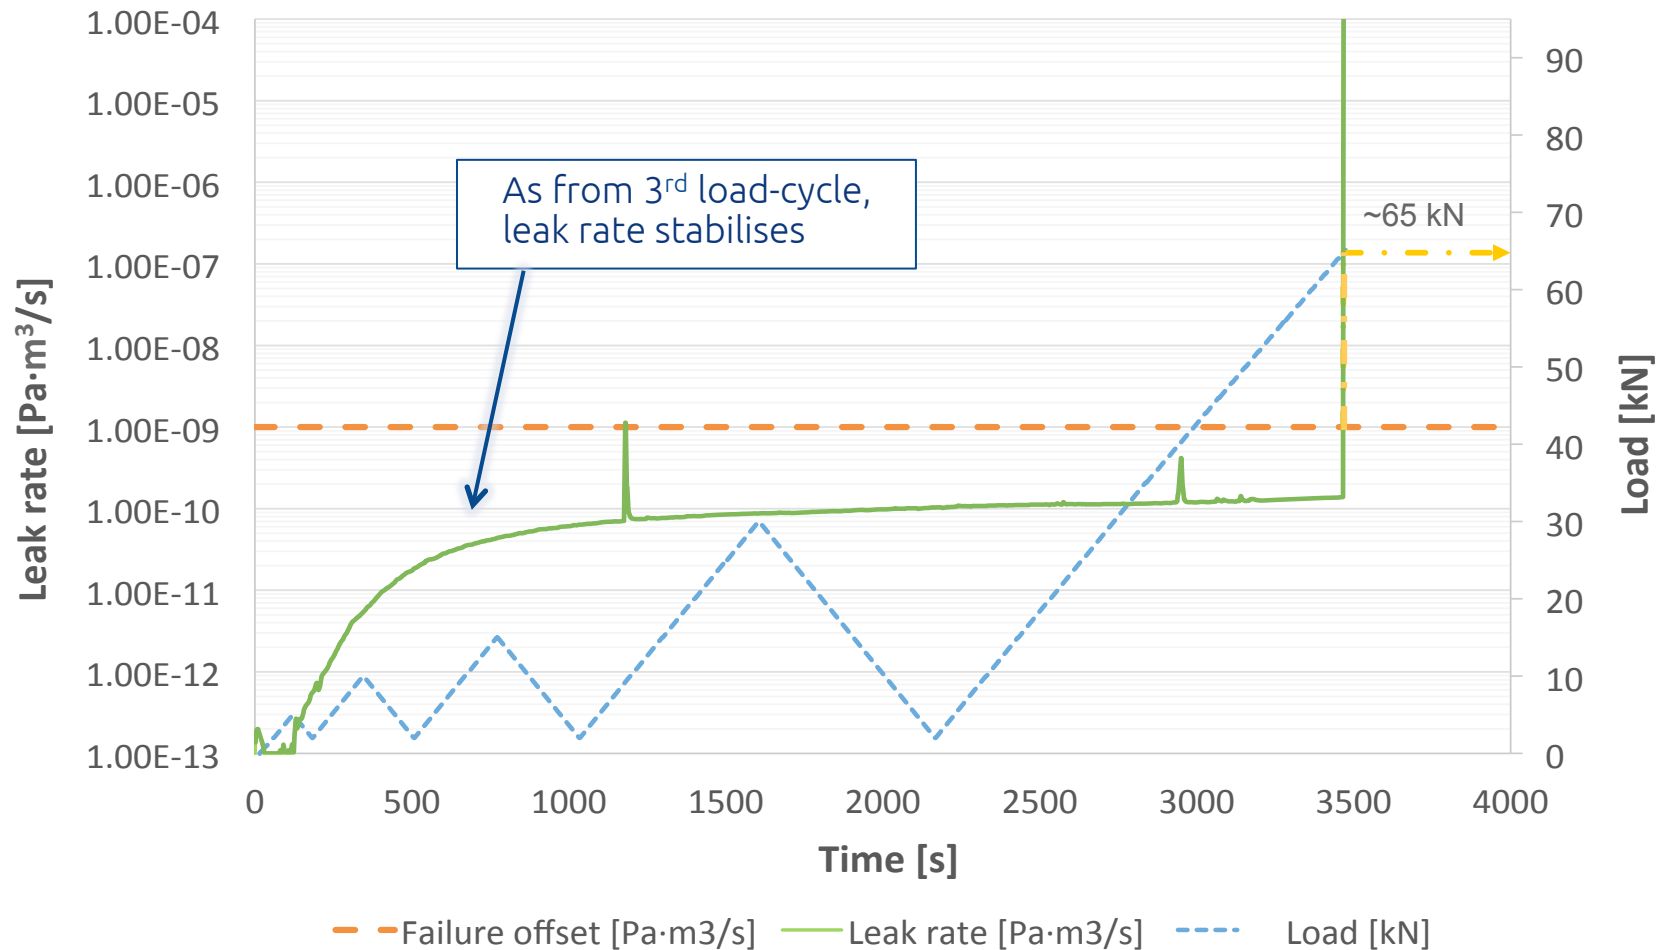
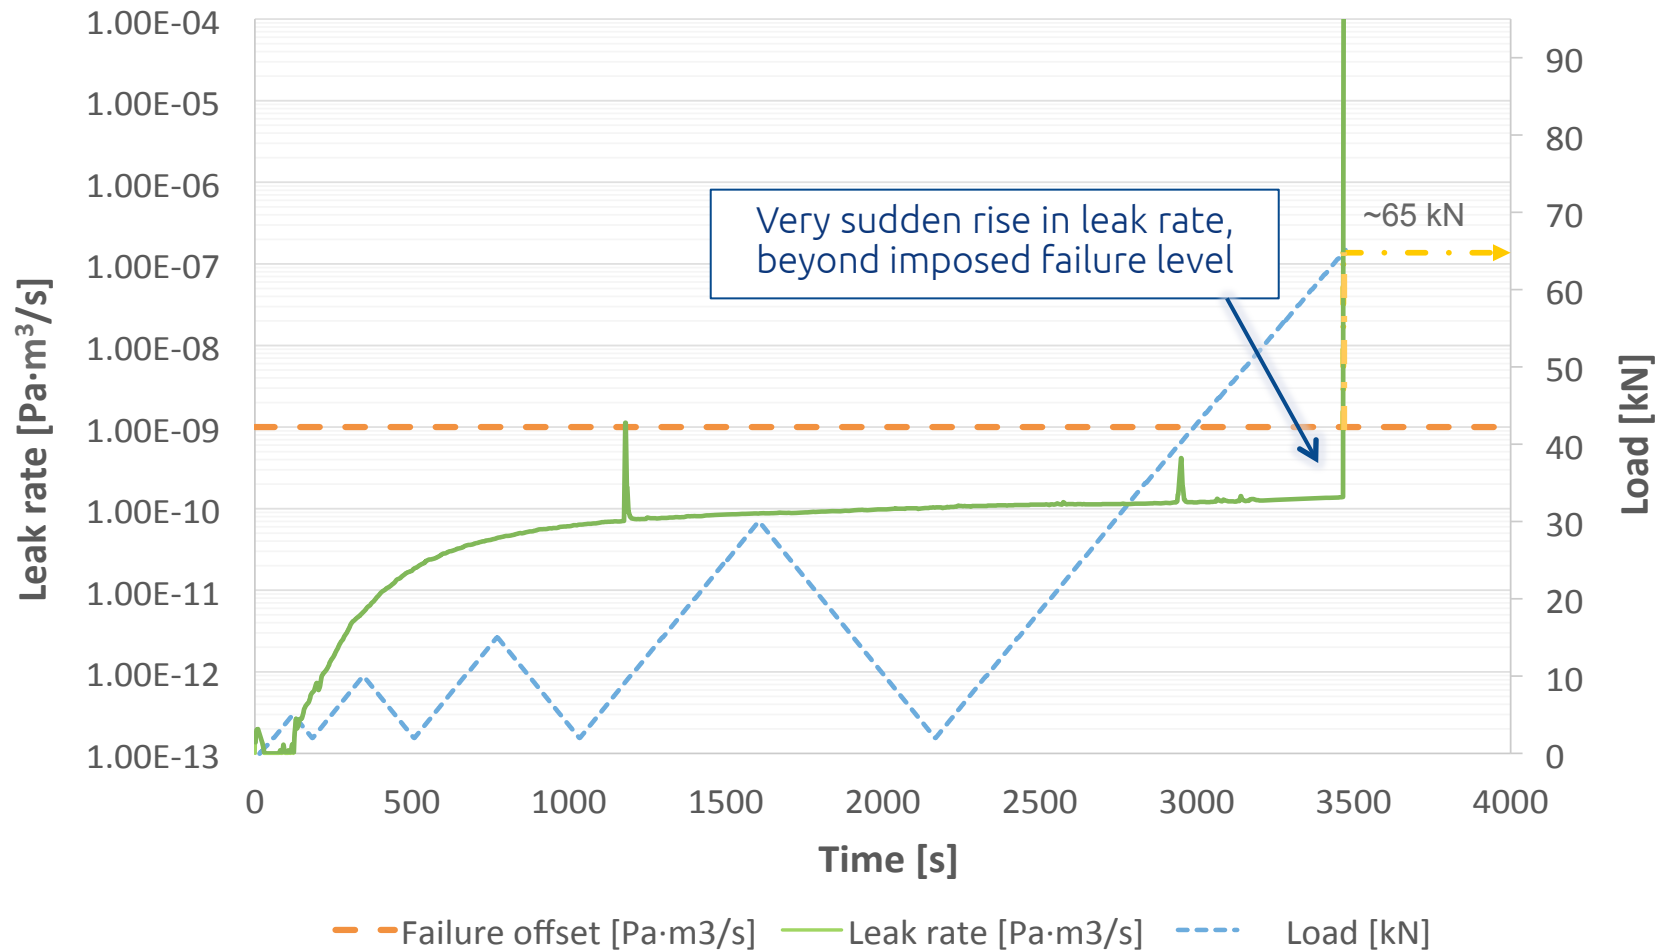
IB30kV1; primary measurement at 77 K

Figure 8: Diagram showing leak rate and applied load over time for the primary load-to-failure test of **IB30kV1** at 77 K

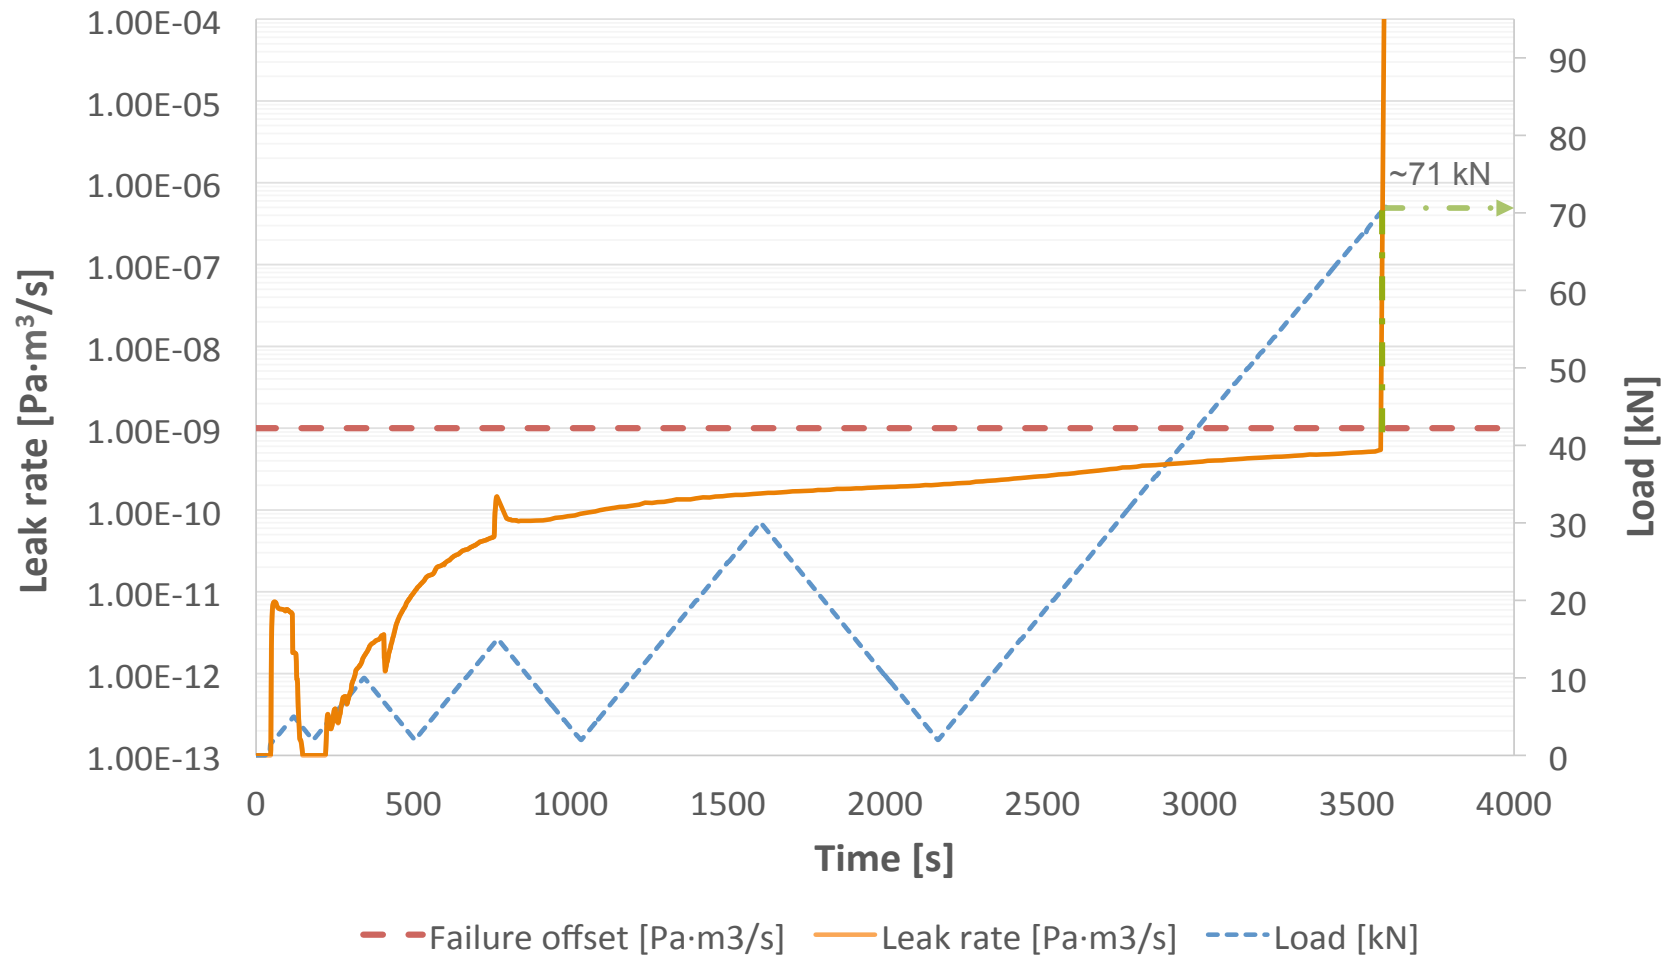
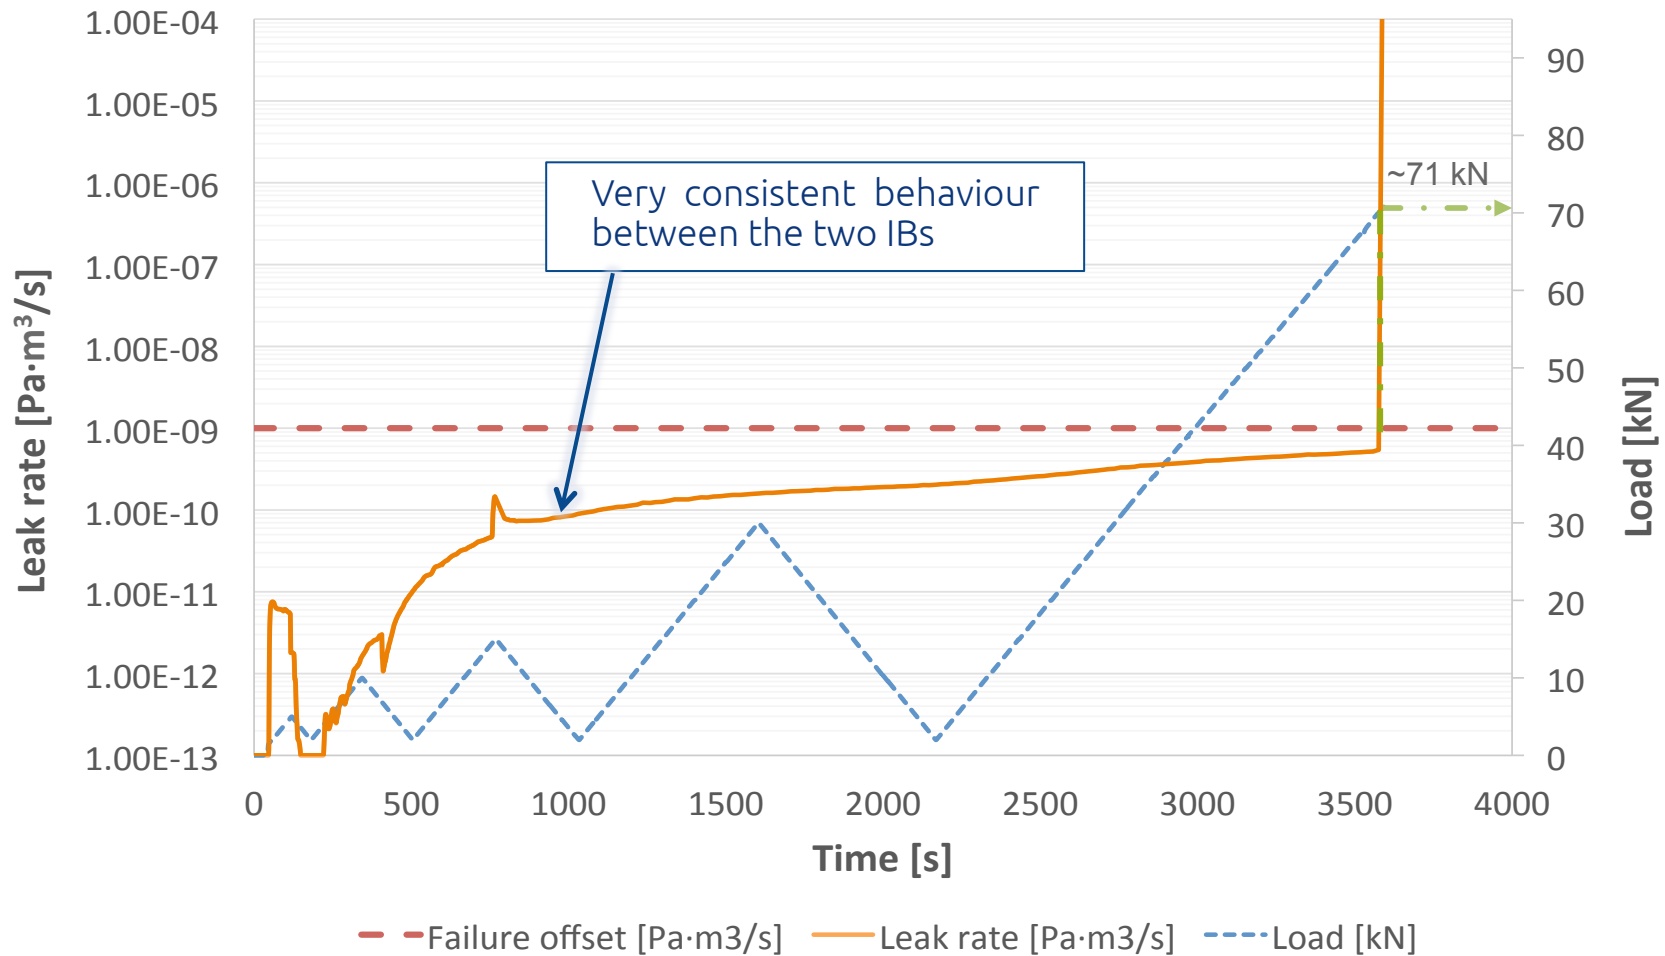
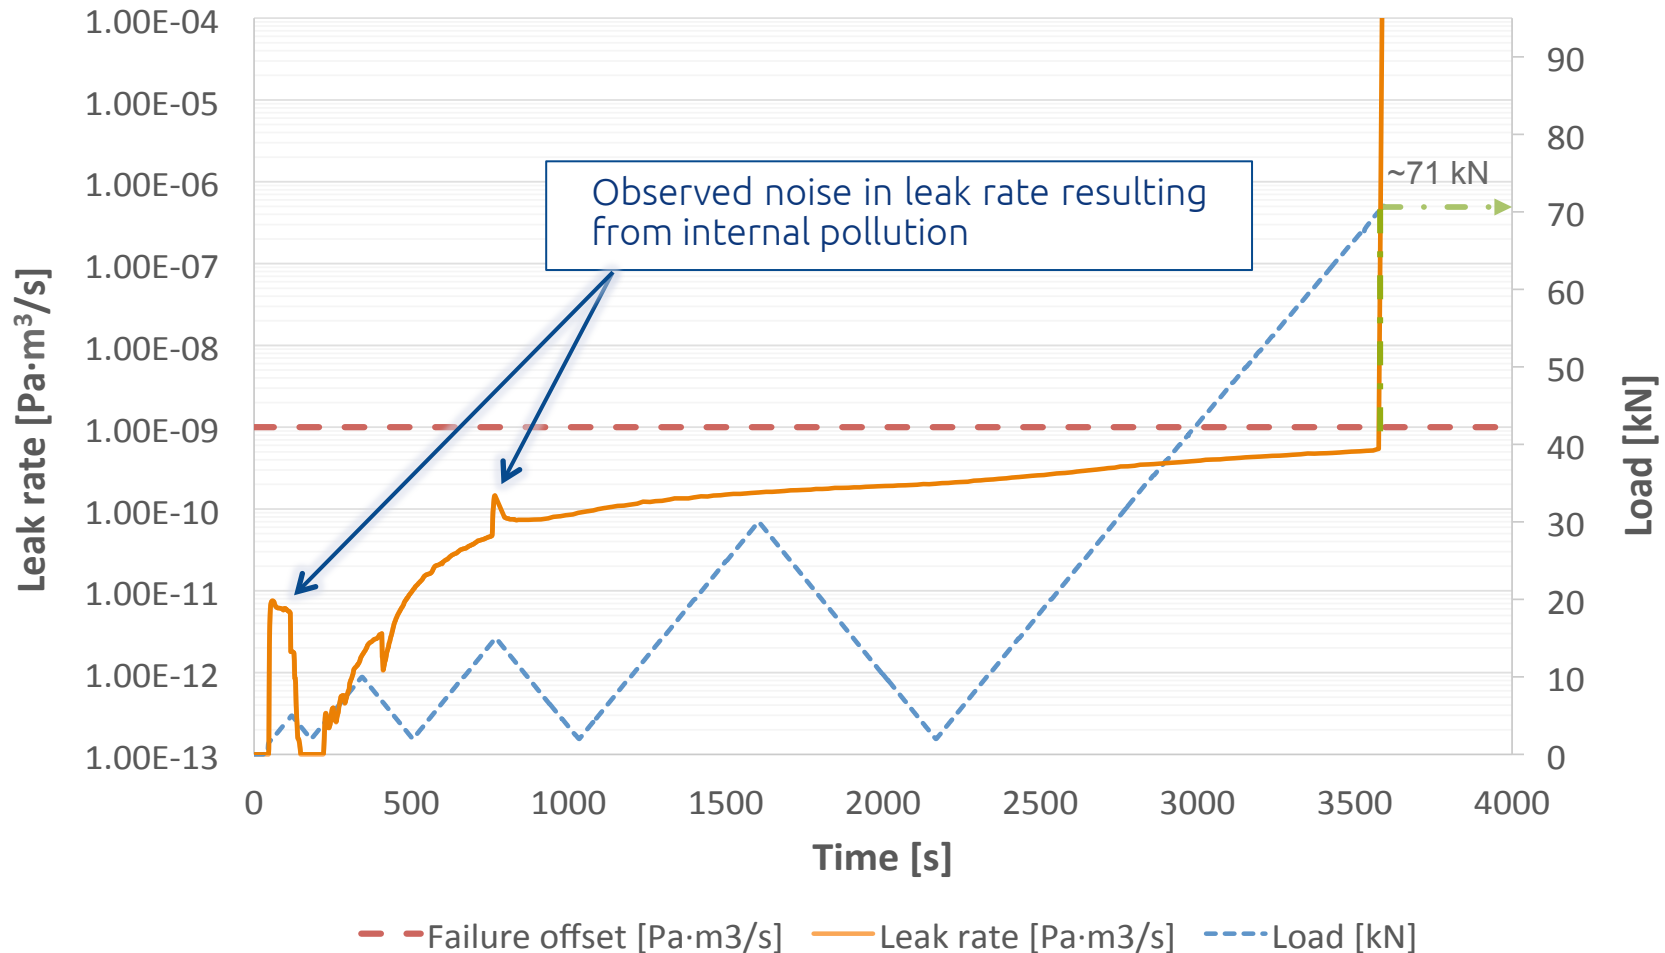
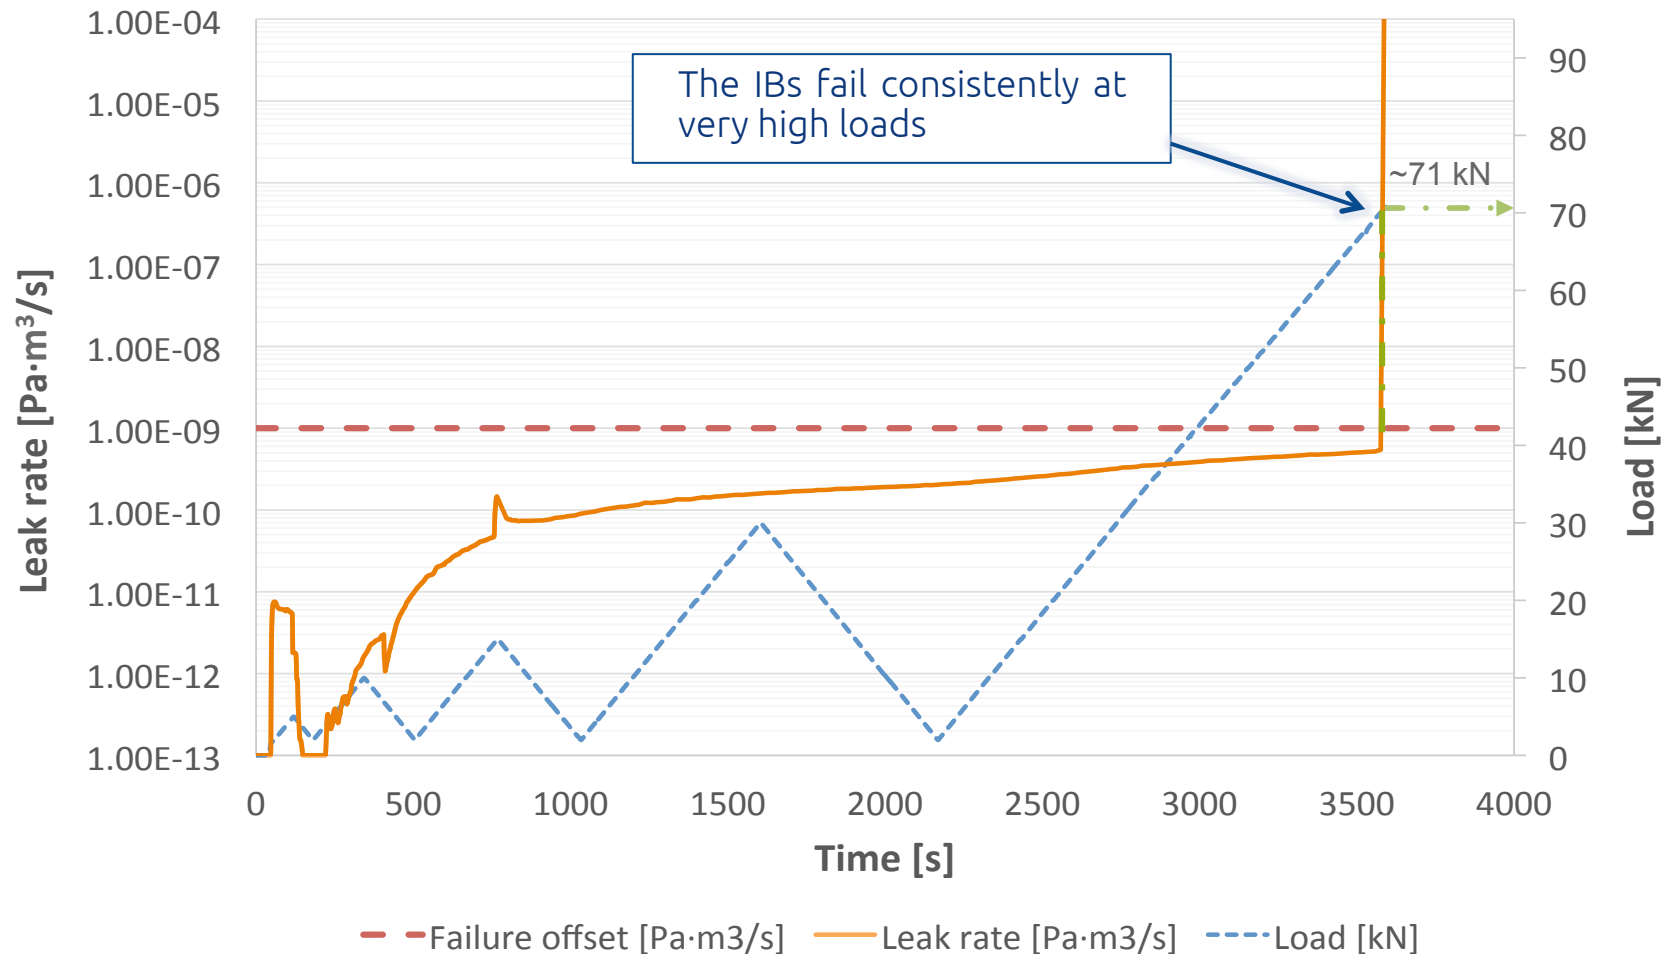
IB30kV2; primary measurement at 77 K

Figure 9: Diagram showing leak rate and applied load over time for the primary load-to-failure test of **IB30kV2** at 77 K

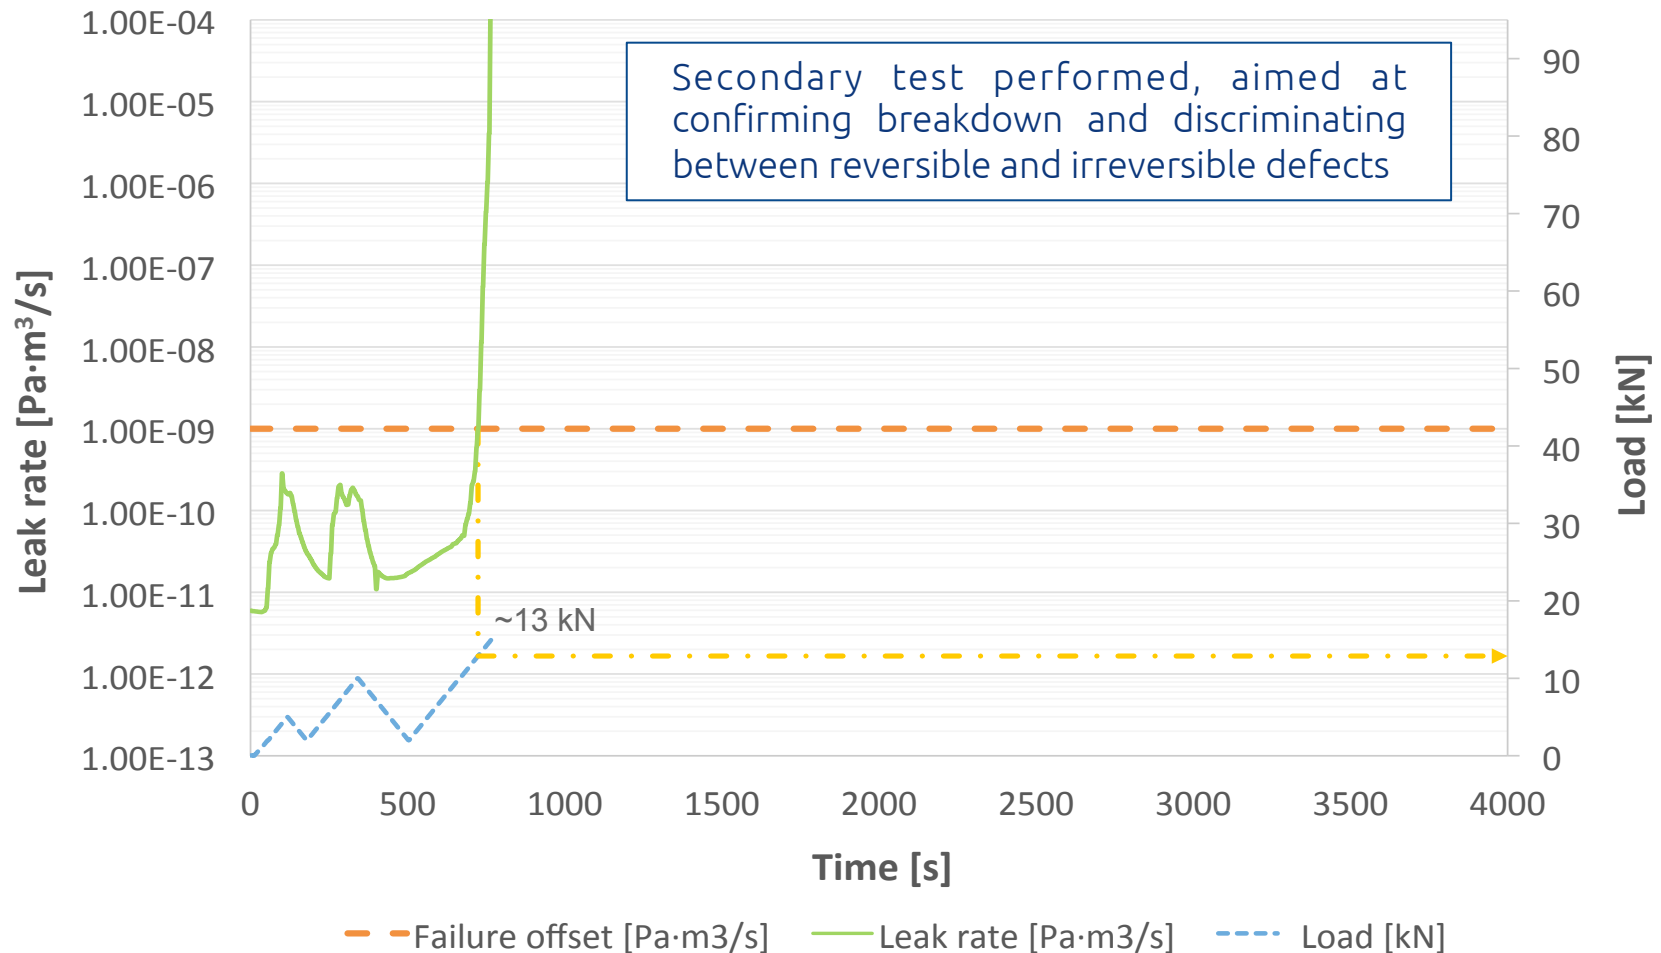
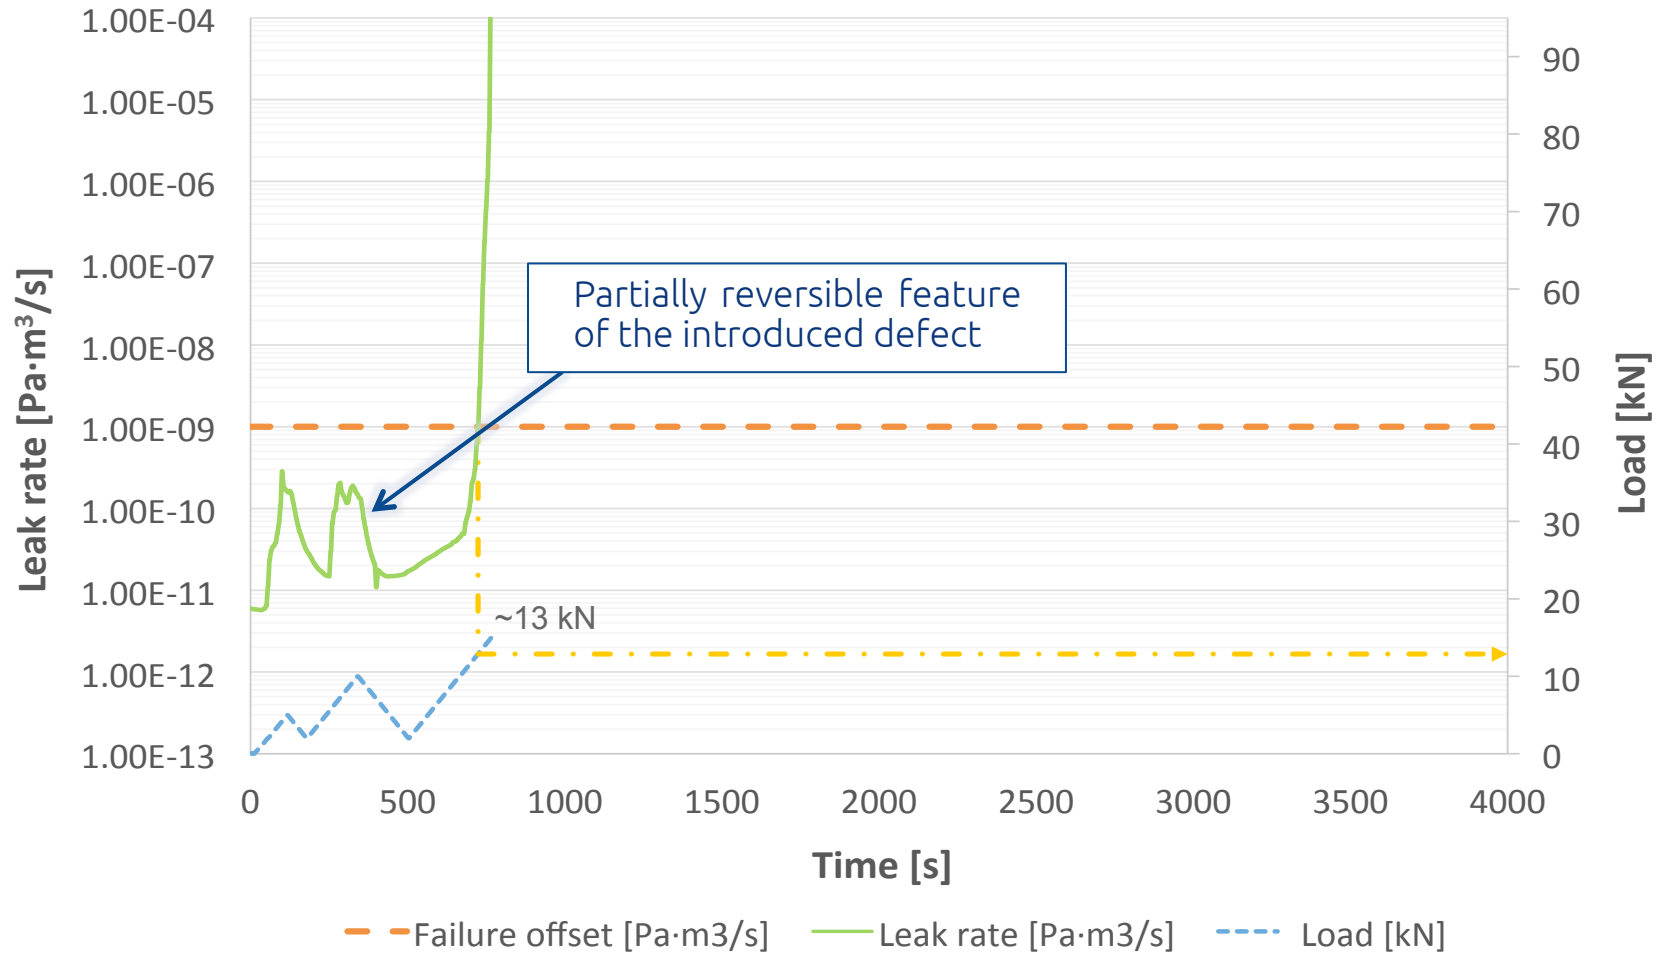
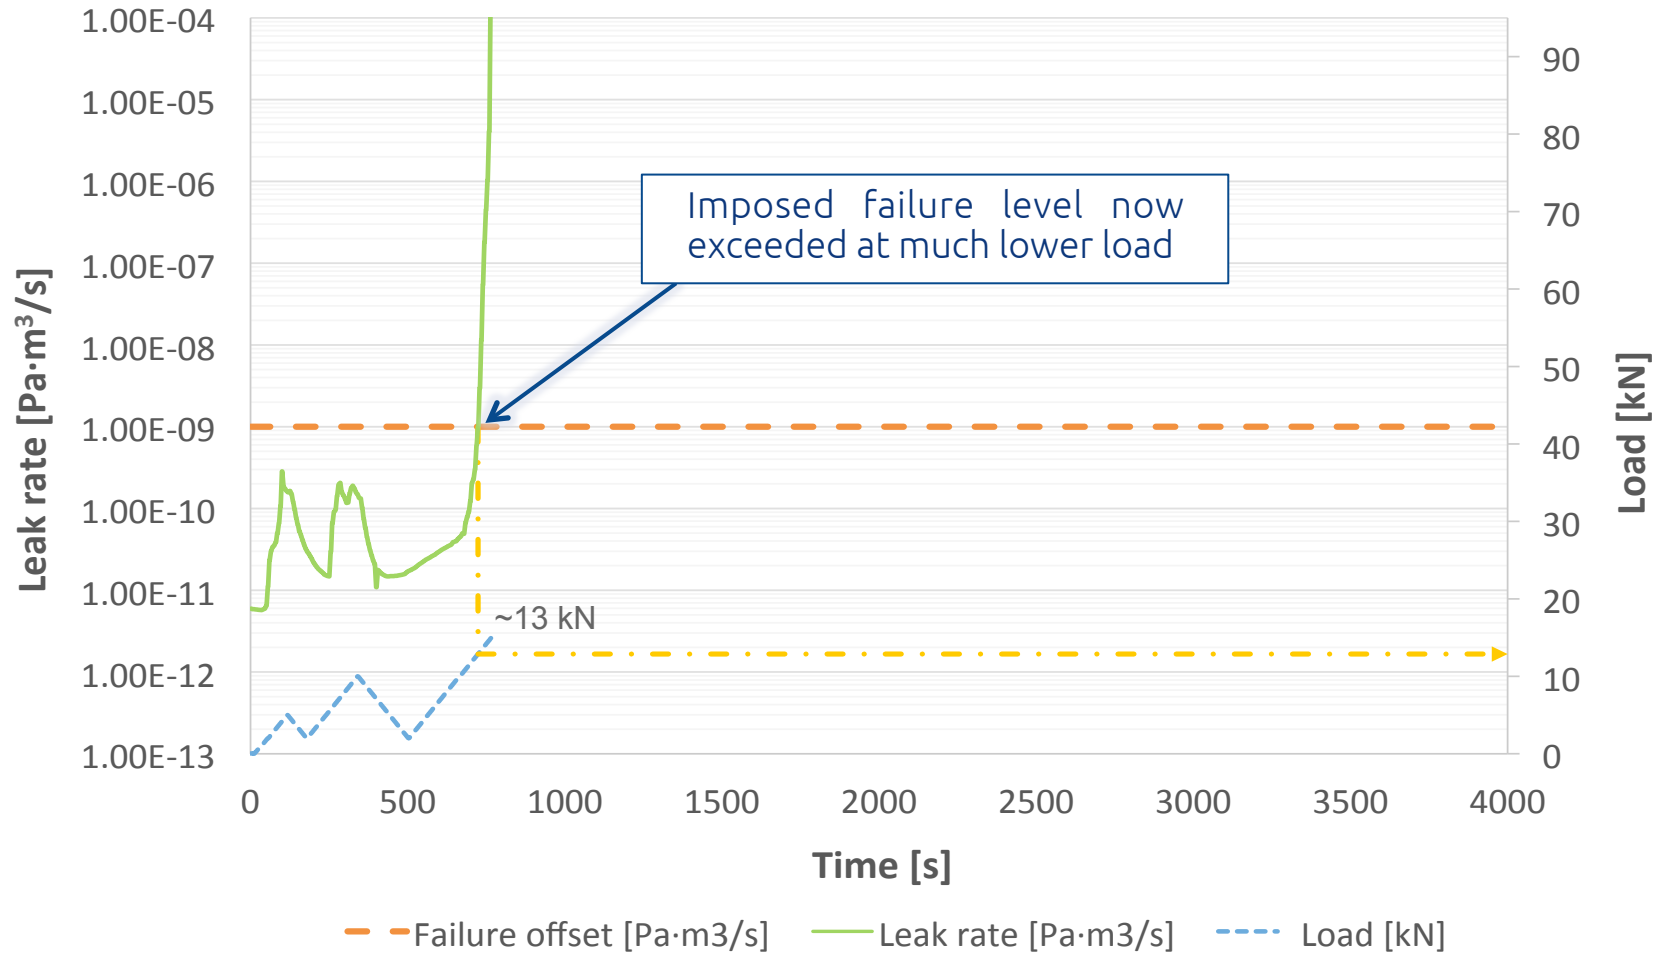
IB30kV1; secondary measurement at 77 K

Figure 10: Diagram showing leak rate and applied load over time for the secondary test of **IB30kV1** at 77 K
