DESIGN OF LOAD-TO-FAILURE TESTS OF HIGH-VOLTAGE ELECTRIC INSULATION BREAKS FOR ITER'S CRYOGENIC NETWORK

*S.A.E. Langeslag, E. Rodriguez Castro, I. Aviles Santillana,
S. Sgobba, A. Foussat*

*CERN, CH-1211 Genève – Switzerland
Stefanie.Langeslag@cern.ch*

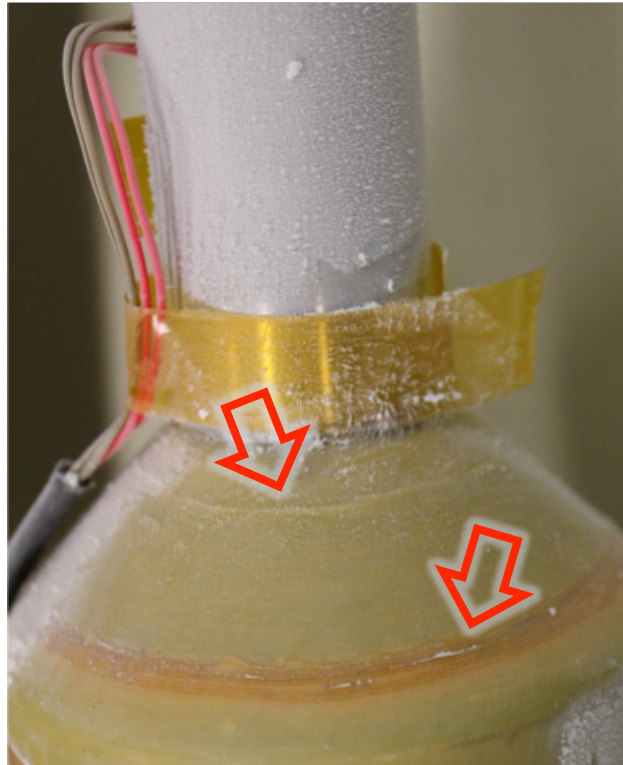
- **Interface** between end-fittings and first glass-resin layer.
- Amidst the glass-resin layers; **interlayer** fashion.

Figure 11: Defective regions observed on the as-tested IB30kV2, by visual inspection

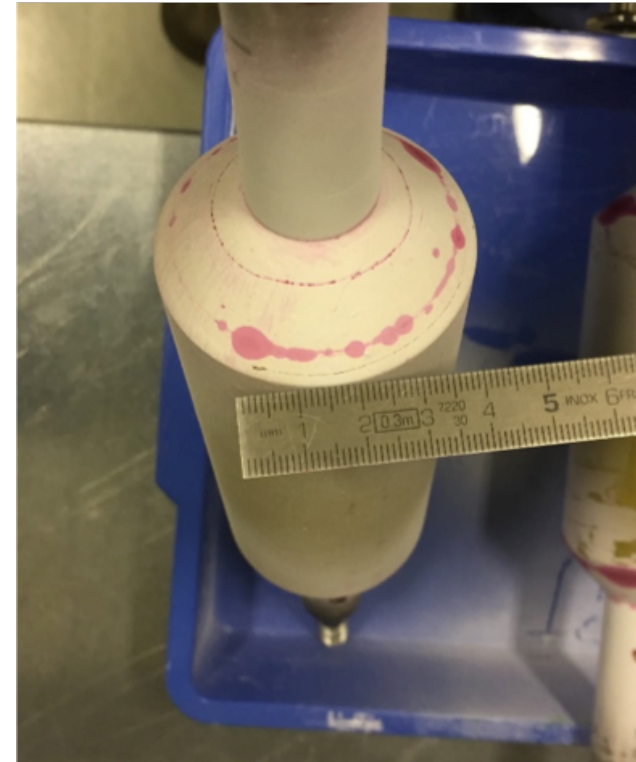
Figure 12: Observation of defective regions on IB30kV2, revealed by the application of liquid penetrant
