CALIFES and Two-Beam Module Status

W. Farabolini

CLIC Project Meeting #23

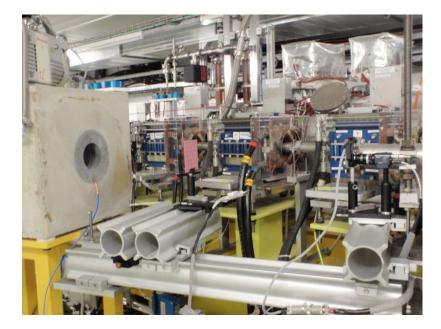
Irradiation Test Bench (E. Del Busto)

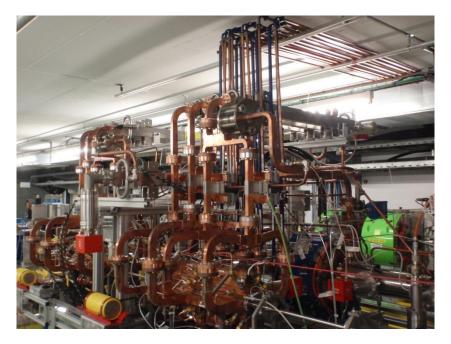
Connection by waveguide to the gallery

- The present installation (16 waveguides + filters) has been developed for the previous TD24.
- The location of the WFM pick-up have changed (2nd cell instead of central cell)
- The TE-like and TM-like frequencies are now different (27.3 GHz instead of 24 GHz, and 16.5 GHz instead of 18 GHz)
- Some problems with the log-detector crates (too low bandwidth -> short the final amplifier)
