# CLAS12 Micromegas Production

AND ISSUES WITH CONNECTIONS TO RESISTIVE LAYERS

MAXENCE VANDENBROUCKE – RD51 MINI-WEEK – DECEMBER 2016

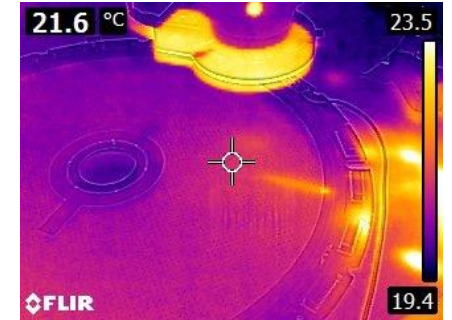
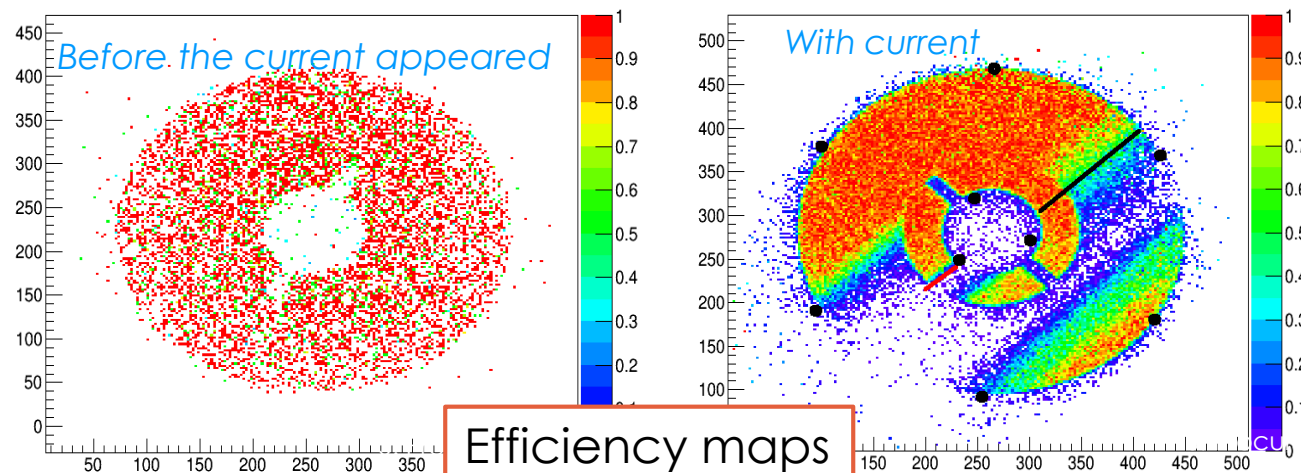
# Pre-Production Forward Disk for CLAS12: issue with resistive ladders

- ▶ 2 pre-production (2015) detector tested, One was not ok :
  - ▶ High current due to a contact in the active area (can't burn it with sparks)
  - ▶ Current flows from the contact to ground (black dots)
  - ▶ Large impacted zone due to ladders
  - ▶ Drift electrode glued (intervention impossible)
  - ▶ Carbon frame for gas distribution

Current without ladders

Resistive Strips

- ▶ Non-glued design
- ▶ Aluminum frame for gas distribution
- ▶ No ladder between resistive strips
- ▶ Validation using X-Ray generator
- ▶ **More ground connections**
- ▶ **Production of 6 Disks finished and sent to Jlab in September 2016**

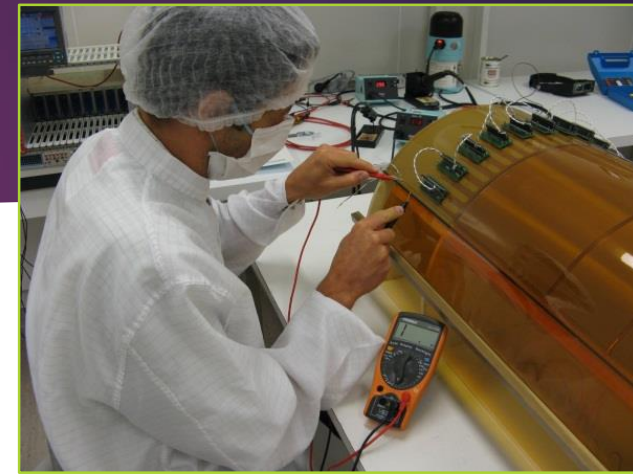
Electric leak test

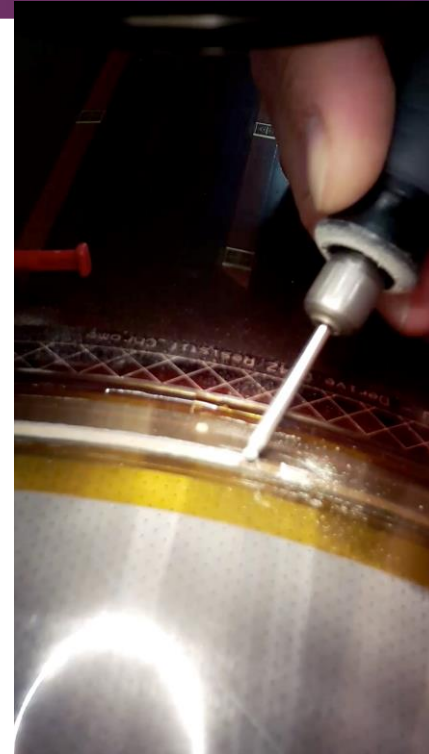
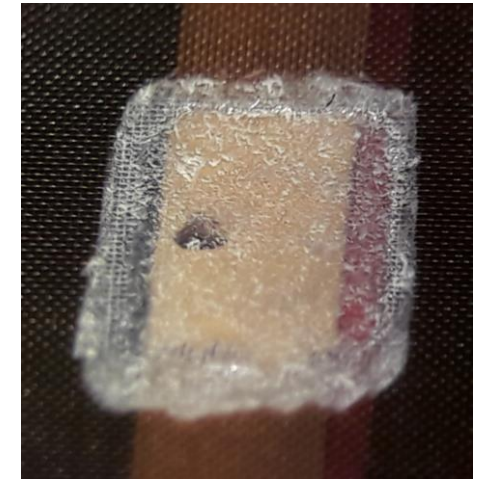
# Investigating the issue

Bubbles has been observed between the mesh and the silver paste contact

**Solution:** Remove the mesh over the full silver paste zone, and modify future layout

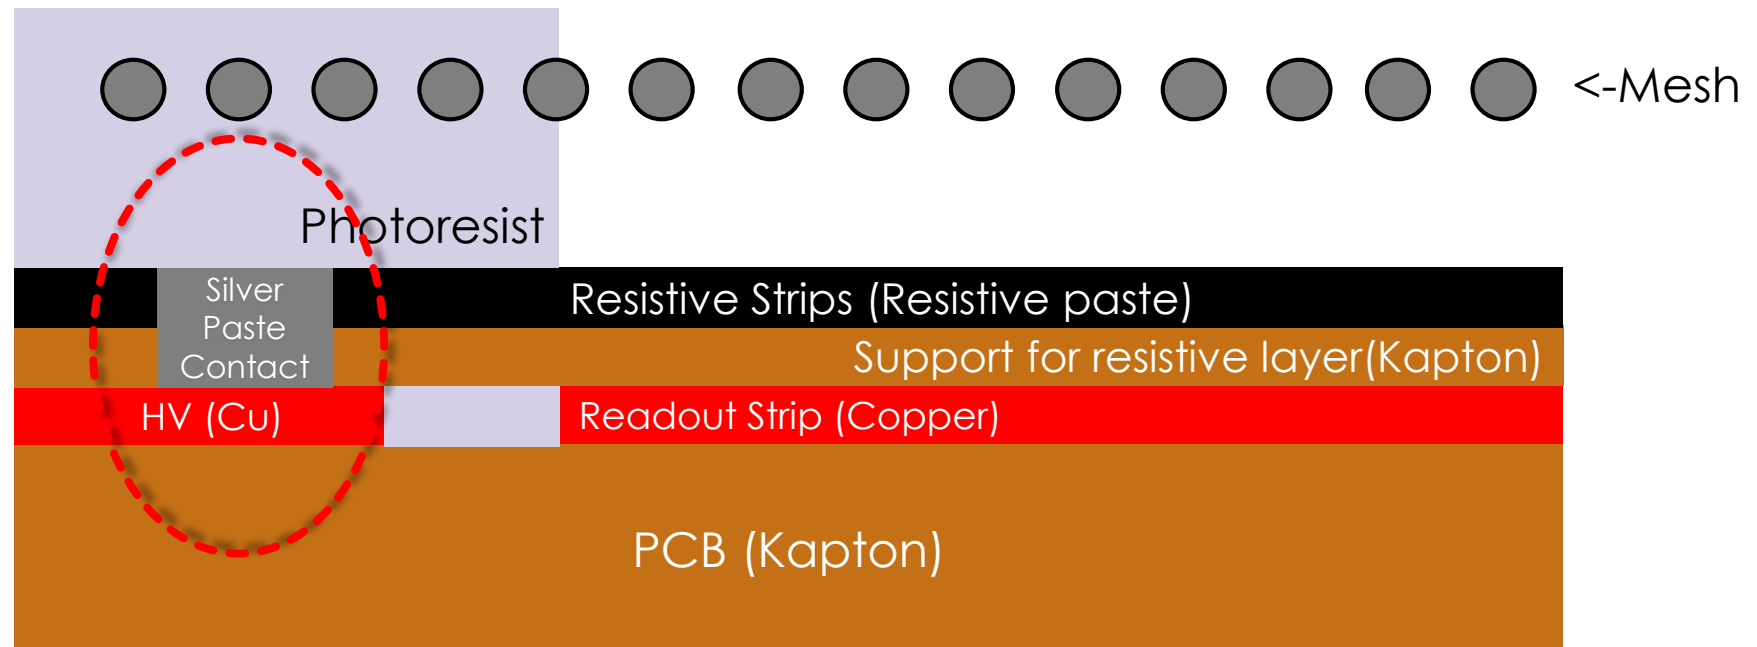
- ▶ The shorts are always located in the silver paste contact area

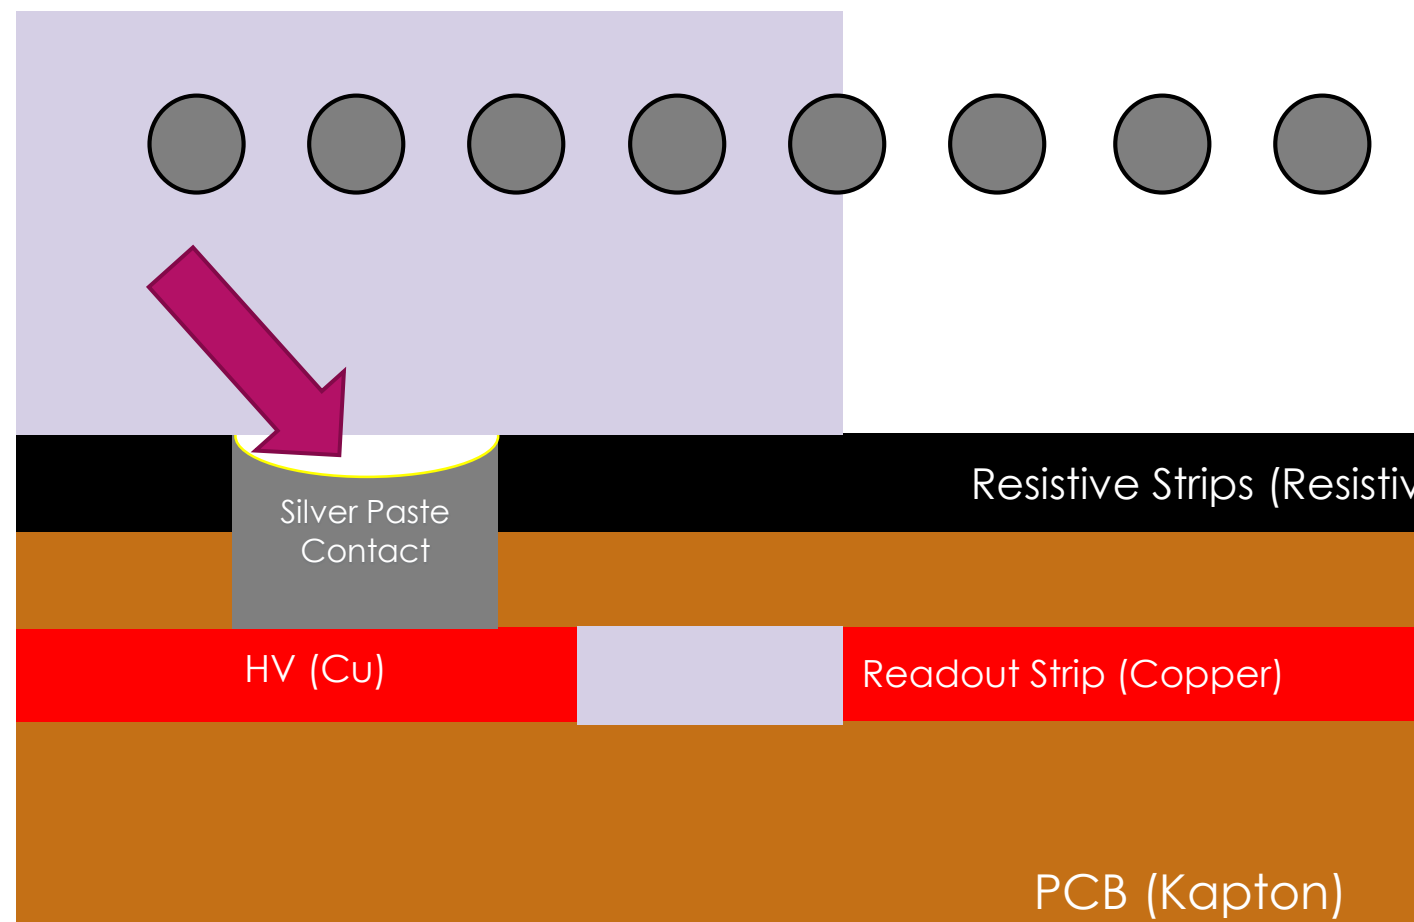
- ▶ Rui's explanation :
  - ▶ The Silver paste hole is not fully filled
  - ▶ Outgassing of the silver paste filled the hole

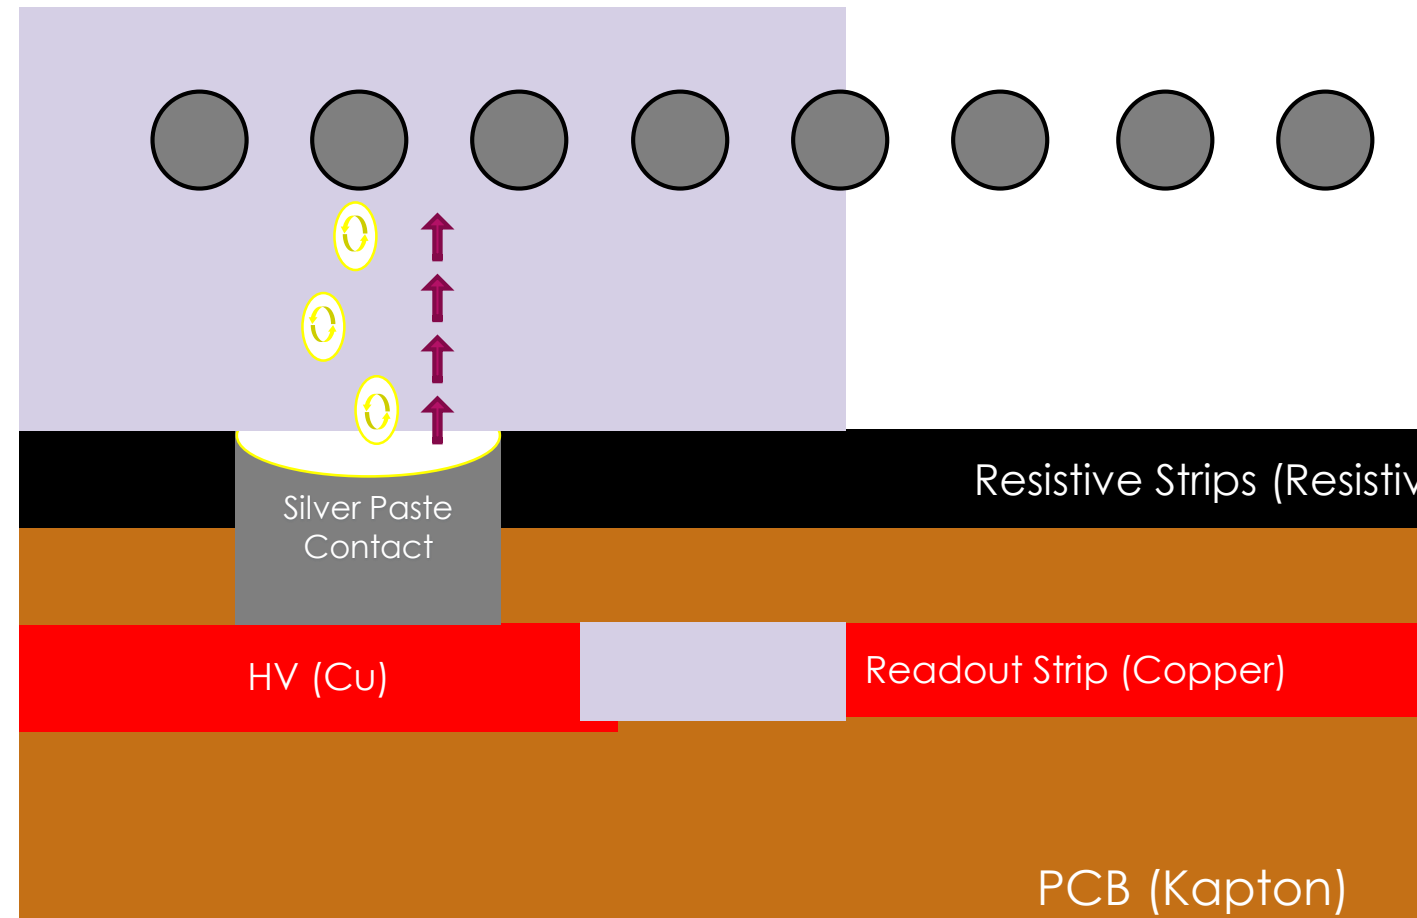
- ▶ Rui's explanation :
  - ▶ The Silver paste hole is not fully filled
  - ▶ Outgassing of the silver paste filled the hole
  - ▶ With HV, a corona effect starts in the hole
  - ▶ Bubbles starts migrating through the photoresist
  - ▶ This creates the short between mesh (ground) and the resistive layer (HV)
