Post-Mortem Mechanical Investigation of ITER TF Conductor Samples After Heat Treatment and SULTAN Testing

Anthony Doan¹, Ben Thronson¹, Matthew C. Jewell¹, V. Tronza², N. Mitchell²

¹Materials Science and Engineering Program ❖ University of Wisconsin – Eau Claire, Eau Claire, WI

²ITER Organization, St. Paul-lez-Durance, France

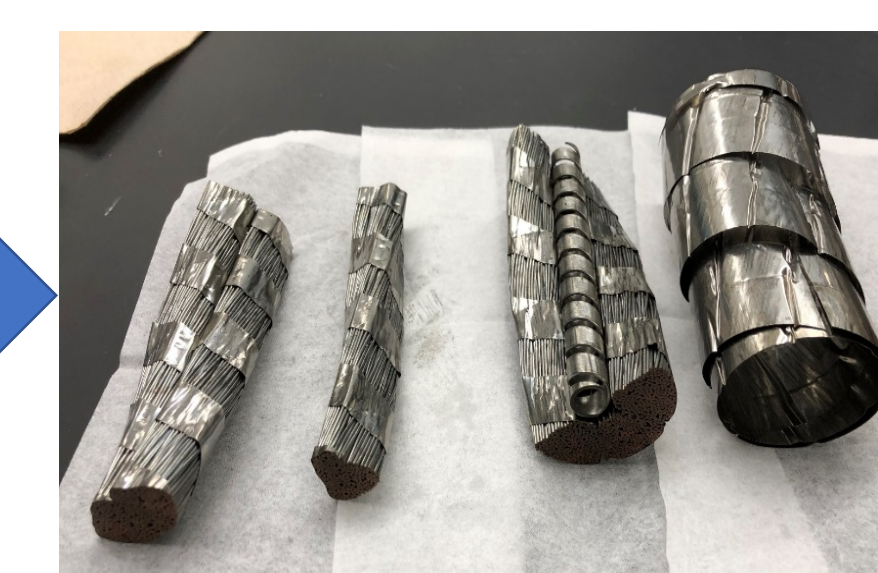
- ❖ To characterize the plastic deformation in the wires, we first disassembled a baseline conductor sample (10 cm) using **electrical discharging machining (EDM)** to section the conductor.
- ❖ We proceeded to separate individual wires based off the level of damage and region-based damage presented on the wire.
- ❖ We use **Laser Scanning Confocal Microscopy (LSCM)** to measure the cross-section and height of the dents.

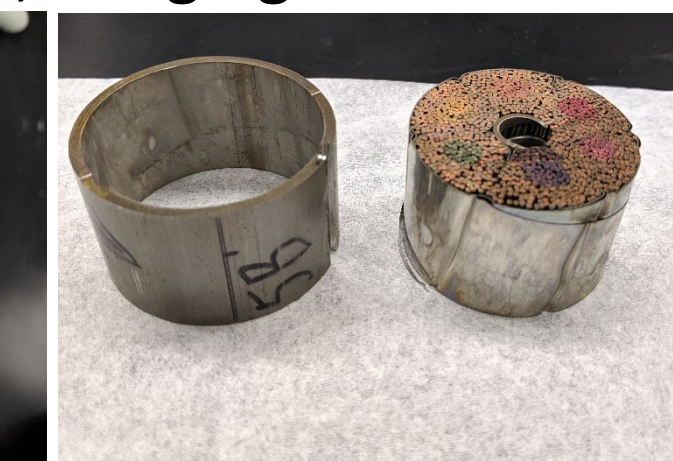
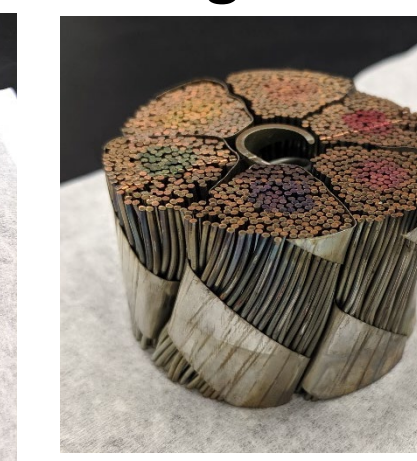
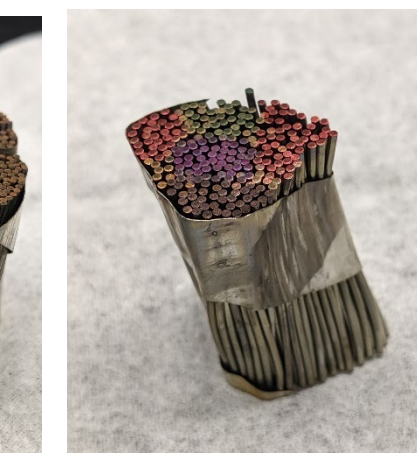
- ❖ Filament crack analysis occurs through the same disassembly process, but with 3 cm sections of conductor instead of 10 cm.
- ❖ After the disassembly of the shorter conductor into individual wires, specific wires with deformity are chosen to be mounted, polished and imaged.
- ❖ A series of polishing steps are performed down to 0.05 colloidal silica in a vibratory polisher.
- ❖ Once polished, imaging was conducted using the LSCM.

Key Result: Filament cracking occurs predominately in the bent regions of wires on the high-pressure side of the TF cable. Little to no filament cracking is found in the heat treated and low pressure wires.

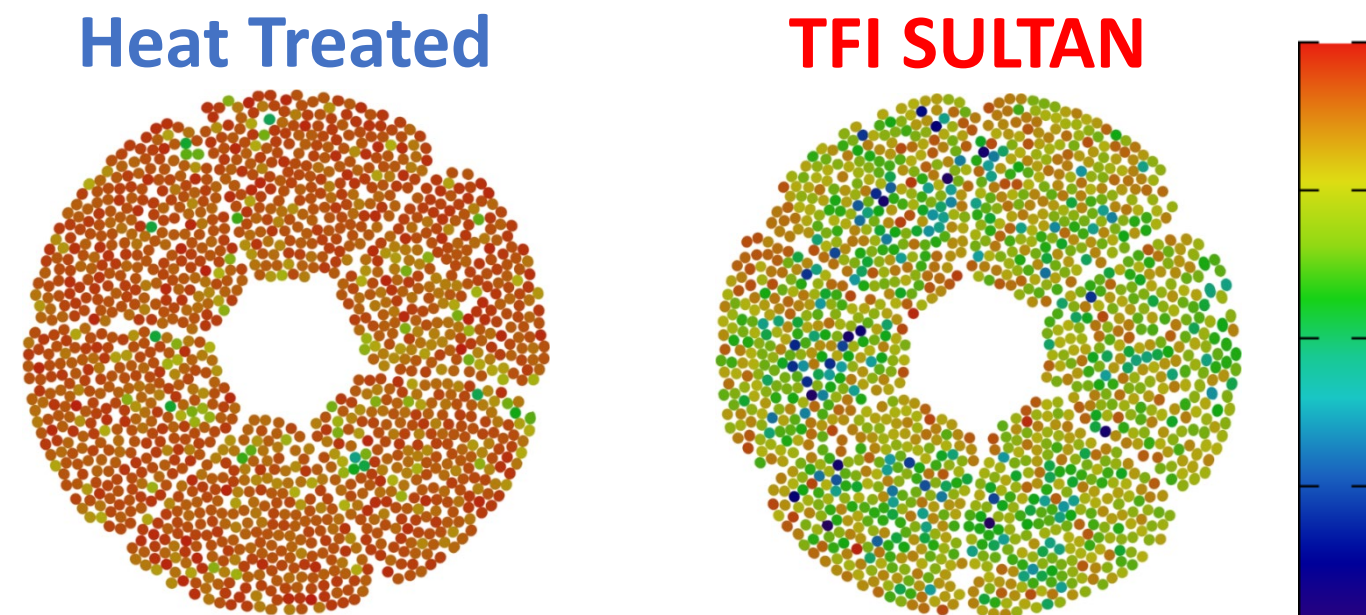
Circularity Color Map

- ❖ Our digital image analysis can detect changes in the wire cross-sections before and after SULTAN testing. For example, the tested conductors have lower wire circularity (possibly a result of the debris observed above), and the low-pressure side of the tested conductor shows greater strand bending (measured here by apparent diameter).

Lorentz force direction

Key Result: 1. The circularity of the wires degrades after extensive testing.
2. Wires shift during testing causing wires on the low pressure side to tilt/bend, which is shown as a change in their apparent diameter.

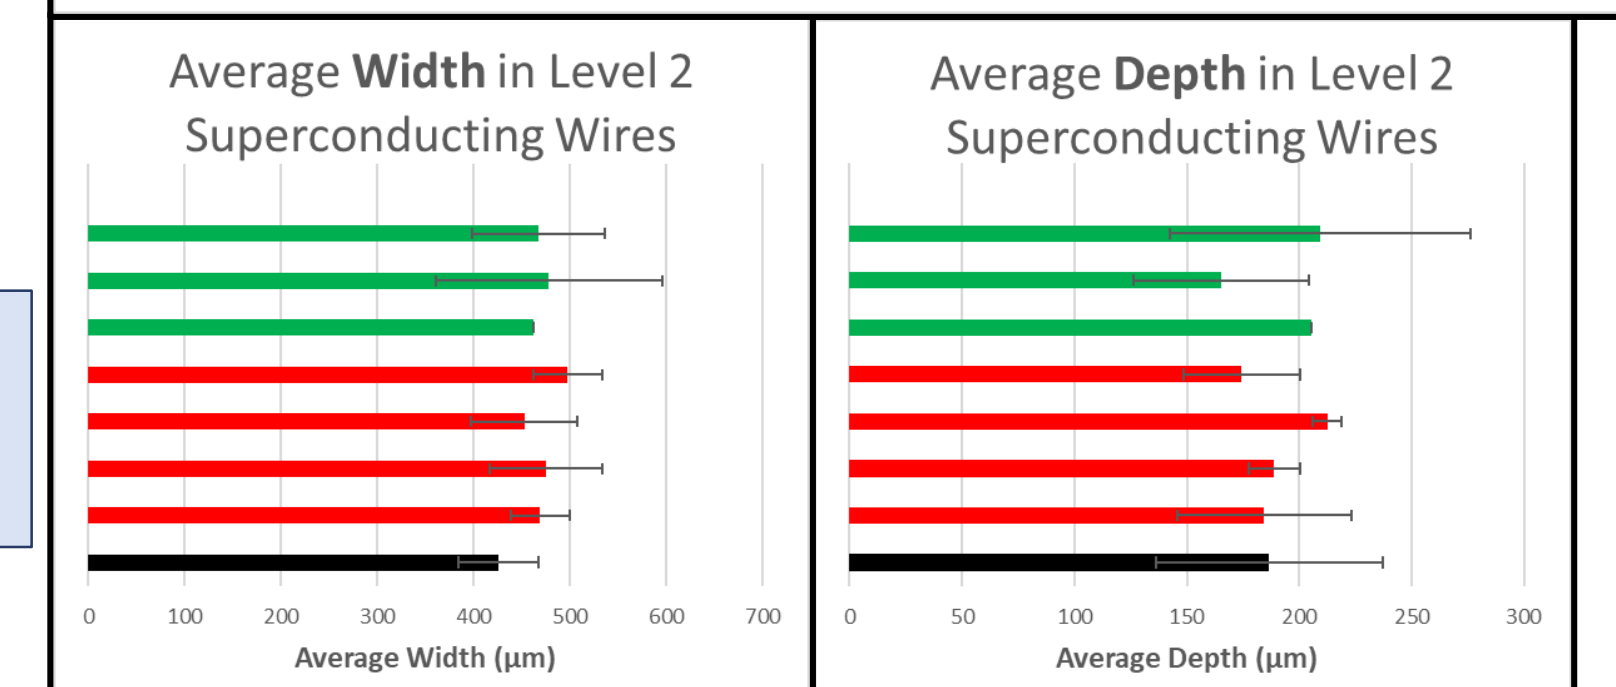
- ❖ The TFI SULTAN samples consistently show more wires exhibiting deformation compared to heat treated samples.
- ❖ For both Cu and SC wires, we found there to be greater than twice the amount of dents compared to the heat treated sample as shown in the graph to the right.

- ❖ The image above left shows the regions where wires were selected from the disassembled cable to observe deformation levels within the petal.
- ❖ To the left are measurements made regarding level 2 wires that show surface defects get longer (but not wider or deeper) after SULTAN testing.

Key Result: The mechanical Lorentz force causes the surface defects to elongate but not deepen, suggesting that the primary motion during testing is wire rubbing rather than wires pressing against each other.
