RESULTS OF BEAM BASED RF POWER PRODUCTION IN CTF3

Alessandro Cappelletti for CTF3 collaboration 5th May 2010

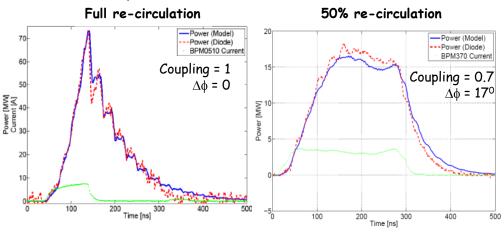
For the fixed parameters of re-circulation (loop delay, coupling, ohmic efficiency and RF phase error) and given pulse shape of the current, the generated RF pulse can be reconstructed/predicted rather well:

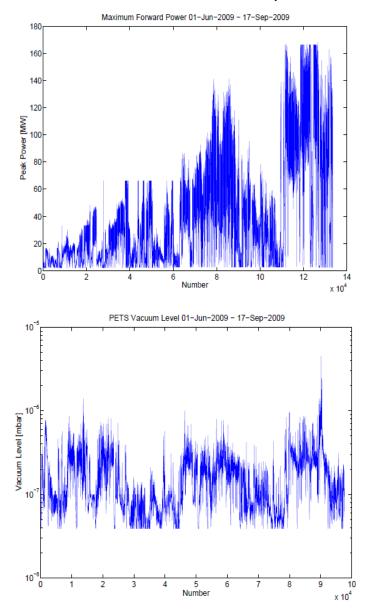
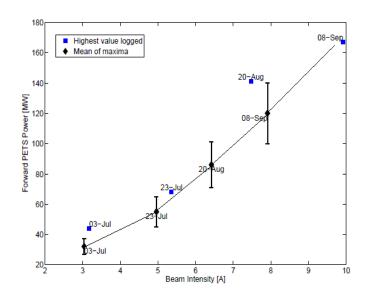
June-September 2009 PETS TBTS processing history

In total, 60 hours (~2×10⁵ pulses) of the RF power production in the PETS was accumulated. The peak RF power in full recirculation regime was gradually increased from 20MW to ~ 180 MW.

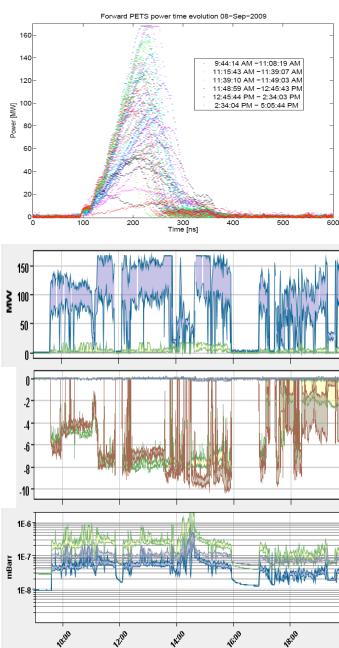
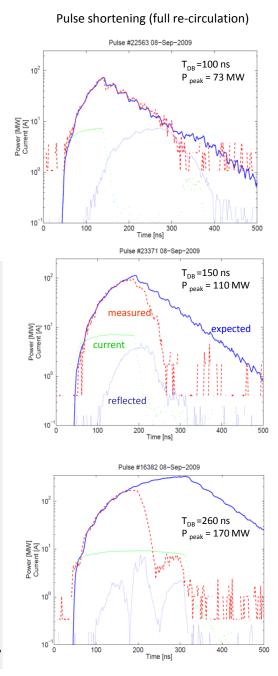
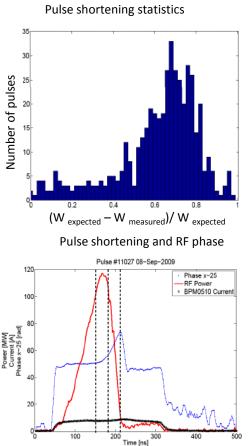
One day at TBTS. 08.09.2009

The processing strategy was rather aggressive. However, in most of the cases the pulse shortening followed the recirculation parameters transient modification (phase and amplitude) and thus the power production was normally quenched (no missing energy).

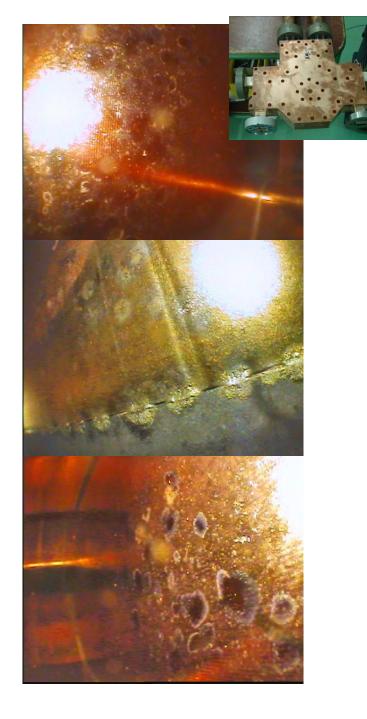
The detailed analysis of the signals gave us a strong indication that in most of the cases the breakdown activity was associated with feedback loop and not the PETS itself.

We have opened attenuator and found multiple traces of breakdowns inside the attenuator splitter.

It was decided to completely remove the attenuator and to continue the next run in a full re-circulation mode using a phase shifter for the power level modulation.

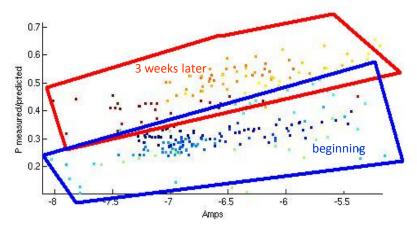
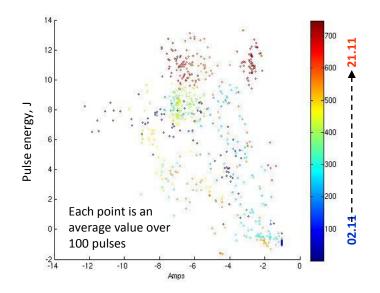
October-December 2009 PETS TBTS processing history

Since 02.11.2009 the phase shifter has being kept at the same position, which corresponds to the <u>full recirculation</u>. In total there were about 75k pulses at 1.2 Hz, which is ~25 beam-hours (25 SLAC's minutes)

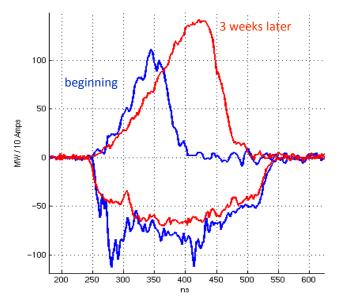
RF pulse envelopes with pulse shortening at the different stages of processing

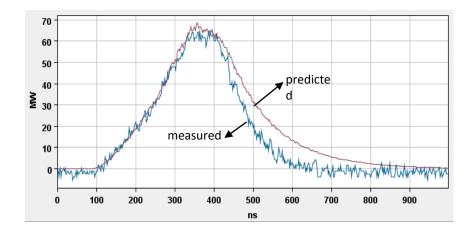
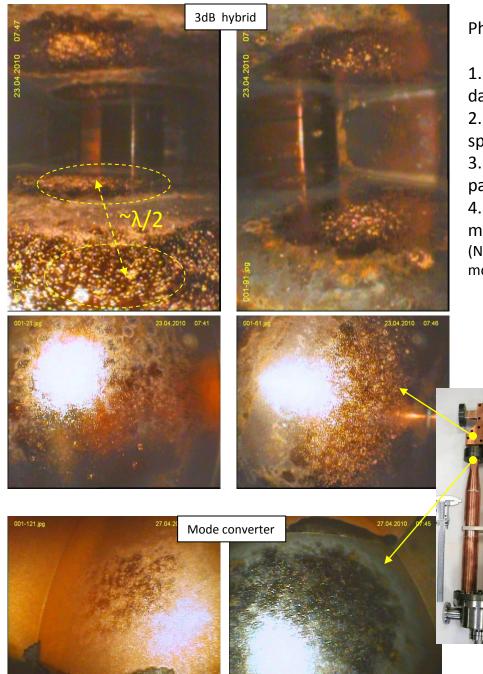
Phase shifter autopsy:

1. The hybrid of the phase shifter showed much stronger damages than that of attenuator.

2. The surface looks melted rather than having "dirty" spots.

3. The breakdown spots nicely show the standing wave pattern.

4. In the mode converter, the breakdown erosion was found mostly at/close to the input flange.

(Note: for the same input power phase shifter was exposed to `~40% more electric filed than attenuator)

The RF signal analysis indicated that in most of the cases breakdown activity was associated with feedback loop and not the PETS itself. Latest visual inspection of the attenuator's and phase shifter's hybrid bodies showed serious breakdown damages and confirmed that these devices were limiting the performance.

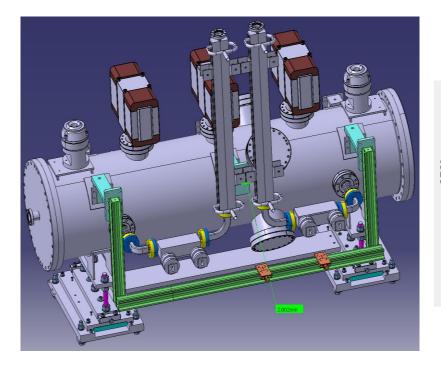
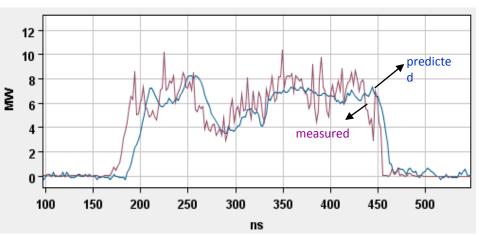
December 2009 PETS TBTS calibration test (no recirculation)

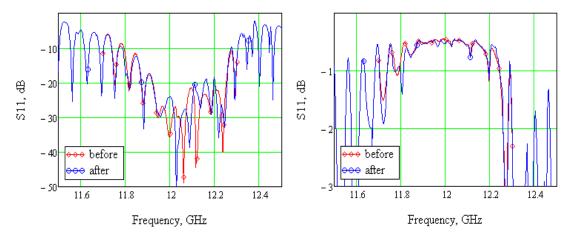
TBTS PETS low RF power measurements before and after processing

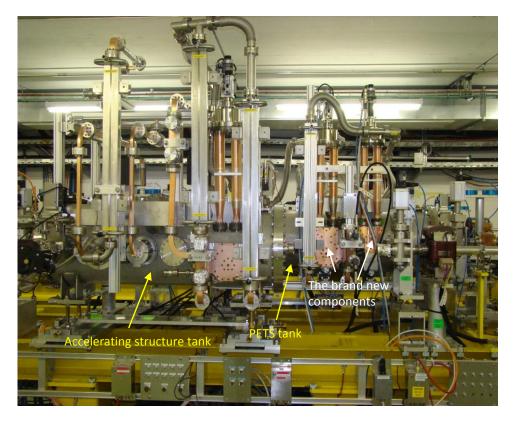
Current TBTS hardware status and actions taken since beginning 2010

The operation will start with fixed 50% RF power split and tuned in-phase recirculation length.

1. The brand new waveguide components made by GYCOM (Russia) went through the complete cleaning procedure:

- Chemical
- Hydrogen firing
- Vacuum firing
- and were installed back into the PETS re-circulation loop

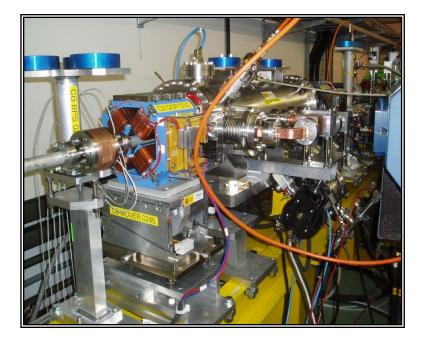
0.8m TBL PETS, beam driven power production

About 15 MW RF power was produced with a 10A beam according to predictions. No pulse shortening or other breakdown activities were observed.
