Status of the LHC

R. Bailey
CERN, Geneva, Switzerland

Incident of September 19th 2008

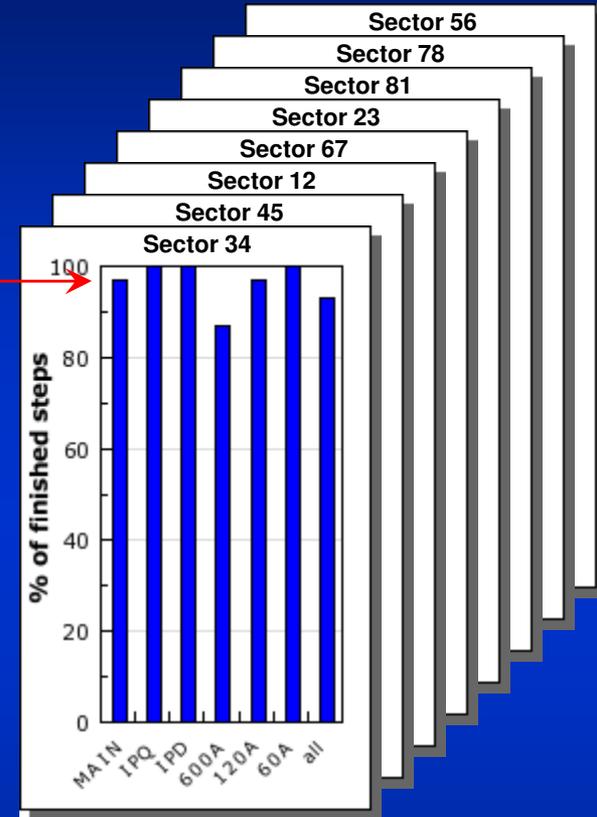
Development of resistive zone in dipole bus bar splice

- During a few days period without beam while recovering from transformer failure
- Making the last step of the dipole circuit in sector 34, to 9.3kA
- At 8.7kA, development of resistive zone in the dipole bus bar splice between Q24 R3 and the neighbouring dipole
 - Later estimated (from cryogenic data on heat deposition) to be 220nΩ
- Electrical arc developed which punctured the helium enclosure, allowing helium release into the insulating vacuum
- Large pressure wave travelled along the accelerator in both directions

1232 dipoles, 392 dipoles, 6 high current splices each

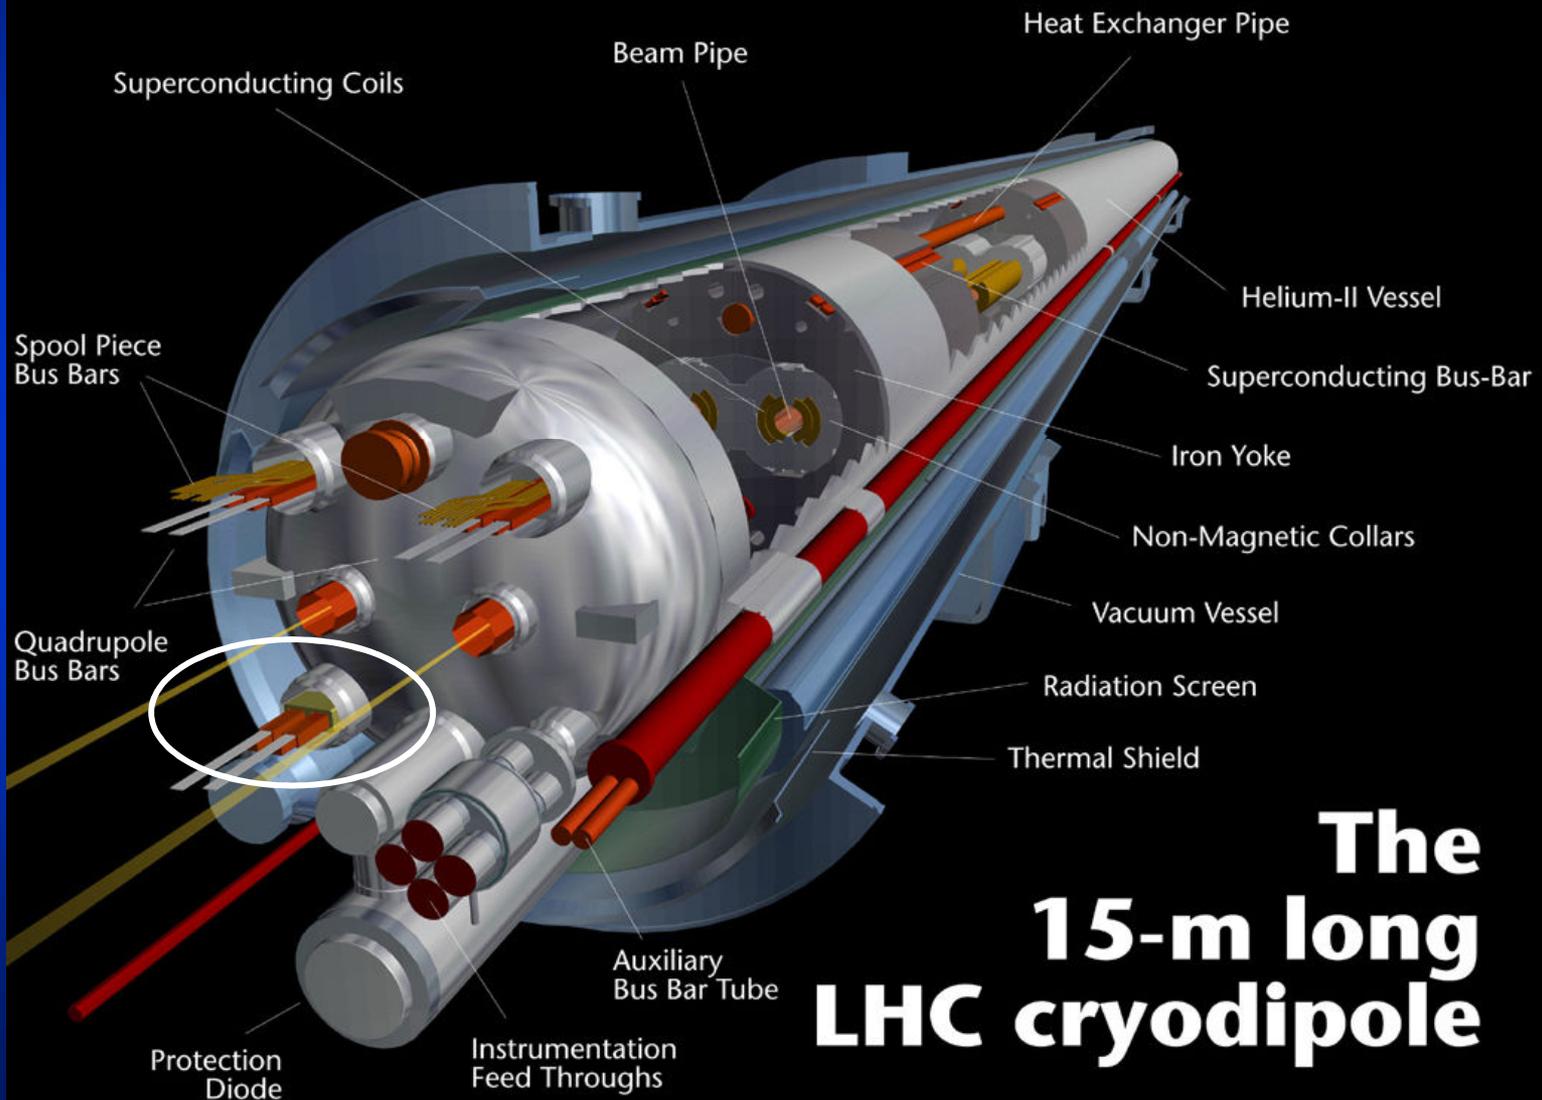
**The
15-m long
LHC cryodipole**

Arc and helium release into the insulating vacuum

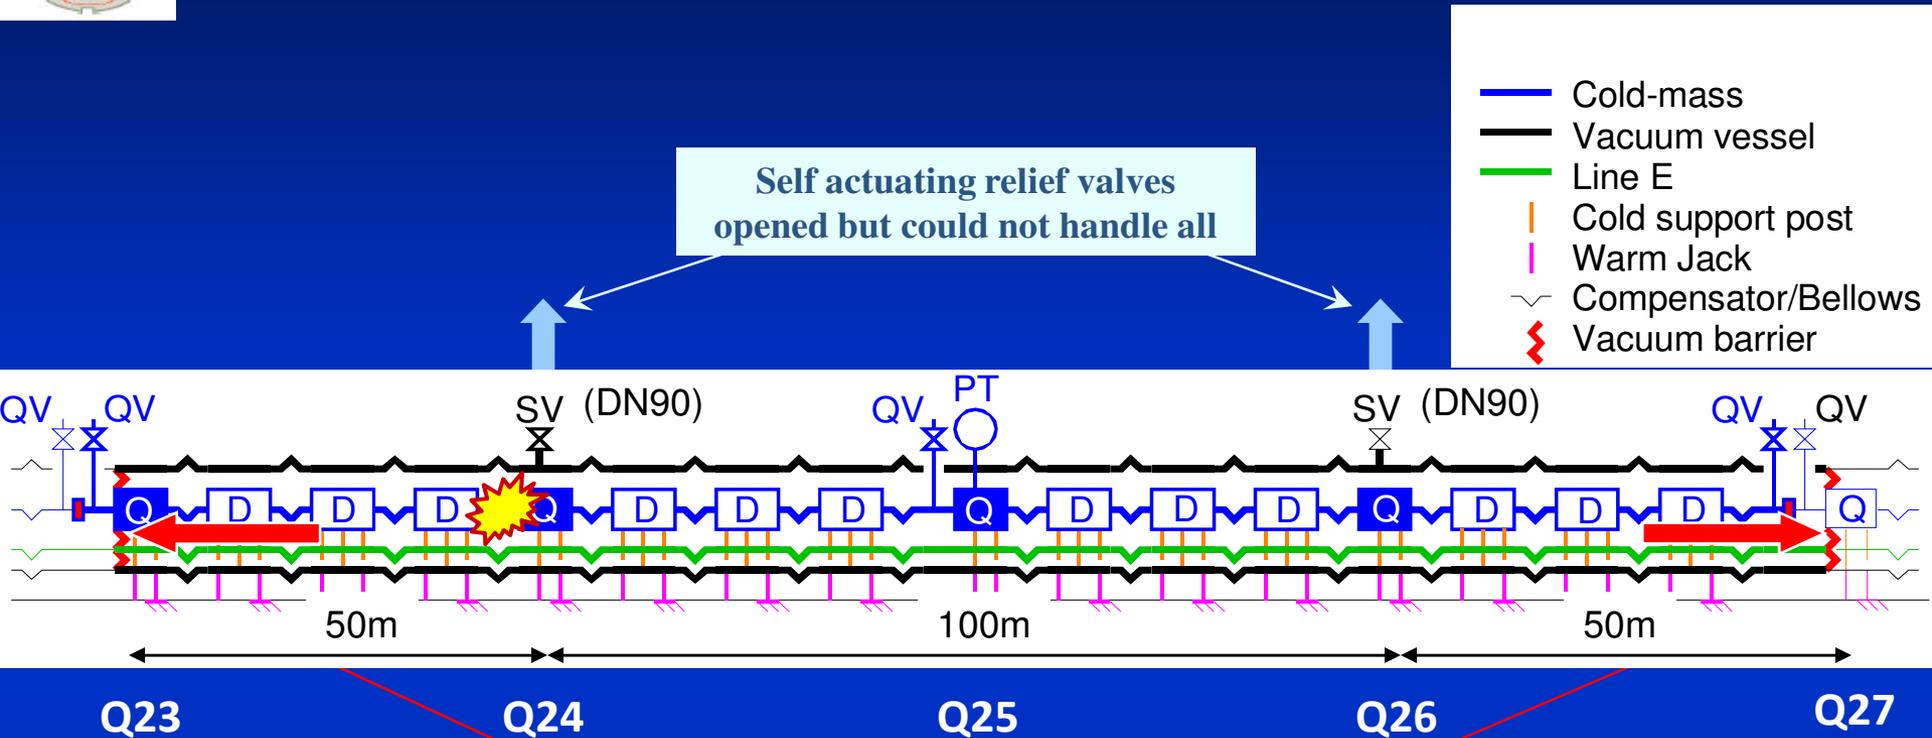
Large pressure wave travelled along the accelerator

Self actuating relief valves opened but could not handle all

Large forces exerted on vacuum barriers located every 2 cells

Connections to cryogenic line also affected in several places

Beam vacuum system also affected

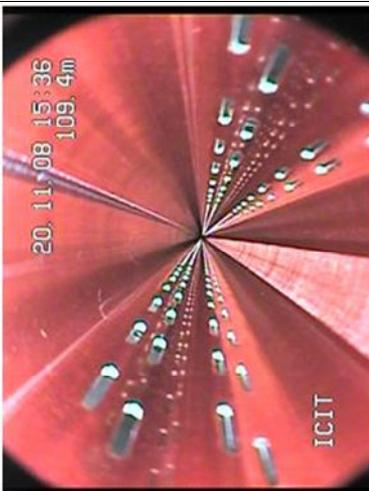
Beam Screen (BS) : The red color is characteristic of a clean copper surface

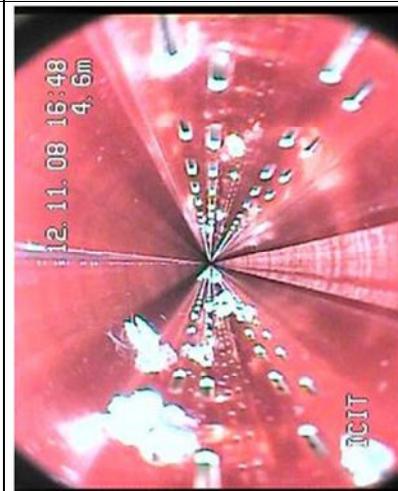
BS with some contamination by super-isolation (MLI multi layer insulation)

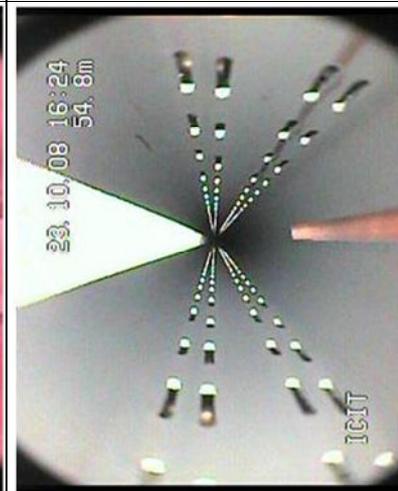
BS with soot contamination. The grey color varies depending on the thickness of the soot, from grey to dark.

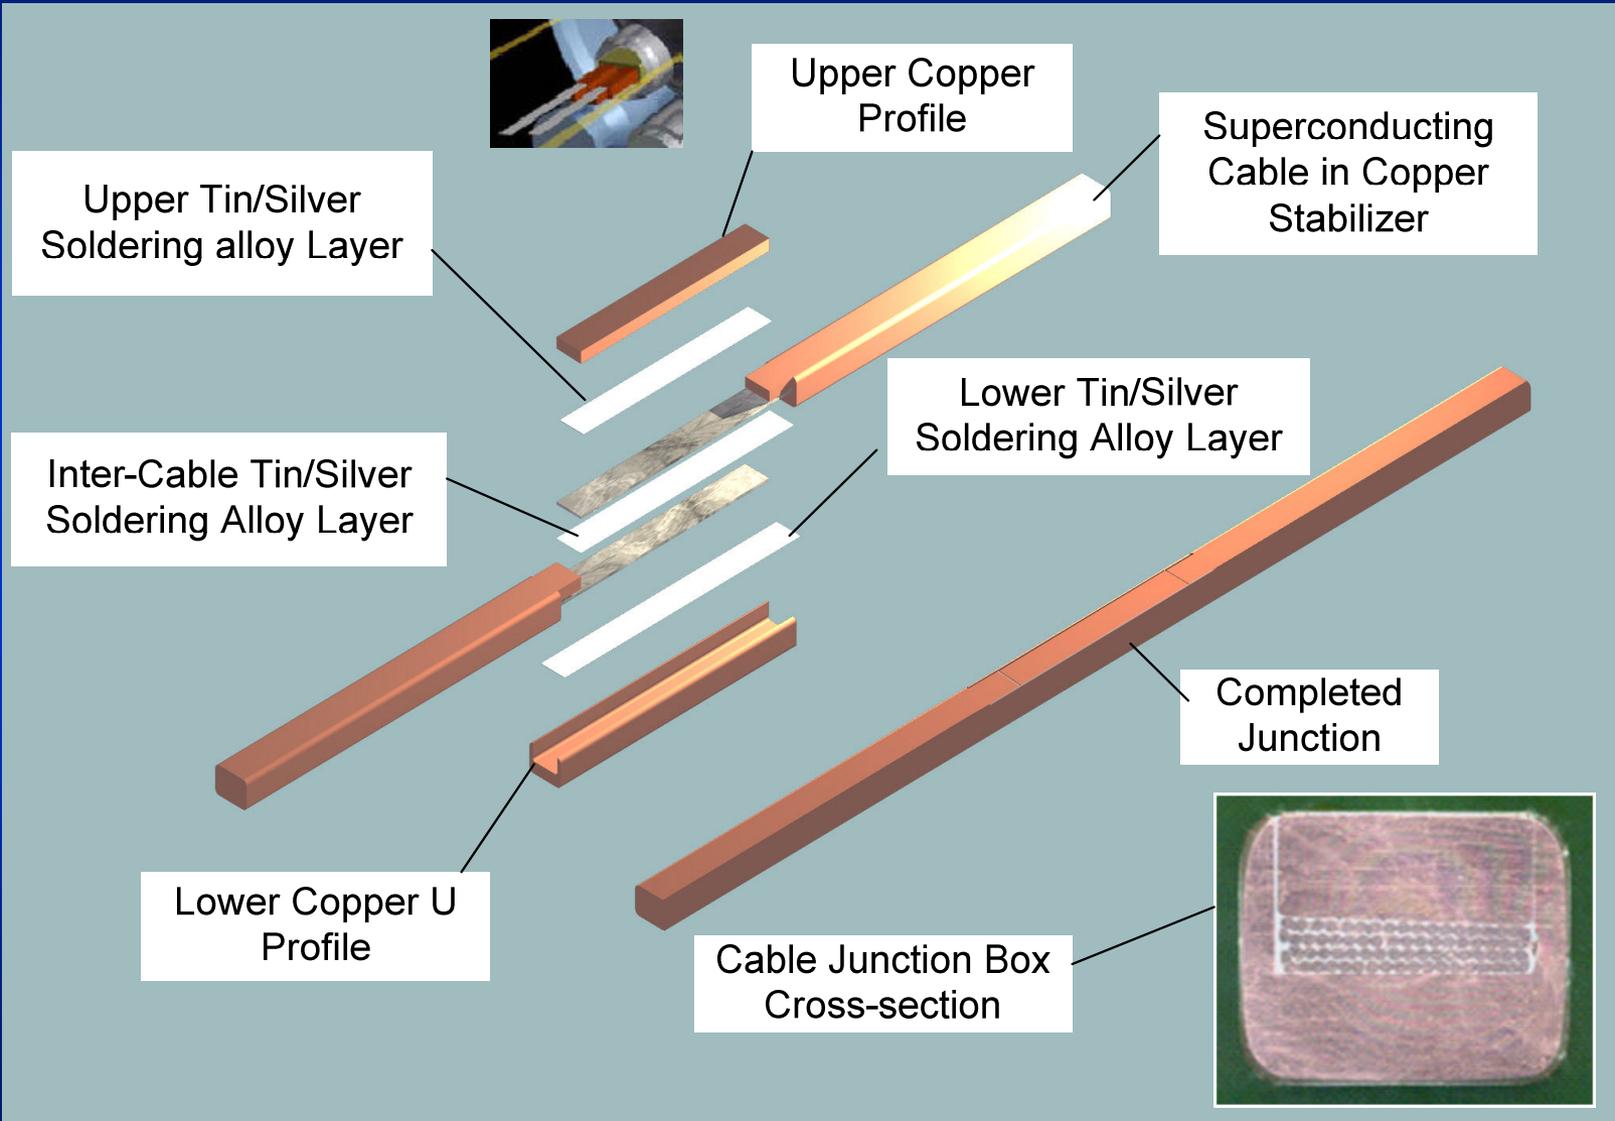
Bus bar splice construction

Interconnects

Superconductor

Solder

Copper stabilizer

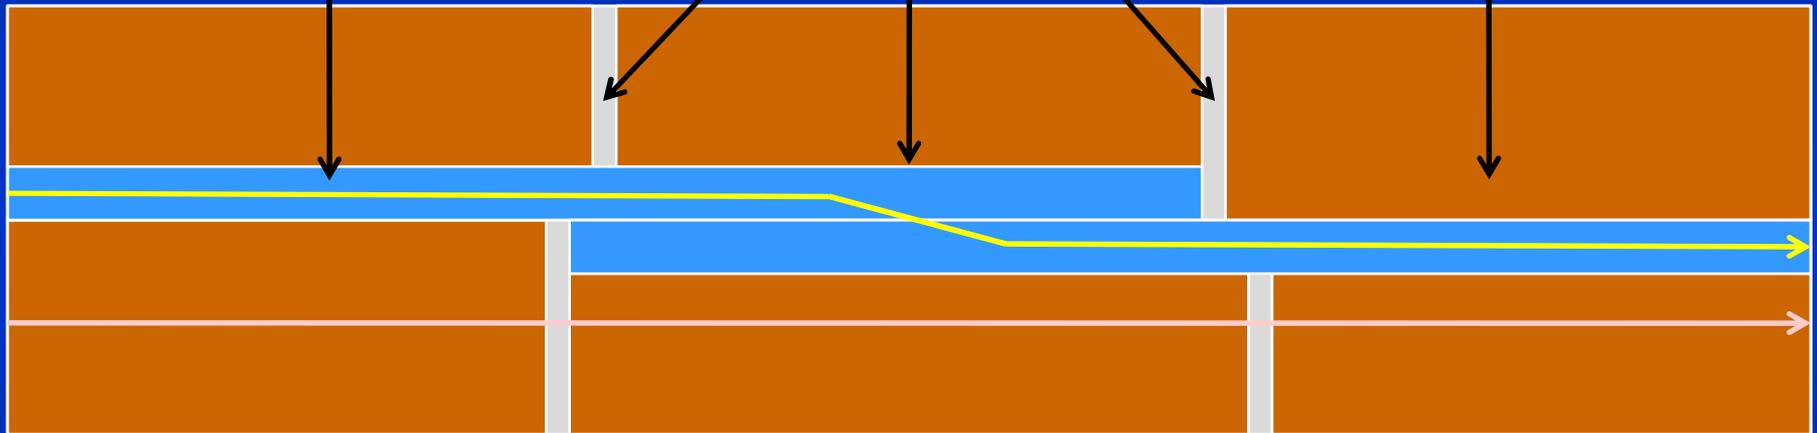
Current flow at 1.9K

Good joint resistance < 1 nΩ

Current flow after a quench

Good joint resistance < 10 μΩ

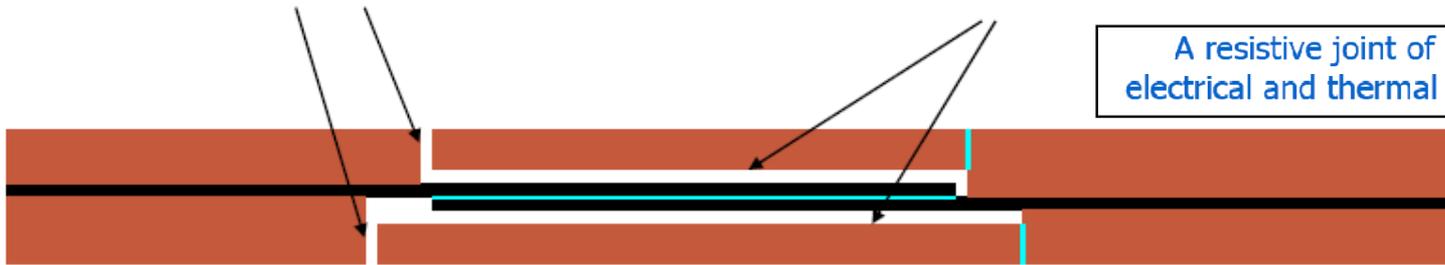
Most likely explanation (after tests and simulations)

No electrical contact between wedge and U-profile with the bus on at least 1 side of the joint

No bonding at joint with the U-profile and the wedge

A resistive joint of about $220\text{ n}\Omega$ with bad electrical and thermal contacts with the stabilizer

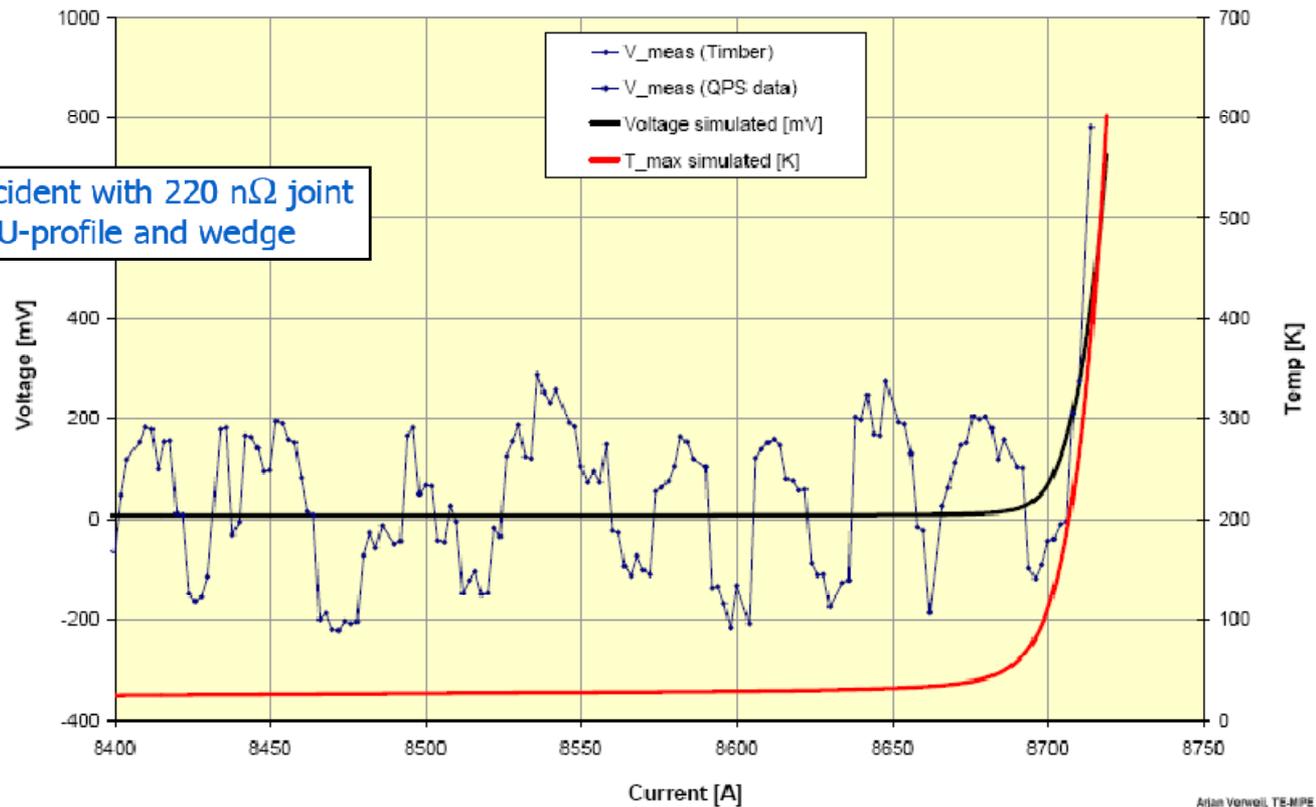
Measured vs simulated incident with $220\text{ n}\Omega$ joint and bad contact with U-profile and wedge

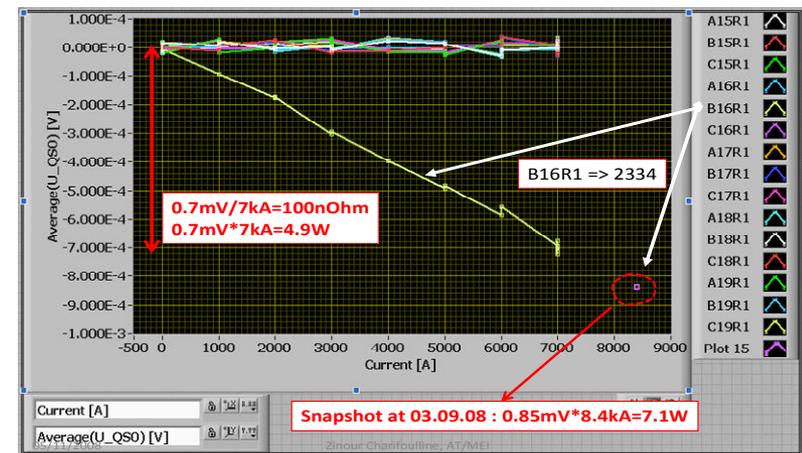
Sector A12: A15R1 – C19R1: Dipole Measurements made on 03.11.08

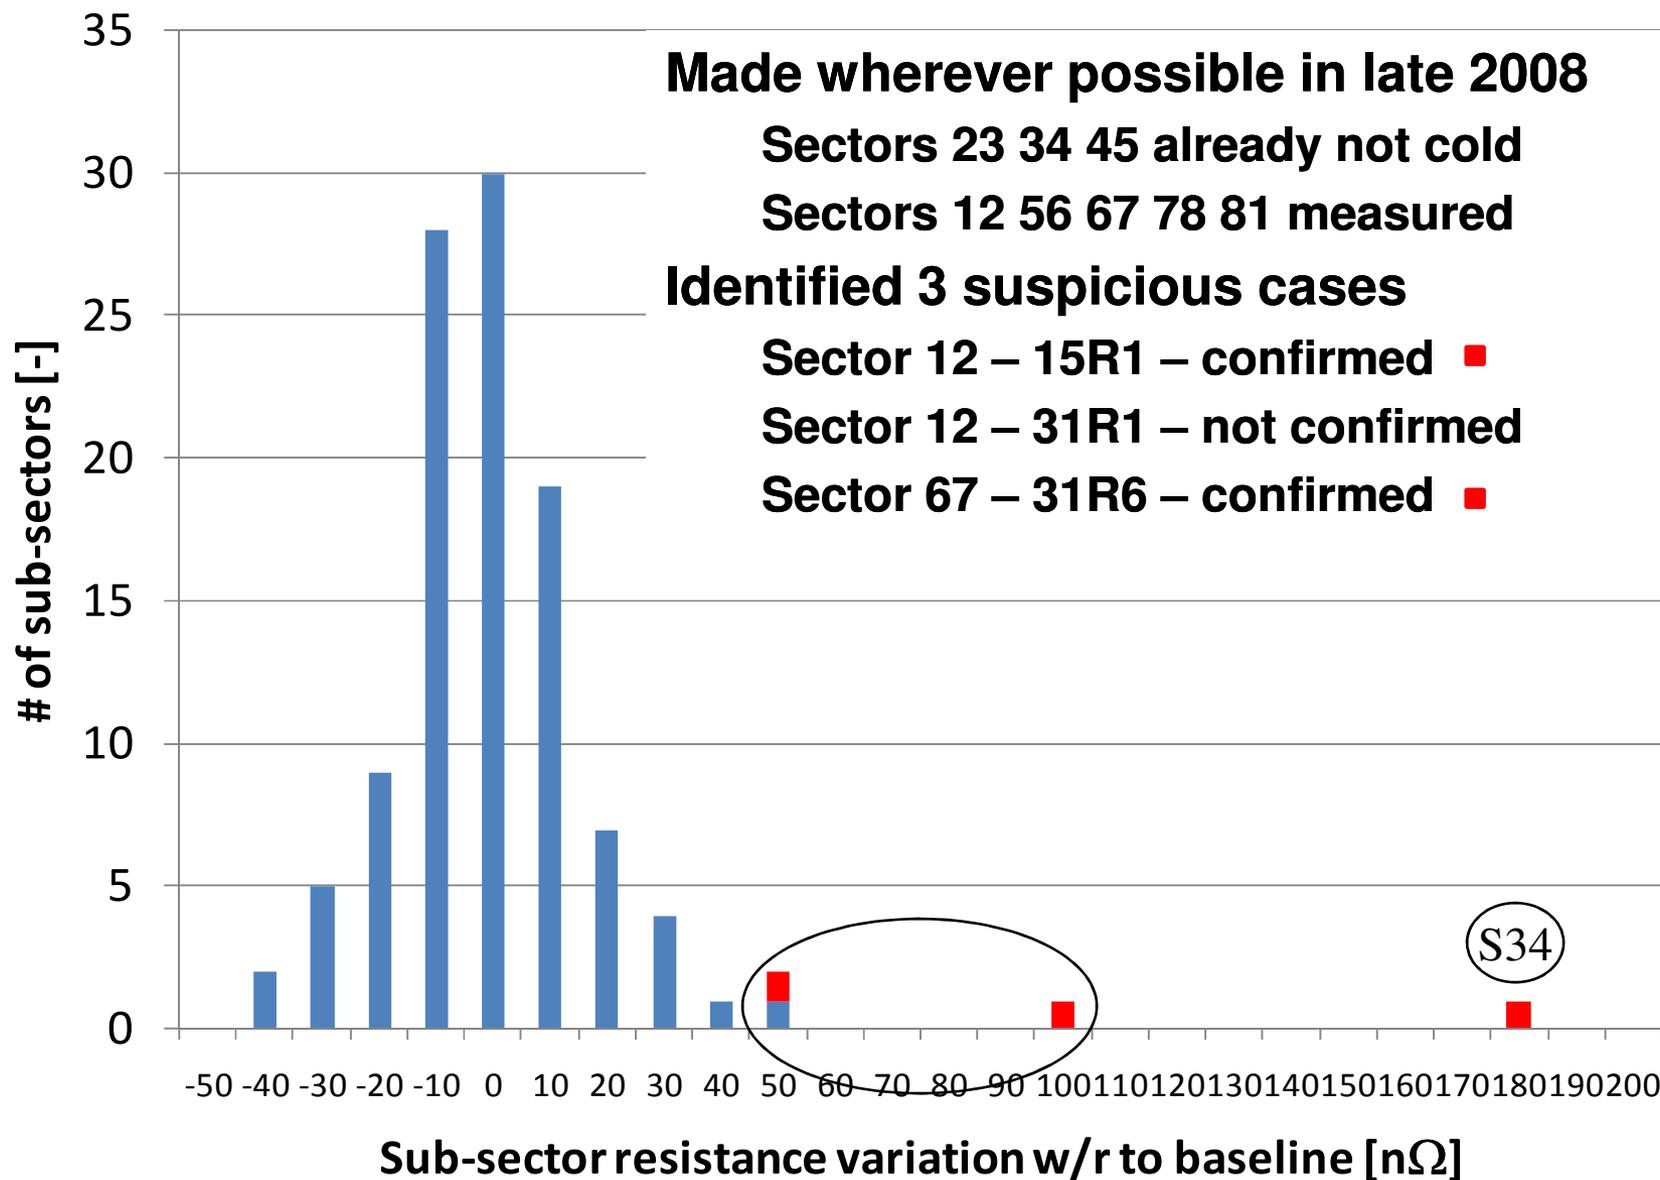
Calorimetric and electrical measurements summary

Splices (worst found 100nΩ, S12) (Chamonix)

SPLICES
23 34 45 not measured

- All in sectors 12 56 67 78 81 fixed above
 - 40 nΩ (magnets, no bad connection splices found)
- QPS threshold of 0.3 mV is needed to protect the dipole bus and the joints in all imaginable conditions
- Running at lower currents gives margin while new system is run in

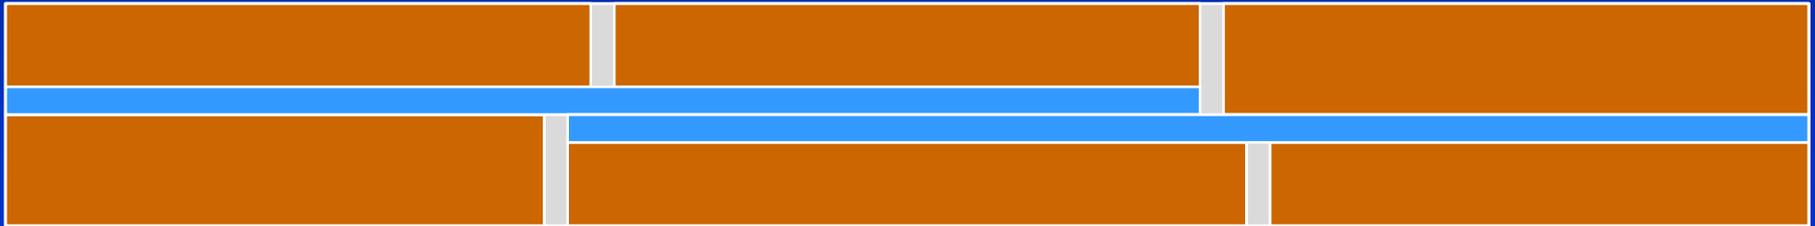
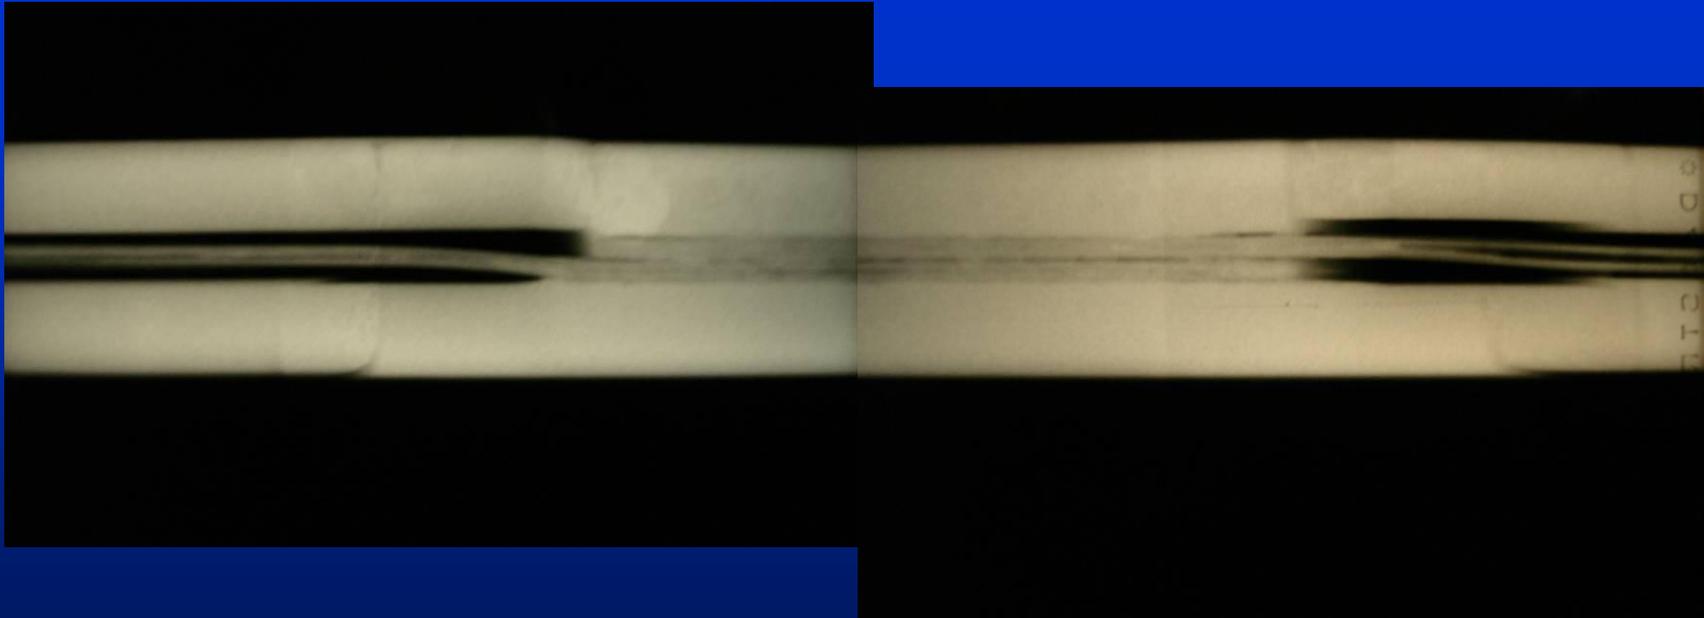
Investigations in sector 34 Q1 2009

Bad surprise after gamma-ray imaging of the joints

Void is present in bus extremities because SnAg flowed out during soldering of the joint

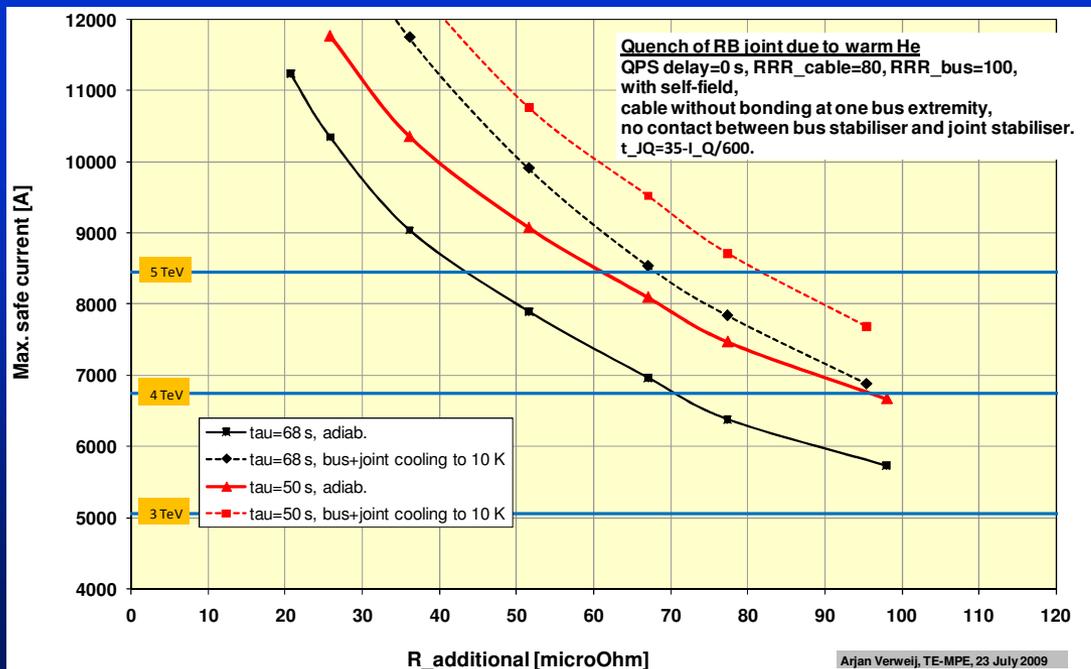
Modeling and outcome

- Simulate effects of a bad copper stabilizer joint
- Input data needed
 - RRR 100 Conservative
 - Worst joint left 90μΩ Conservative
 - Time needed for energy extraction (easily modified)
 - Conditions at the joint when quench occurs
 - Essentially determined by quench propagation and cooling

68s OK for 3.5 TeV

51s OK for 4 TeV
