Mortality study on irradiated HPK-P2 W36 LGADs and PINs

(I part): TCT-SPA

38th RD50 Workshop, June 21-23, 2021, CERN

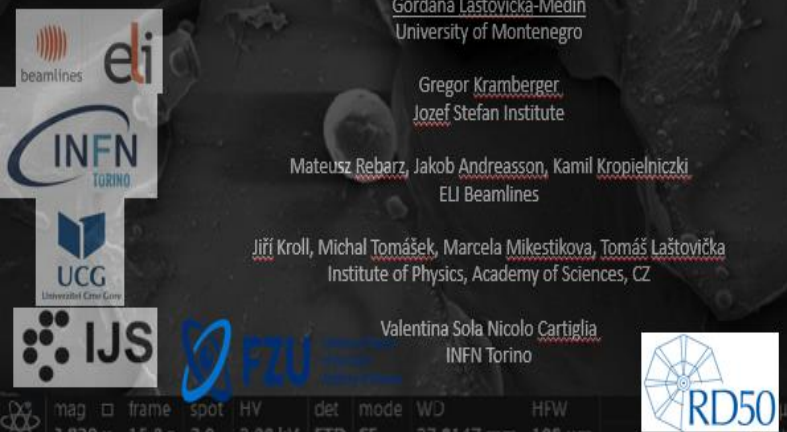
mag	frame	spot	HV	det	mode	WD	HPW
3.830 x	15.8 s	3.0	2.00 kV	ETD SE		27.8147 mm	108 μm

- ❑ It seems that all the fatalities occur at the metallization-opening interface!
- ❑ The “avalanche” seems to be triggered in the centre of opening where the laser hits the sensor, but the damage occurs at the point metal-Si interface, as there is a resistive path at metal-si interface which causes the heating and melting away the silicon. At lower bias voltages these sensors can take huge abuse with highly energetic laser pulses and that doesn't hurt them. So it must be field related.
- ❑ No crater fatality signature seen as it was the case in test-beams; this is the most probable because in ELI tests we did not use 10 nF capacitor (set on timing board) so damage happen later. There is no discharge through sensor, and thus no crater rupture.

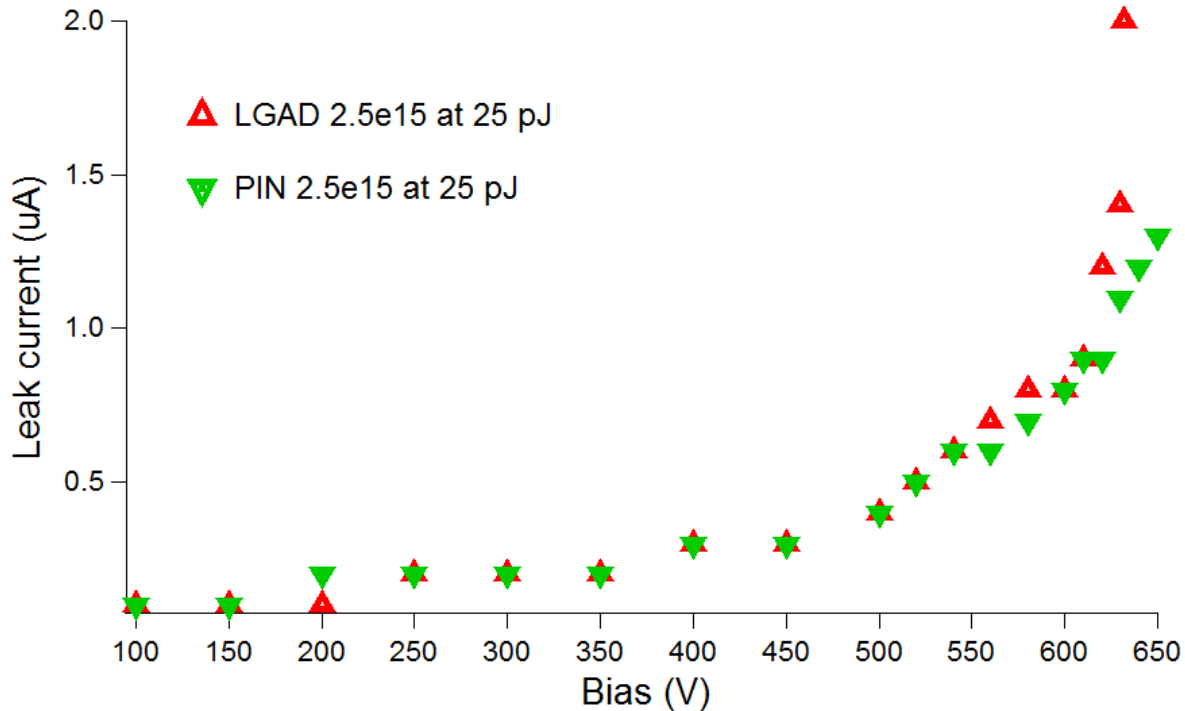
Leak current

- ❑ The leak current was recorded for different bias values.
- ❑ Nearly identical dependency was observed for all the samples at low illumination level. The small differences between LGADs and PINs appears only for higher laser power (see example below).
- ❑ Above stability threshold the current is jumpy and it's not possible to define the value.

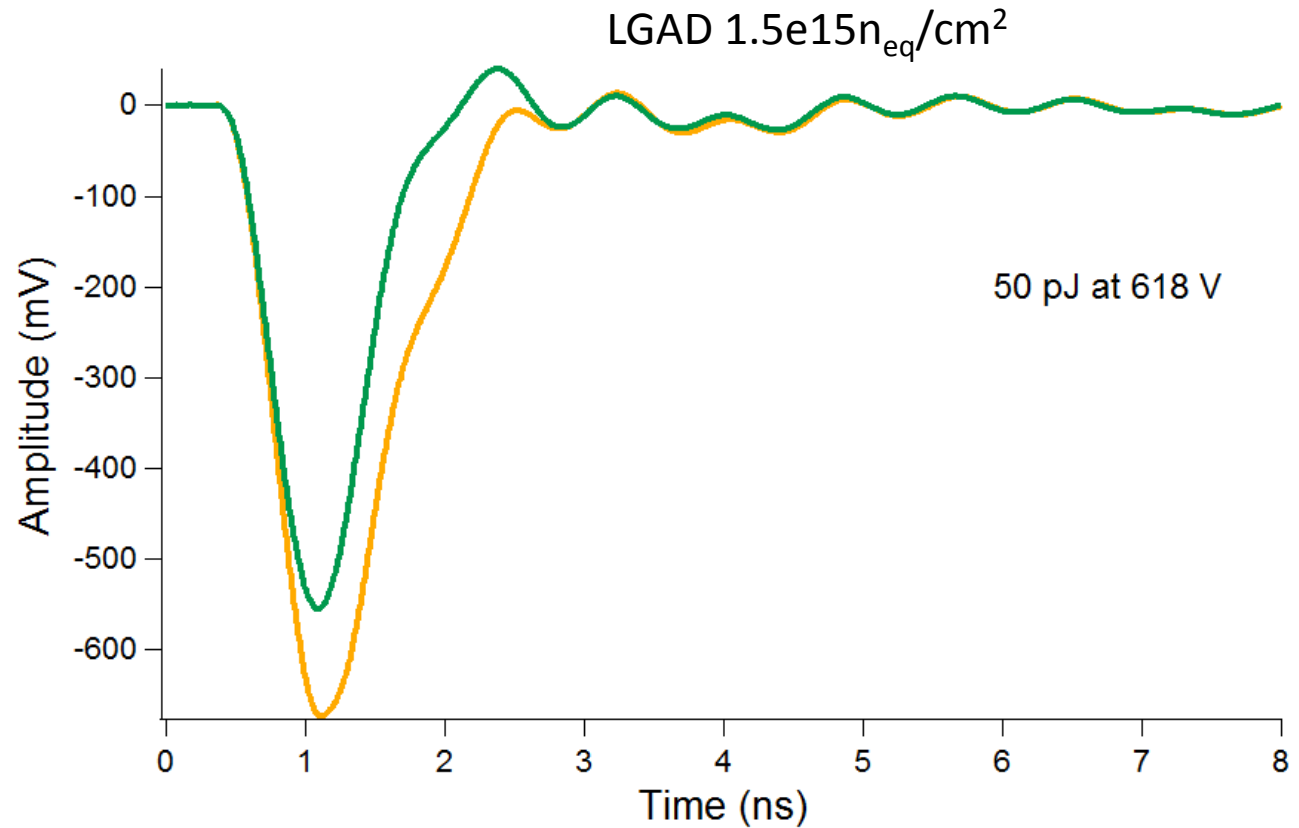
Stability threshold was found as pulse energy/bias conditions when the signal started slightly jumping at the constant laser power.

In spite of clear instabilities in the signal, the leak current was stable at the same time (at least with our 0.1 μA accuracy).

Example of two waveforms measured at the constant laser power and constant bias at two different moments (amplitude and width vary)

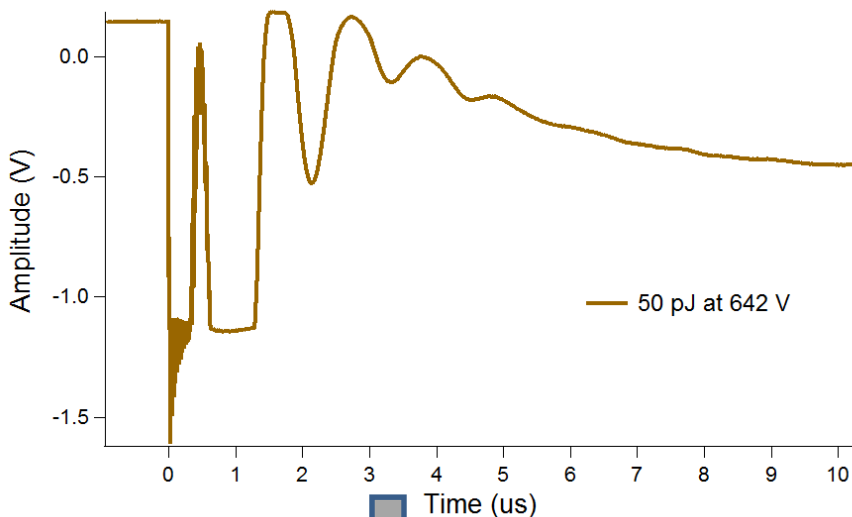
Further increase of bias results in completely deformed **signal waveforms extending to hundredths of microseconds**. The leak current jumps very rapidly and it shows that we are close to damage threshold.

Example of waveforms corresponding to very unstable region for LGAD $1.5e15 \text{ n}_{eq}/\text{cm}^2$
(it's not the one where LGAD went into irreversible breakdown)

- Sensor not yet irreversible damaged, but next to it
- Instability is not yet destructive, still reversible
- Energy imported by laser and el field is such that sensor become unstable but not destroyed yet
- If HV bias is reduced, for instance by 5V, the sensor would be stable again (tested experimentally and confirmed)

- ❑ The waveforms recorded at 642V and 50 pJ represent the **signal just before irreversible breakdown** occurred. They are the last waveforms recorded for this sensor. The amplitude and shape of the waveform is very unstable in such condition. The current is also very jumpy and varies between 10 and 70 μA . Since we know from experience that such signal means that we are close to breakdown and amplitude jumps to several Volts we disconnected the scope (for safety) and increased the bias by 1 V observing the current only. At 645V the system broke down.
- ❑ Thus, it's hard to say what was exactly current drawn at that moment. This is very rapid increase and we don't have yet any solution how to record exact value. One thing we can say is that the current drawn is in region **10s of μA when the sensor is close to damage threshold**. Of course this conclusion is valid at temperature -25 C.

Remark: **when instability occurs and LGAD experiences sequence of reversible breakdowns, if the HV bias is reduced by a few Volts it is possible to bring LGAD back to the fully operational and stable conditions (experimentally confirmed). Such control over instability (switching from the reverse breakdown to the working LGAD conditions or accelerating the irreversible breakdown by increasing the HV bias by a few Volts) is advantage of fs-laser beam tests.**

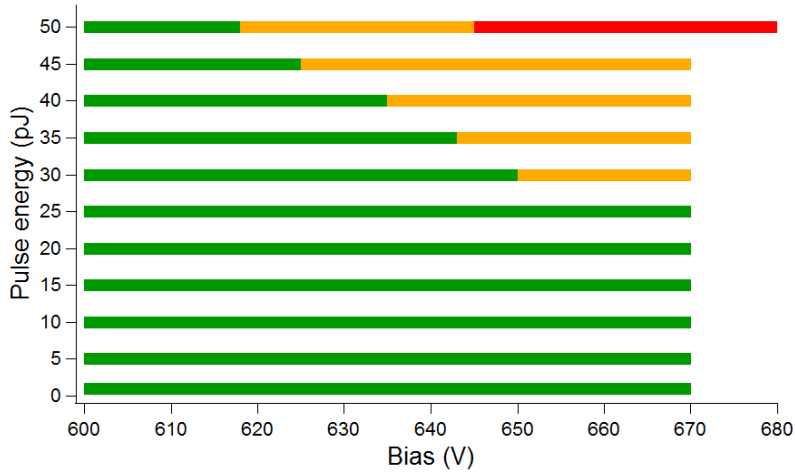
LGAD 1.5e15

Extended version with damage thresholds

■ Stable region
■ Unstable region
■ Damage region

No mitigation needed for 1.5e15 neq/cm²
